LAND-SURFACE COLLAPSE AND
GROUND-WATER PROBLEMS
IN THE JAMESTOWN AREA, BERKELEY COUNTY, SOUTH CAROLINA

B.C. Spigner
Hydrologist

South Carolina Water Resources Commission
Open-File Report No. [REDACTED] 2
July, 1978

South Carolina Water Resources Commission
Open-File Report No. 78-1
July, 1978

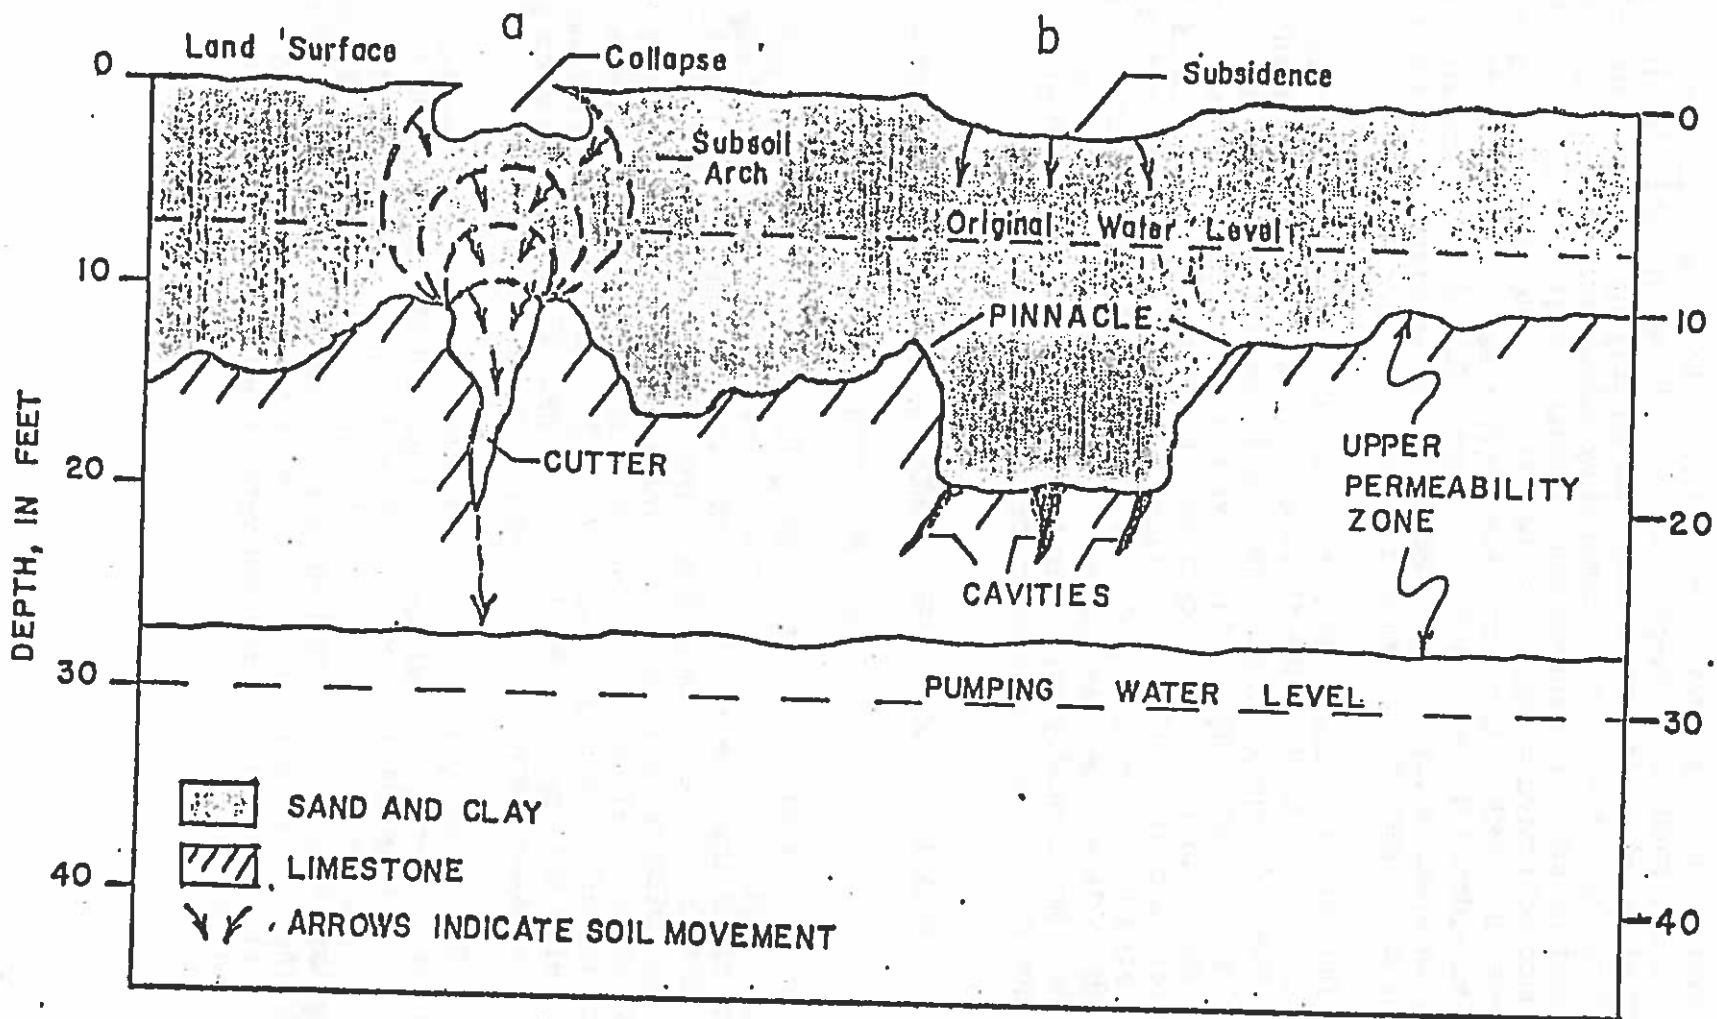
FIGURE 8. FORMATION OF COLLAPSES IN JAMESTOWN AREA

Indirect evidence to support the arching theory is also provided by examination of the soil-limestone contact in the quarry walls. Cutters and pinnacles are exposed in the northwest wall of the B.A.S.S. quarry and in the southeast wall of the Ware quarry. Cutters are filled with cohesive clays and the soil-limestone contact is highly irregular. The irregular contact is responsible for differential subsidence because of uneven stress distribution of loads imposed on the ground surface or as the water table declines. This irregular contact provides the necessary conditions for arching; the limestone pinnacles provide the solid abutments and the cutters provide the conduits for subsurface erosion of soils.

Subsidence depressions (fig. 8 b) are more likely to form in areas where the pinnacles are more widely spaced so an arch cannot form. Such depressions are also more likely to form where the soils overlying limestone bedrock are sandy and non-cohesive. As the water table declines and unconsolidated sands are carried into underlying cavities, inward soil creep replaces the material removed by subsurface erosion. Subsidence depressions are often surrounded by radial tension cracks which form as the unconsolidated material is sheared along the circumference of the depression. Such cracks sometimes provide early warning of the formation of a subsidence depression or a collapse. Subsidence depressions can also occur in areas underlain by cohesive clays. As clays are drained, compaction of the clays results in compaction subsidence depressions.

The lateral diameter and depth of collapses and subsidence depressions are directly related to the thickness of unconsolidated sediments in which these features occur. The size is not necessarily related to the diameter of underlying solution cavities in the Santee Limestone nor the total amount of water-level decline. A solution cavity which is 6-in in diameter is capable of transporting large volumes of water and sediment. It is also not necessary that cavities in the limestone occur directly beneath collapses because sediment can be transported vertically a short distance, horizontally for several hundreds of feet, and then discharged into quarries or natural subsurface outlets.

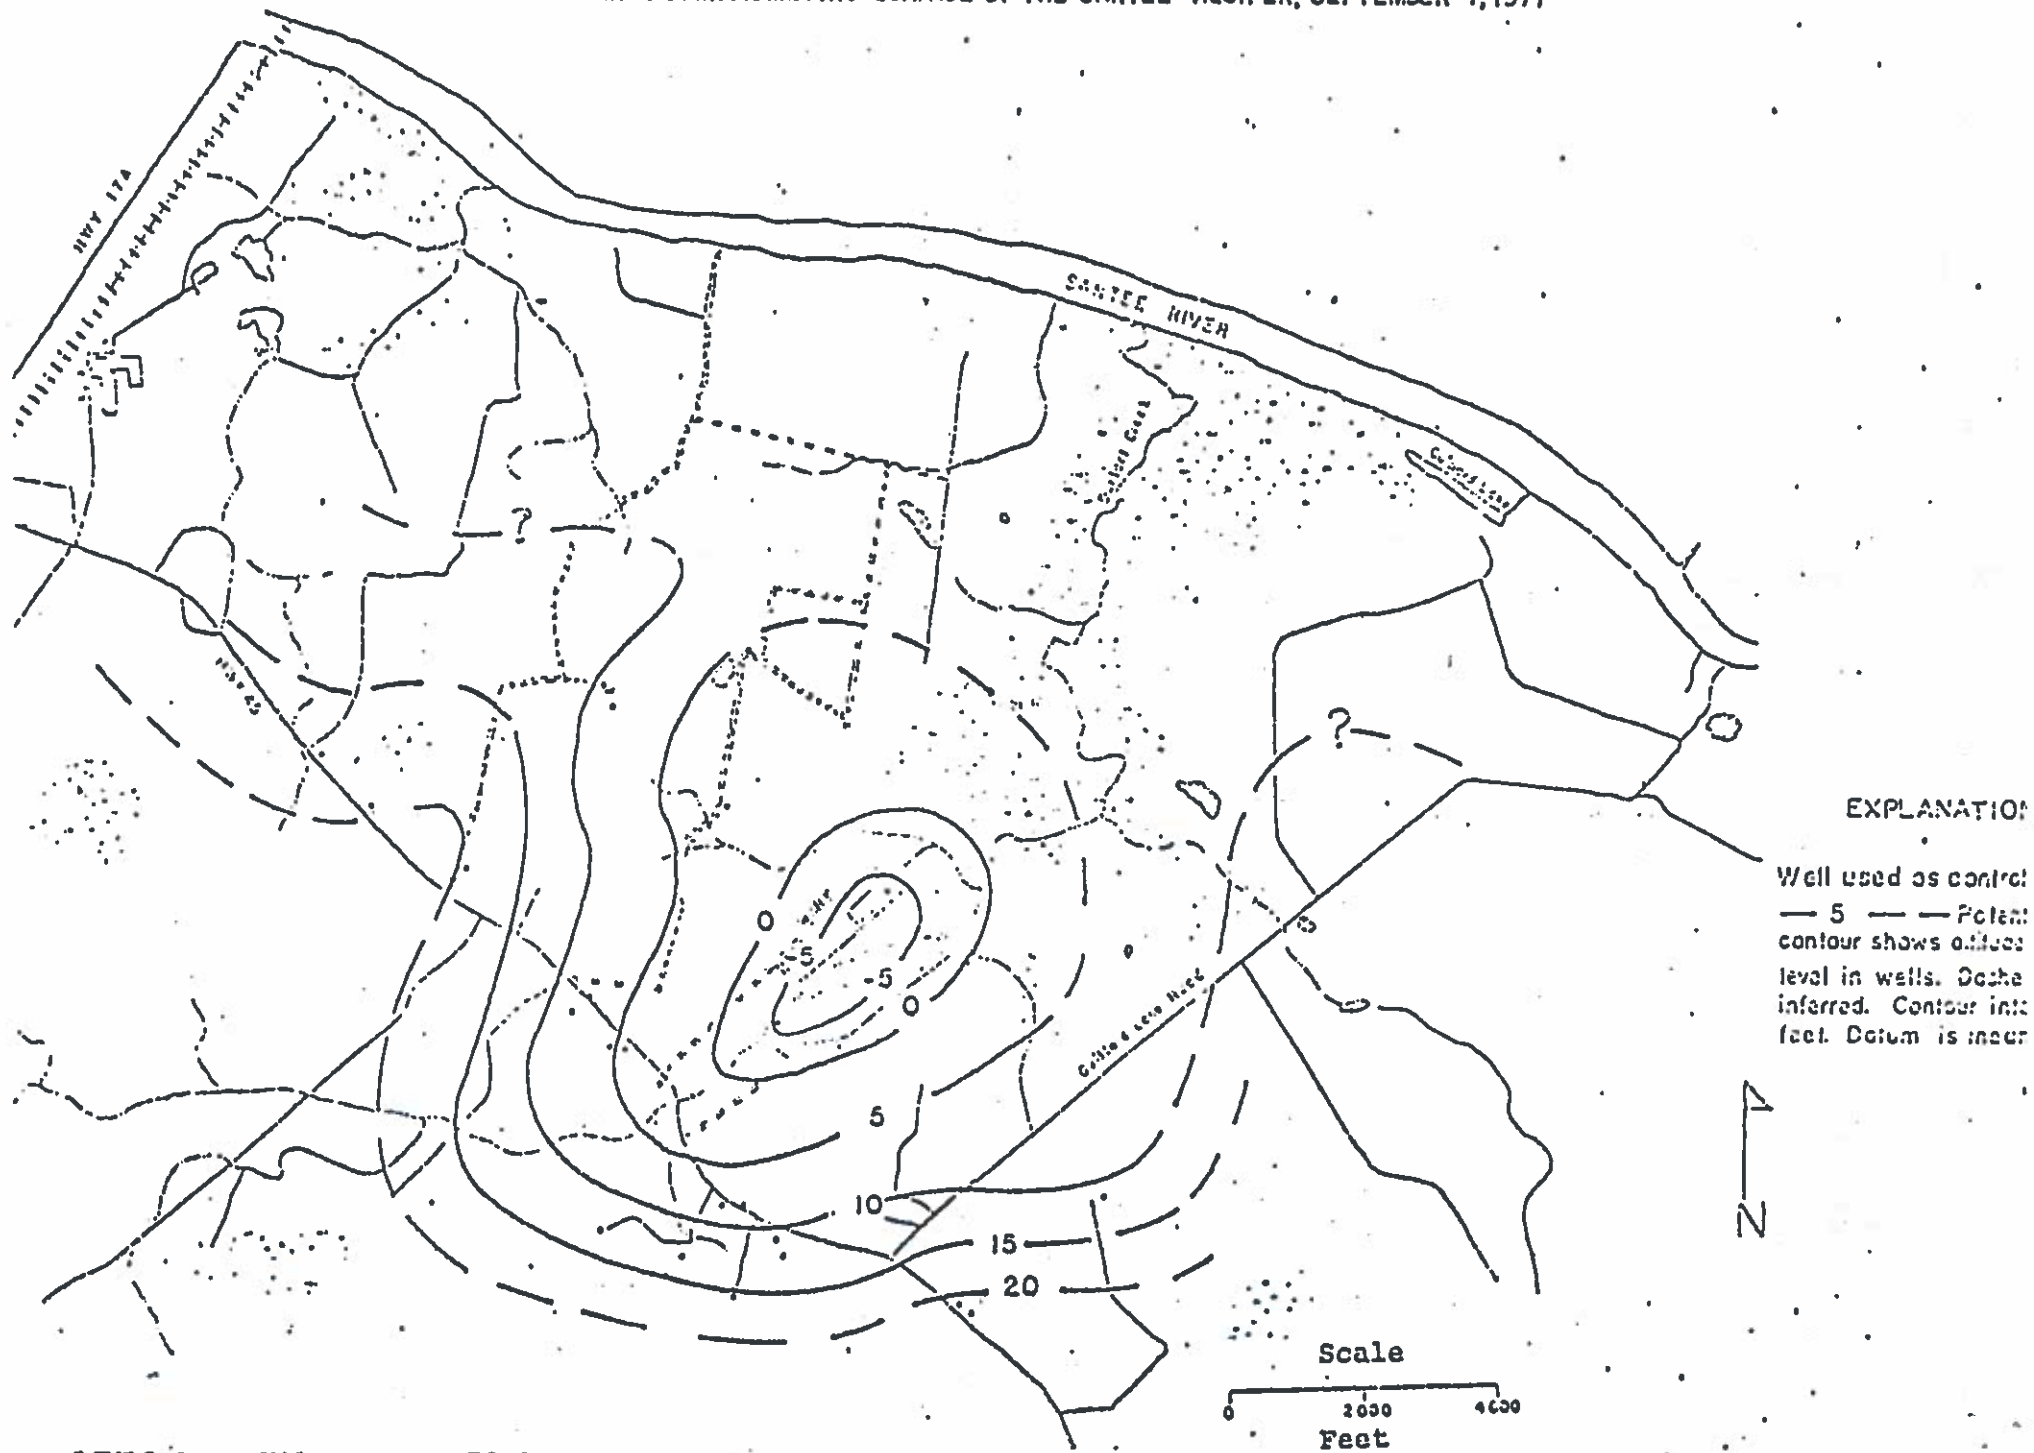
FIGURE 6. MAP SHOWING POTENTIOMETRIC SURFACE OF THE SANTEE AQUIFER, SEPTEMBER 7, 1977

A potentiometric map of the Santee aquifer was constructed from water-level measurements made in 11 unused wells and 10 temporarily unusable wells on September 7, 1977 (fig. 6). In addition, accurate elevations of the water levels in the two quarries were obtained by leveling. It was reported that there had been no pumpage at either quarry for 3 or 4 days prior to September 7, 1977 (Mr. Jack Whisnant, written communic., September, 1977). The potentiometric map shows a semi-circular cone of depression centered on the quarries, and ground water is moving toward the quarries from all directions. In addition, the map indicates that water in the B.A.S.S. quarry serves as a line-source of recharge to the Ware quarry. The swampy area along Dutart Creek northeast (downstream) of the quarries has been dewatered and is also a source of recharge to the cone of depression. Consequently,

the water-level contours are elongate in a northeastward direction-- indicating a lower hydraulic gradient in that direction. The steepest hydraulic gradient are south and west of the quarries between the +20 and +5 water-level contours.

The potentiometric map indicates that the upper part of the Santee aquifer, at least near Dutart Creek, behaves hydraulically as a confined, diffuse-flow aquifer. The large cone of depression centered on the limestone quarries has steepened the hydraulic gradient and has caused adjustment in ground-water flow in a large area around the quarries. Therefore, the potentiometric map is believed to accurately reflect ground-water levels in the Santee aquifer in the Dutart Creek area.

The underlying cause of collapses and subsidence depressions in the Jamestown area has been a substantial lowering of the ground-water table or potentiometric (artesian) head of the Santee aquifer. As shown previously (fig. 6), a large cone of depression exists around the limestone quarries and the water level in the Santee aquifer has been substantially lowered. Prior to the beginning of dewatering in 1975, the potentiometric head (water level) of the Santee aquifer was at an approximate elevation of +15 ft msl in the southwest end of the B.A.S.S. quarry. Conversation

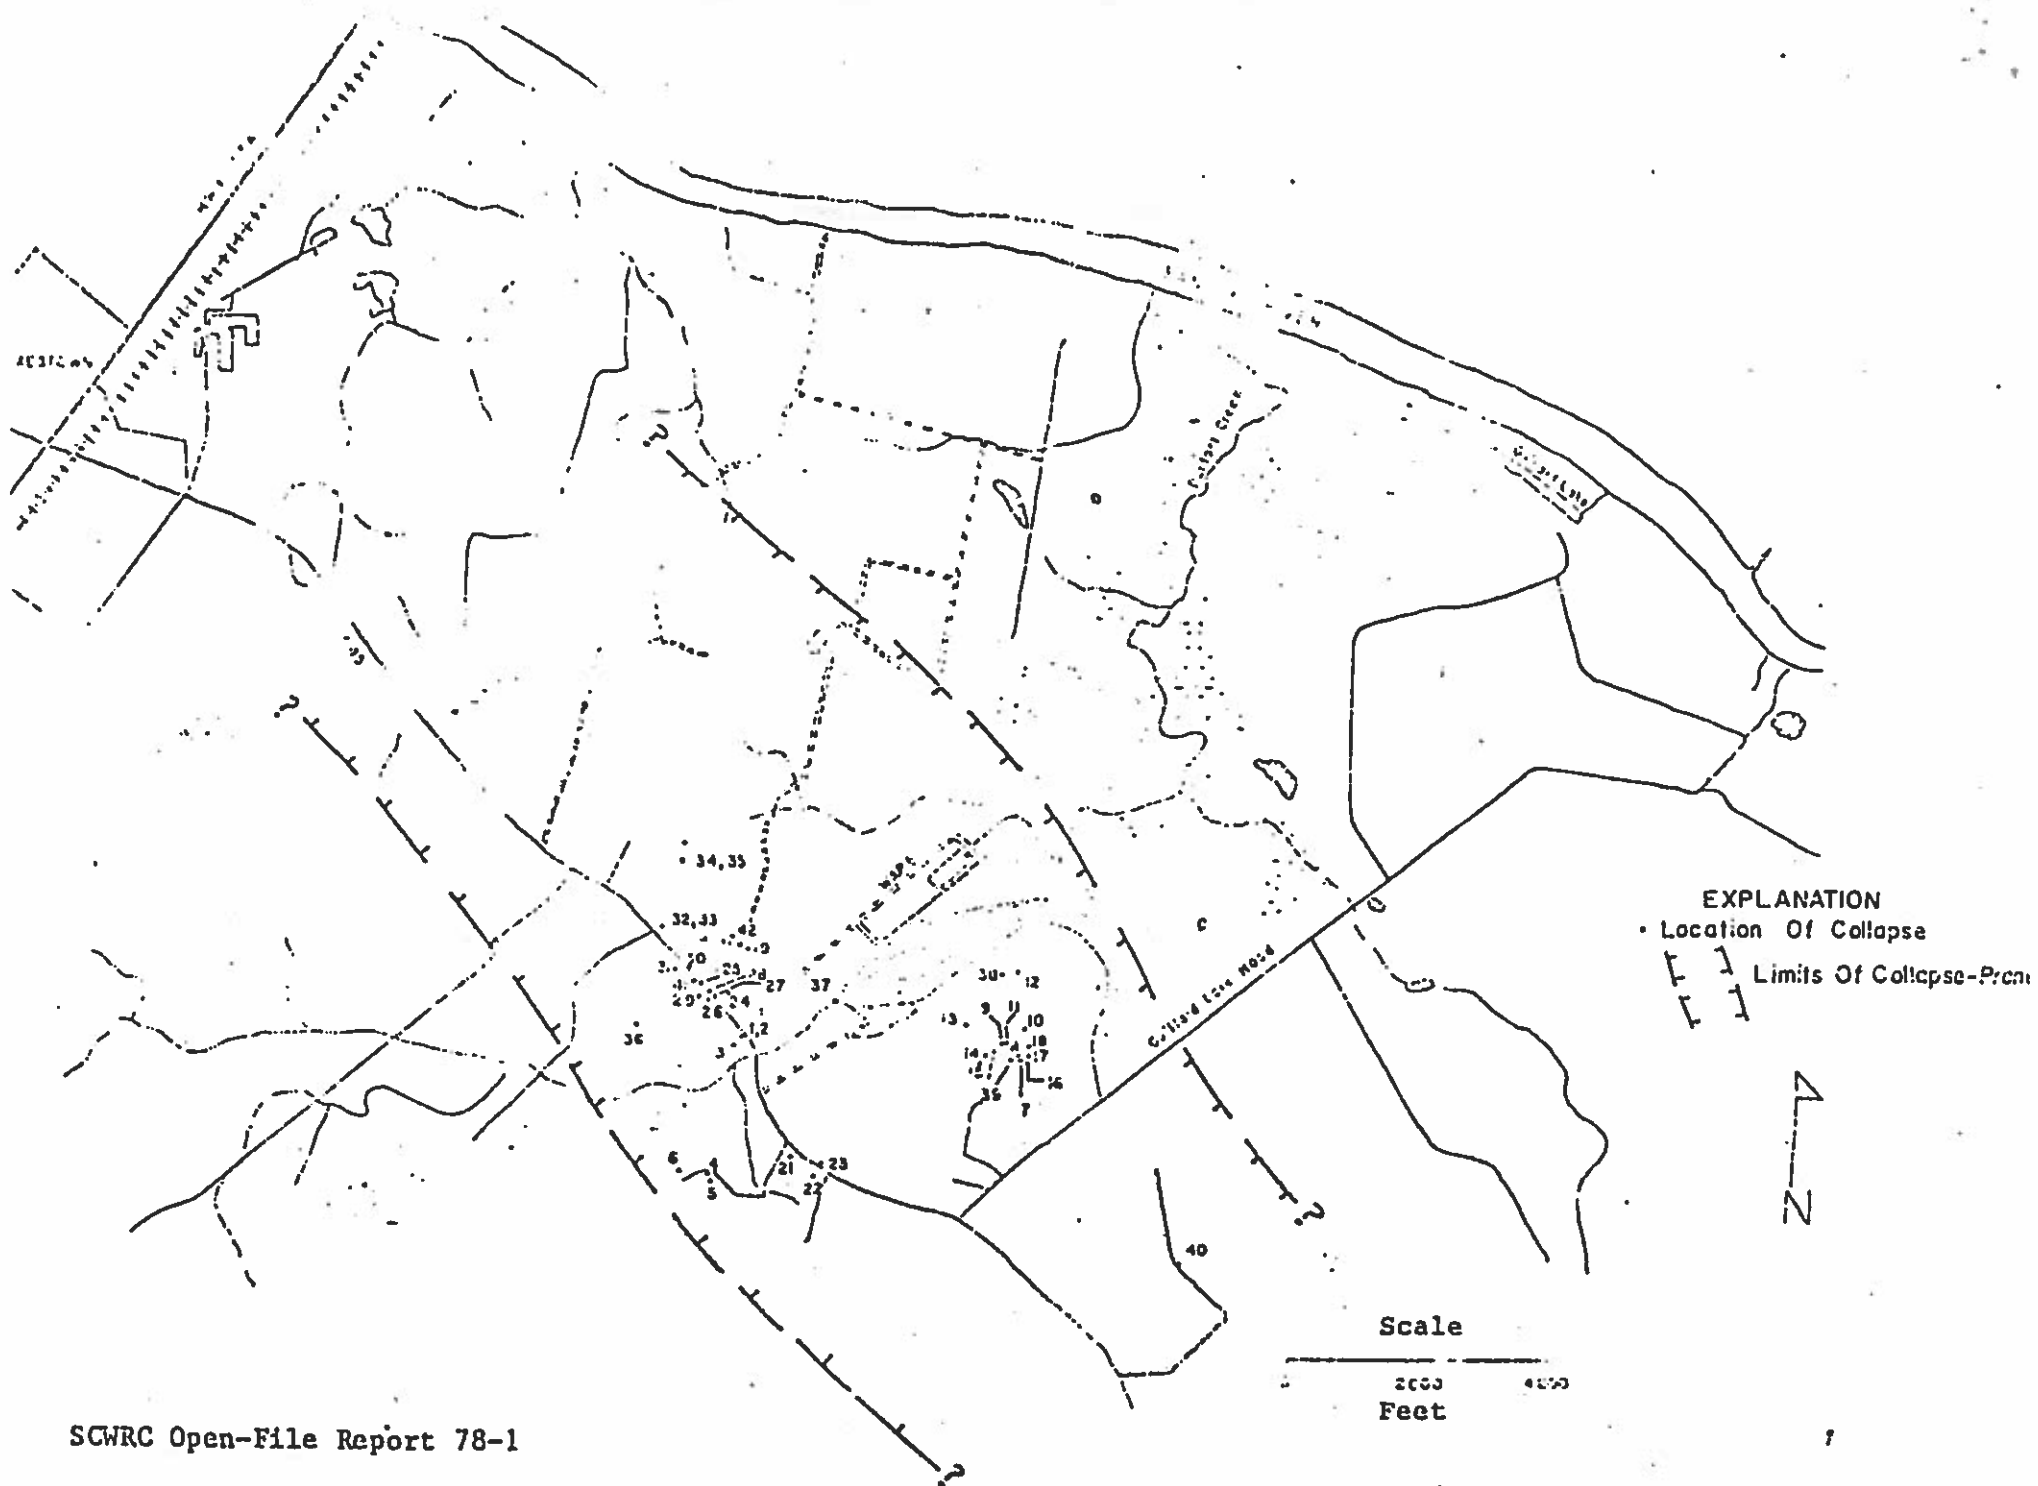
SUBSIDENCE · DEPRESSIONS, JAMESTOWN AREA.

The most serious incident occurred in the Winter of 1976, when Mrs. L. D. Myers was reportedly injured by a fall into a subsoil cavity that collapsed in her back yard (no. 29). On August 31, 1977, a collapse (no. 15) occurred under a combine driven by Mr. T. E. Casselman, who escaped possible injury because the corn header caught on the rim of the collapse, probably preventing overturning of the combine. When visited by the writer on September 1, 1977, the collapse was approximately 5 ft in diameter and at least several feet deep, although the bottom of the collapse could not be observed. Several days later, on September 3 or 4, 1977, Mr. Casselman's combine fell into another collapse. In 1976, a collapse (no. 3) occurred under or near a tractor driven by Mr. Glenn Pipkin at the St. James cemetery.

The collapses and subsidence depressions in the Jamestown area have caused damage to private property, County Highway 45, and the foundation of a church and recreation building (table 3). The most potentially dangerous situations exist from unstable (metastable) subsoil arches which cannot be seen. Various "triggering" mechanisms, as previously described, have caused the sudden collapse of land surface. One local resident was reportedly injured when a collapse occurred in her back yard, and at least four other residents are reported to have escaped injury when subsoil arches were collapsed by a combine, farm tractor, or car.

Collapses and subsidence depressions have occurred on and near the apron of Highway 45, requiring filling and periodic maintenance by the S. C. Department of Highways and Public Transportation. A collapse (no. 26) has damaged the foundation of the Mt. Zion Church recreation building. Church members have, on several instances, added fill to the depression in order to prevent further damage.
