Gills Creek Watershed: Assessment of Regulated Dams

February 15, 2016

PROJECT NAME: Gills Creek Watershed Assessment of Regulated Dams Report

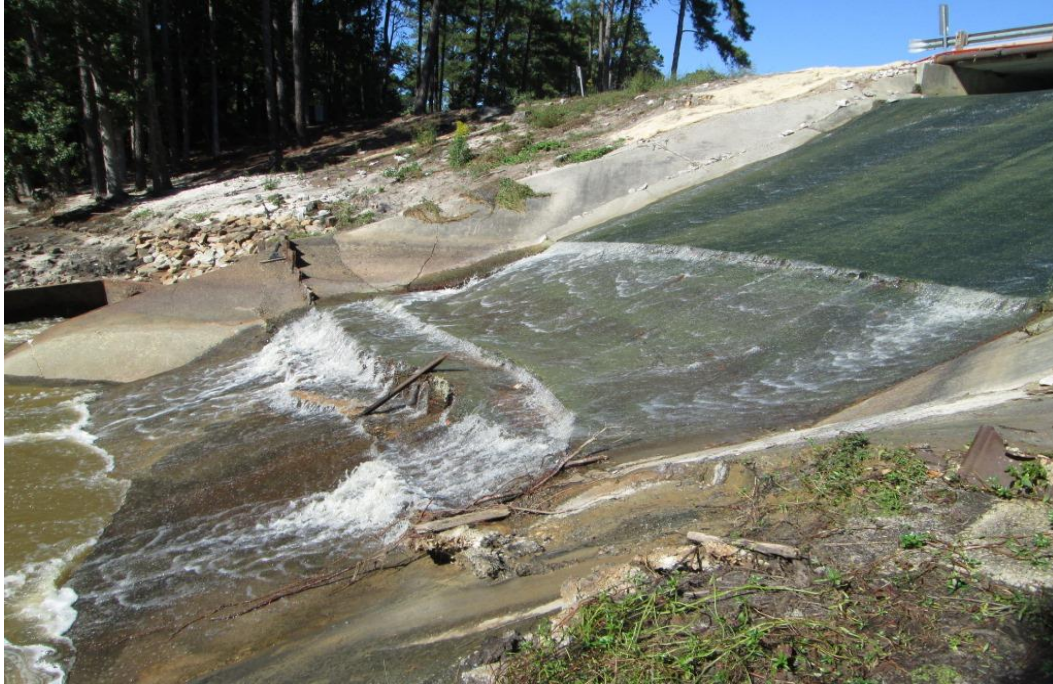
Photo 6: Eroded/filled areas along right side of auxiliary spillway channel

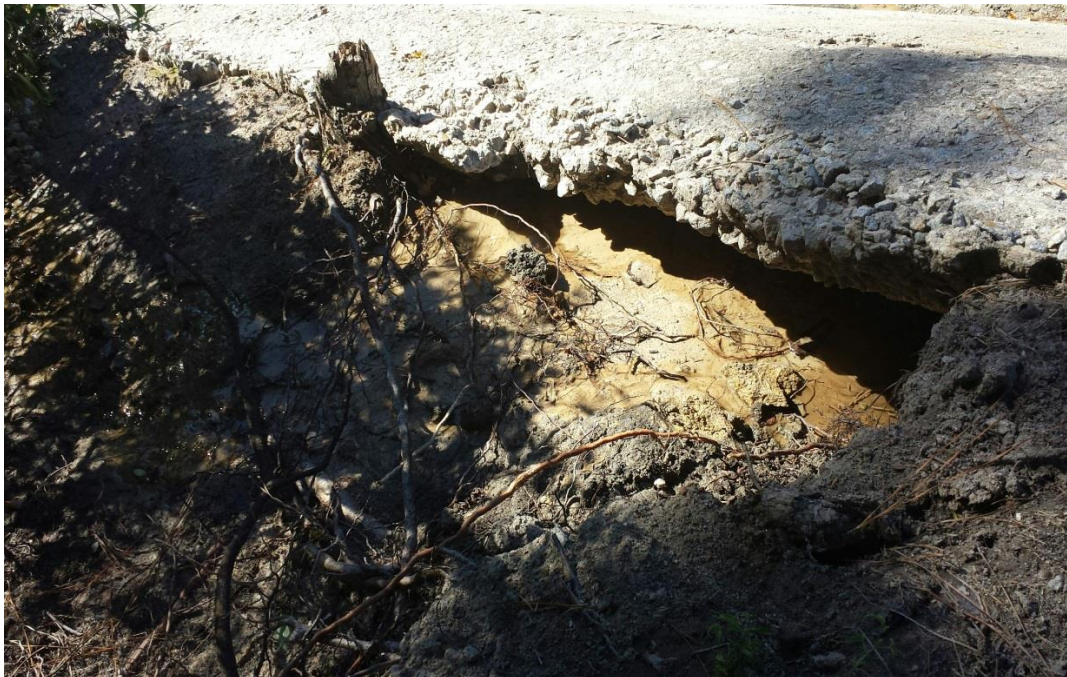
Photo 7: View of sheetpile at toe of auxiliary spillway; note cracks in concrete surface adjacent to sheetpiles

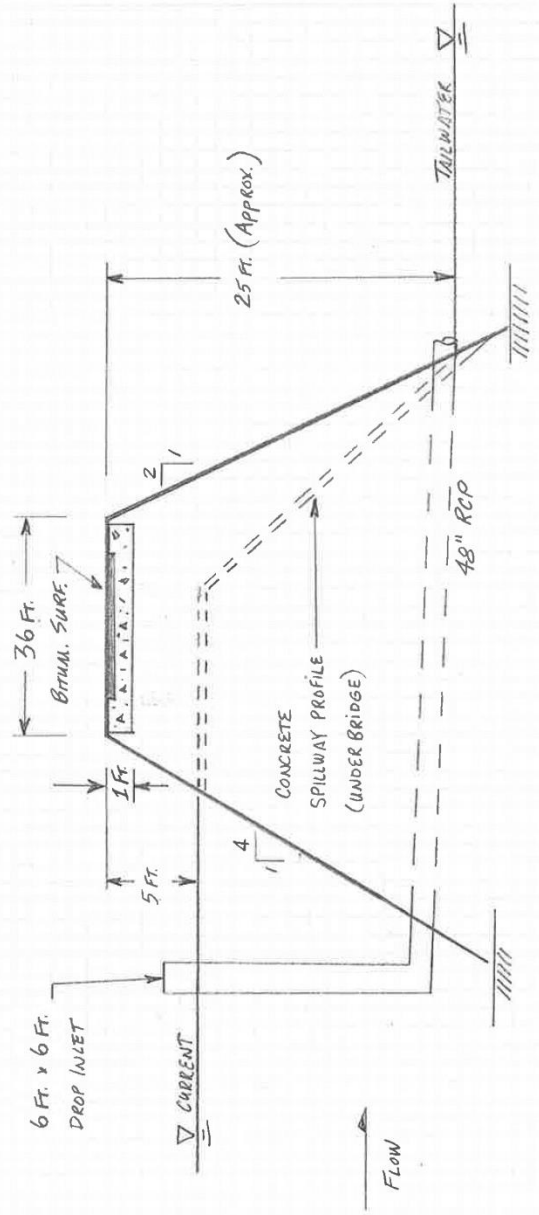
- NOTES:
- SPILLWAY LENGTH = 45 FT.
 - MINIMAL OVERTOPPING EVIDENCE OBSERVED
 - WATER FLOWING OVER SPILLWAY AT TIME OF INSPECTION
 - CURRENT WATER SURFACE = NORMAL WATER SURFACE
 - RISE & FALL DIMENSIONS & 48" RCP OUTLET PIPE SHOWN PER RECORDED DRAWINGS
 - ALL OTHER DATA SHOWN PER FIELD MEASUREMENTS / OBSERVATIONS / ESTIMATE

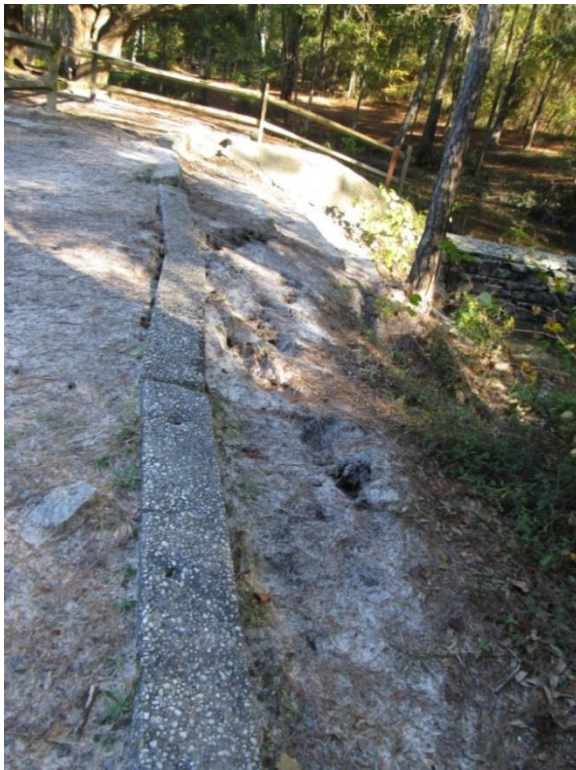
Photo 9: Vertical crack/slabbing in left abutment of lower stone dam

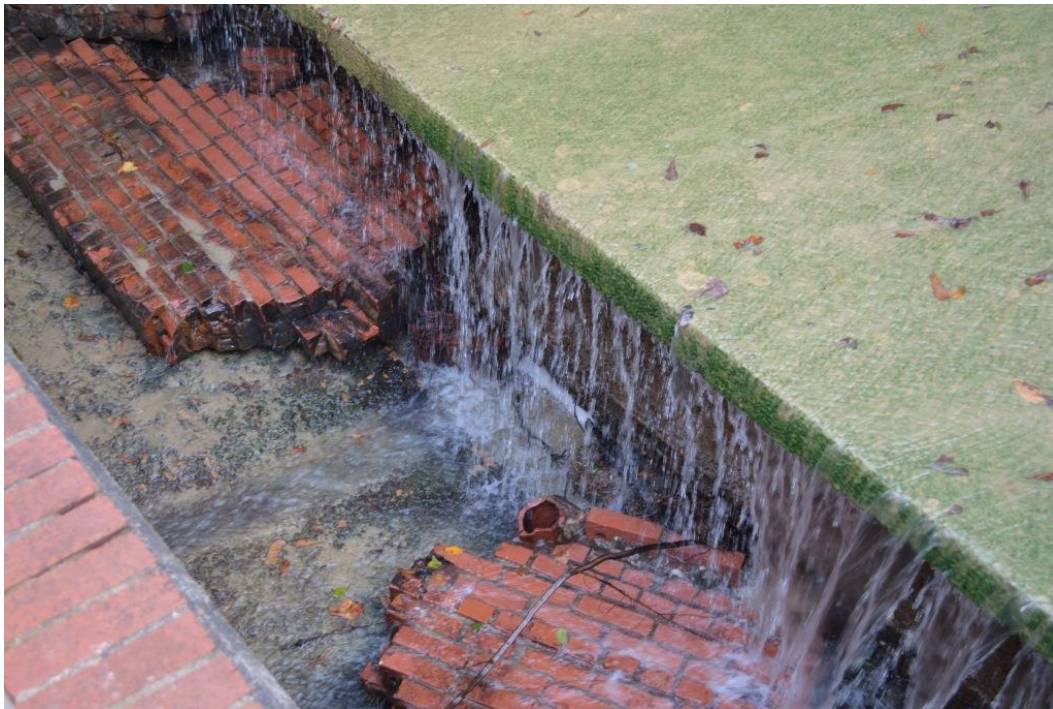
Photo 9: Auxiliary spillway with debris

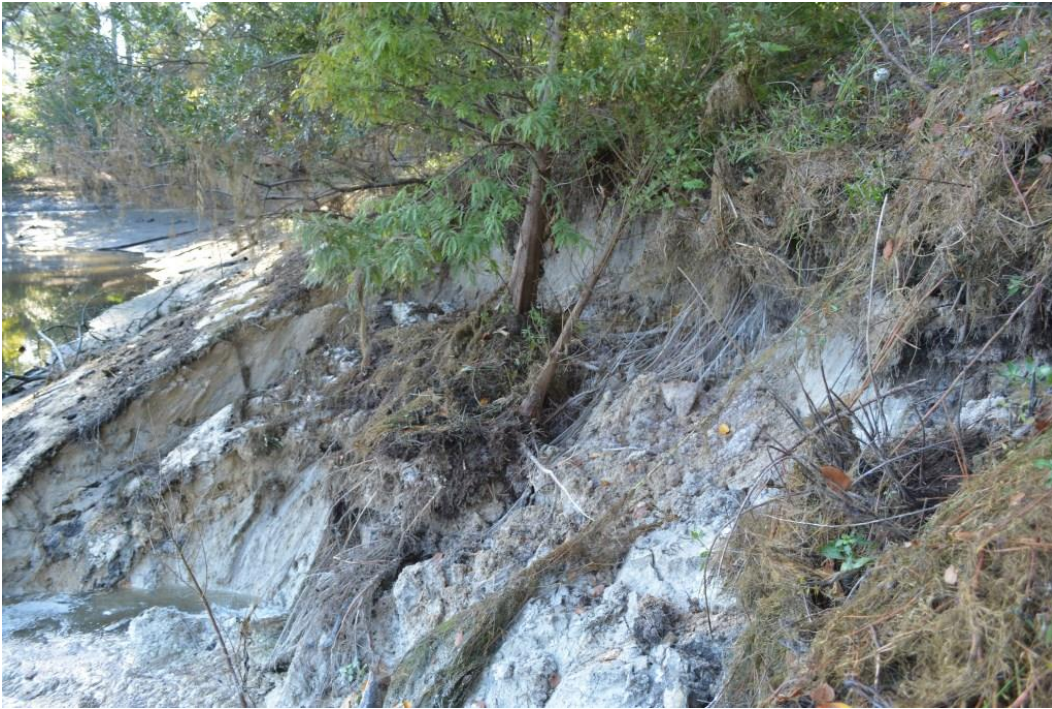
Photo 3: Downstream embankment slope

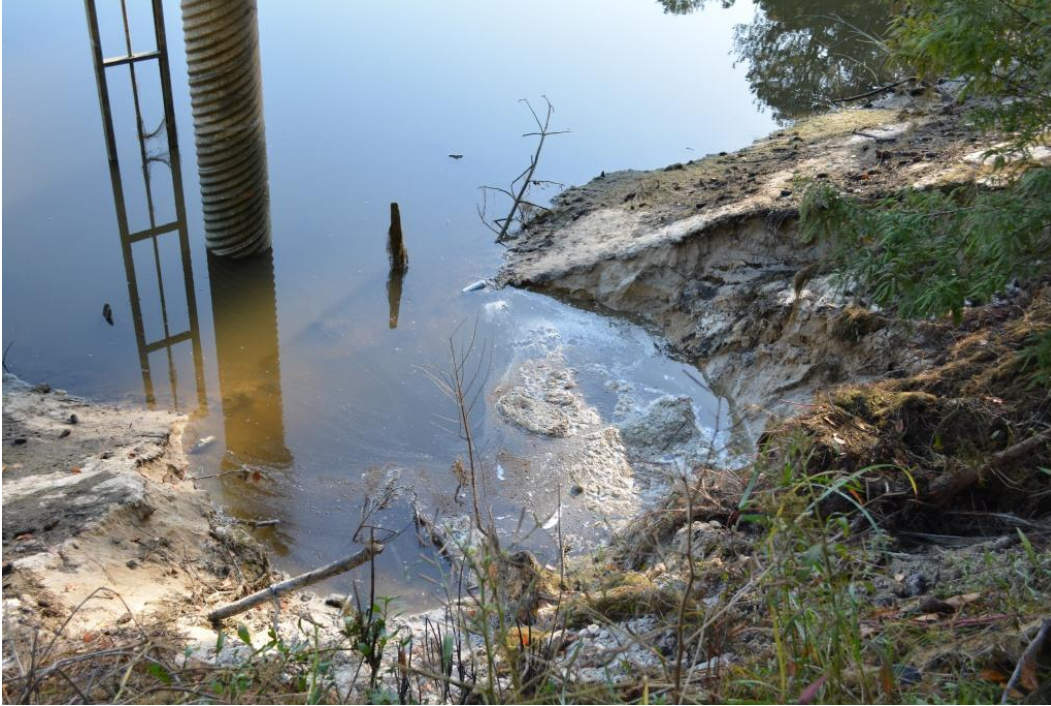
Photo 6: Service spillway intake

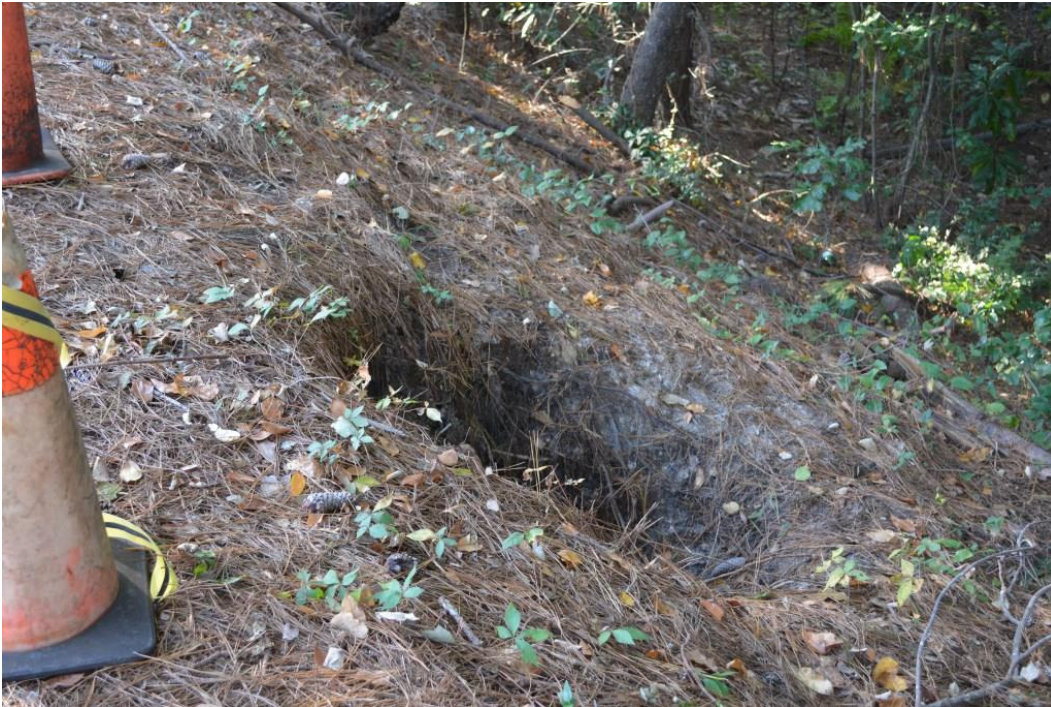
Photo 7: Upstream slope failure along service spillway alignment

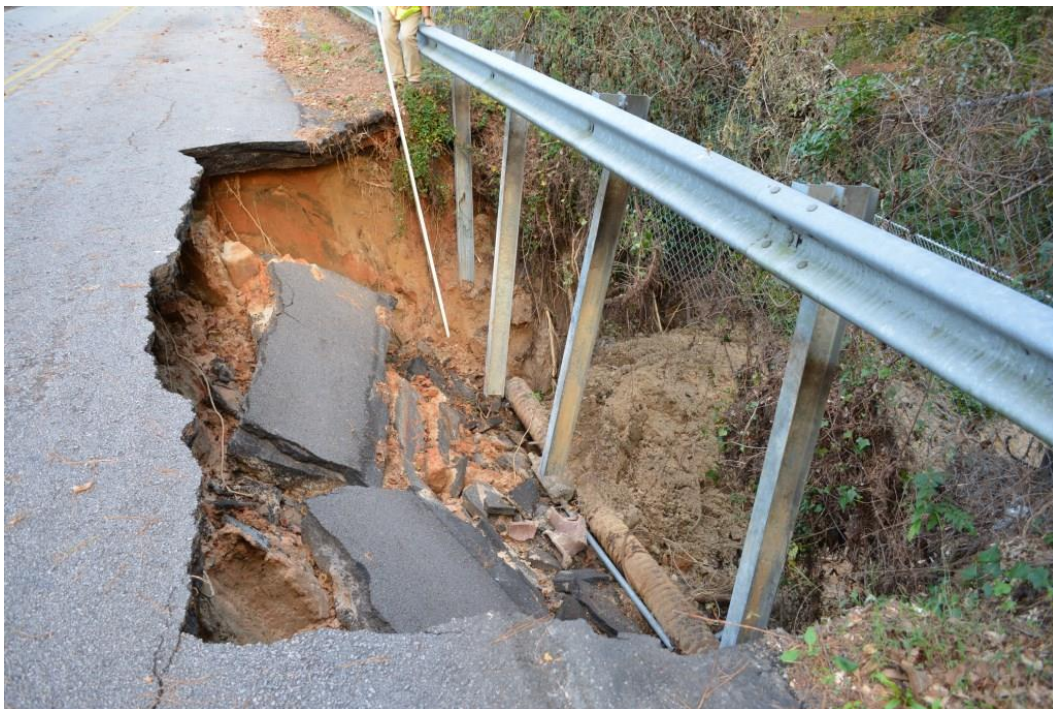
Photo 3: View of embankment downstream slope from crest
