**RE: Field Demonstration Project – Documentation Report
SCE&G - Congaree River Sediments
Columbia, South Carolina**

July 2016

Apex Companies, LLC

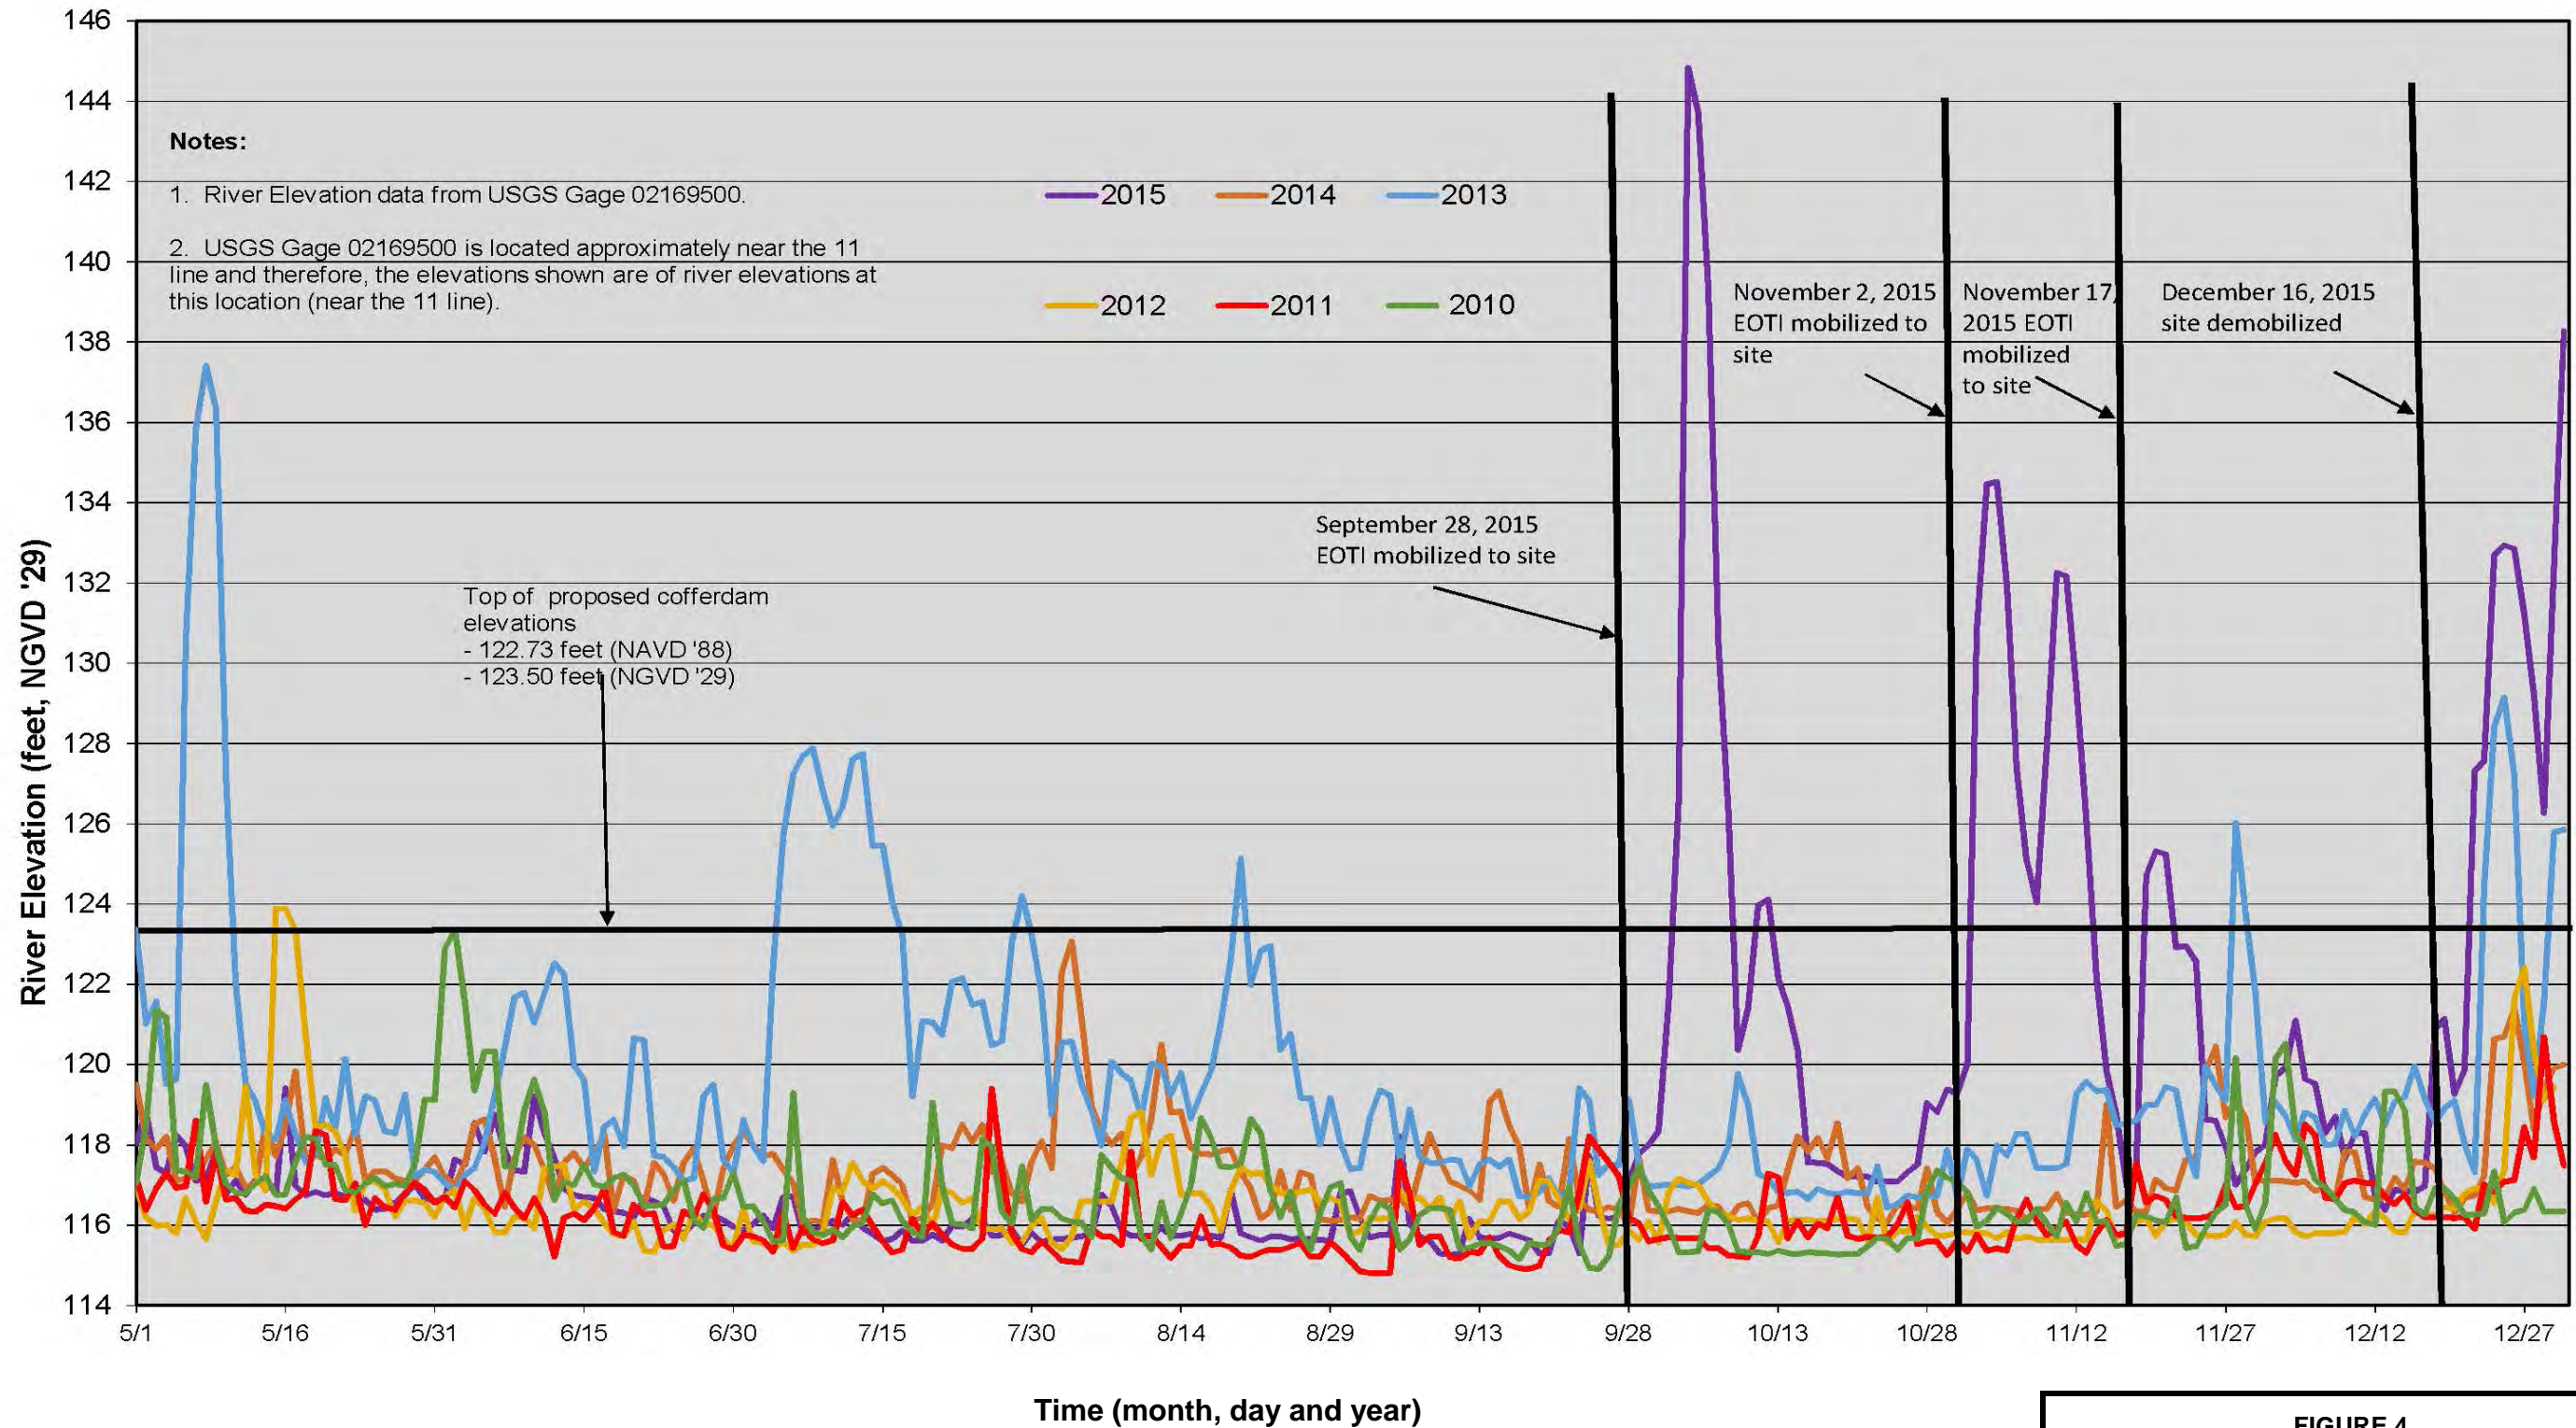
FIGURE 4

Figure 4 (also referred to as Figure D-1 in Appendix D) provides a vivid graphical representation of the timing and magnitude of the storm events that occurred in October and November of 2015. These extreme weather conditions and the subsequent impacts from the flooding in the Columbia area severely limited the scope of work that could be completed in support of the FDP. Please note how soon after each of EOTI's mobilization events that the river elevation spiked. Figure 4 also clearly illustrates the anomalous nature of the severe storm events in the fall of 2015 with respect to the last six years of river elevation data. The rising river levels flooded the project area and resulted in a failure of the Columbia Canal dike, located above the project area. The dike failure, in addition to the large amount of sediment entrained in the runoff from the upstream drainage basin, resulted in the deposition of approximately 1-2 feet of sediment on the alluvial fan area and a greater sediment accumulation within the river (recently obtained data indicates approximately up to 5 feet of new sediment exists below the alluvial fan area).

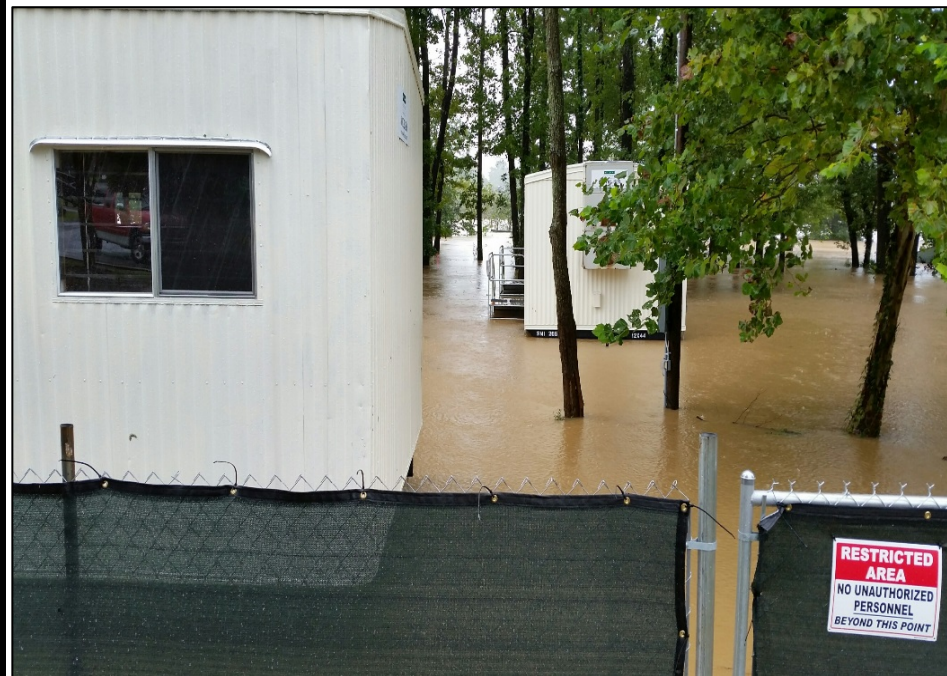
10/04/2015 - Flood waters reaching just below construction trailer floors

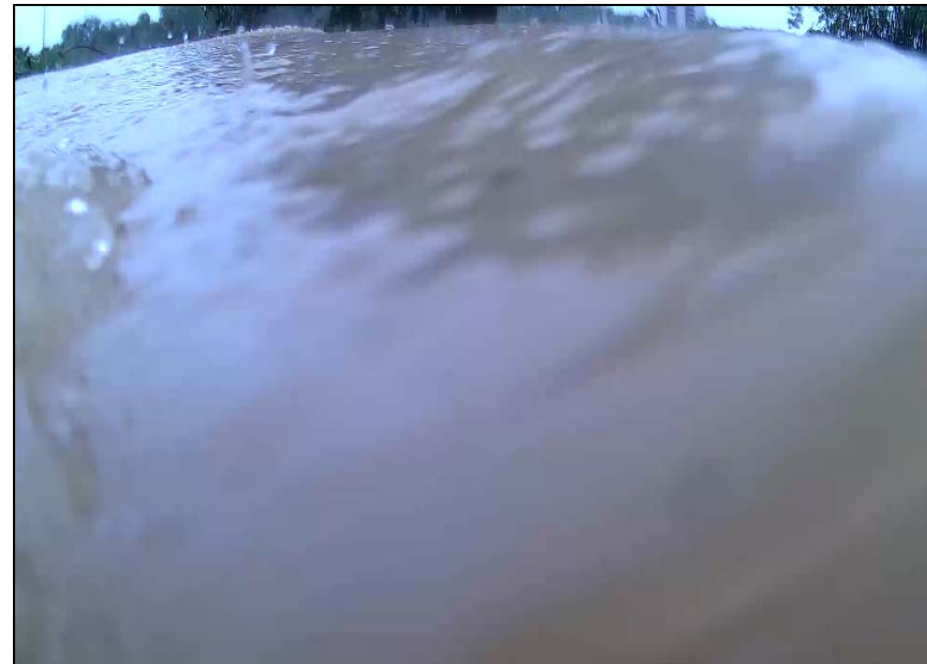
10/04/2015 - View from riverfront camera looking upriver - 11:13 AM
Cameras mounted approx. 10 feet above ground

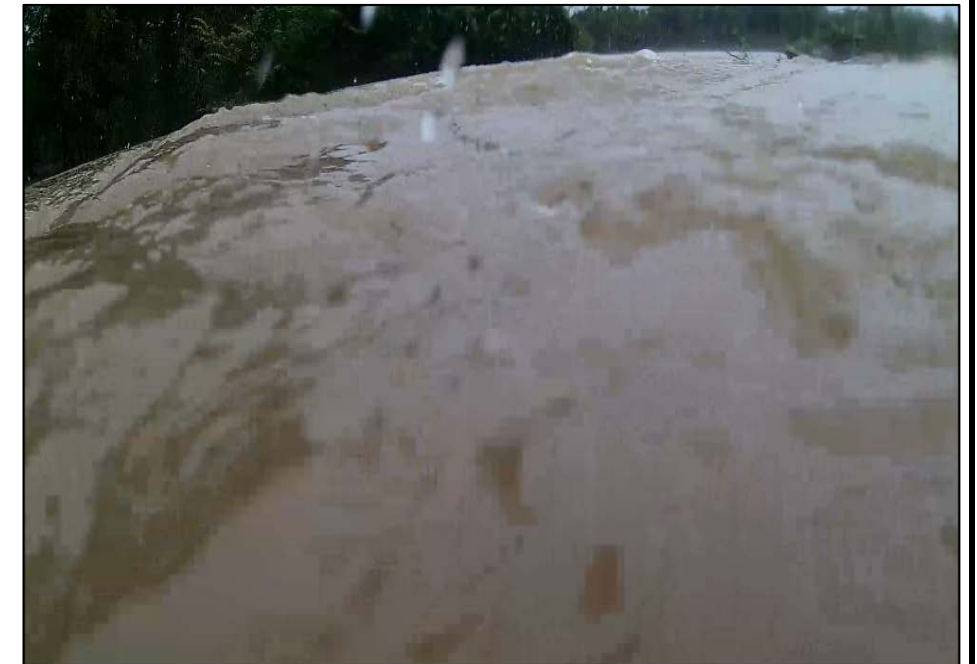
10/04/2015 - View from riverfront camera looking downriver - 11:13 AM
Cameras mounted approx. 10 feet above ground

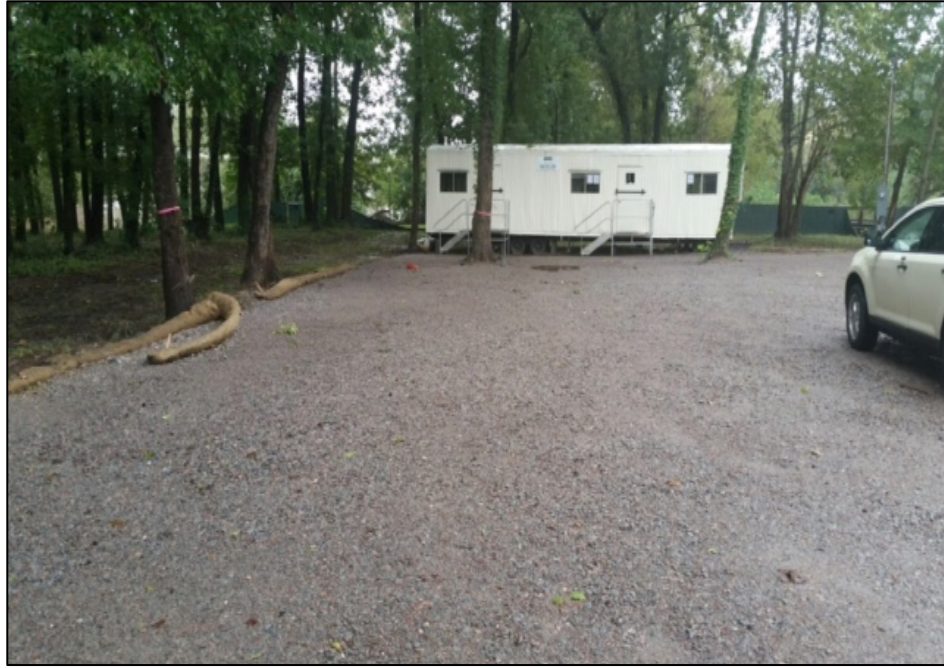
10/05/2015 - Trailer and parking lot after flood water receded

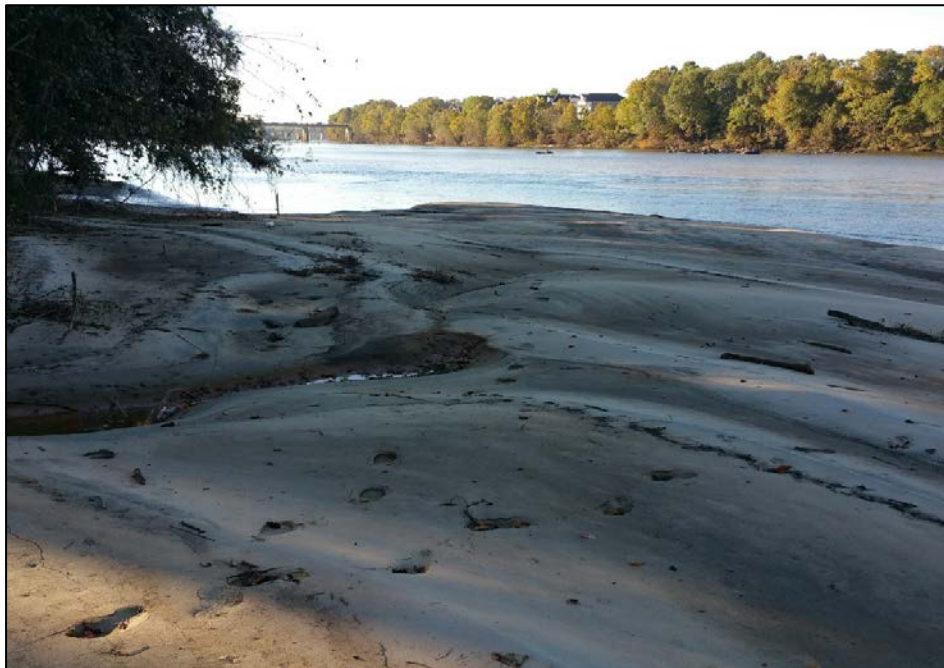
10/19/2015 - View of alluvial fan showing amount of sediment deposited during flood

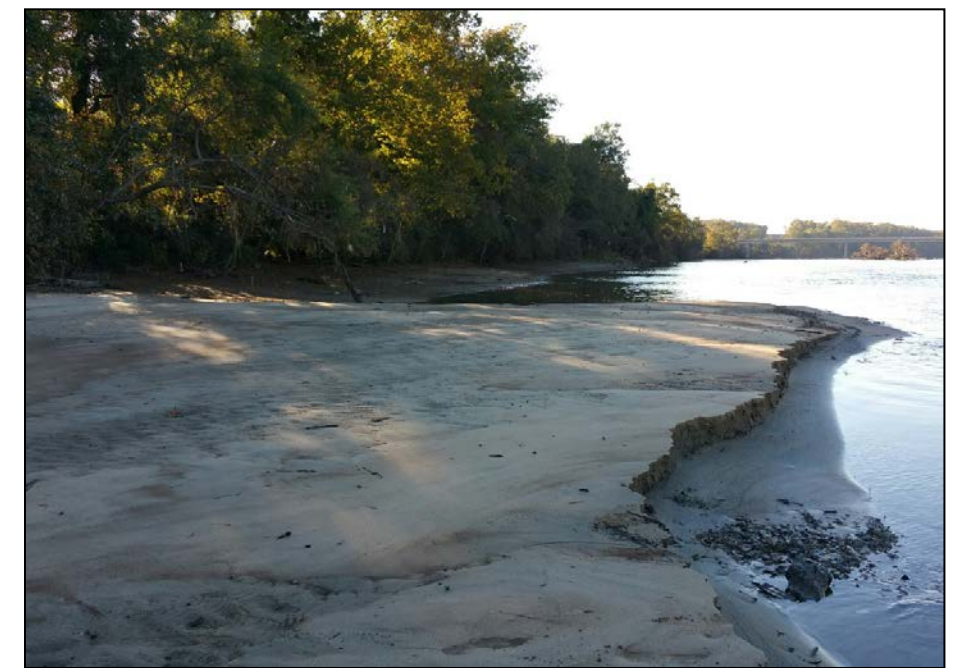
10/19/2015 - View of alluvial fan showing amount of sediment deposited during flood

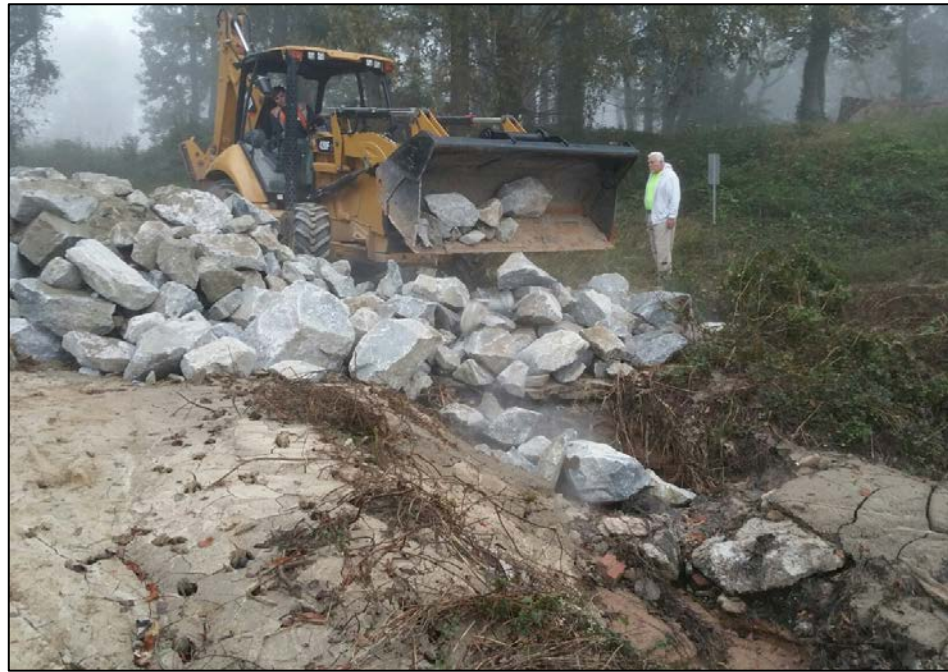
10/23/15 - Stabilizing boat ramp to allow access to alluvial fan

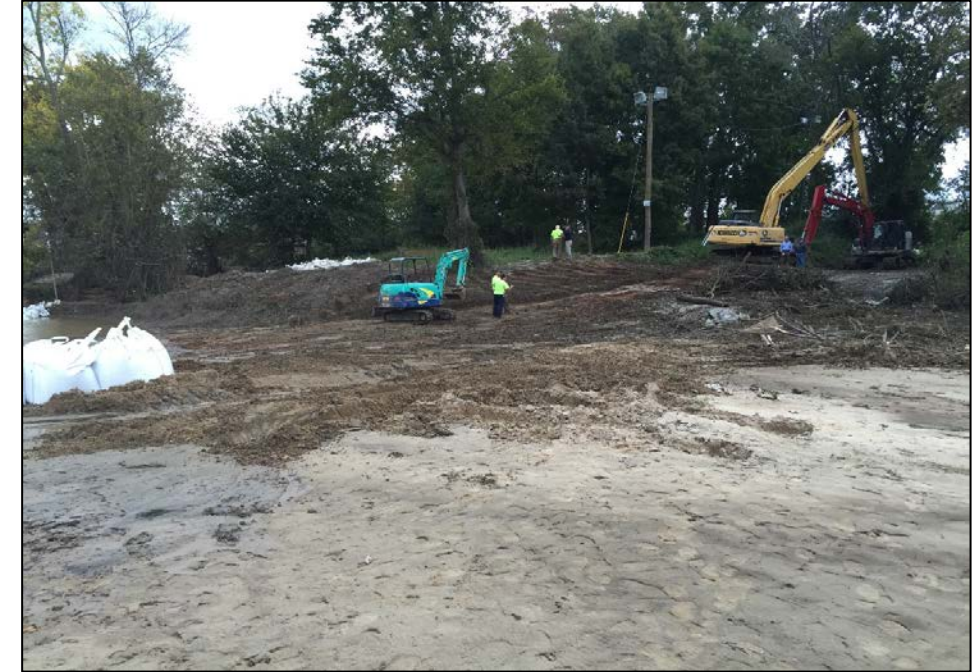
10/28/2015 - Sediment deposited by flood event removed and alluvial fan restored to pre-flood elevations

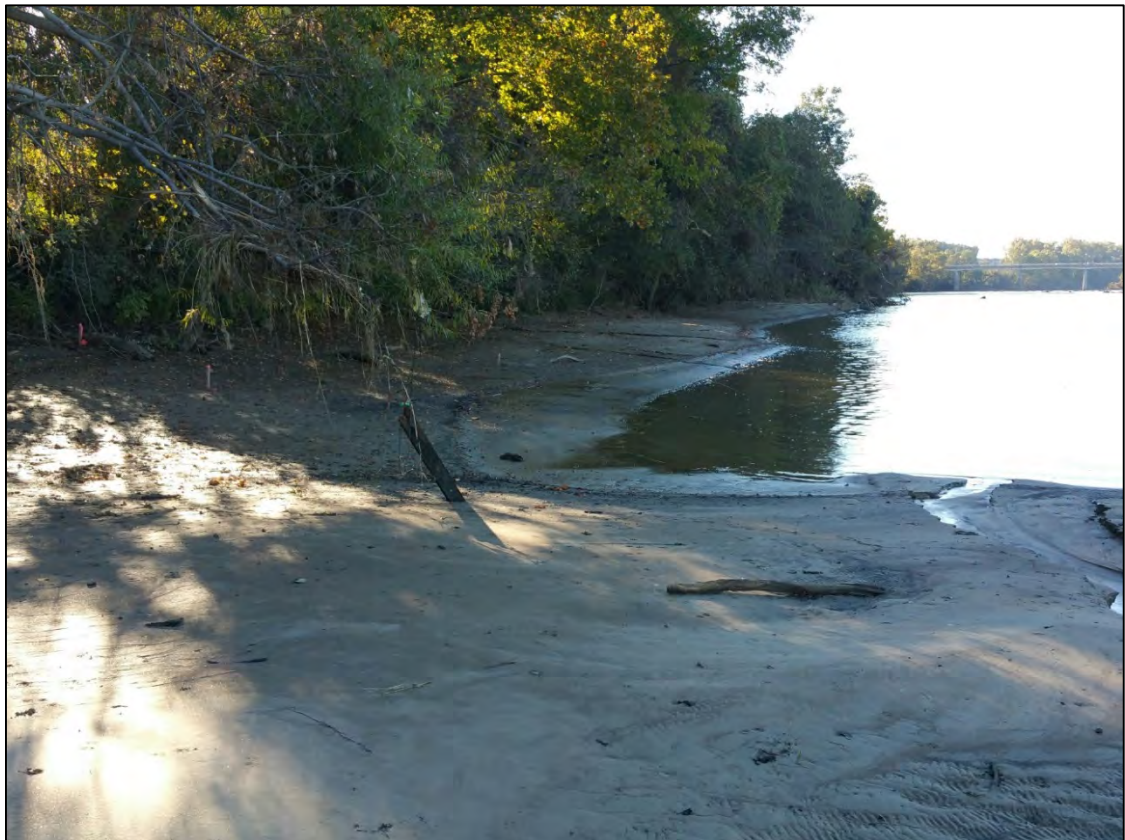
10/19/2015 – View from Alluvial Fan looking towards the southern FDP area. Note: no orange flags can be seen due to amount of sediment deposited during the October flooding event.

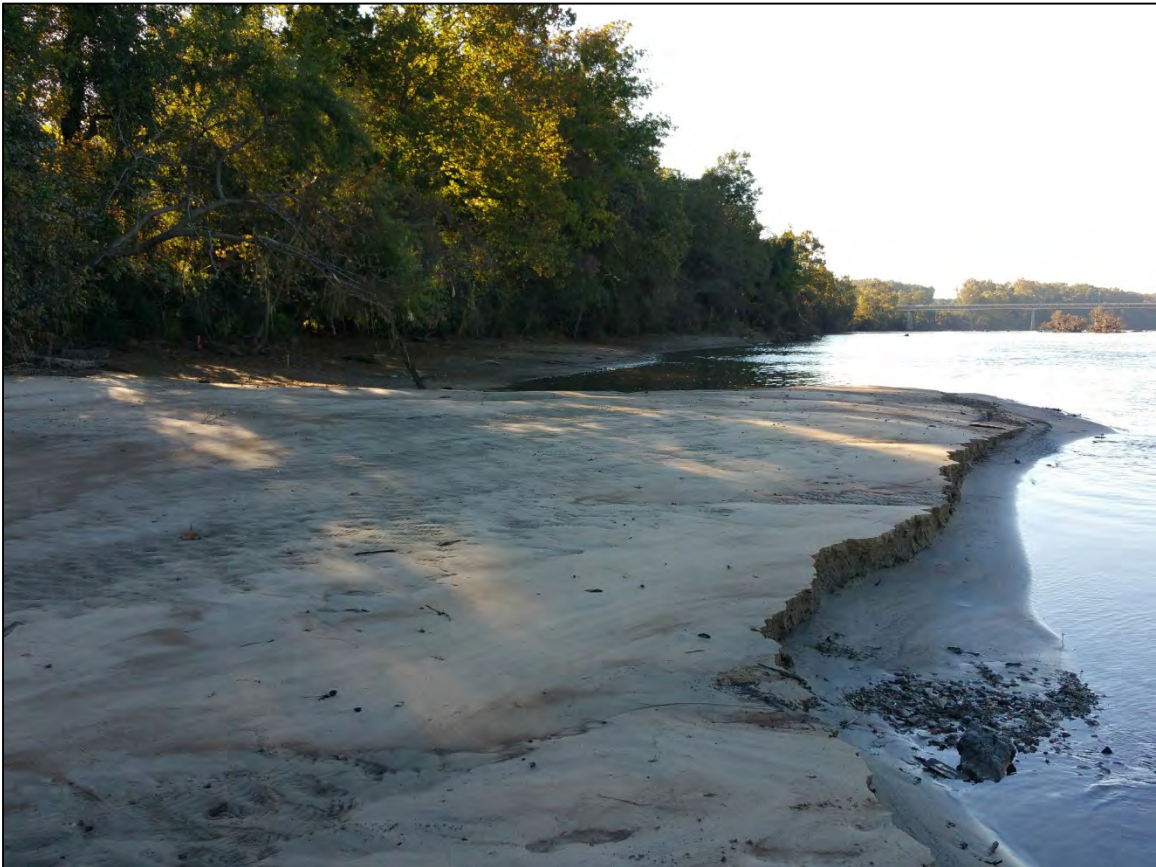
10/19/2015 – View of southern FDP area from the Alluvial Fan. Notice amount of deposited sediment.
