Subject: Inspection of CONESTEE LAKE DAM, D2876, Greenville County, Significant Hazard Class

CONESTEE LAKE DAM : D2876

Dams Preliminary Inspection Form

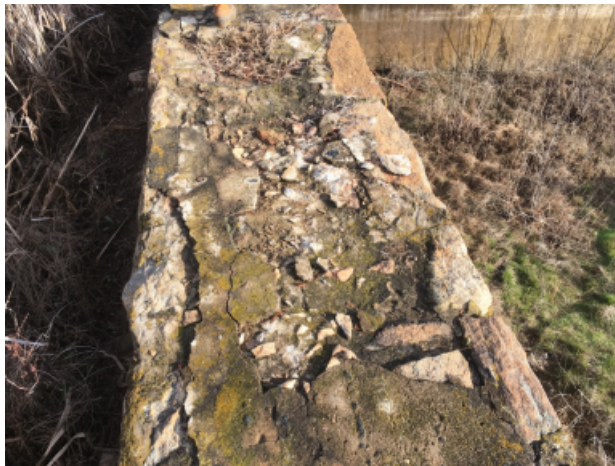
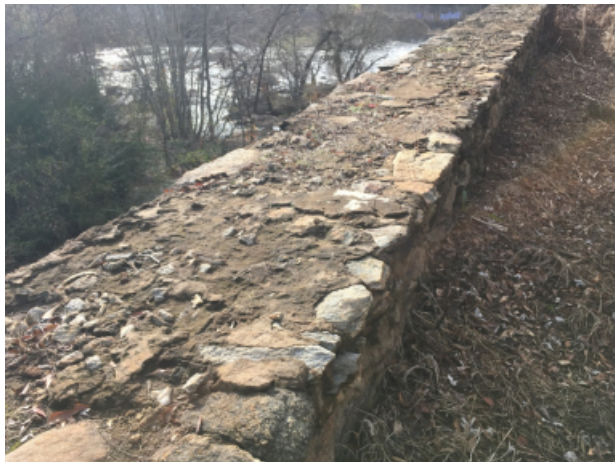
1. Surface Conditions

Monitor, Action Required

Repair the delaminated concrete veneer on the dams crest.

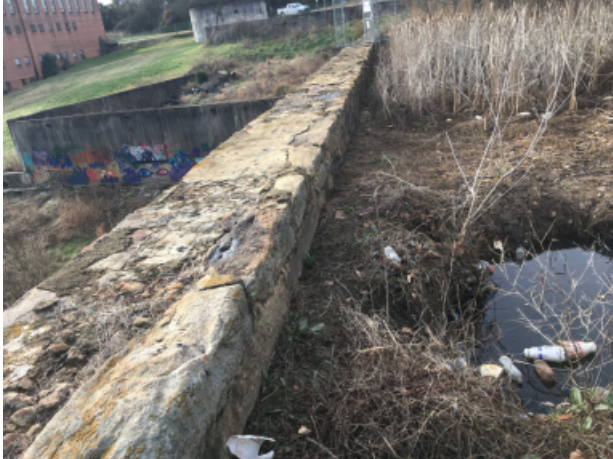
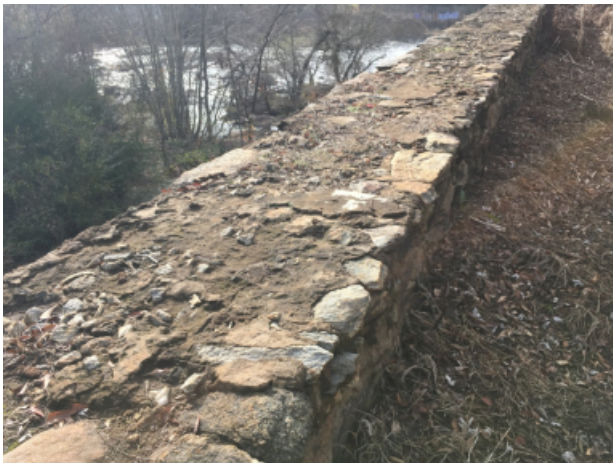
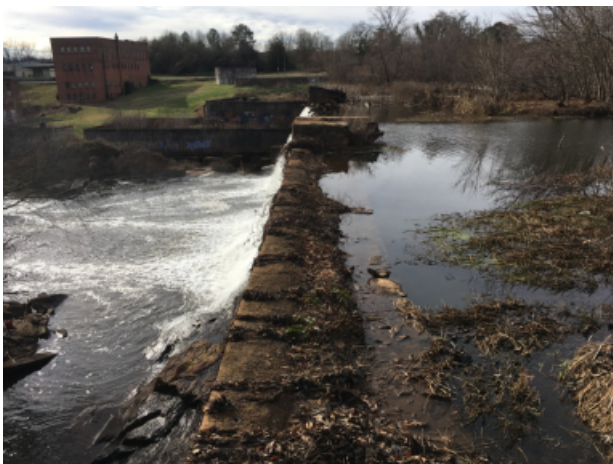
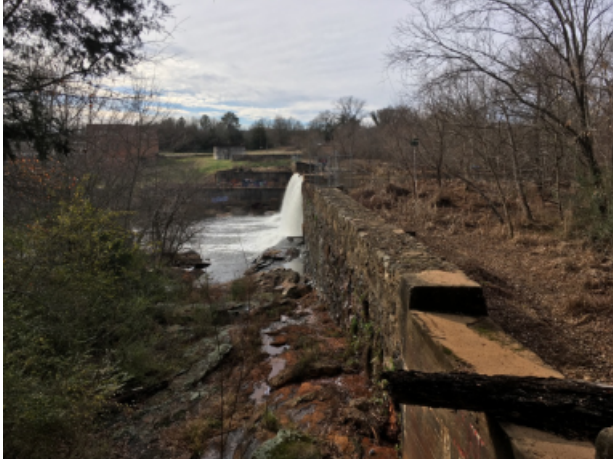
Could not be inspected due to the build up of sediment behind the dam and the primary spillway section was submerged.

Regular Monitoring
 Necessary, Condition
 Prevented Full
 Inspection

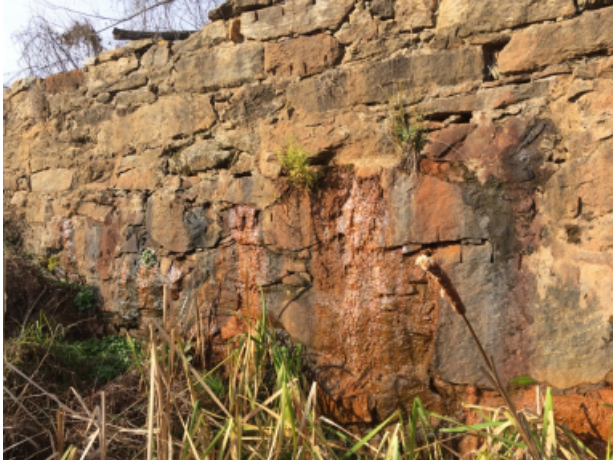
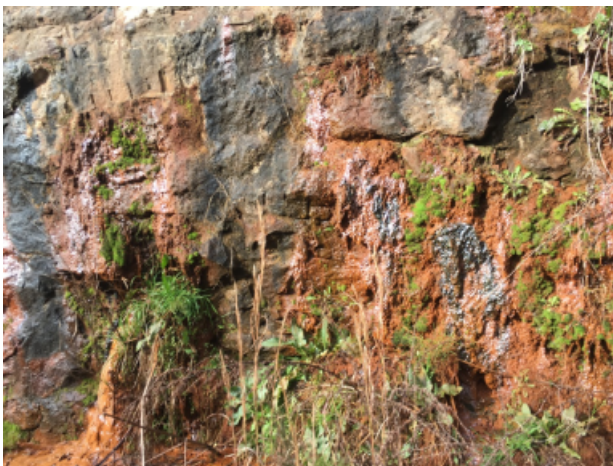
The previous SCDHEC inspections on December 18, 2014, December 1, 2016 and the inspection on December 11, 2019, noted numerous active seeps and deterioration of the masonry joints throughout the downstream face on the both the left and right side

•The previous SCDHEC inspections on December 18, 2014, December 1, 2016 and the inspection on December 11, 2019, noted numerous active seeps and deterioration of the masonry joints throughout the downstream face on the both the left and right side. A recent engineering study was submitted on April 19, 2019 by Kleinschmidt and the report noted "Numerous active seeps were observed along the entire length of the downstream face of the dam. Most of these seeps appear to be transporting fine sediment (silt and clay) resulting in an ochre coloration to the seeps and the accumulated materials where the seeps flow across the bedrock at the base of the dam. These accumulated translocated materials have been analyzed and documented to contain high concentrations of heavy metals previously detailed in this report." Due to the movement of fine sediments containing hazardous constituents, a repair plan should be developed to address and control the seepage through the dam.

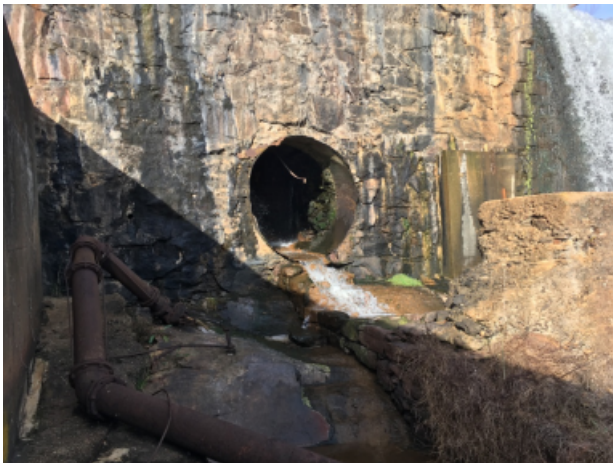
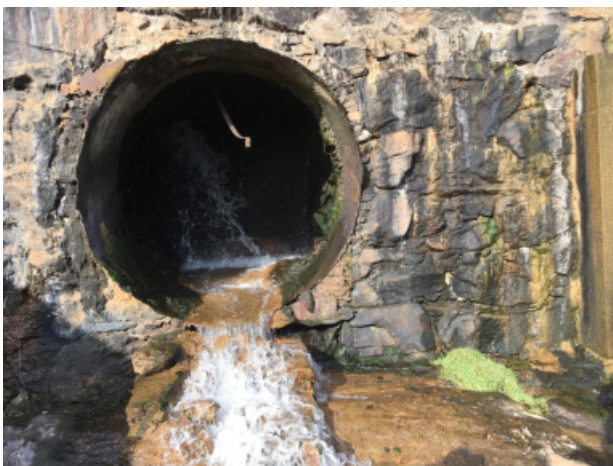
A temporary replacement plate was added on the penstock orifice in 2001. The Kleinschmidt report stated: "The timber plate installed in 2001 against an existing timber frame to stop uncontrolled river flow through the penstock orifice allows flow through the orifice estimated at less than 3-5 cfs. The plate was intentionally designed to allow this discharge so as to provide a minimum flow in the river after the repair in June 2001. These existing timber frame, believed to be at least 110 years old, is in an undetermined condition. The flow of water around the temporary plate will continue to erode the timber seals. Once these wooden seals fail, there will be an increase in flow. The volume of flow could transport sediment and contaminants downstream of the dam. If the flow is great enough or if the bulkhead plate were to fail or be displaced, then there could be a repeat of the loss of the impoundment and release of sediment that occurred from June 2000 to June 2001, when the lake reservoir drained, and the river eroded a "canyon" through the lakebed." Due to the concerns associated with the previous repairs and the potential for an uncontrolled release of water and sediment, a repair plan should be develop to permanently seal the 8 ft diameter penstock orifice.

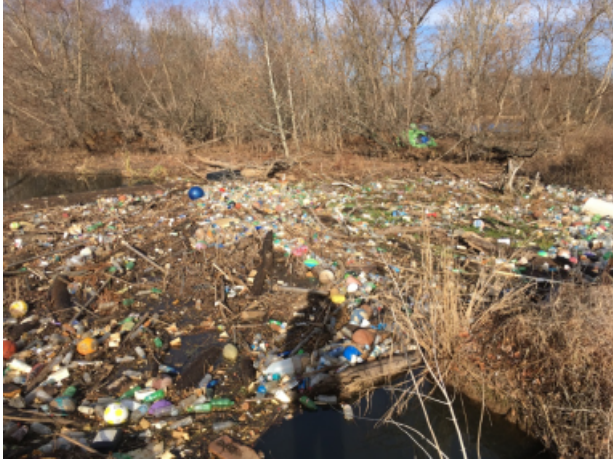
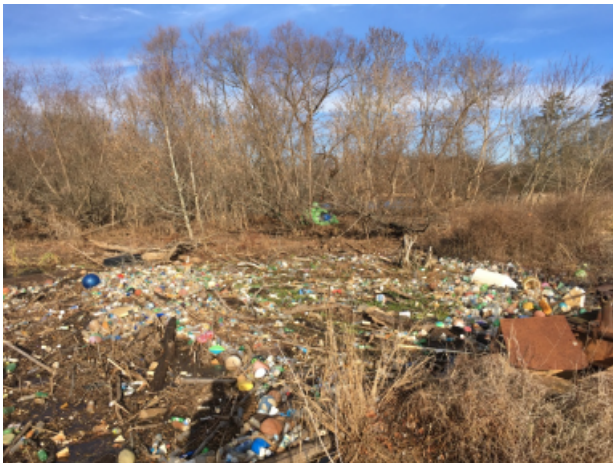
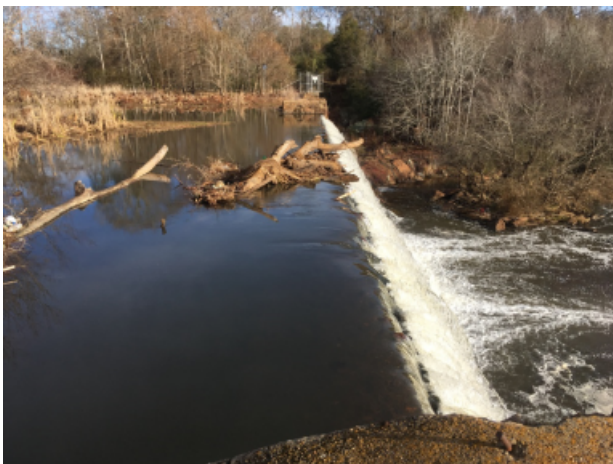
16. Additional Comments (Refer to item number if applicable) At the time of the inspection, a large area of trash and heavy woody debris had accumulated on and behind the dam. The mass of debris and large woody vegetation has the potential to cause stability issues when flows increase during above normal rain events. This area behind the dam should be cleared of all debris.	
Spillways: Inlet Structure	
Is this section applicable for this dam?	<input type="checkbox"/> Yes <input checked="" type="checkbox"/> No
