CRAWFORD POND DAM : D1824

Dams Preliminary Inspection Form

Inspector: Ryan Sullivan

Start Date: 09/28/2018 Completed Date: 09/28/2018

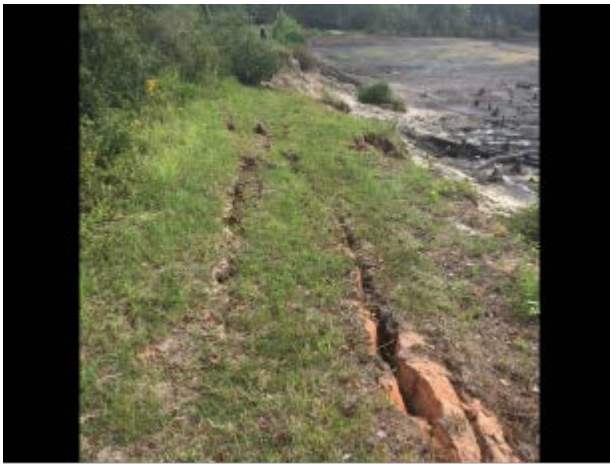
Longitudinal cracking at left side of breach.

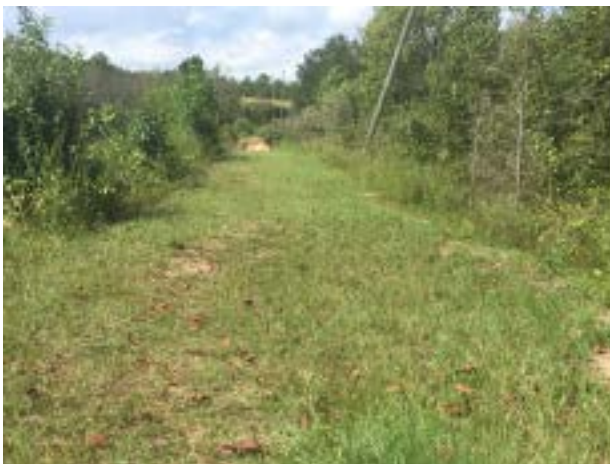
Depressed section of the crest on the right side of the breach. Picture is difficult to tell. About the area of an inflatable kiddie pool, about 4" deep. Area on downstream slope right there is very steep and heavily vegetated, but appeared less stable than other areas.

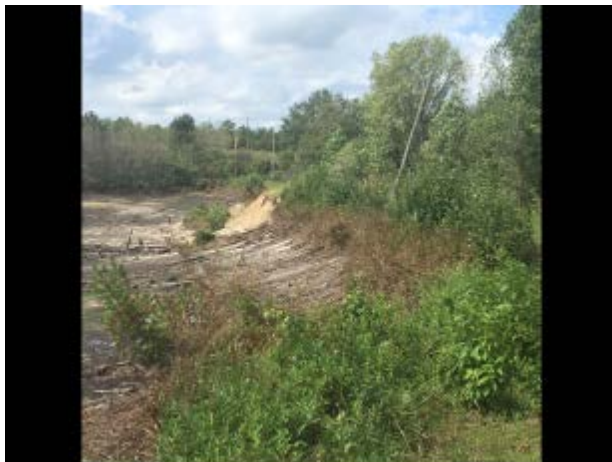
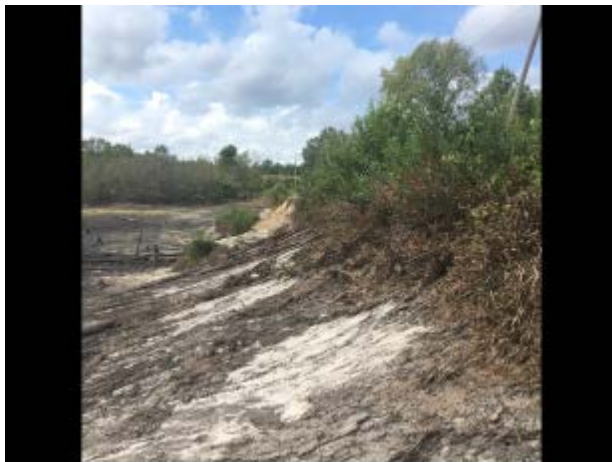
No grass cover observed on upstream slope.

Brush and woody vegetation observed on the upstream slope.

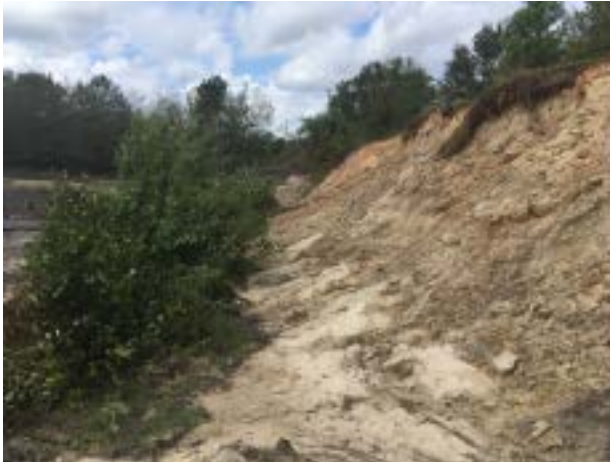
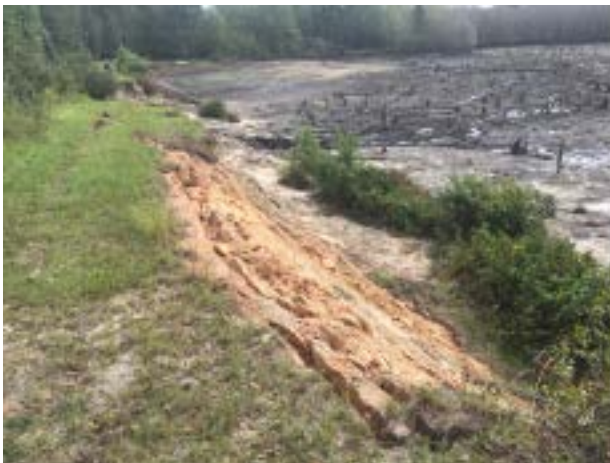
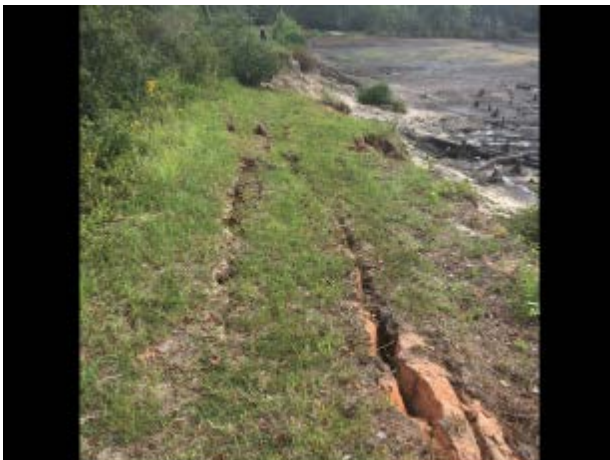
Large slide on left side, near breach. More cracking near slide may indicate another possible slide in the future.

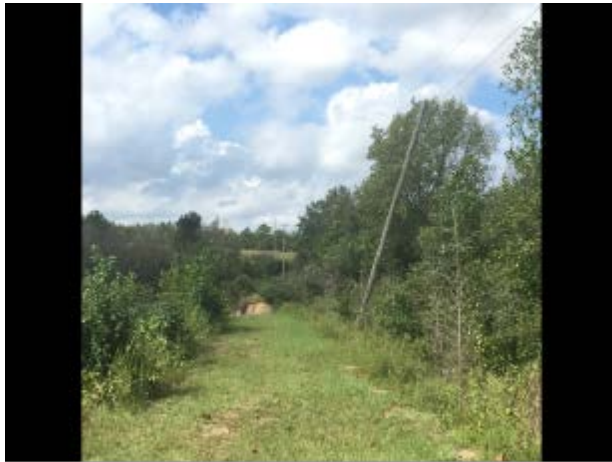
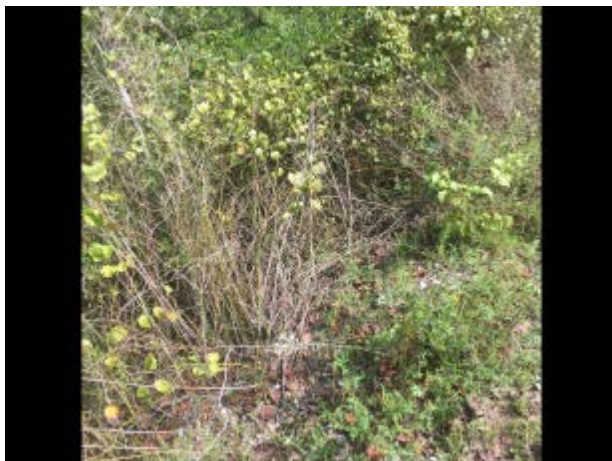
Heavy vegetation prevented full inspection.

Brush and woody vegetation observed on downstream slope.

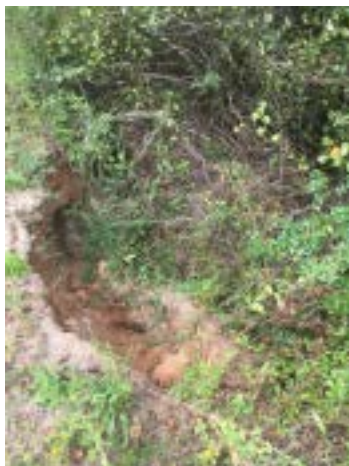
Embankment: Downstream Slope	
<i>9. Erosion</i>	Action Required
<p>Large breach through center of the dam. Area at the spillway also eroded.</p> <p>Photo Taken: 9/27/2018 12:57:31 PM</p>

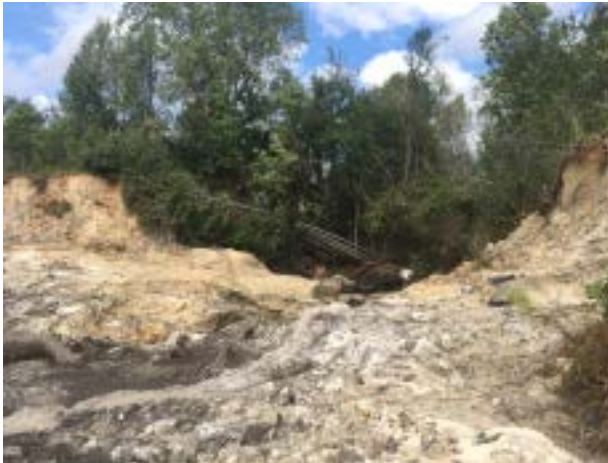
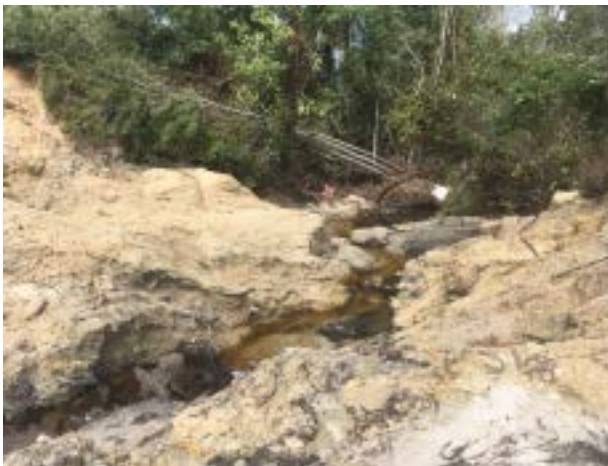
Heavily vegetated with brush and trees greater than 4" in diameter.

Trees greater than 4" in diameter observed in the downstream area.

Brush and woody vegetation observed in downstream area.

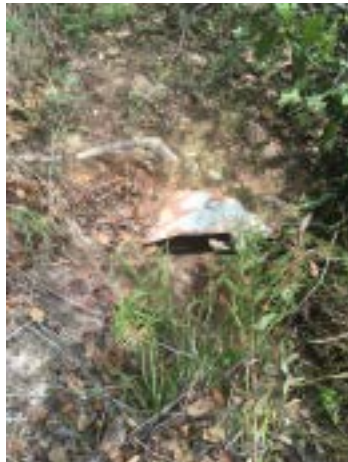
Intake pipe bent and damaged.

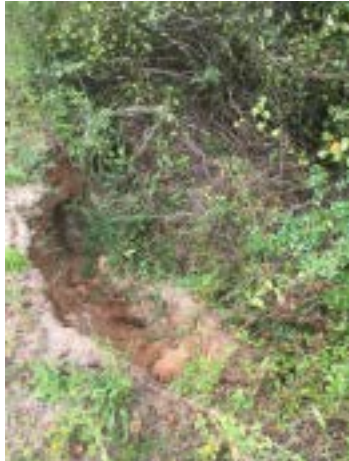
Spillways: Outlet Works	
<i>2a. Outlet Structure</i>	Action Required
<p>Section of dam above outlet has eroded and collapsed over it.</p> <div style="display: flex; justify-content: space-between;">

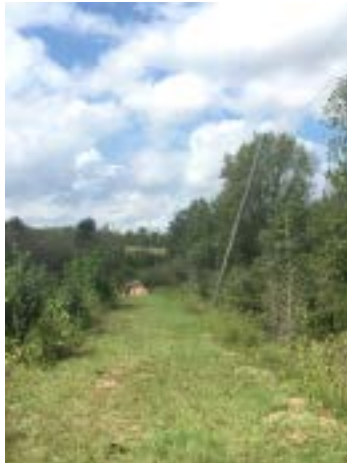
Power line runs along the crest of the dam.
