McMEEKIN POND DAM : D3430

Dams Preliminary Inspection Form

Inspector: Hannah Vinson

Start Date: 09/26/2018 Completed Date: 10/05/2018

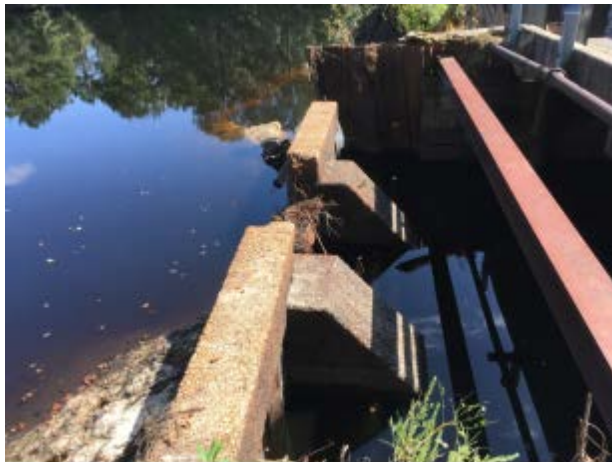
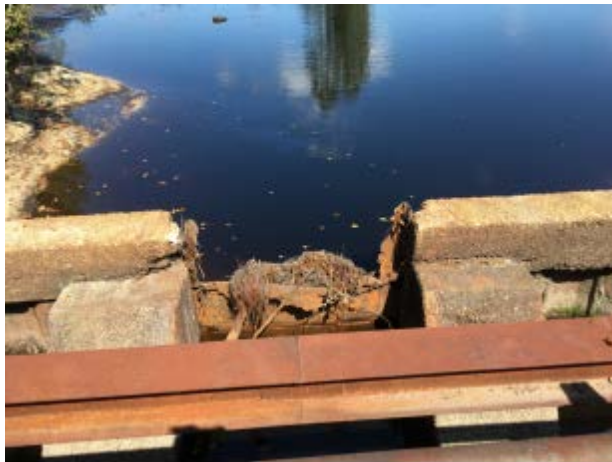
7b. Type of Spillways Present

Weir (Ogee, Labyrinth, etc)

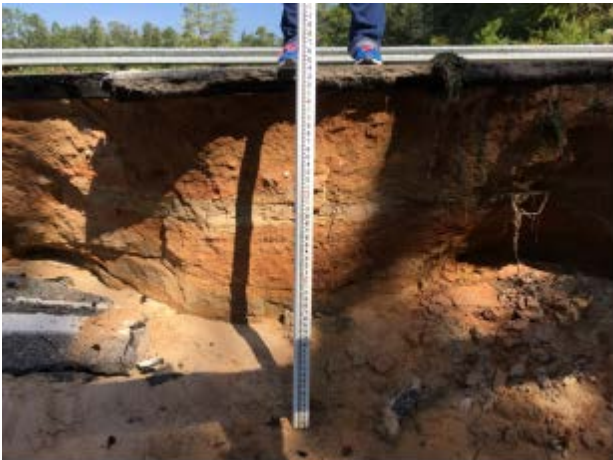
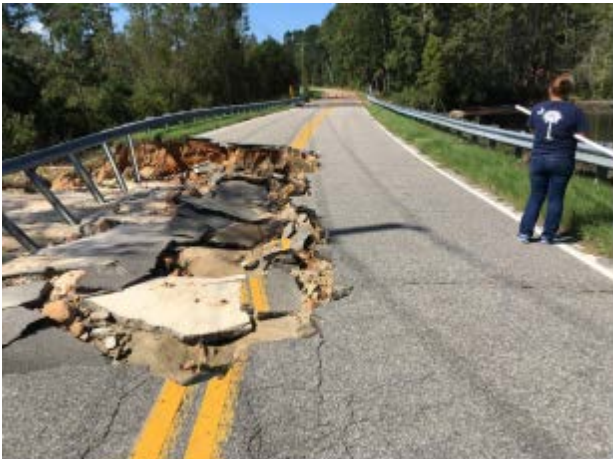
8. <i>Sinkhole</i>	Action Required
9. <i>Erosion</i>	Action Required
<p>Erosion over 4' deep. Caused by overtopping during Hurricane Florence.</p> <div style="display: flex; justify-content: space-between;"> <div style="width: 45%;">

Embankment: Crest	
12. <i>Embankment: Crest Condition</i>	Needs Permitted Repair(s)
<div style="border: 1px solid black; padding: 5px;"> Violation Determined: 10/5/2018 DAMMAINTREP </div>

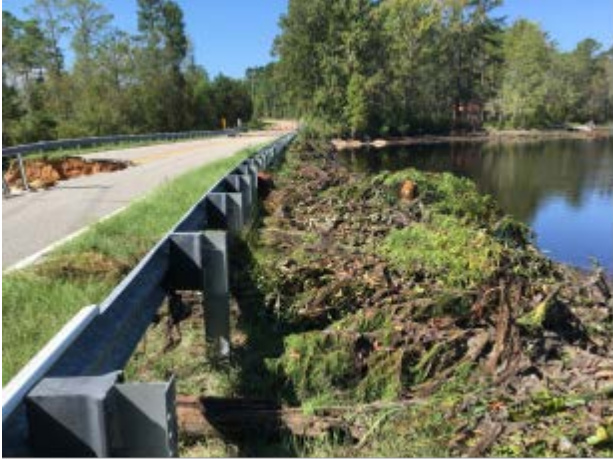
Embankment: Upstream Slope	
<i>2. Deleterious Vegetation</i>	Action Required
Small bushes and tall grass (laid down due to overtopping)

<i>12. Other:</i>	Action Required
<i>13. Embankment: Upstream Slope Condition</i>	Needs Maintenance, Condition Prevented Full Inspection
Violation Determined: 10/5/2018 DAMMAINTREP	
<i>14. Additional Comments (Refer to item number if applicable)</i>

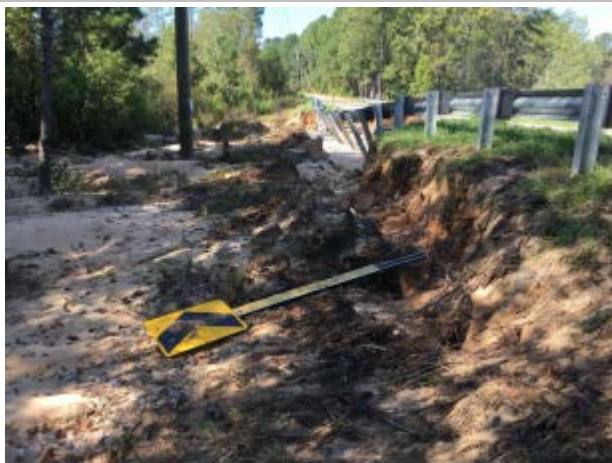
1. Grass Cover

Action Required

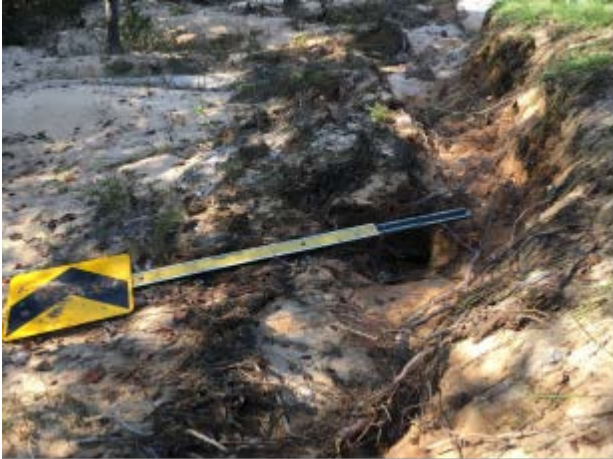
Embankment: Downstream Slope	
8. Groins	No Deficiency
9. Erosion	Action Required
<div style="display: flex; align-items: flex-start;">

15. Other:	Action Required
16. Embankment: Downstream Slope Condition	Needs Permitted Repair(s), Condition Prevented Full Inspection
<div style="border: 1px solid black; padding: 5px;"> <p>Violation Determined: 10/5/2018 DAMMAINTREP</p> </div>

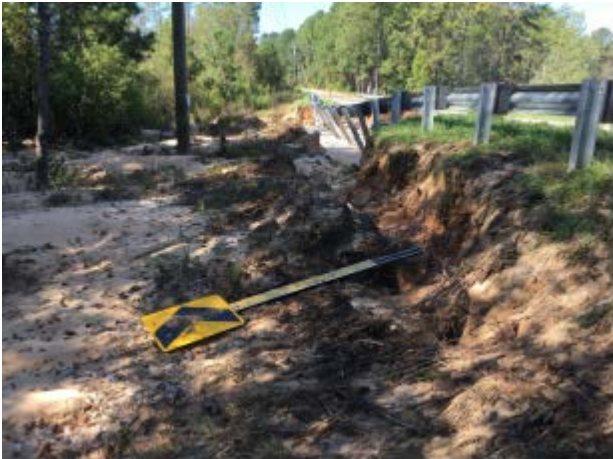
8. Other:	
9. Concrete/Masonry Dam: Downstream Face Condition	
10. Additional Comments (Refer to item number if applicable)	
Downstream Area	
<i>Is this section applicable for this dam?</i>	<input checked="" type="checkbox"/> Yes <input type="checkbox"/> No
<i>Is Downstream Area clear?</i>	<input type="checkbox"/> Yes <input checked="" type="checkbox"/> No
<p>Downstream area contains trees and swamp. Condition prevented inspection.</p> <div style="display: flex; align-items: flex-start;">

7. <i>Other:</i>	
8. <i>Downstream Area Condition</i>	Needs Maintenance, Condition Prevented Full Inspection
<input type="text" value="Violation Determined: 10/5/2018
DAMMAINTREP"/>

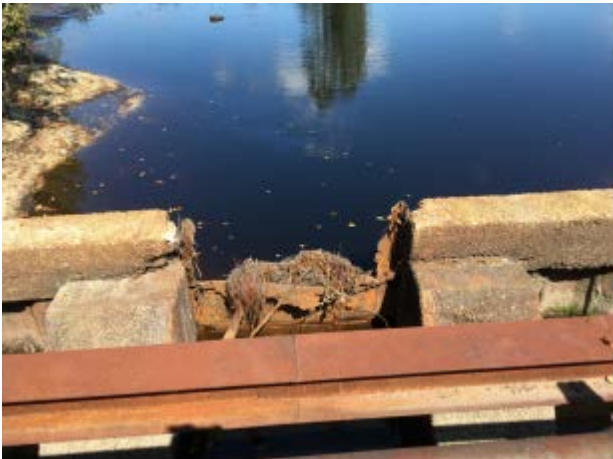
Spillways: Inlet Structure	
<i>Is this section applicable for this dam?</i>	<input checked="" type="checkbox"/> Yes <input type="checkbox"/> No
<i>1. Location</i>	
<i>2a. Intake Structure</i>	Action Required
<i>2b. Intake Structure Types</i>	Other (Explain In Comments)
<p>Bridge over weir type spillway.</p> <div style="display: flex; justify-content: space-between;"> <div style="width: 45%;">   </div> <div style="width: 45%;"> <p>Photo Taken: 9/26/2018 11:48:45 AM GPS Latitude: 34.7375555277778 GPS Longitude: -79.7997583333333 GPS Altitude: 41.4931271477663 meters GPS Azimuth: 46.5940246045694 degrees</p> </div> </div> <div style="display: flex; justify-content: space-between; margin-top: 10px;"> <div style="width: 45%;">

Spillways: Inlet Structure	
6a. Repairs/Alterations Present	<input checked="" type="checkbox"/> Yes <input type="checkbox"/> No <input type="checkbox"/> NA
Prior to the arrival of Hurricane Florence, owner removed a portion of the metal pieces acting as water level control in order to lower the water level.	
6b. (If Present:) Alterations/Repairs Condition

7. Other:	
8. Spillway: Inlet Structure Condition	Needs Permitted Repair(s)
Violation Determined: 10/5/2018 DAMMAINTREP	
9. Additional Comments (Refer to item number if applicable)	
Spillways: Outlet Works	
Is this section applicable for this dam?	<input type="checkbox"/> Yes <input checked="" type="checkbox"/> No
