MCLAURINS MILLPOND DAM : D3441

Dams Preliminary Inspection Form

Start Date: 09/28/2018 Completed Date: 10/01/2018

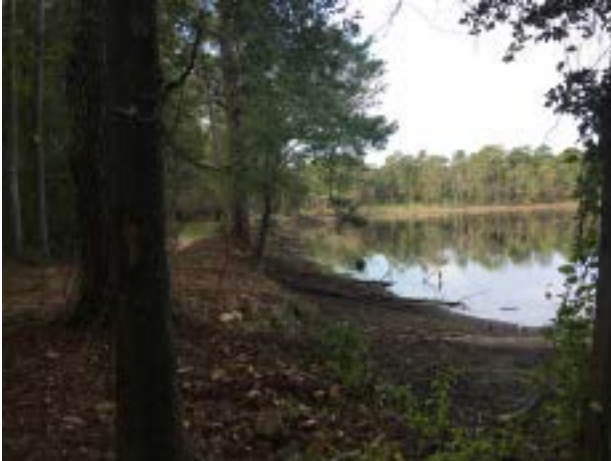
| Inspection Information | |
|--|---|
| <p>The dam is breached at the midway section of the dam. Pond is holding some water. Right side of the dam was not accessible due to the breach.</p> <p>Note: All directions given looking downstream.</p> <div style="display: flex; align-items: flex-start;"> <div style="margin-left: 20px;"> <p>Photo Taken: 9/27/2018 10:47:44 AM GPS Latitude: 34.6763 GPS Longitude: -79.756775 GPS Altitude: 48.1004066312168 meters GPS Azimuth: 232.915603532875 degrees</p> </div> </div> | |

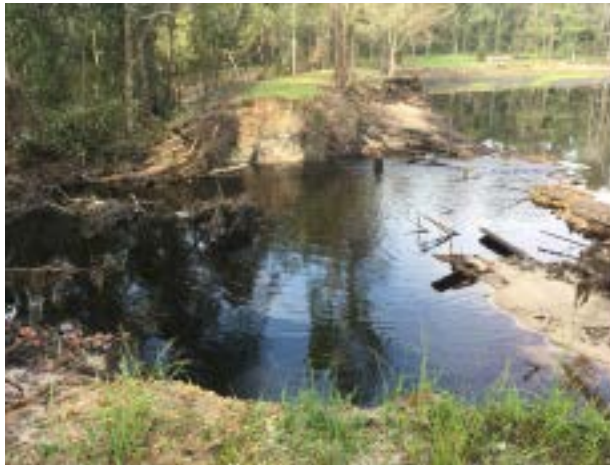
7b. Type of Spillways Present

Dam sustained a breach at the middle of the dam. Concrete auxiliary spillway is located at the left abutment of the dam.

Right side of the dam was not accessible due to the breach.

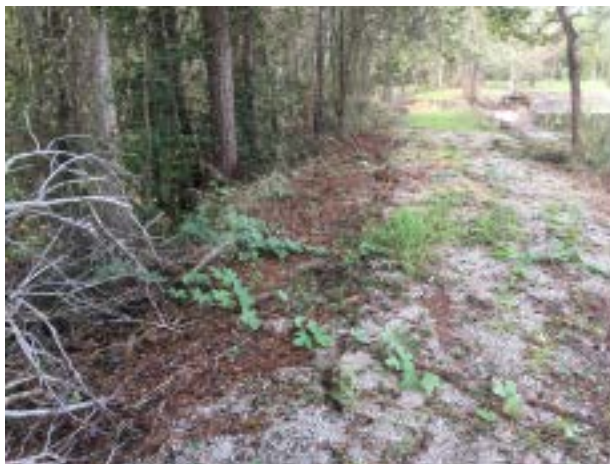
1. Grass Cover

Little to no grass cover.

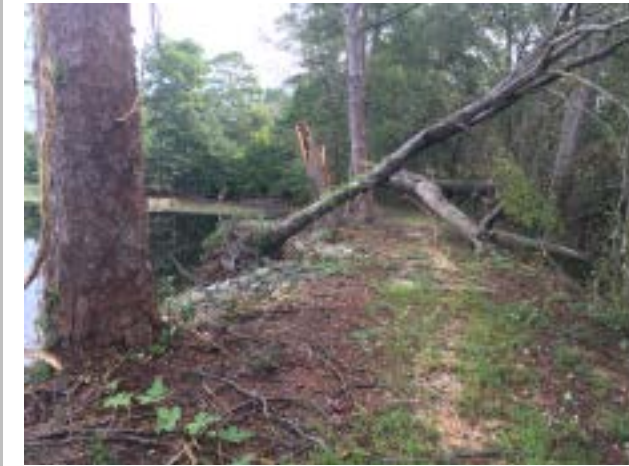
3. Trees

Action Required

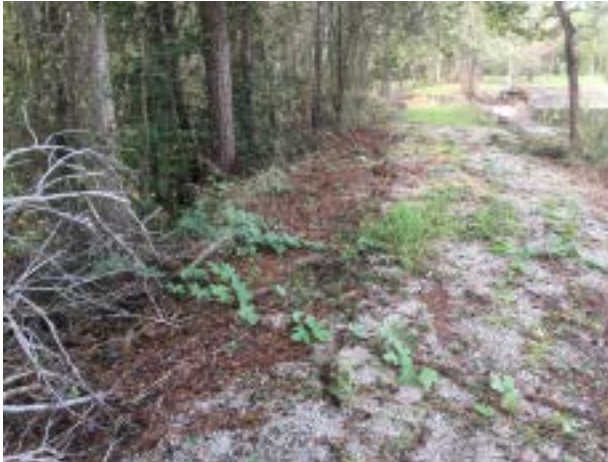
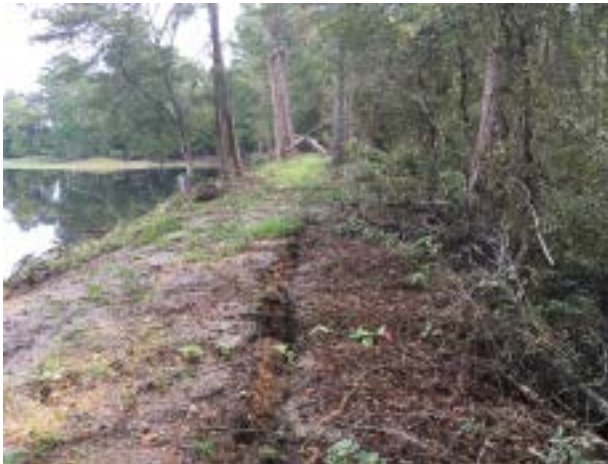
5. Surface Cracking

Cracking and settlement was observed along the crest approximately 50 feet to the left of the breach

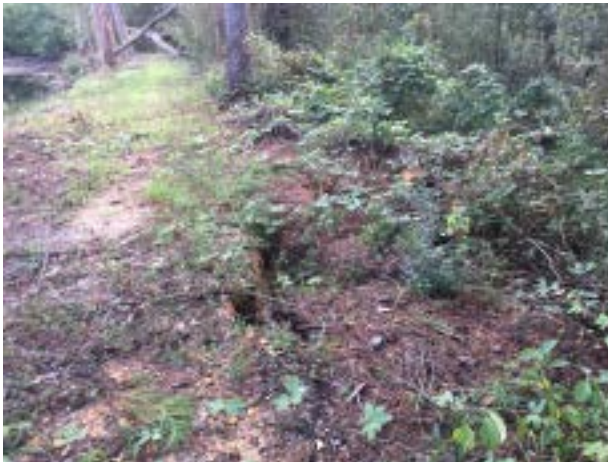
9. Erosion

Areas of the dams crest have eroded due to overtopping of the dam.

Needs Permitted
Repair(s)

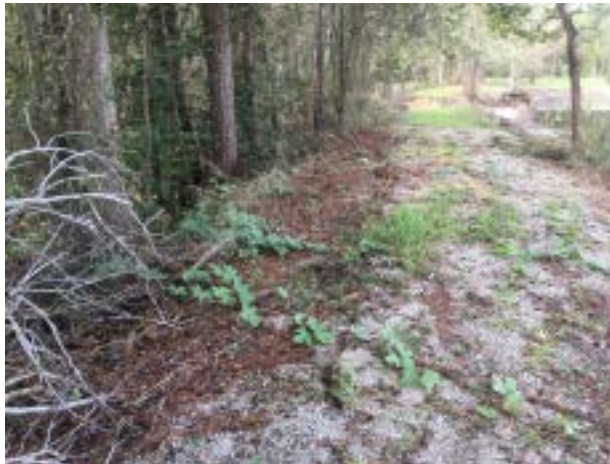
3. Trees

Action Required

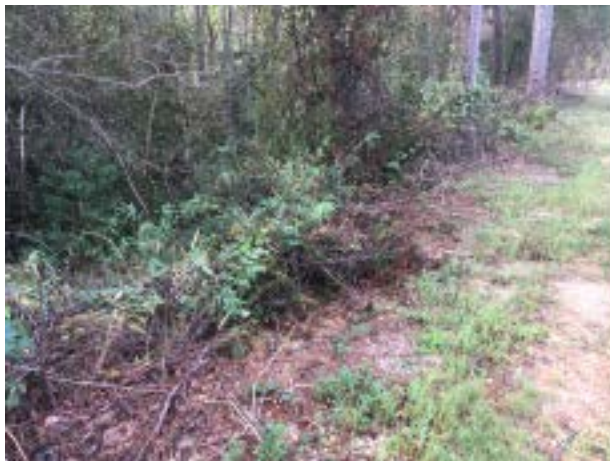
7. Slide, Slough, Scarp

Eroded areas and scarps were observed in several places on the downstream slope due to overtopping of the dam

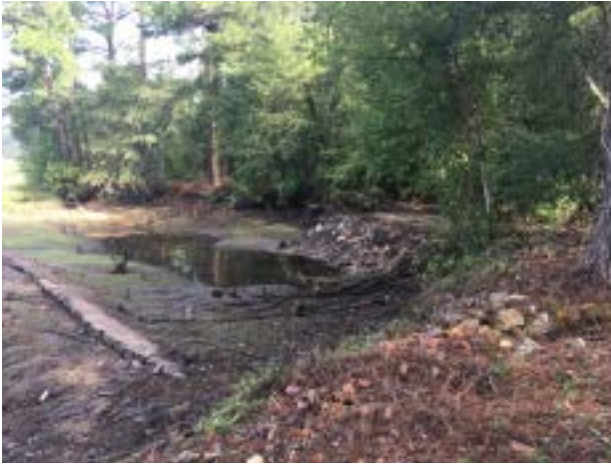
| Spillways: Erodible Channel | |
|--|--|
| 2. <i>Approach Area</i> | Action Required |

| Spillways: Erodible Channel | |
|--|--|
| <p>Approach to the control section of the auxiliary spillway has collapsed. Appears to have been this way prior to Hurricane Florence</p> <div style="display: flex; align-items: flex-start;"> <div style="flex: 1;"> </div> <div style="flex: 1; padding-left: 20px;"> <p>Photo Taken: 9/27/2018 10:48:03 AM GPS Latitude: 34.6762 GPS Longitude: -79.7569194444444 GPS Altitude: 47.7667274939173 meters GPS Azimuth: 10.4799194259096 degrees</p> </div> </div> | |

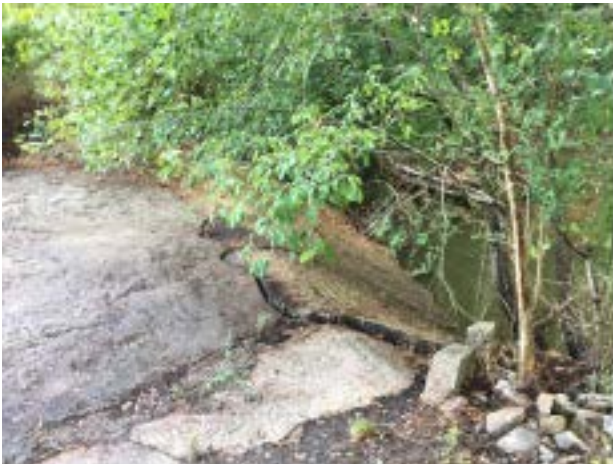
| Spillways: Non-Erodible Channel | |
|--|--|
| <i>5. Channel Floor</i> | Action Required |

| Spillways: Non-Erodible Channel | |
|--|--|
| Cracks were observed in the concrete channel | |
