GREENVILLE COUNTY POTENTIAL FLOOD DAMAGE ASSESSMENT

Prepared for the U.S.D.A. Soil Conservation Service by George S. Saussy III
working under contract with the S.C. Water Resources Commission.

March 1985

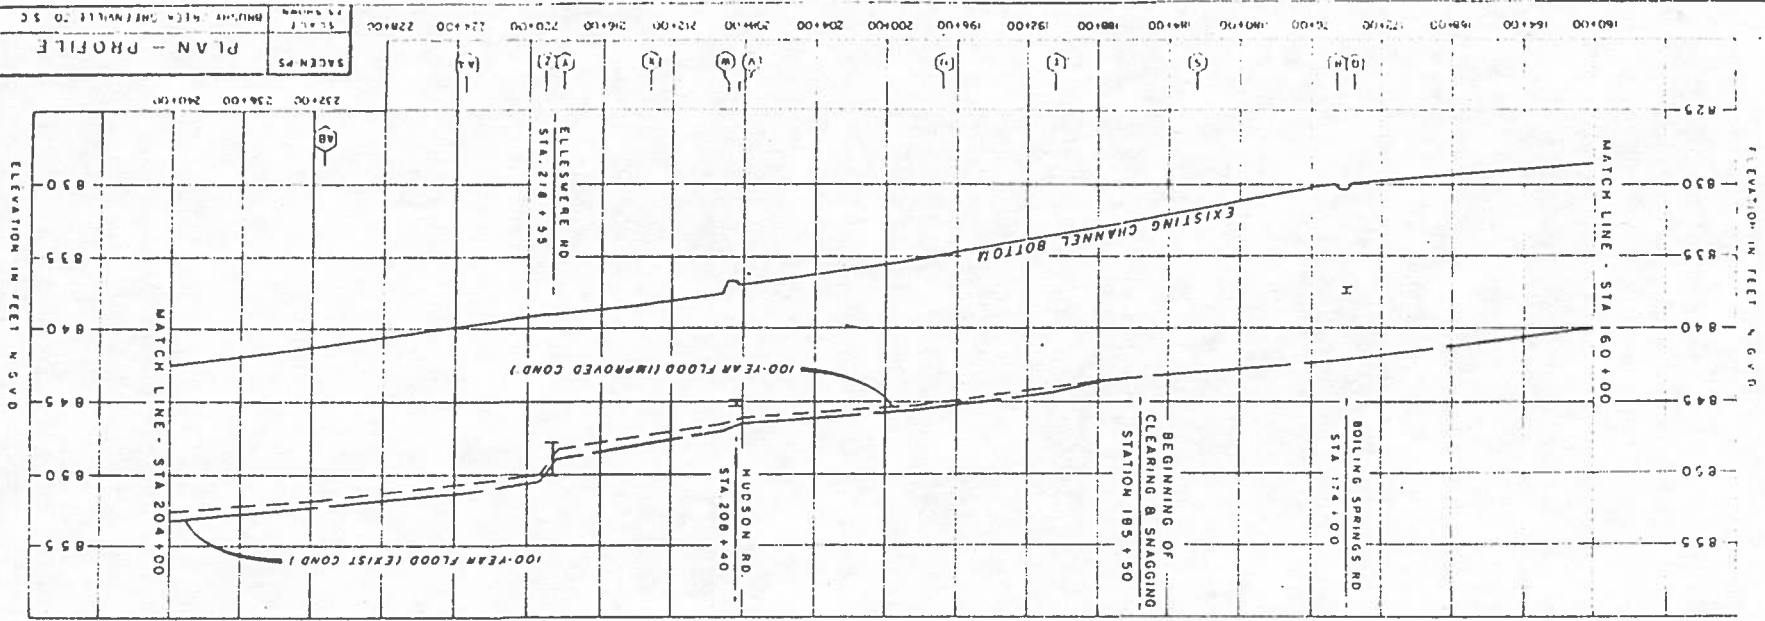
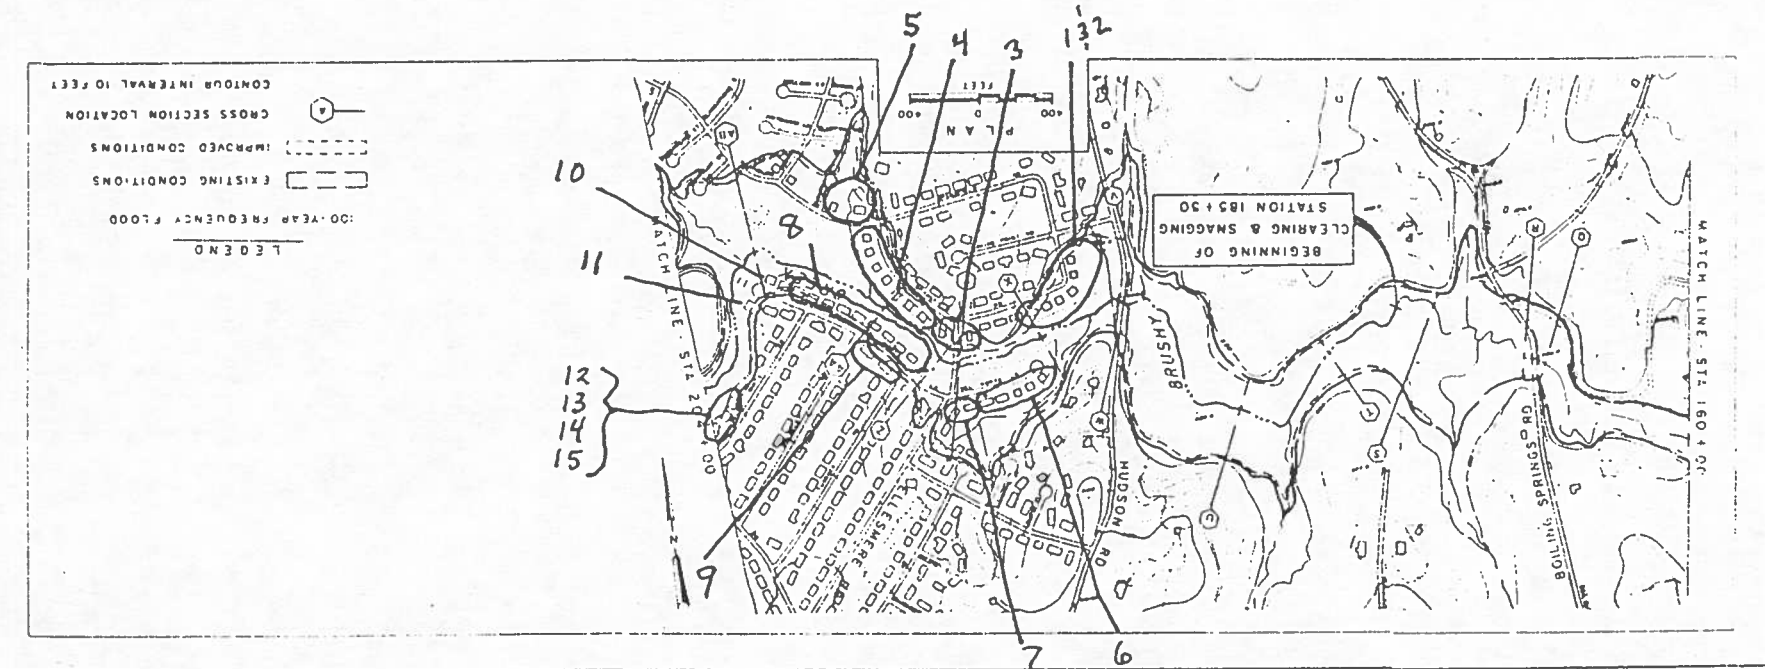
DETAIL MAP # 165A Brushy Creek: Hudson to Terramount

Structure # (Refer to map)	100 yr. Flood Elevation in reference to 1st Floor (in feet)	TYPE	CLASS	Stories	Basement?	Size	Furnishing Class	Yard Damage or Bus. Type	Estimated Damage
1	-2	RBV	B	1	yes	A	A	major	7,950
2	+0	RFS	B	2	no	L	A	major	6,200
3 (2)	+1	RBV	B	1	no	A	A	major	27,300
4	< -3							moderate	1,000
5	+1	RBV	B	1	no	L	A	moderate	15,300
6	+0	RFS	B	1½	no	A	A	major	5,550
7	+0	RFS	B	1	no	A	A	moderate	6,200
8 (3)	< -3							moderate	3,000
9 (4)	+0	RBV	B	1	no	A	A	moderate	24,800
10	< -3							moderate	1,000
11(9)	< -3								9,000
12	+0	RBV	B	1	no	L	A	major	8,000
13	+0	RBV	B	2	no	L	A	major	6,300
14(2)	-6	RBV	B	1	yes	L	A	moderate	8,200
15	-6	RBV	B	2	yes	L	A	moderate	4,000
16	+3	RFS	B	2	no	L	A	major	21,500
									155,300

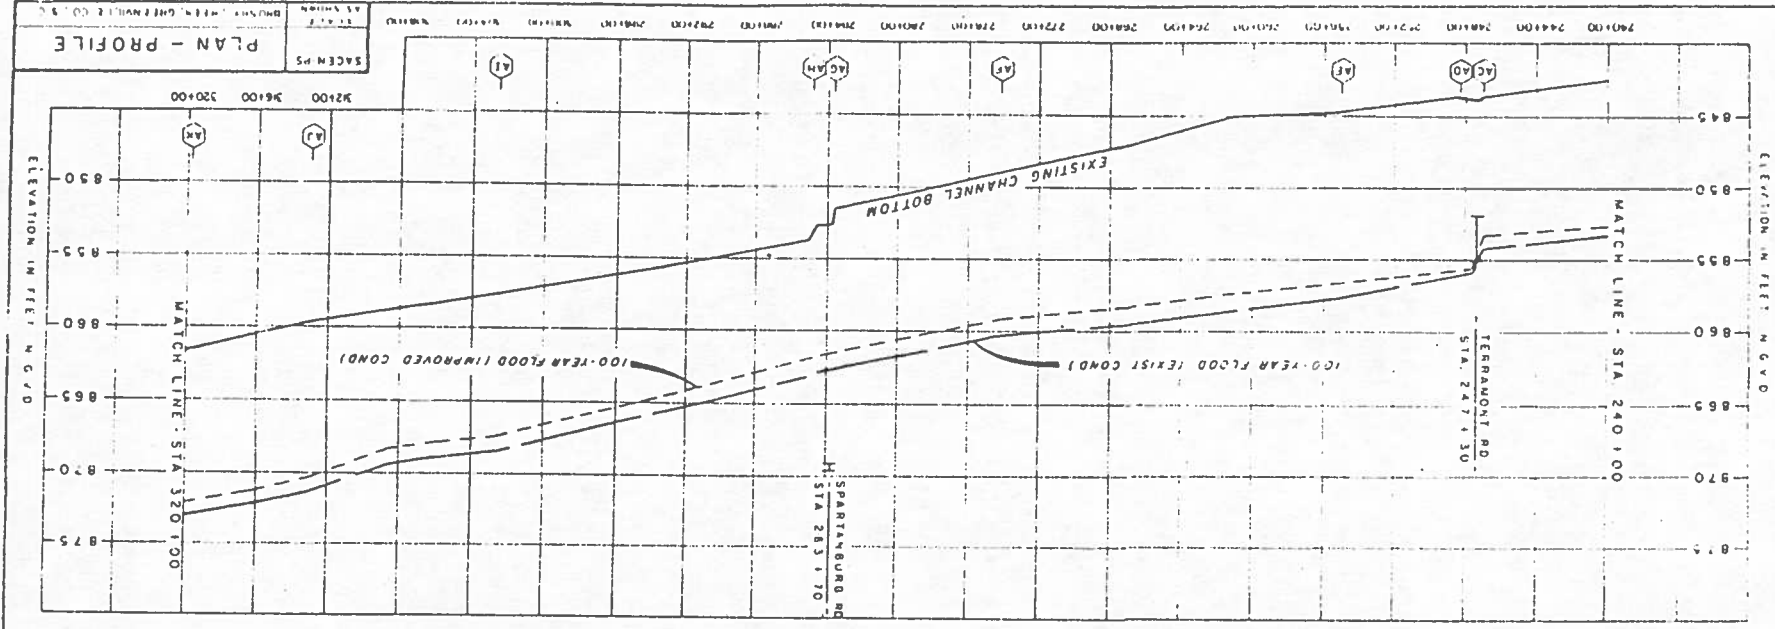
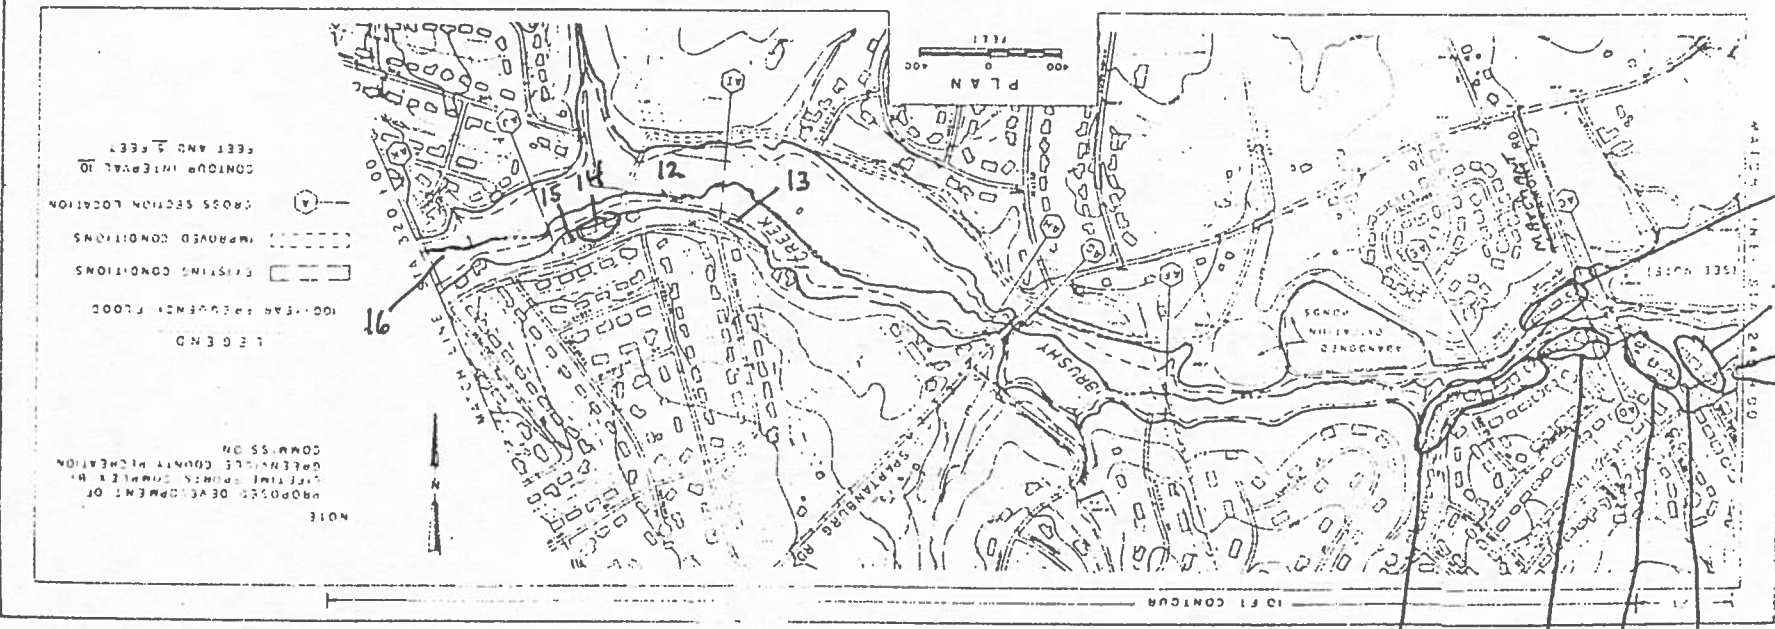
Detail Map # 165 B Brushy Creek: Marchant to Kenilworth

Structure # (Refer to map)	100 yr. Flood Elevation in reference to 1st Floor (in feet)	TYPE	CLASS	Stories	Basement?	Size	Furnishing Class	Yard Damage or Bus. Type	Estimate Damage
1	<-3							moderate	1,000
2	0	RBV	B	2	no	L	A	moderate	15,400
3 (7)	0	RBV	B	1	no	A	A	moderate	44,400
4 (2)	0	RBV	B	1	no	A	A	moderate	12,400
5	+2	RBV	B	1	no	A	A	moderate	21,500
6	+3	RBV	B	2	no	A	A	moderate	17,400
7 (2)	0	RBV	B	1	no	A	A	moderate	12,400
8	0	RBV	B	2	no	A	A	moderate	4,700
9	+3	RBV	B	2	no	A	A	major	18,150
10(3)	0	RBV	B	1	no	A	A	major	20,850
11(4)	0	RBV	B	1	no	A	A	moderate	24,800
12(4)	<-3							moderate	1,000
13	0	RBV	B	1	no	A	A	moderate	6,200
14	<-3							major	2,000
15	+3	DUPLEX	B	1	no	A	A	minor	28,600
16	+2	DUPLEX	B	1	no	A	A	minor	21,000
17	<-3							major	1,750
18	+2	RBV	B	2	no	A	A	major	14,150
									267,700

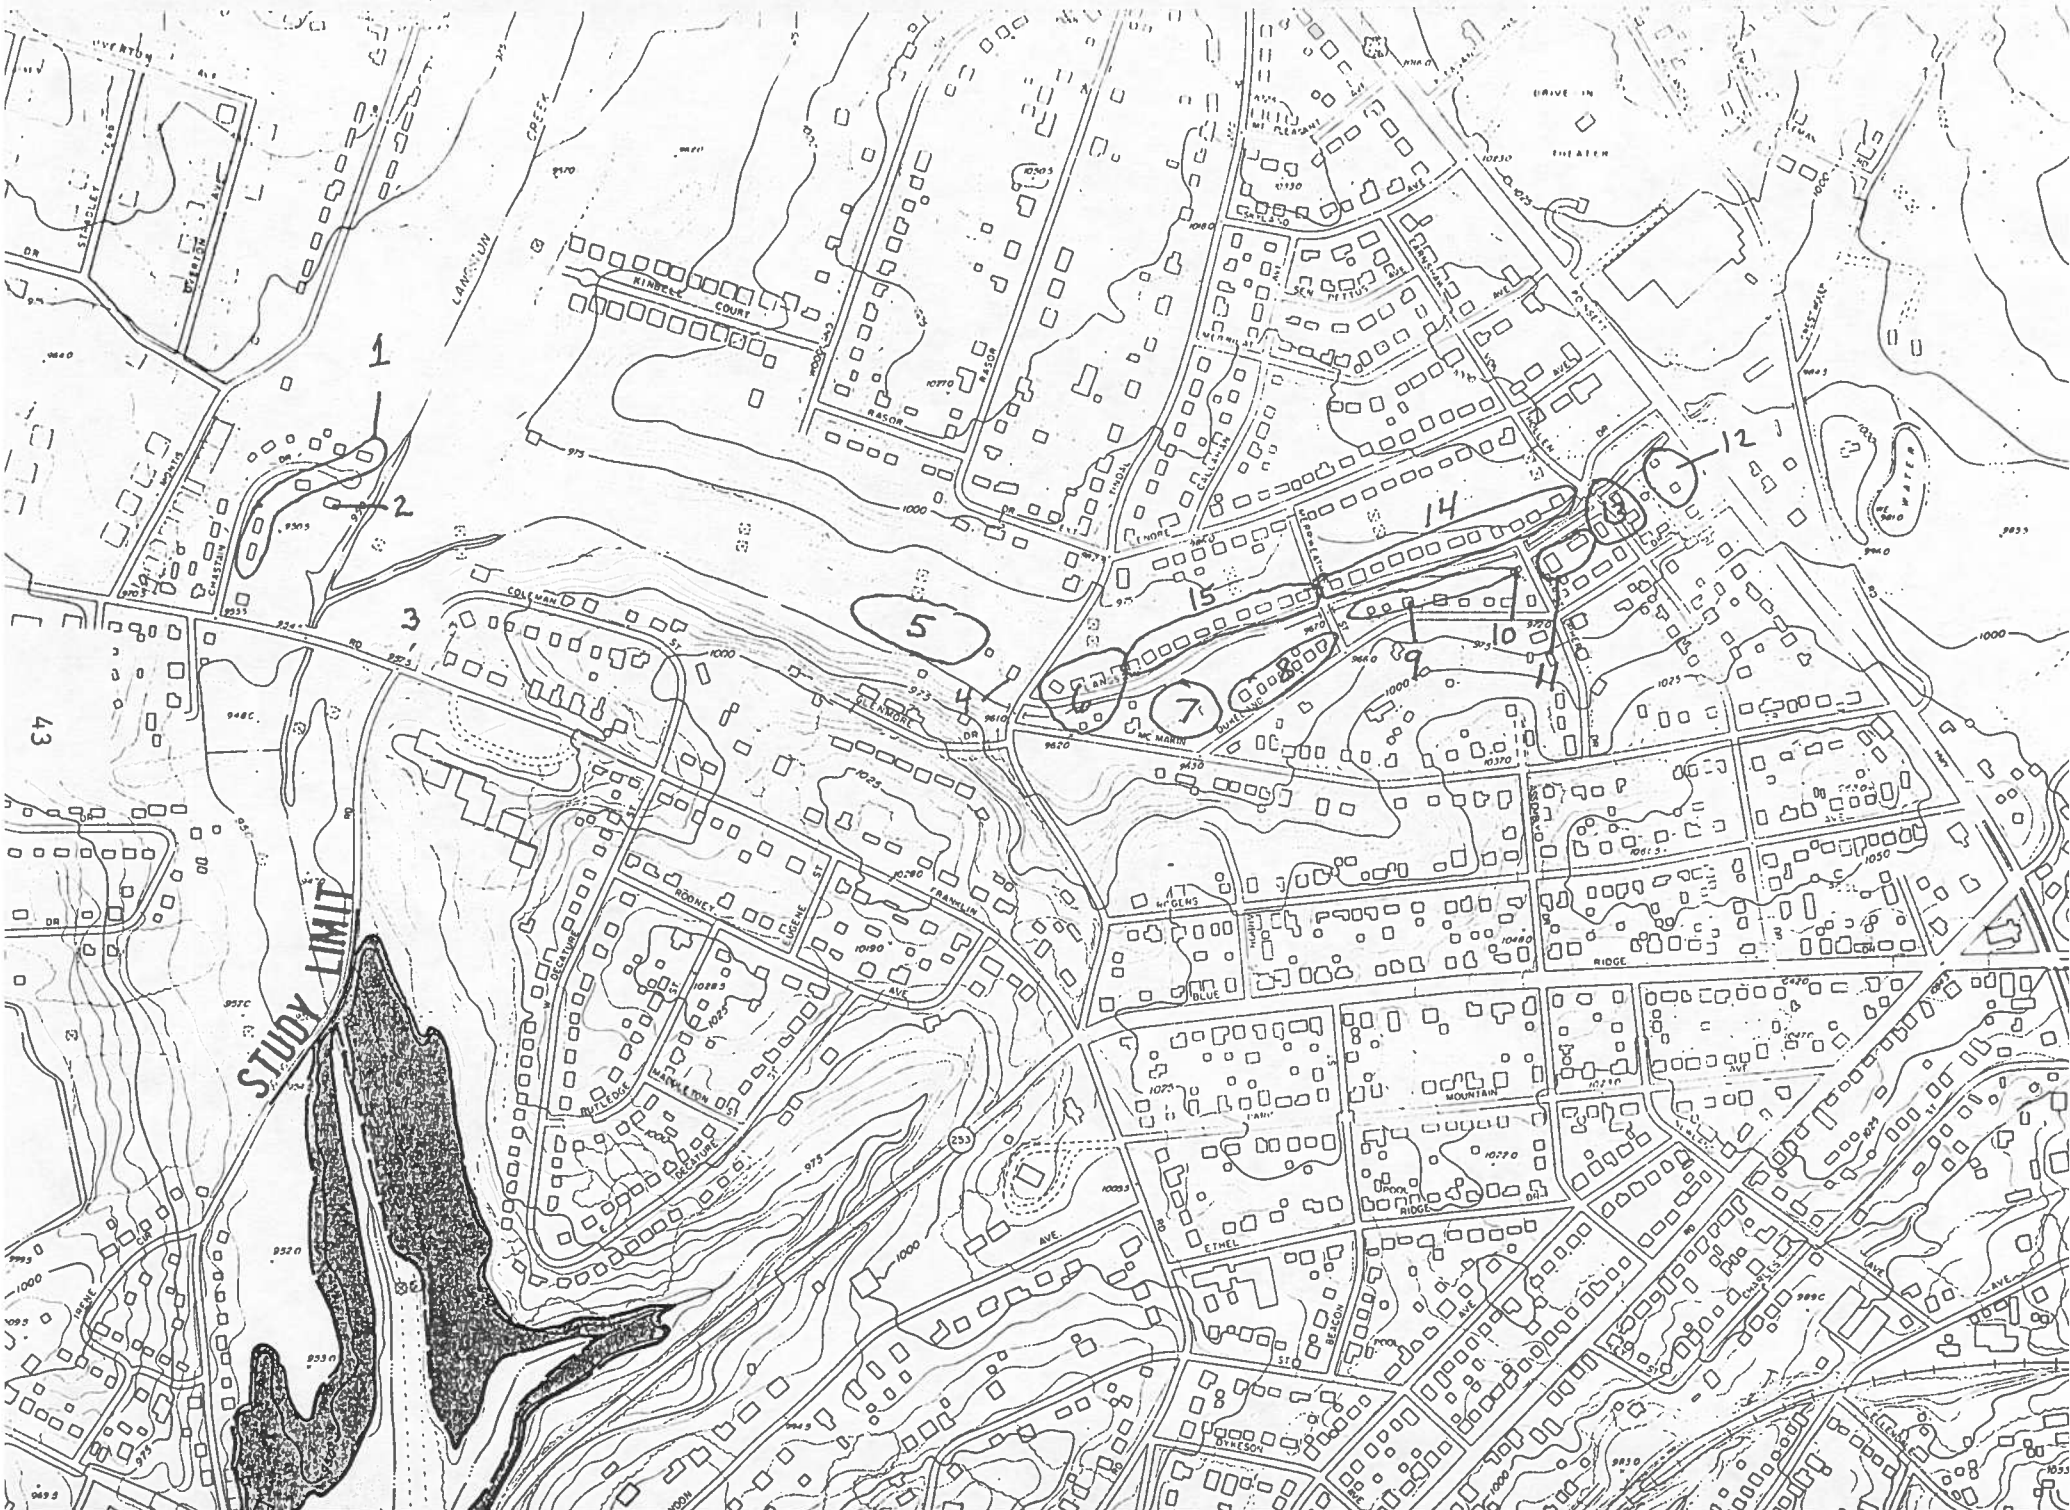
DETAIL MAP # 145A LANGSTON CREEK

Structure # (Refer to map)	100 yr. Flood Elevation in reference to 1st Floor (in feet)	TYPE	CLASS	Stories	Basement?	Size	Furnishing Class	Yard Damage or Bus. Type	Estimated Damage
1 (2)	-1	RBV	B	1	no	A	A	major	4,000
2	+1	RBV	B	1	no	A	A	major	13,650
3 (2)	0	RBV	C	1	no	A	A	major	9,500
4	0	RBV	C	1	no	DUPLEX	A	minor	2,400
5	0	RBV	B	2	no	A	A	moderate	4,700
6	0	RBV	B	2	no	A	A	major	5,450
7 (6)	0	RBV	B	1	no	A	A	major	48,650
8 (2)	∇ -3	na						major	3,500
9	0	RBV	B	2	no	A	A	major	5,450
								TOTAL	97,300

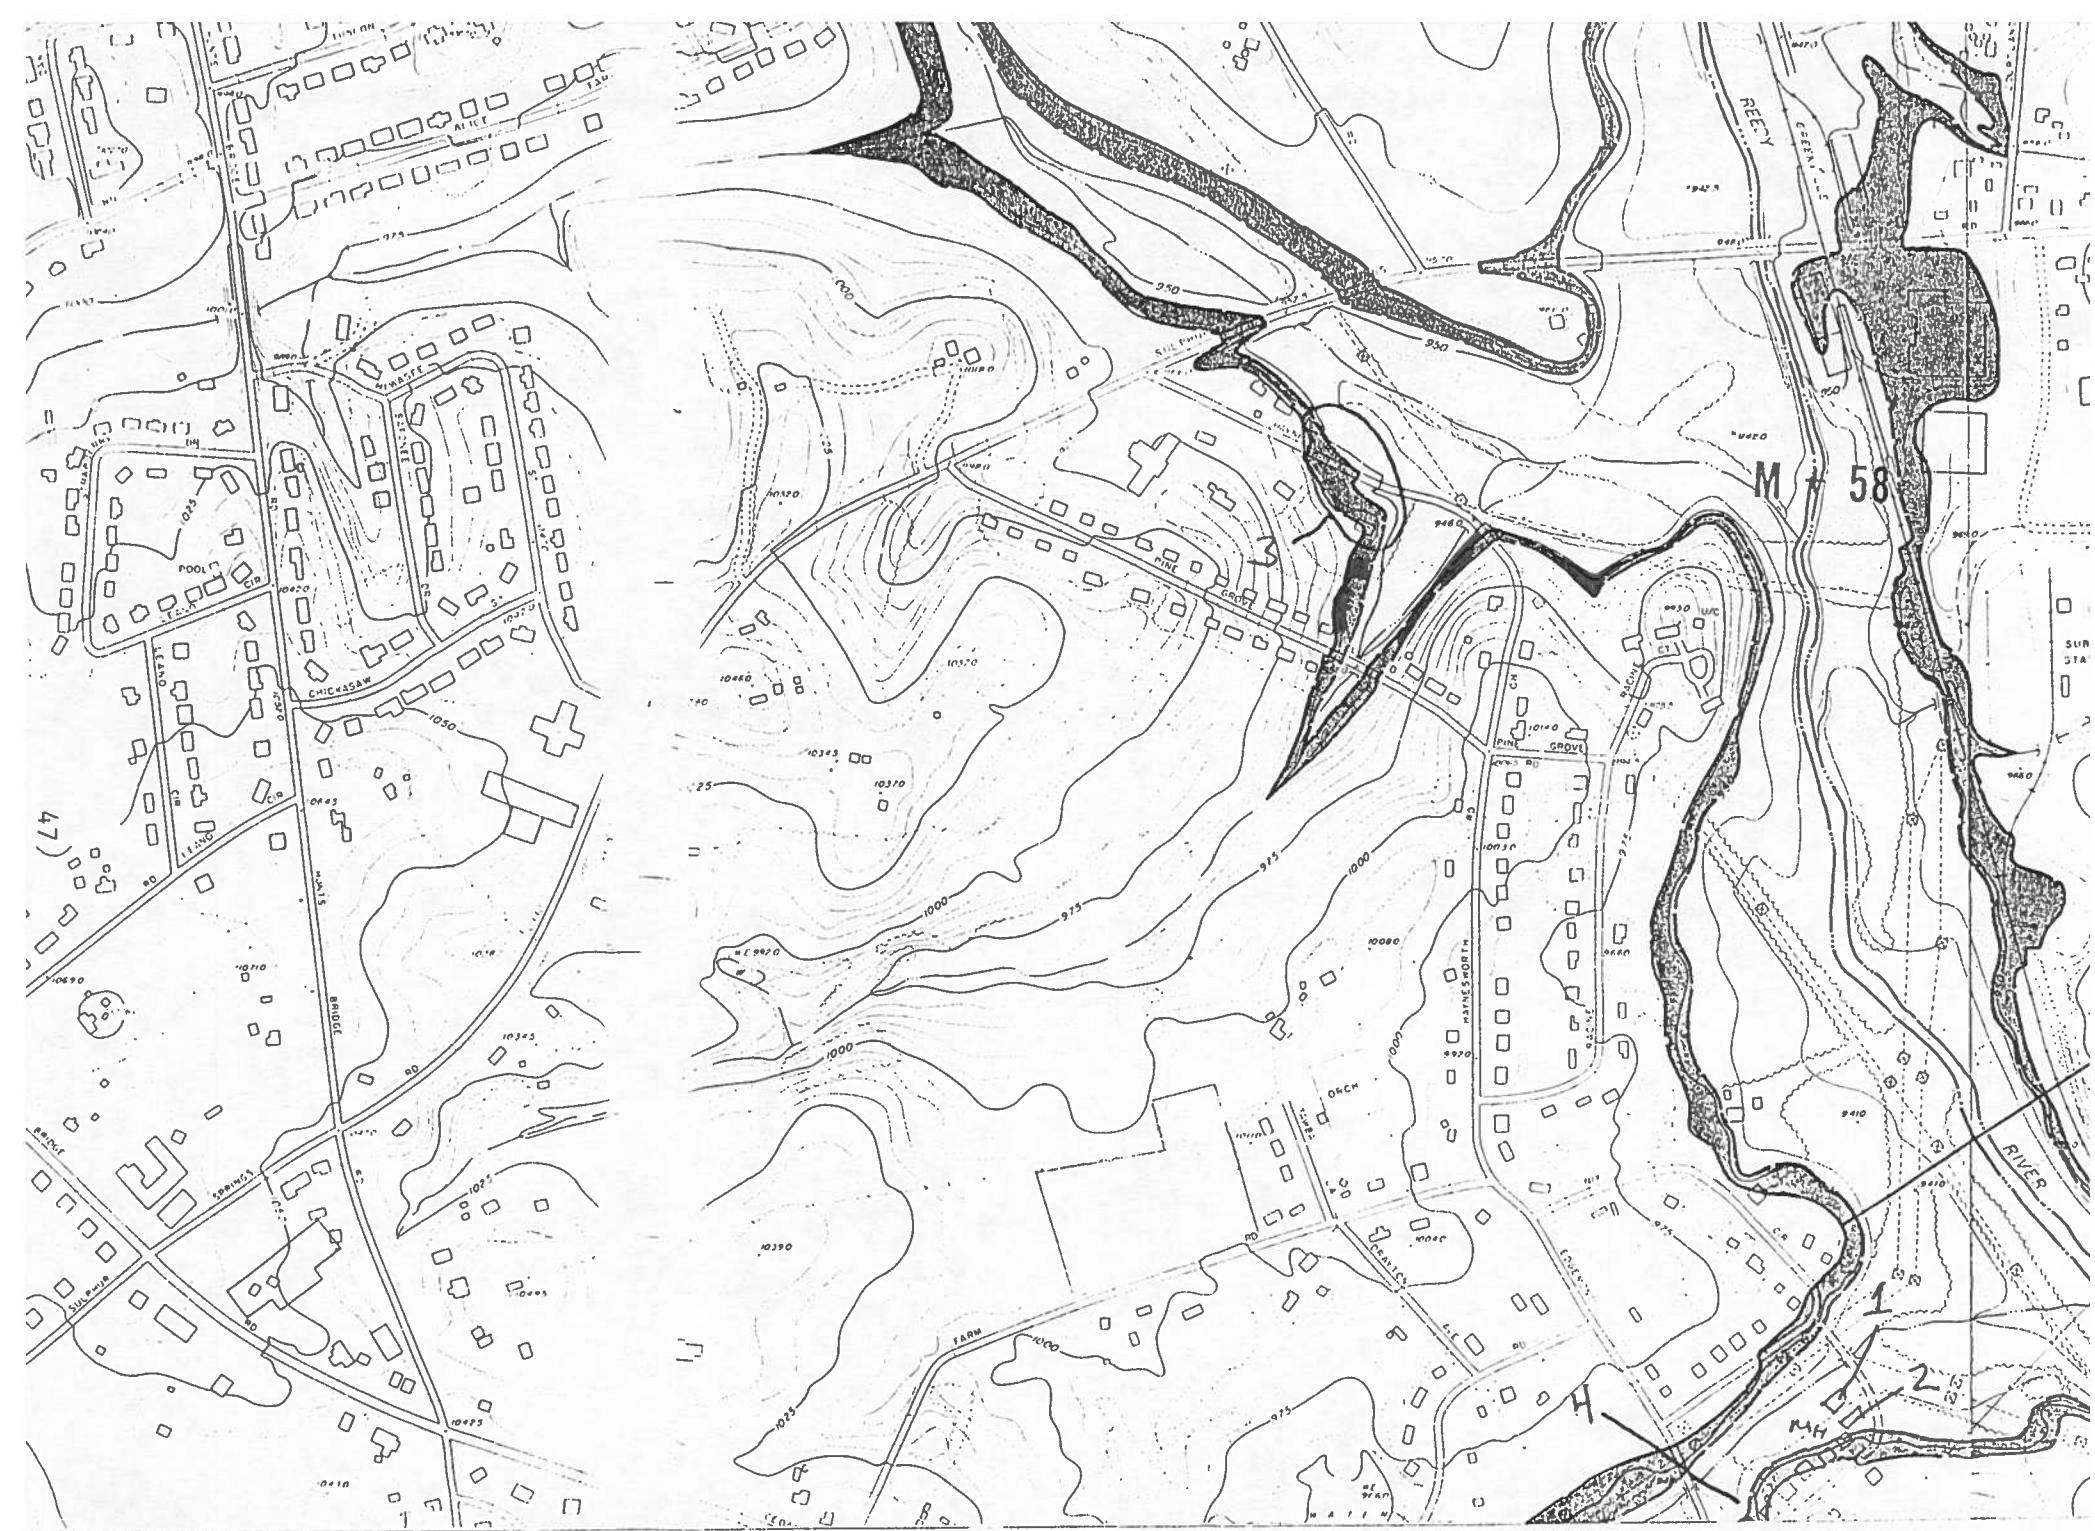
DETROIT MAP # 145 C Jones Cir. To Suburban Spruce

Structure # (Refer to map)	100 yr. Flood Elevation in reference to 1st Floor (in feet)	TYPE	CLASS	Stories	Basement?	Size	Furnishing Class	Yard Damage or Bus. Type	Est D
1	+0	COM	C	1	no	30x60	na	Body shop	10,000
2	+1	COM	C	1	no	20x40	na	Tavern	3,000
3 (2)	0	RFS	C	1	no	S	A	minor	5,600
4	0	MH	na	1	no	M	A	minor	1,100
5 (8)	0	RFS	C	1	no	S	A	minor	22,300
6 (3)	-1	RFS	C	1	no	A	A	minor	2,100
7	-1	RFS	C	1	no	A	A	major	2,000
								total	46,100

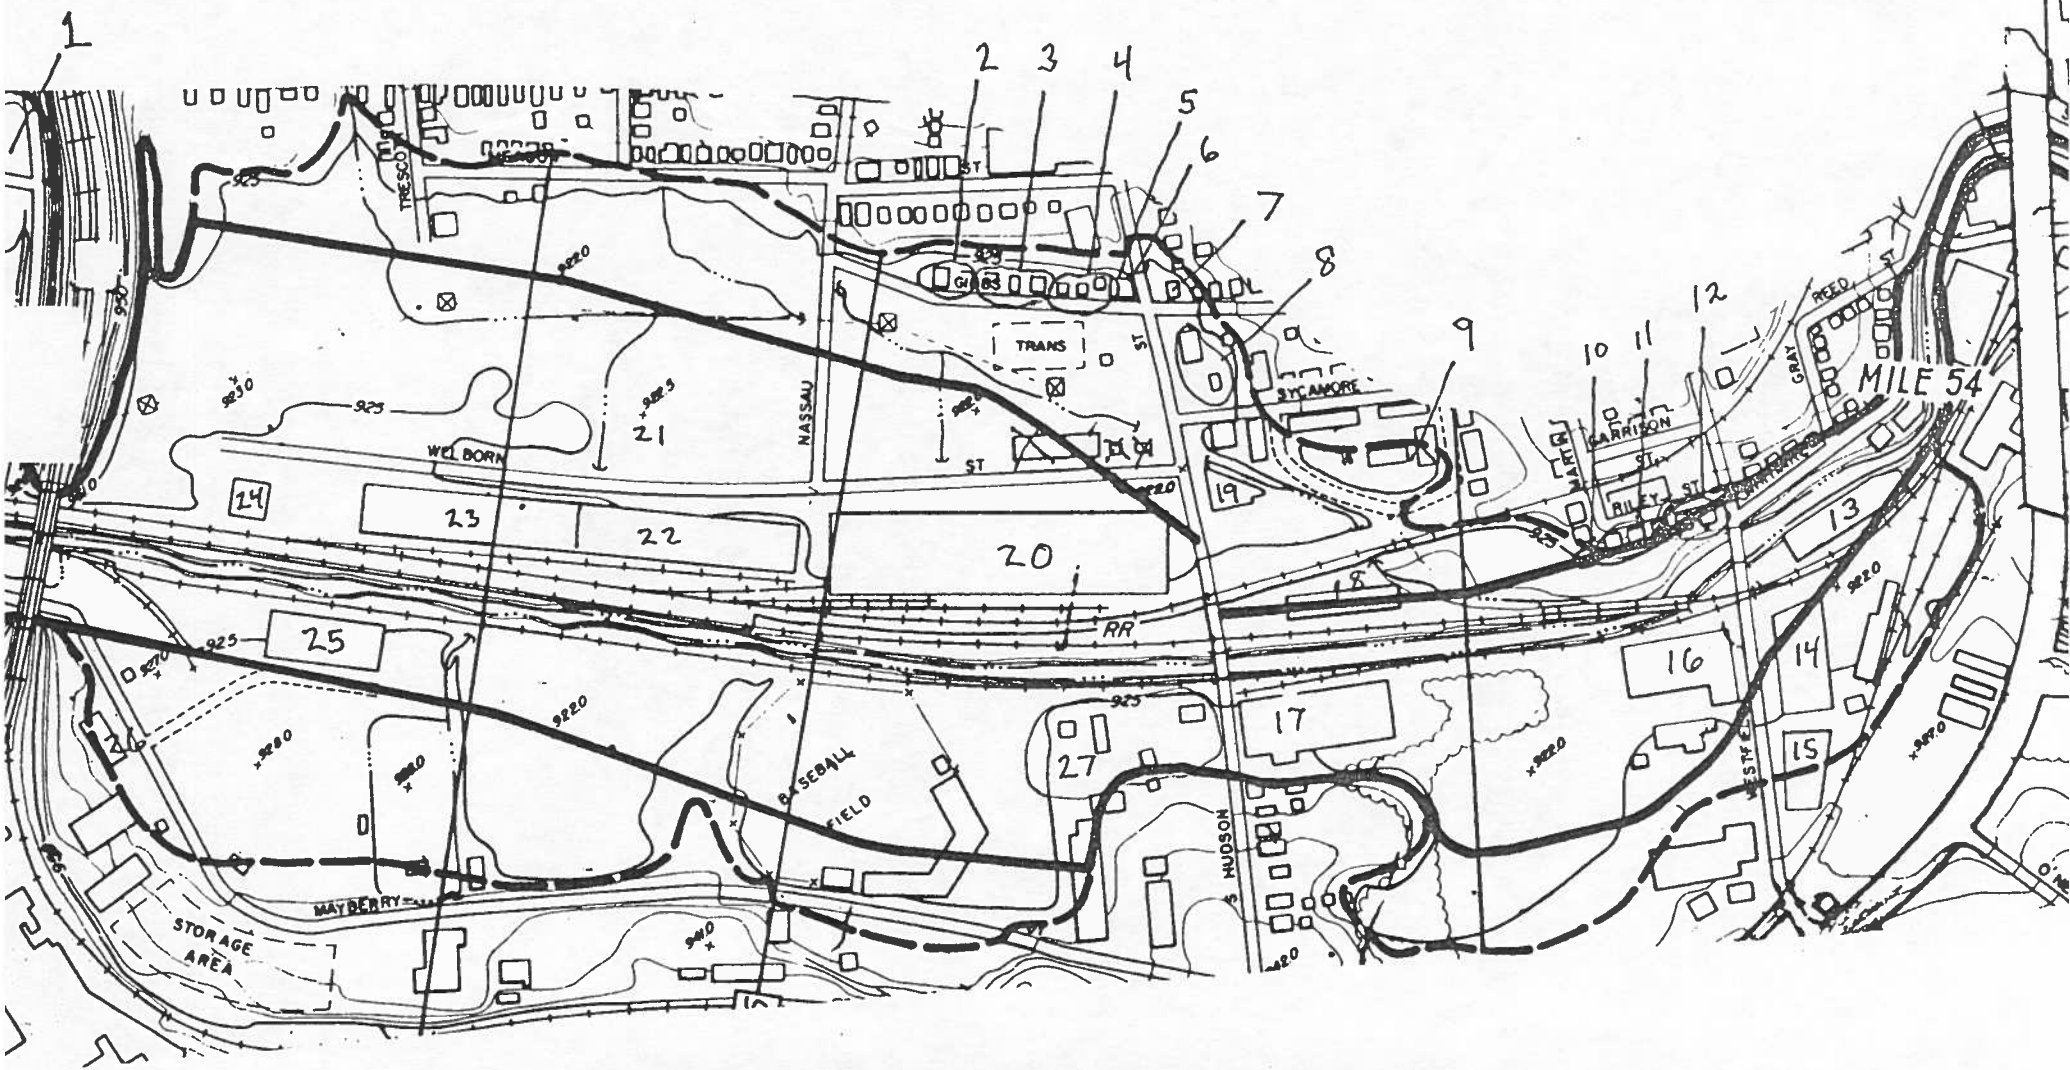
Detail MAP; City of Greenville panel # 4A, Willard st. to Academy ST

Structure # (Refer to map)	100 yr. Flood Elevation in reference to 1st Floor (in feet)	TYPE	CLASS	Stories	Basement?	Size	Furnishing Class	Yard Damage or Bus. Type	Estimate Damage
1 (3)	<-3								3,000
2 (2)	+1	RFS	C	1	no	duplex	A	MINOR	10,200
3 (2)	+0	RFS	C	1	no	duplex	A	MINOR	6,800
4 (3)	+0	RBV	C	1	no	duplex	A	MINOR	10,200
5	+2	COM	C	1	no	20x30	NA	GROCERY	50,000
6	+2	COM	C	1	no	20x30	NA	BEAUTY PARLOR	20,000
7	+1	COM	C	1	no	30x30	NA	TAVERN	25,000
8	+2	COM	C	1	no	12x20	NA	GAS/BEER	30,000
9 (11)	+1	RBV	C	1	no	S	L	RENTAL UNITS	22,000
10	+0	RFS	C	1	no	S	A	MAJOR	4,000
11 (5)	-1	RFS	C	1	no	S	A	MAJOR	10,000
12	+0	RFS	C	1	no	S	A	MAJOR	4,000
13	+1	COM	NA	1	no	30x100	NA	WAREHOUSE	10,000
14	+1	COM	NA	1	no	50x100	NA	WHOLESALE	2,000,00
15	+1	COM	NA	1	no	50x50	NA	WHOLESALE	100,000
16	+1	COM	NA	1	no	100x100	NA	VACANT	20,000
17	+1	PUBLIC	NA	1	no	40x100	NA	CITY ENG.	
18	+1	PUBLIC	NA	1	no	20x100	NA	CITY ENG.	10,000
19	+3	COM	NA	2	no	50x100	NA	MATTRESS FAC.	50,000

20	+1	COM	NA	2	no	100x400	NA	TEXTILE	250,000
21	+1	COM	NA	1	no	100x600	NA	WAREHOUSE	400,000
22	+1	COM	NA	1	no	50x200	NA	WAREHOUSE	40,000
23	+1	COM	NA	1	no	50x200	NA	WASTE PAPER	20,000
24	+1	COM	NA	1	no	50x100	NA	BEER DIST.	250,000
25	+1	COM	NA	1	no	50x100	NA	WAREHOUSE	1,000
26	<-3								
27	city maintenance park							n/a	
								TOTAL	3,344,200
