SOUTH CAROLINA
WATER RESOURCES COMMISSION
GEOLOGY - HYDROLOGY DIVISION

INVESTIGATION
OF GROUND - WATER PROBLEMS NEAR
THE VULCAN MATERIALS MARBLE QUARRY
CHEROKEE COUNTY, SOUTH CAROLINA

May 1988

Open-File Report No. 19

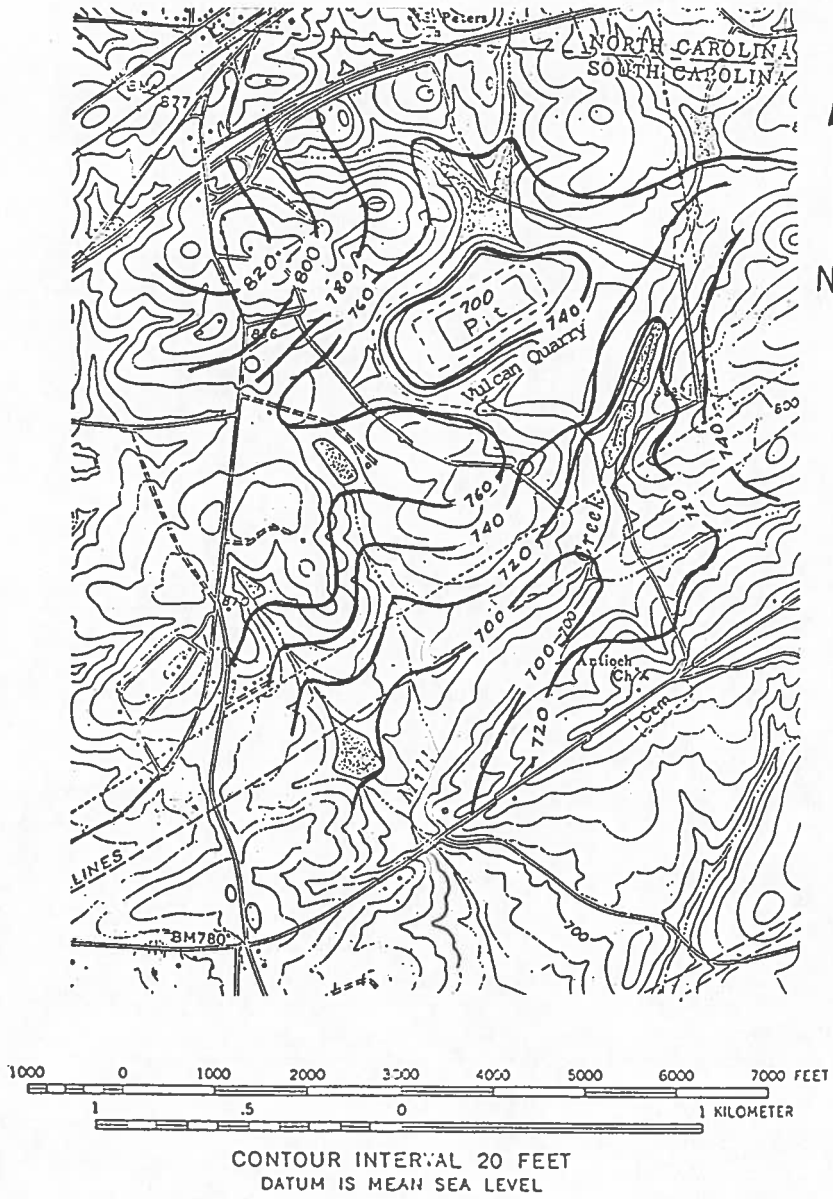
Figure 4. Water-table contours, March 1986.

Analysis of the well data indicates that the hydraulic head in the saprolite is similar to the head in the crystalline rock; therefore, if water-table conditions are assumed in the rock aquifer, then the well yields are dependent on local recharge and are largely influenced by geological trends.

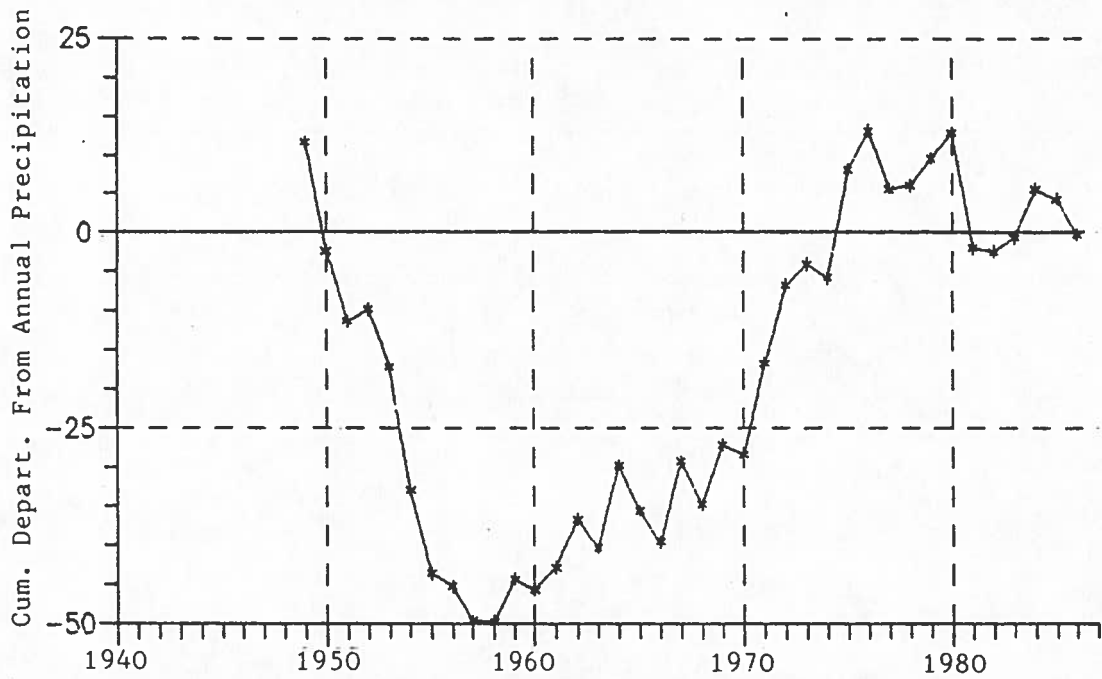
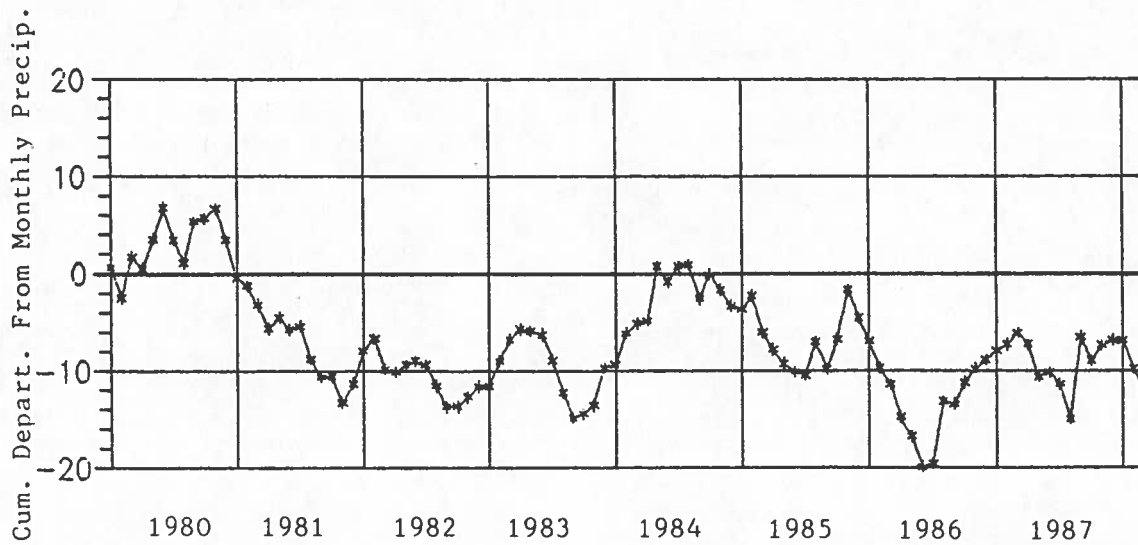
Figure 6. Cumulative departure from normal precipitation, in inches, Gaston Shoals, S.C.

The water table is also affected by short-term fluctuations, the most important of which is the seasonal variation. Figure 6-B is a plot of precipitation for the Gaston Shoals station for the past 8 years. Monthly values of precipitation are plotted as cumulative departures from normal. Intensity and duration of rainfall are closely related to ground-water recharge. Whereas precipitation of low intensity and long duration is favorable for ground-water recharge, precipitation of high intensity and short duration is not, as it tends to run off rather than infiltrate.

Figure 6-B shows that during 1985 there were 4 months with above-normal precipitation and 8 with below-normal precipitation. This suggests that ground-water recharge was less than normal for most of the year. Moreover, since 2 of the 4 above-normal months (August and November) had high-intensity precipitation it is very likely that most of the rain ran off and did not infiltrate the ground to recharge the water table. This indicates that before the drought of 1986 there was already a deficiency in ground-water recharge.

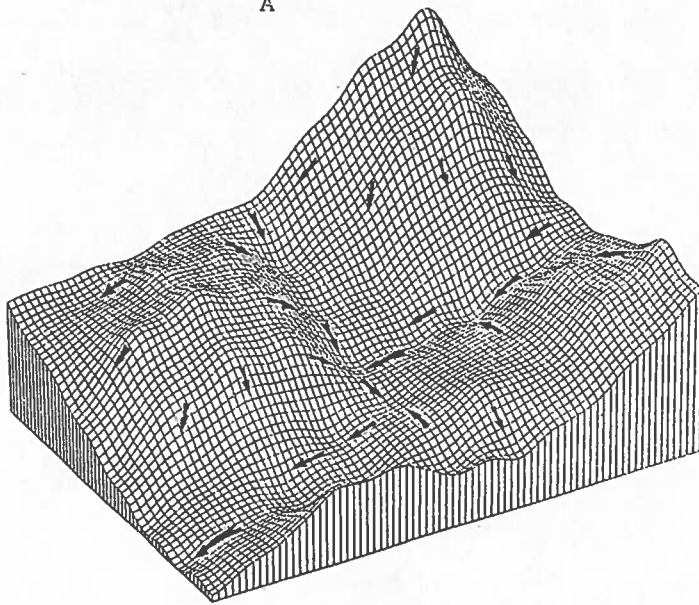
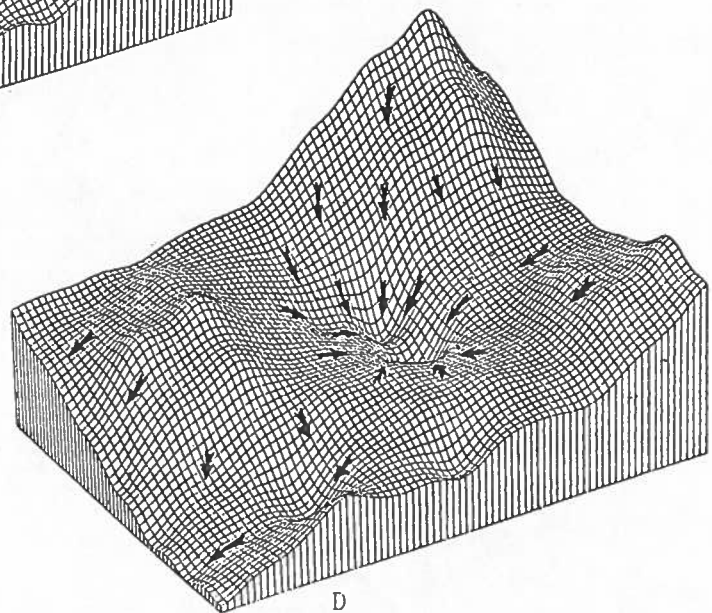
Figure 8. Three-dimensional representation of the land surface in the study area. Outline of study area (A), land surface and roads on three-dimensional figure (B), and representations of water table before (C) and after (D) quarry construction.

Lowering of the water table. The 90-foot deep pit constructed in the lower portion of the northern basin acted to lower the local water table. The pit acts as a huge well, allowing ground water to flow into it. The quarry operation pumps this water out. The water table has been effectively lowered to the base of the pit. Figure 8 shows close-up projections of the study area and the water table. In Figure 8 (C and D) three-dimensional computer-generated representations of the water table before and after the start of the quarry operations are depicted. It is evident from these plots that the pit works as a sink, controlling the gradient and direction of the local ground water flow. The pit is continuously collecting ground water and has increased the natural gradient of the water table.

The pit's radius of influence is the radial distance to where effects of the sink are negligible. Because there are no data regarding aquifer characteristics, it is not possible to estimate the radius of influence nor to quantify the impact of the pit on wells in the trailer park.

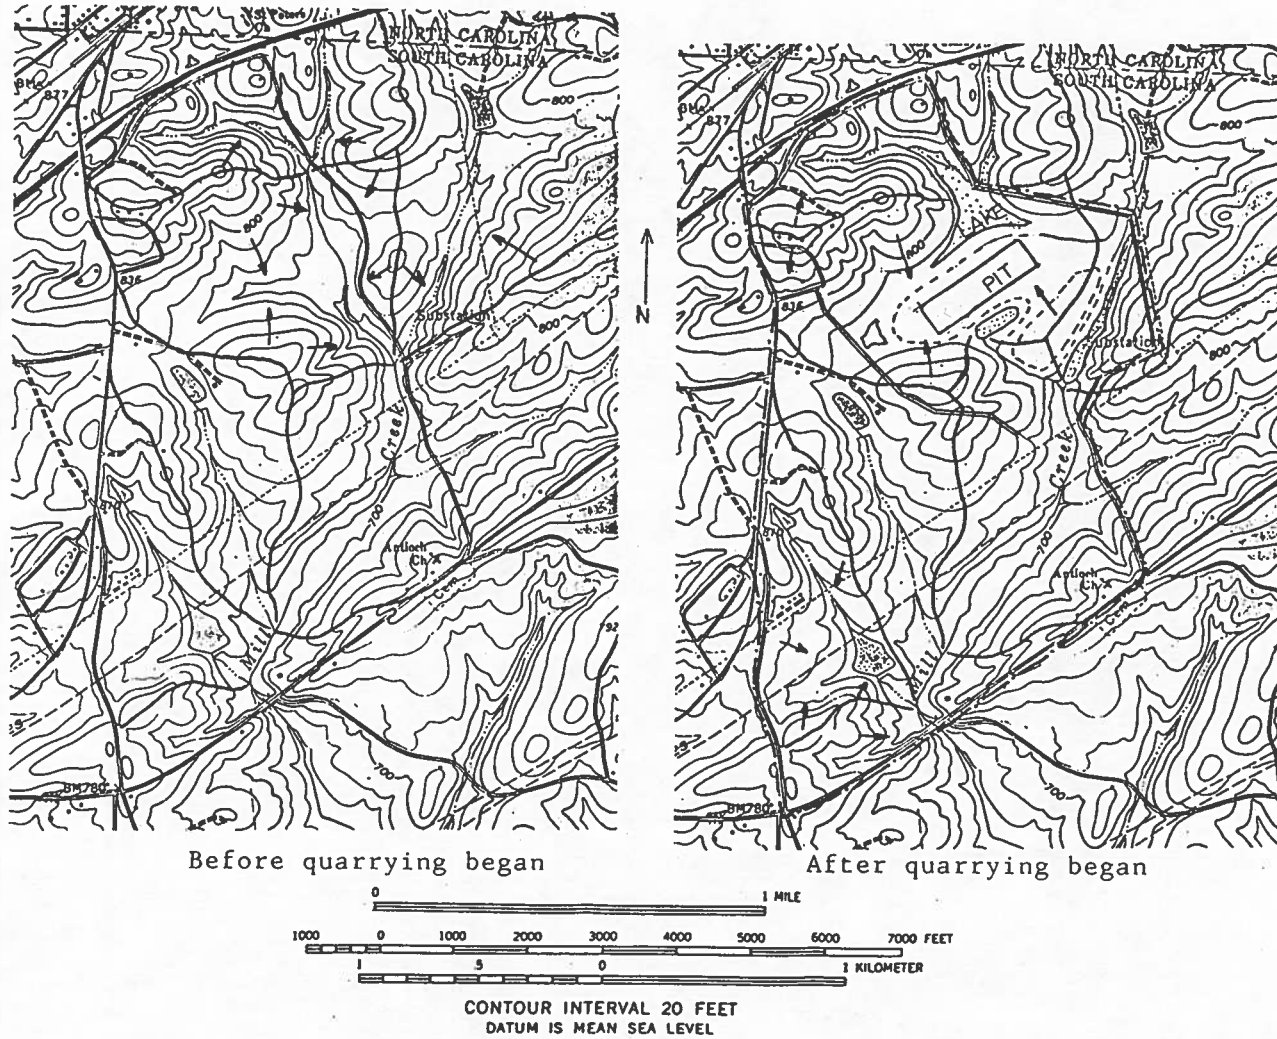
Figure 9. Major and minor drainage basins and direction of surface runoff.

Reduction of recharge areas. Figure 9 shows two topographic maps of the study area. The figures, left to right, represent conditions before and after the quarrying operations began. Thick lines show the drainage basins, and arrows indicate the direction of surface runoff. If it is assumed that surface and ground water divides coincide, the arrows would also show the direction of local ground-water flow.

Assuming that local ground water is recharged by local precipitation, the volume of water infiltrating the ground is estimated by multiplying the surface area by the percentage of rainfall that infiltrates the ground. If this percentage remains constant, the volume of water infiltrating the ground is proportional to the surface area. Therefore reduction of infiltration rate of some of the areas will result in reduction of ground-water recharge.

The pit, being of considerable areal extent and depth (400 by 1,500 by 90 feet representing 9 1/2 percent of quarry area, or 1 3/4 percent of study area) has modified surface and ground water flow. The pit is collecting all direct rainfall and nearby surface runoff. This water is pumped out of the pit and little is left for infiltration. Outside the pit, construction changes have also resulted in reduction of infiltration rates. Roads, buildings, parking lots, and settling ponds cover extensive areas, thus reducing infiltration. Thus, roughly 2 percent of the study area's recharge has been eliminated and portions of another 21 percent (quarry property is 23 percent of area) has had its infiltration rate reduced. Most of this area is within the lower and eastern portions of the northern ground-water basin. Recharge impacts should therefore be limited to this area.

To compensate for the reduction of recharge, the quarry should induce ground-water recharge at selected sites. These sites should be chosen where infiltration properties of the soil are most favorable and where artificial recharge would not interfere with quarrying processes.

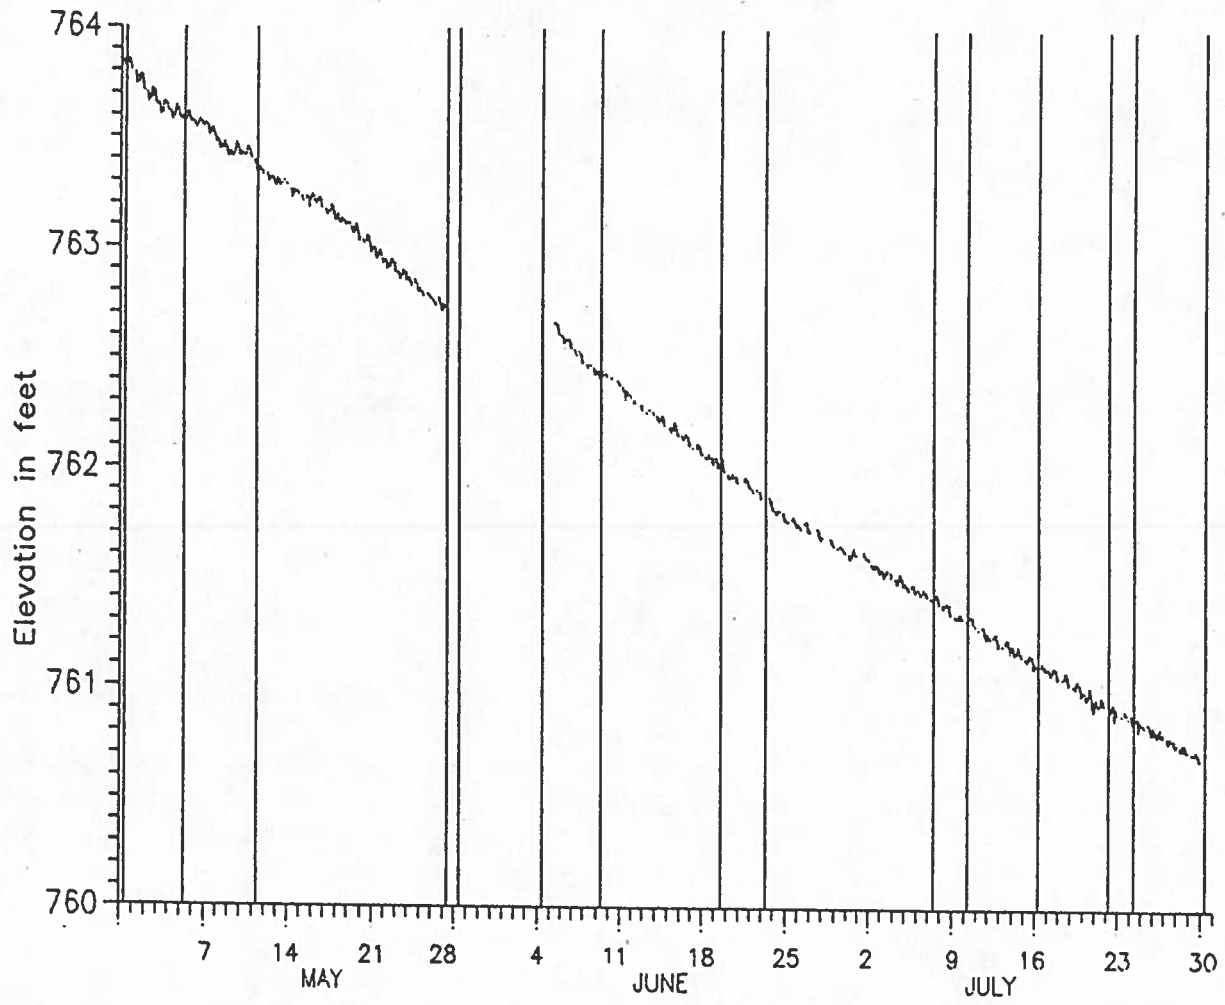
Figure 11. Water levels of observation well, May to July 1986. Vertical lines indicate times of blasts.

No noticeable fluctuation in the water level is visible after blasts. Daily trends are uninterrupted and show no response to the blasts. This could be viewed in three different ways:
