**Subject: Well Abandonment Summary
Products (SE) Pipe Line Corporation
Lewis Drive Remediation Site
Belton, South Carolina
Site ID #18693, "Kinder Morgan Belton Pipeline Release"**

Figure 1. Abandoned Well Locations
 Lewis Drive Remediation Site
 Belton, South Carolina
 Site ID #18693 "Kinder Morgan Belton Pipeline Release"

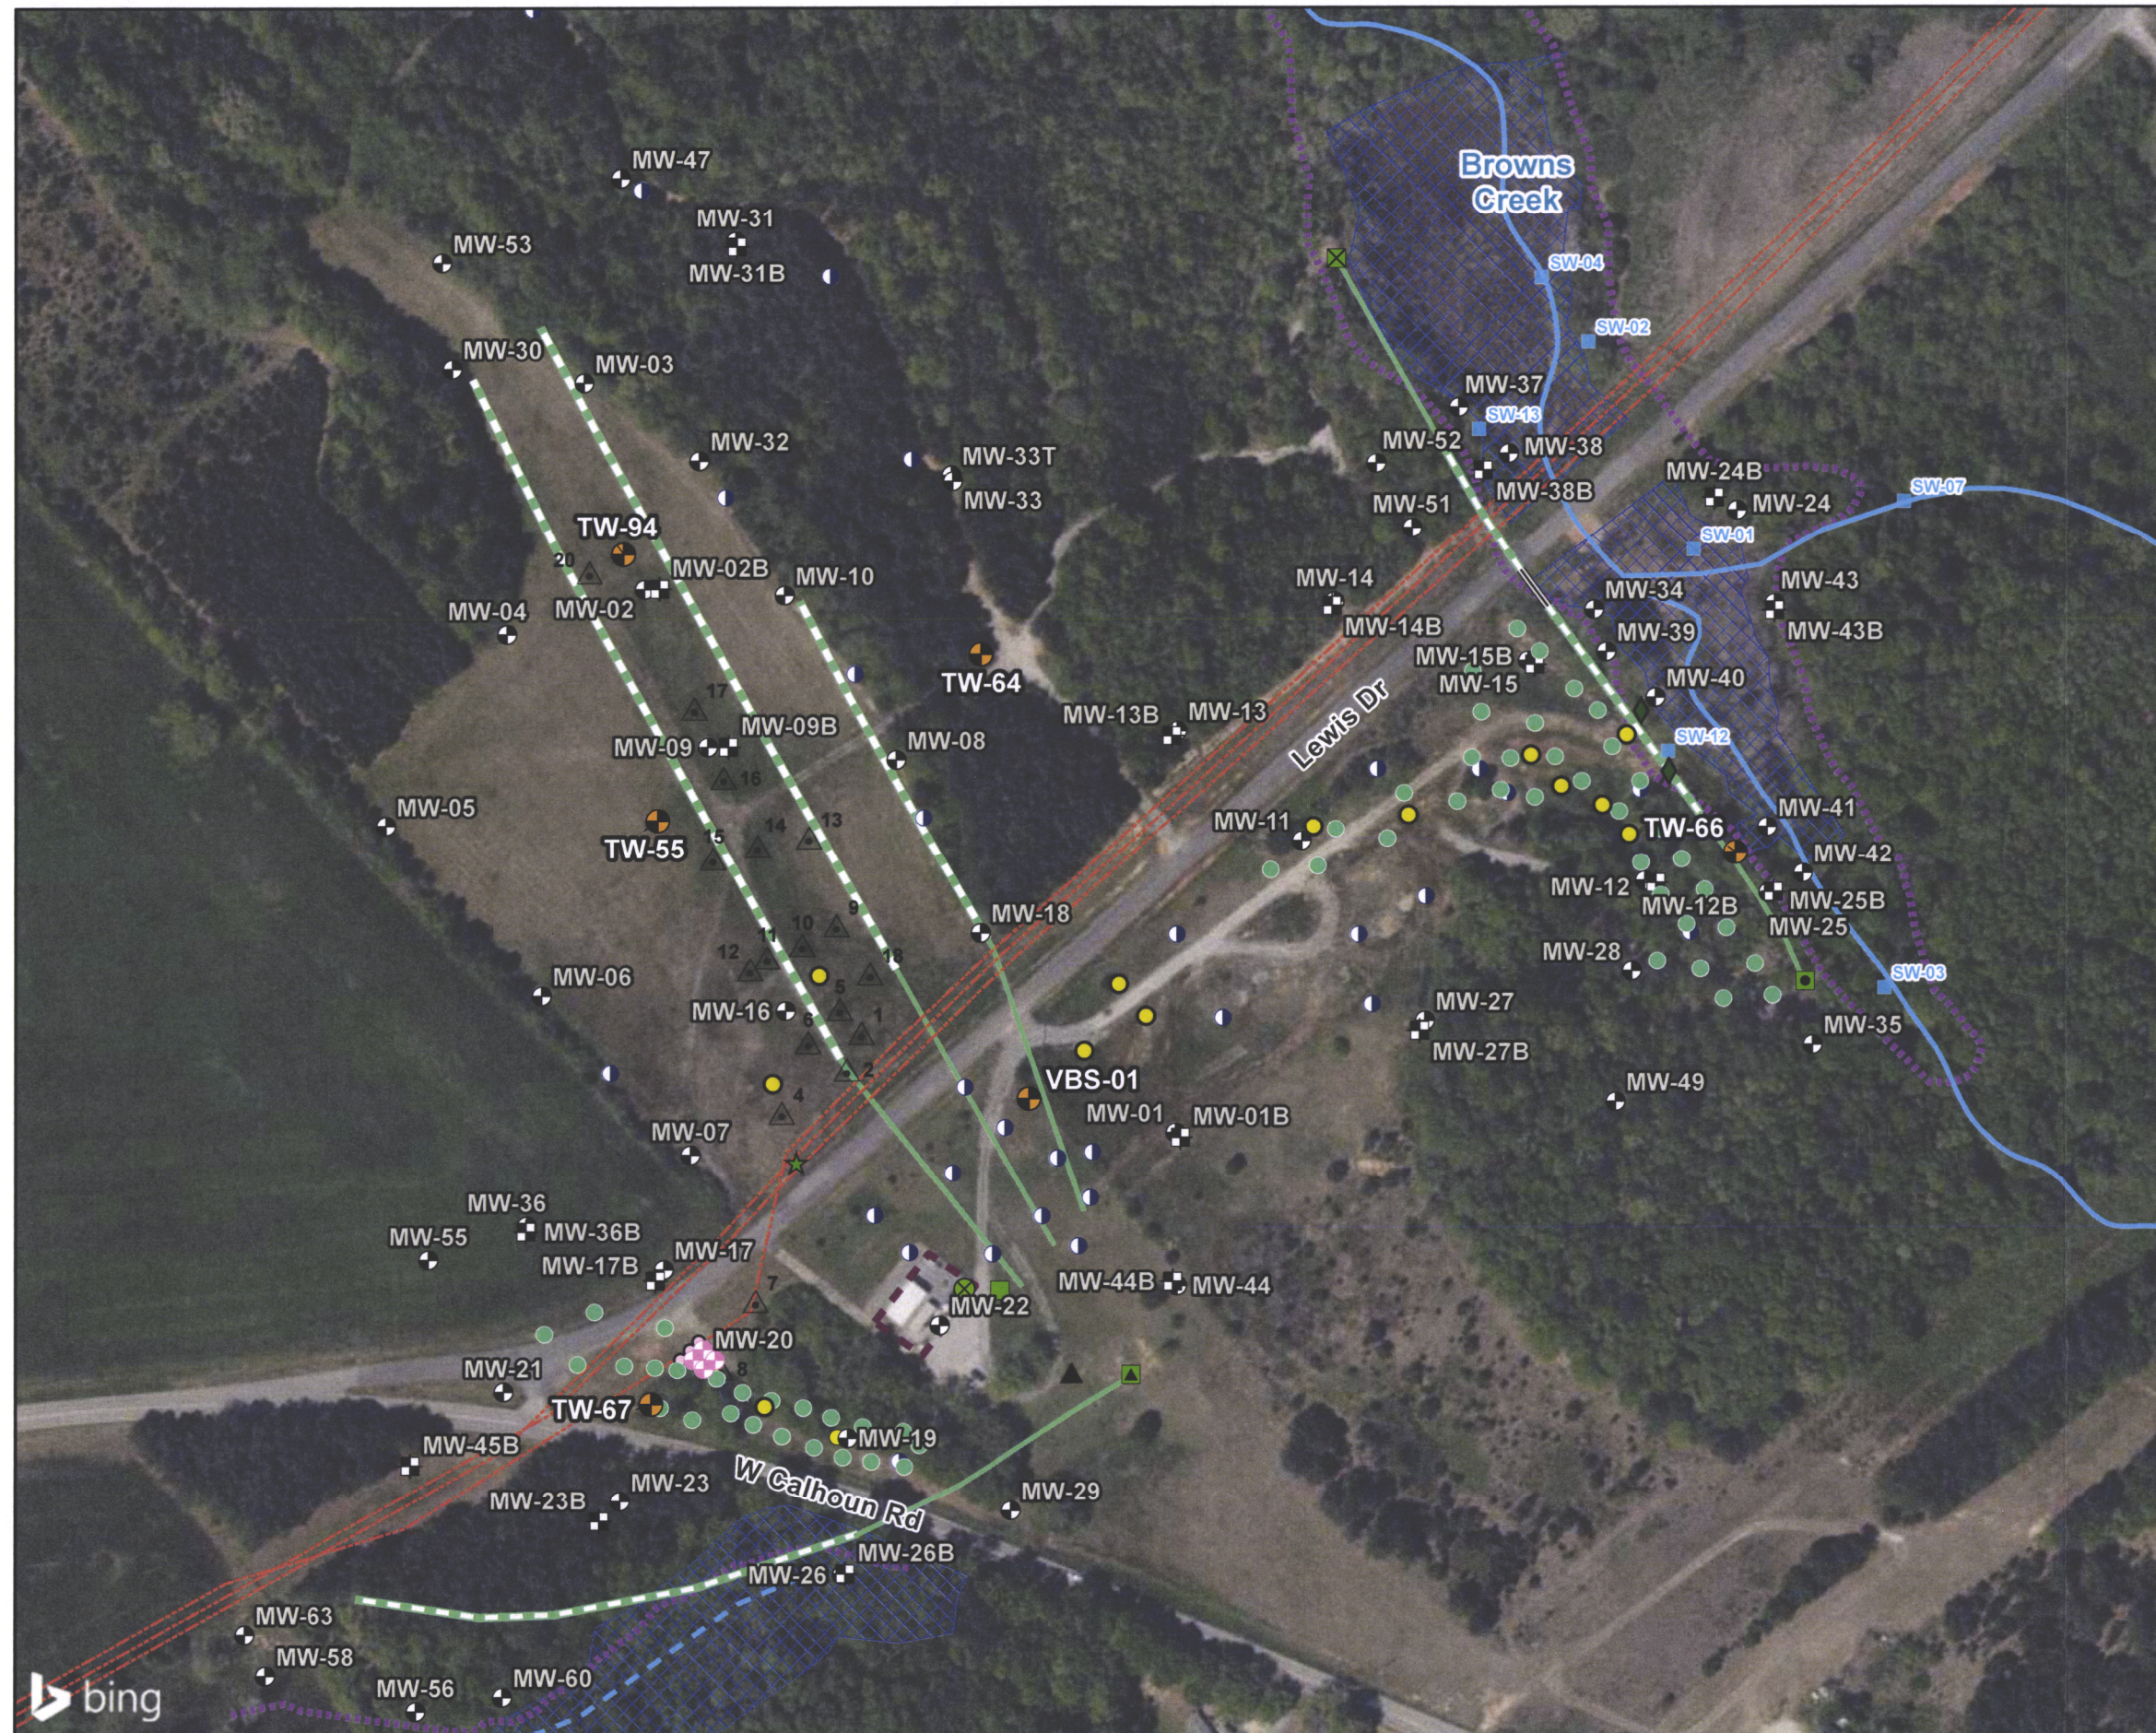
The wells abandoned between October 30, 2023 and November 3, 2023 are presented on **Figure 1**. **Table 1** lists the former temporary piezometer well construction and abandonment information.
