SC DEPARTMENT of
**ENVIRONMENTAL
SERVICES**

Subject: Inspection of UPPER SUNNY HILL POND DAM, D2523, Kershaw County, High Hazard Class

UPPER SUNNY HILL POND DAM : D2523

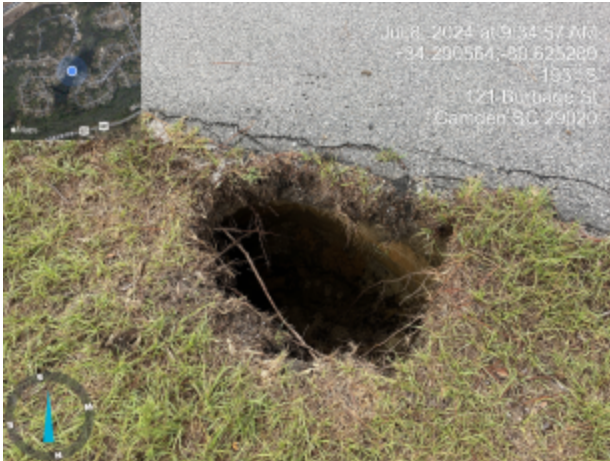
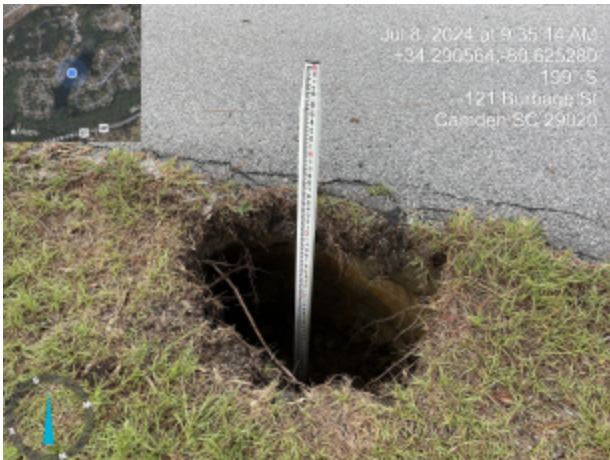
Sinkhole formed alongside the pavement nearly in-line with the primary spillway structure. Sinkhole is approximately 3.5 feet deep and 3 feet in width.

Engage a Professional Engineer to evaluate the stability of the crest around the sinkhole and develop a permit application for repairs and stabilization of the embankment.

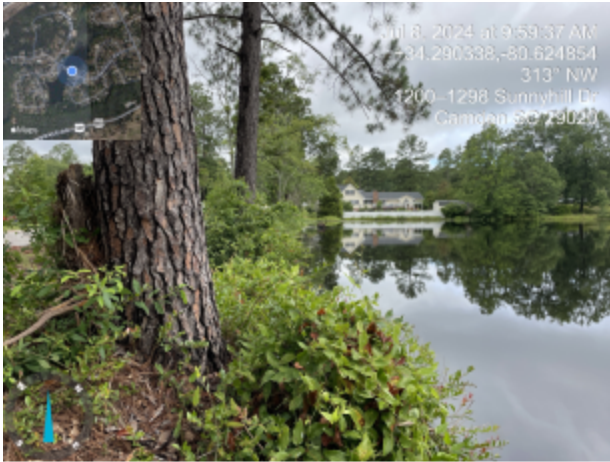
2. Deleterious Vegetation

Dense brush and woody vegetation less than 4 inches in diameter observed along the upstream slope, mainly along the water line.

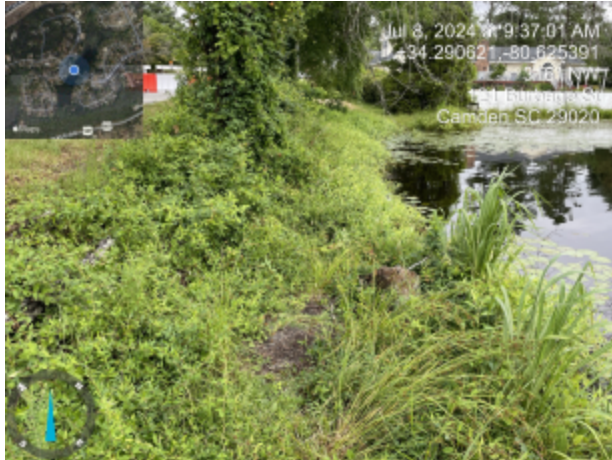
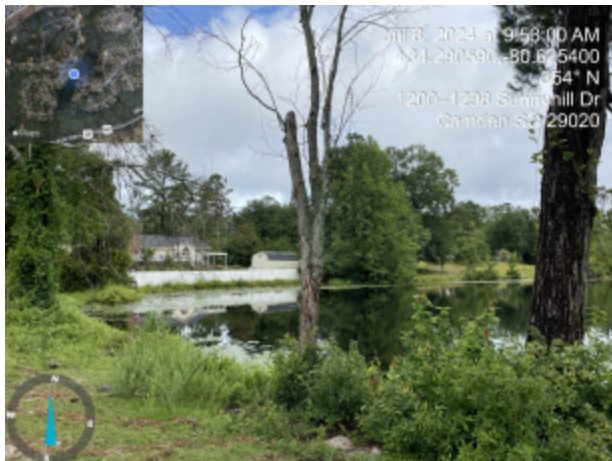
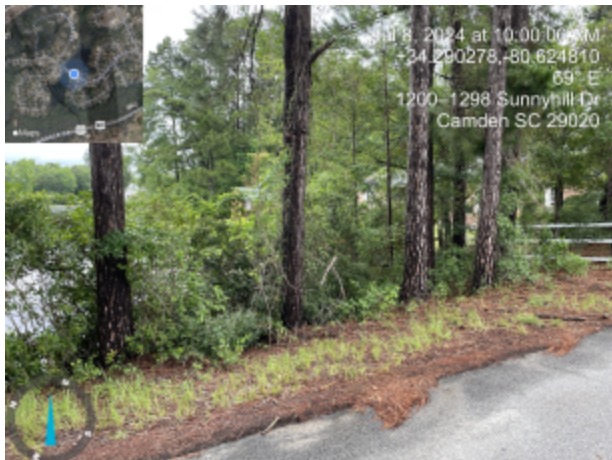
Numerous trees greater than 4 inches in diameter observed, including dead trees and decaying stumps.

- Engage a Professional Engineer to develop a tree management plan to address the trees and stumps greater than 4 inches in diameter.
- The newly formed sinkhole may be a sign of internal erosion within the dam, engage a Professional Engineer to conduct a full investigation into the extent of voids/internal erosion pathways within the dam.

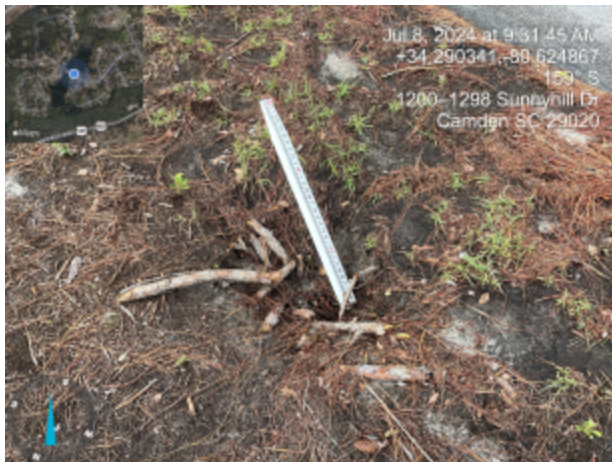
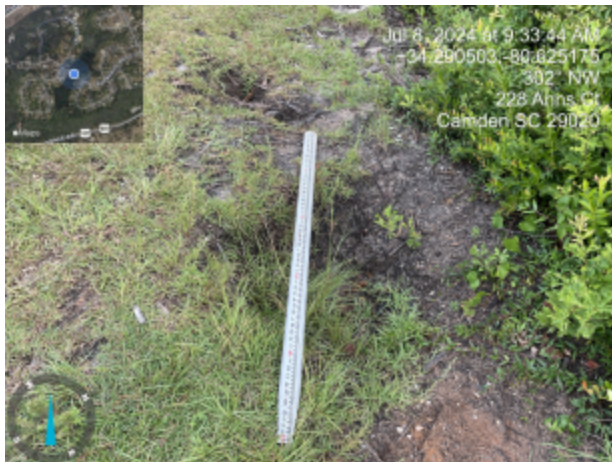
Numerous voids/subsided areas observed within the upstream slope. Depths vary, but all are greater than 12 inches in depth. Standing water was observed within one of the voids. Some of the voids appear to have formed around tree roots.

Engage a Professional Engineer to evaluate the condition and stability of the upstream slope, especially around areas with voids. Engineer should develop a permit application for repairs and stabilization of the upstream slope.

Engage a Professional Engineer to evaluate the condition and stability of the upstream slope, especially around areas with voids, and develop a permit application for repairs of the voids and stabilization of the upstream slope.

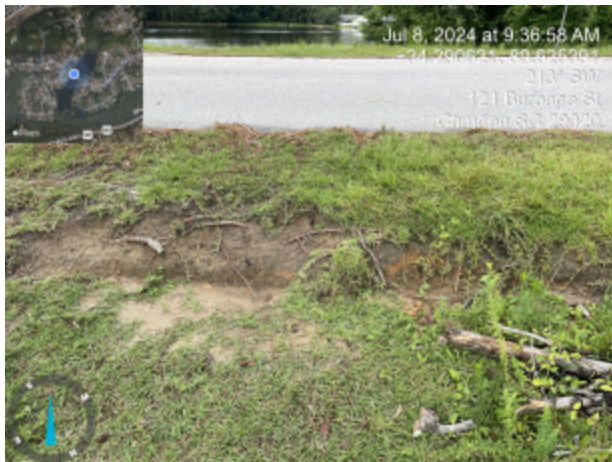
Minor scarping observed on the upstream slope near the right side of the dam. Less than 12 inches.

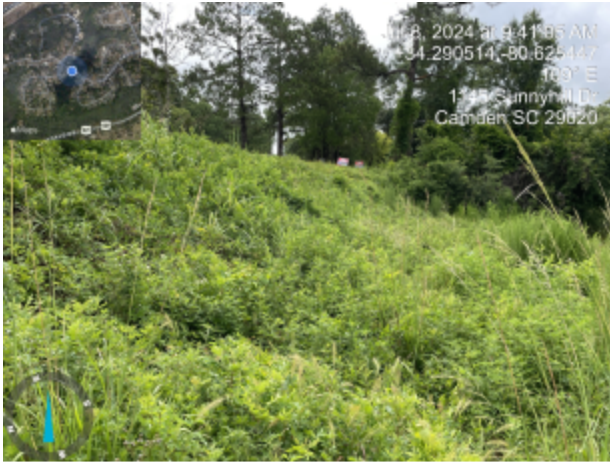
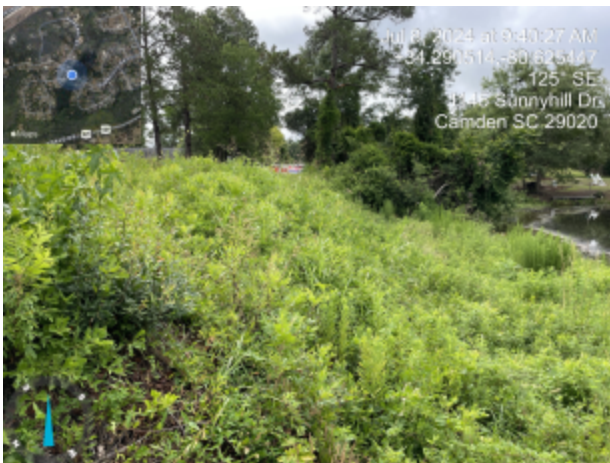
Dense brush and woody vegetation less than 4 inches in diameter prevented full inspection of the downstream slope.

- Manage/remove brush and woody vegetation less than 4 inches in diameter.
- Develop grass coverage or other form of erosion protection following deleterious vegetation removal.

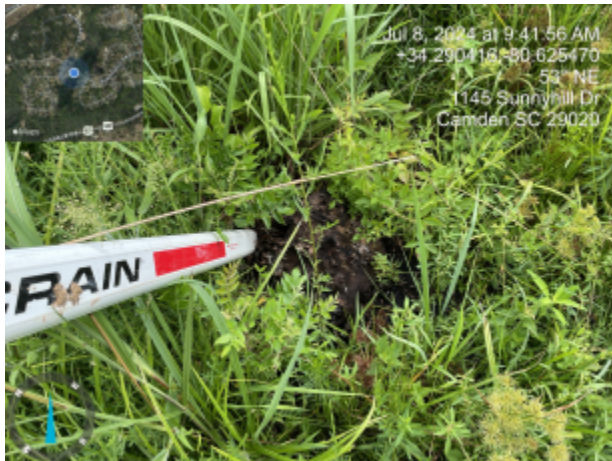
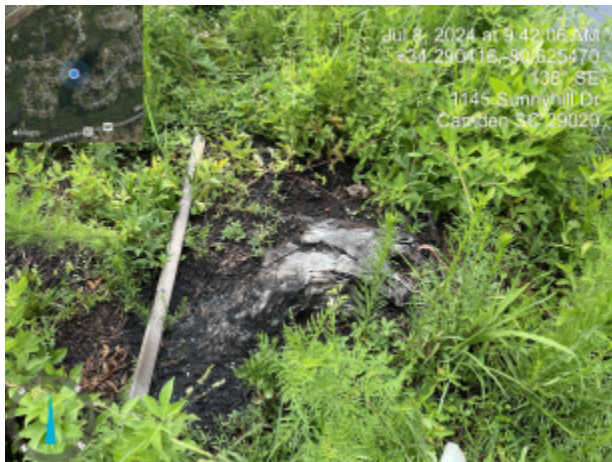
Decaying tree stumps observed.

Engage a Professional Engineer to evaluate the condition and stability of the downstream slope, especially around decaying tree stumps, and develop a permit application for repairs of the voids and eroded sections of the downstream slope.

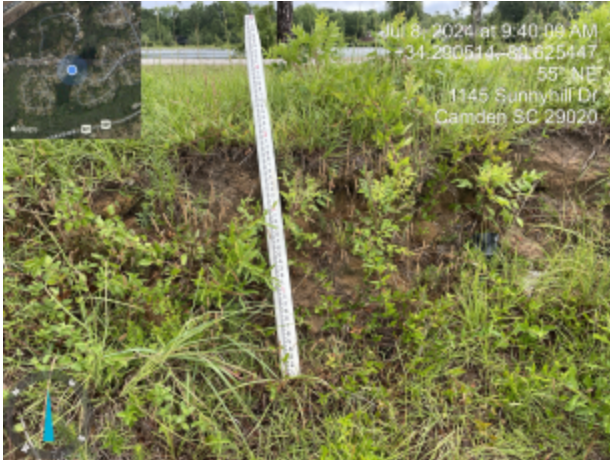
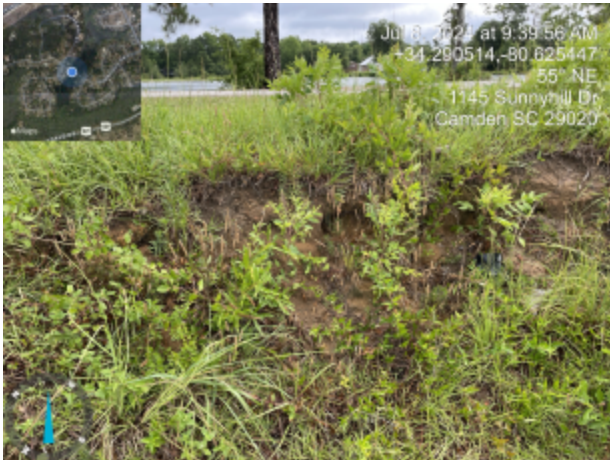
Scarp along the shoulder of the crest and downstream slope. Nearly vertical slope along this section of the downstream slope.

Engage a Professional Engineer to evaluate the area of the downstream slope experiencing scarping and to develop a permit application for slope repair and stabilization.

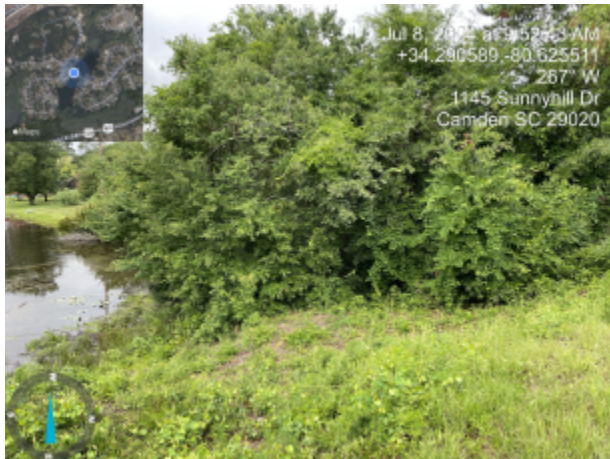
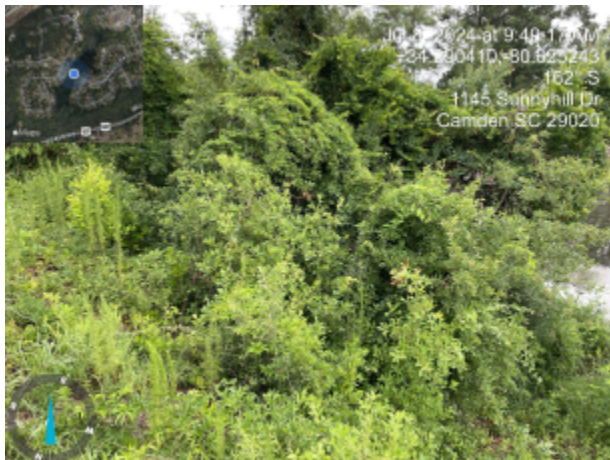
Dense brush and woody vegetation observed in the groins of the downstream slope.

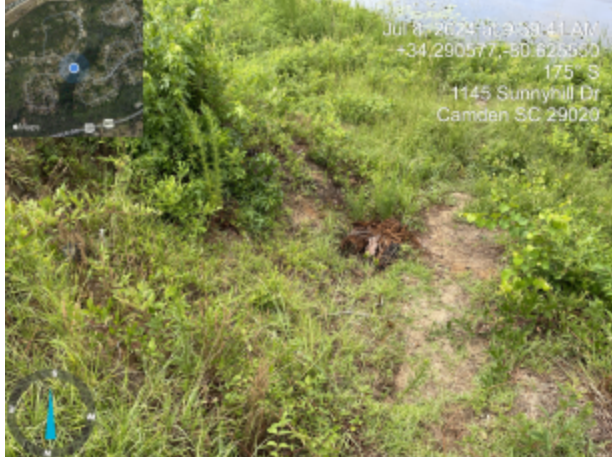
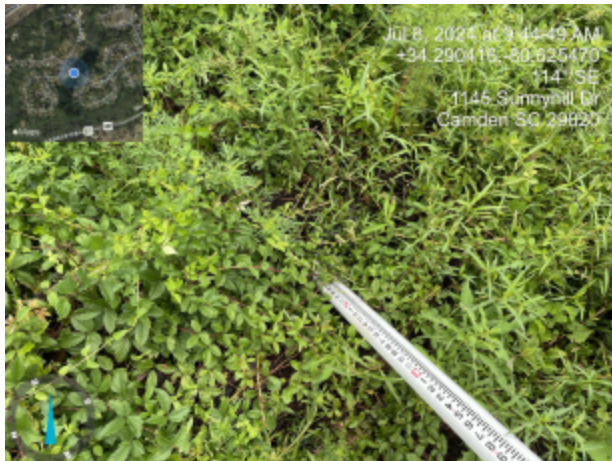
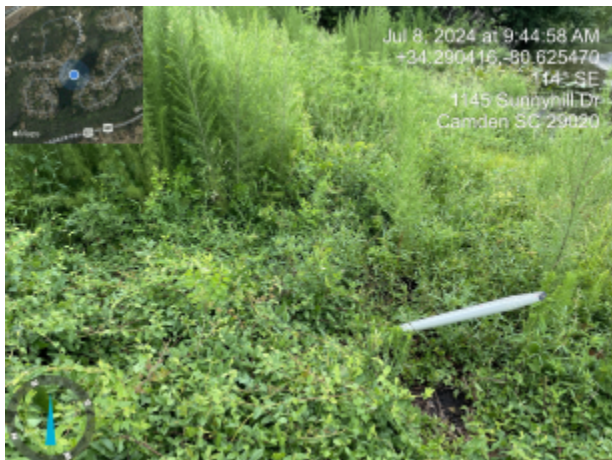
Multiple voids observed within the downstream slope, potentially around tree roots and stumps. Depths greater than 2 feet observed in some areas.

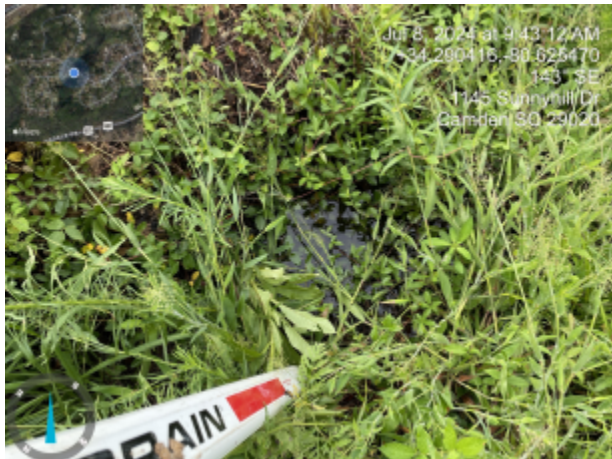
Puddles observed along the downstream slope, potentially due to recent rainfall.

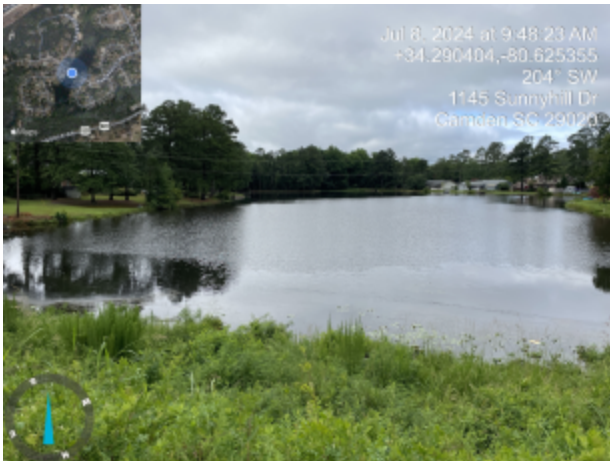
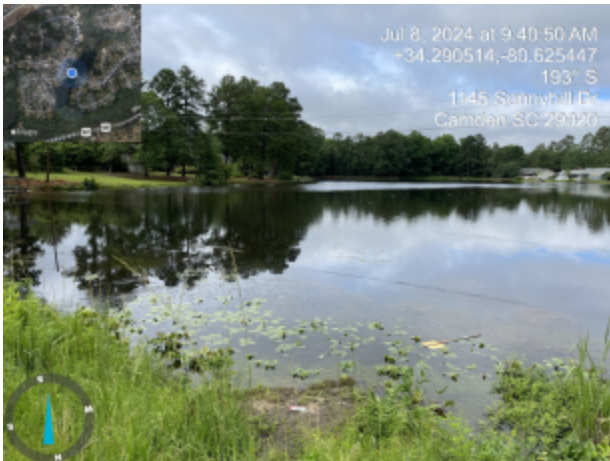
Downstream area is the reservoir for Lower Sunnyhill Pond Dam.

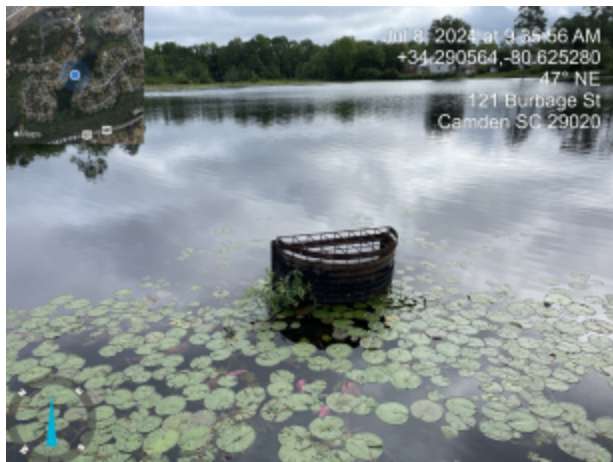
3. Trashrack

Trashrack is present, but is off-centered.

Monitor for deterioration and rusting of the inlet structure.
Recommend engaging a Professional Engineer to conduct a camera investigation of the primary spillway to assess the condition of the spillway pipe.

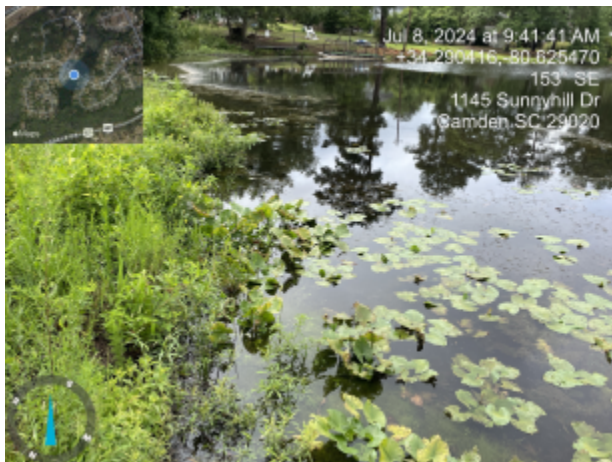
Approximate location of the outlet pipe. Due to water level of lower pond, outlet pipe could not be observed.

Recommend engaging a Professional Engineer to conduct a camera investigation of the primary spillway to assess the condition of the spillway pipe.
