PRO DISPOSAL USA (BARNWELL RESOURCES) CLASS 2 LANDFILL

P1TJ-QJAP-426

Solid Waste - Class 2 Landfill	
Facility	
Facility Name	PRO DISPOSAL USA (BARNWELL RESOURCES) CLASS 2 LANDFILL
Date of Inspection	5/26/2026
Time of Inspection	12:39 PM
County	Beaufort
Permit #	072410-1201
Inspection Processing	
Reason for Inspection	Routine
Weather Conditions	Partly Sunny
Temperature	80s
Rainfall in past week	0-0.5
Weather Condition Description	Extreme drought conditions. Wind 13mph, gusts up to 20mph.
Last Inspection	04/20/2026
Inspection Detail	
1. Attendant Present	Yes
2. Required signs posted	Yes
3. Inspection of all incoming loads conducted	Yes
4. Unauthorized waste training conducted and documented	Not Inspected
5. No unauthorized waste present	Yes
6. Access controlled	Yes
7. Adequate entrance all-weather roads	Yes
8. Adequate internal all-weather haul roads	Yes

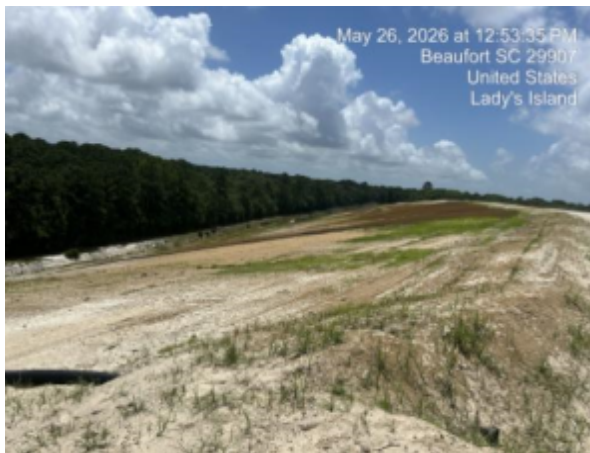
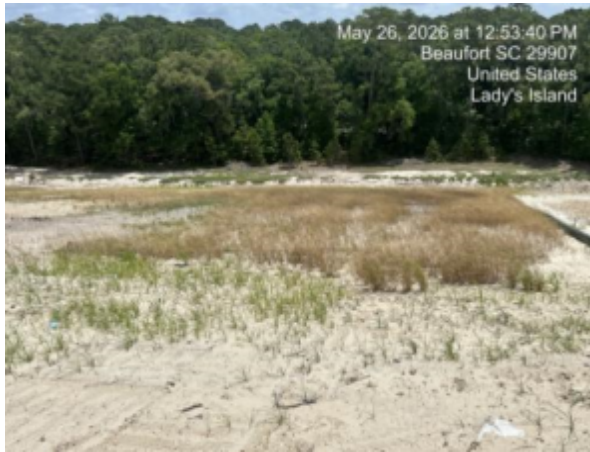
21. Disposal area graded to a minimum 1% slope	Yes
22. Adequate condition of ditches/swales	Yes
23. Adequate condition of berms/terraces/downchutes	Yes

Eastern slope grass has moderate growth, still some bare spots.

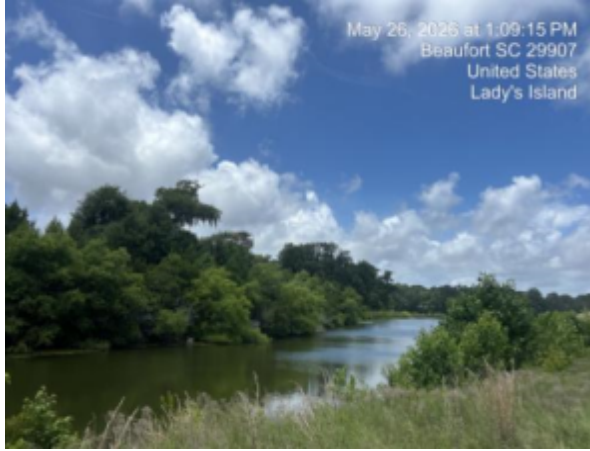
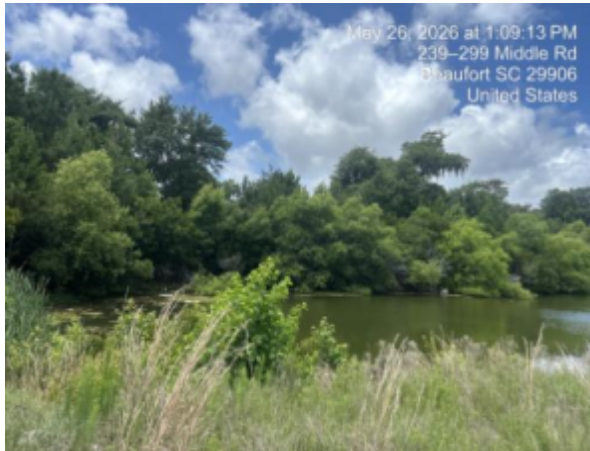
24. Adequate condition of sedimentation ponds

Yes

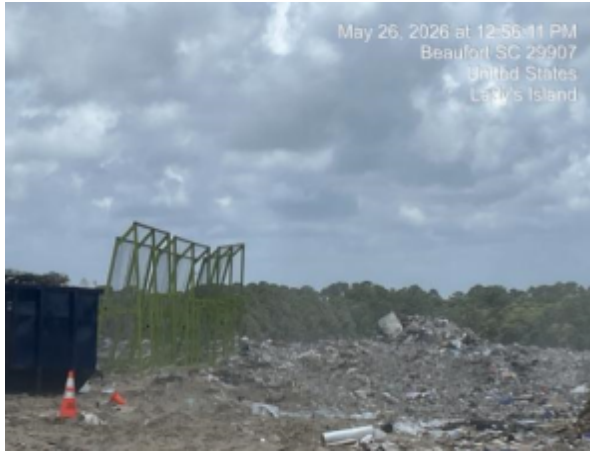
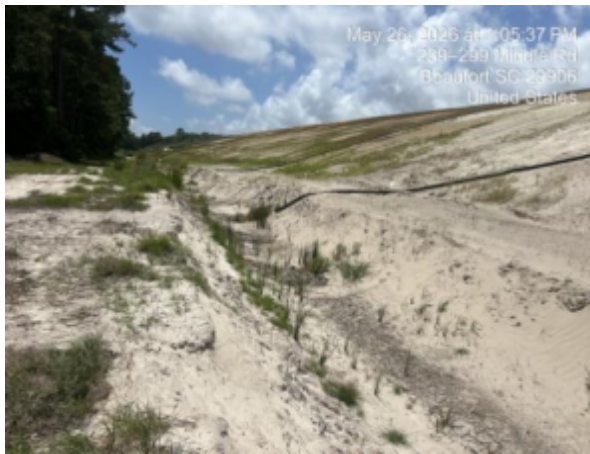
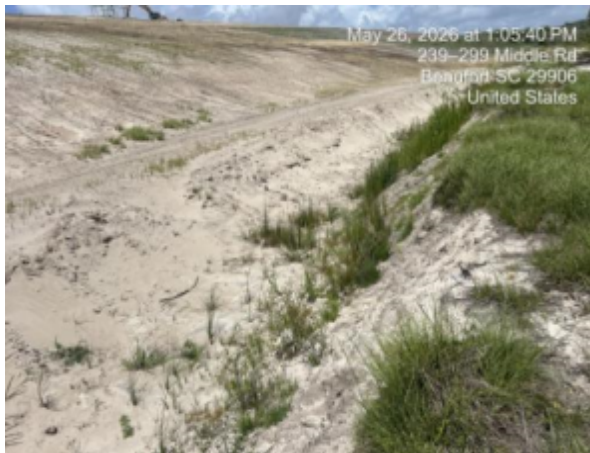
Litter in eastern ditches has been cleaned up. Litter fencing present on top near working face.

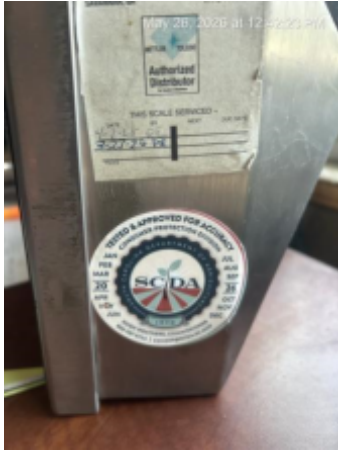
29. Control of Fires/Open Burning	Yes
30. Scales installed and functioning properly	Yes
31. Scales calibrated adequately	Yes
<i>Comments:</i> Inspected for accuracy by SC Dept of Agriculture, sticker located.	
<div style="display: flex; align-items: flex-start;">
