# Lexington Mill Pond Update 6/9/15 site visit

# Lexington Mill Pond Dam D-0958

Preliminary Inspection Report for South Carolina  
Regulated Dams and Impoundment Structures  
Regulations  
R.72-1 through R.72-9

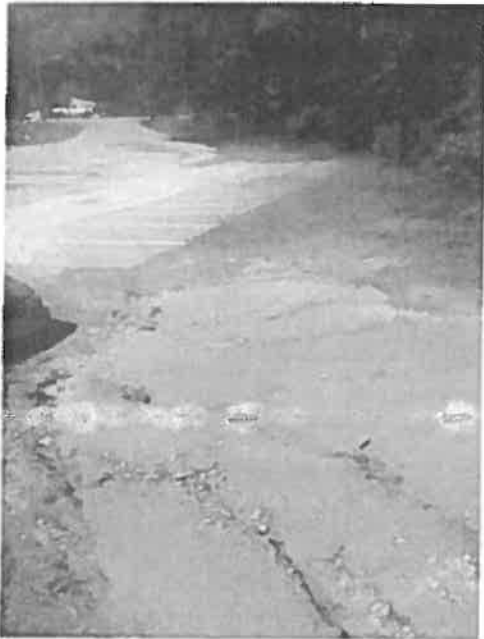
**Erosion on access drive leading to dam crest.**

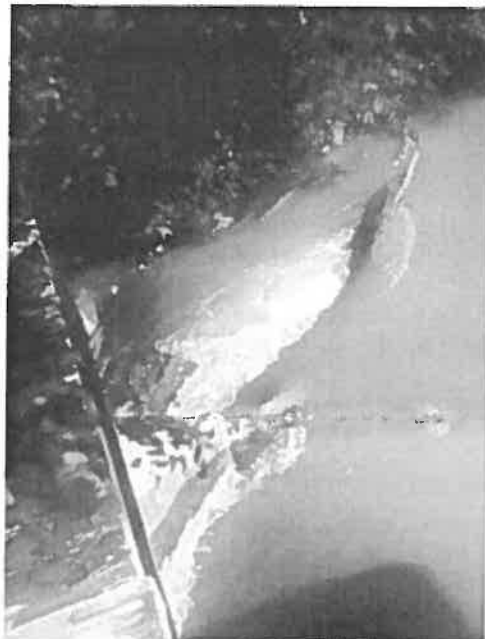
**Flow through auxiliary spillway.**

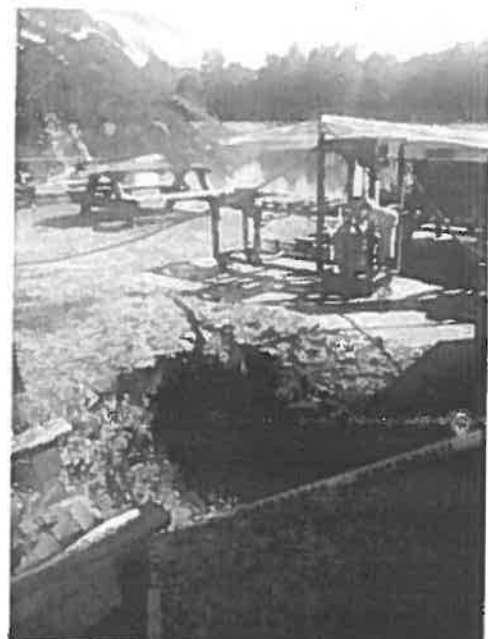
Gentleman, as you can see from today's pictures, the sinkhole has gotten significantly larger in the 5 days since the last pictures I shared in this morning's e-mail.

**Sinkhole forming near gate for penstock.**

Due to the high hazard classification of this dam, significant loss of life and property could result in it's failure. **It is EXTREMELY URGENT that you lower the lake level another 6-inches over the next 24 hours and initiate a monitoring program on the sinkhole condition.**

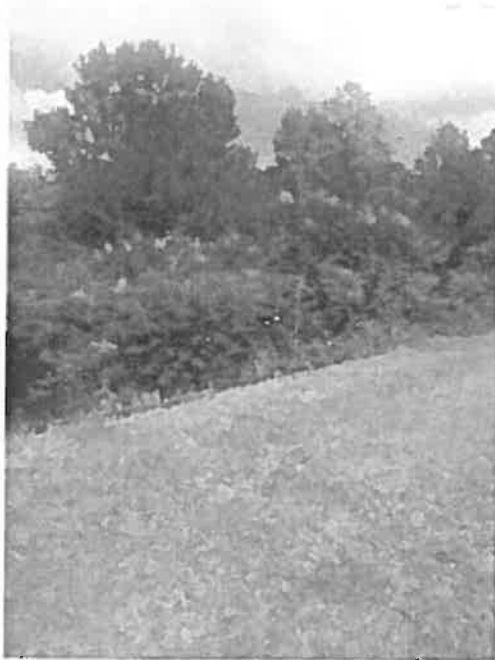
**Vegetation on downstream slope of dam.**

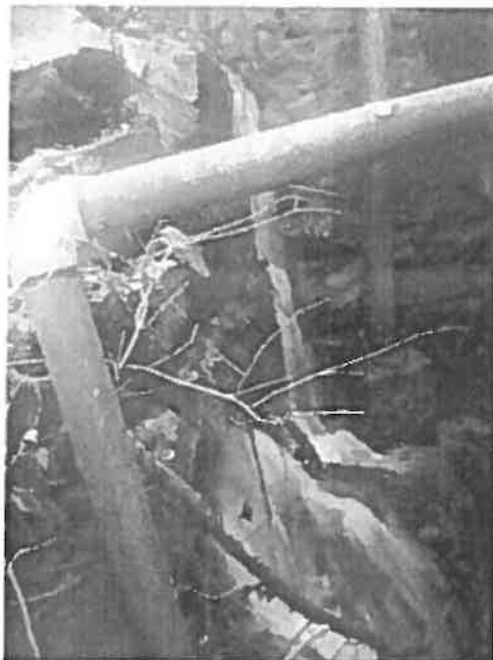
**Seepage through masonry wall near penstock.**

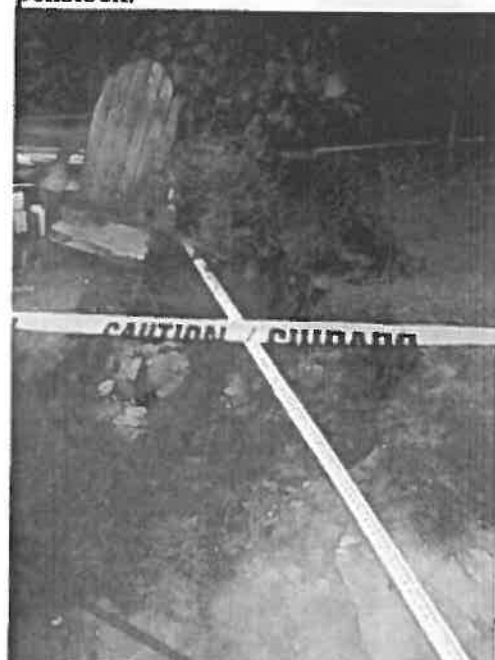
**Sinkhole forming near gate for penstock.**
