RE: Inspection of Lake Conestee Dam
D-2876, Greenville County

**Preliminary Inspection Report for South Carolina
Regulated Dams and Impoundment Structures
Regulations
R.72-1 through R.72-9**

A. Dam Number: D 2876 & Hazard Class 2 B. Name of Dam: Lake Conestee
C. Inspection Date (12/01/2016) & Time: 9:15 a.m. D. Date of Last Inspection: (12/18/2014)
E. Location-County/City: Greenville / Greenville F. EQC Regional Office: Upstate EQC Greenville
G. Inspector's Name: Melissa Dawkins, Chuck Owens
H. Owner's Name: Conestee Foundation Inc.
I. Contact Person (if different from above): Dave Hargett, PhD
J. Dam Owner's or Contact Person's Phone Numbers: Home () -
Office (864) 277 - 2004
Other (864) 787 - 8160
K. Dam Owner's or Contact Person's mailing address:
Address 1 P.O. Box 9111
Address 2 (optional) _____
City Greenville, State SC Zip Code 29604 -

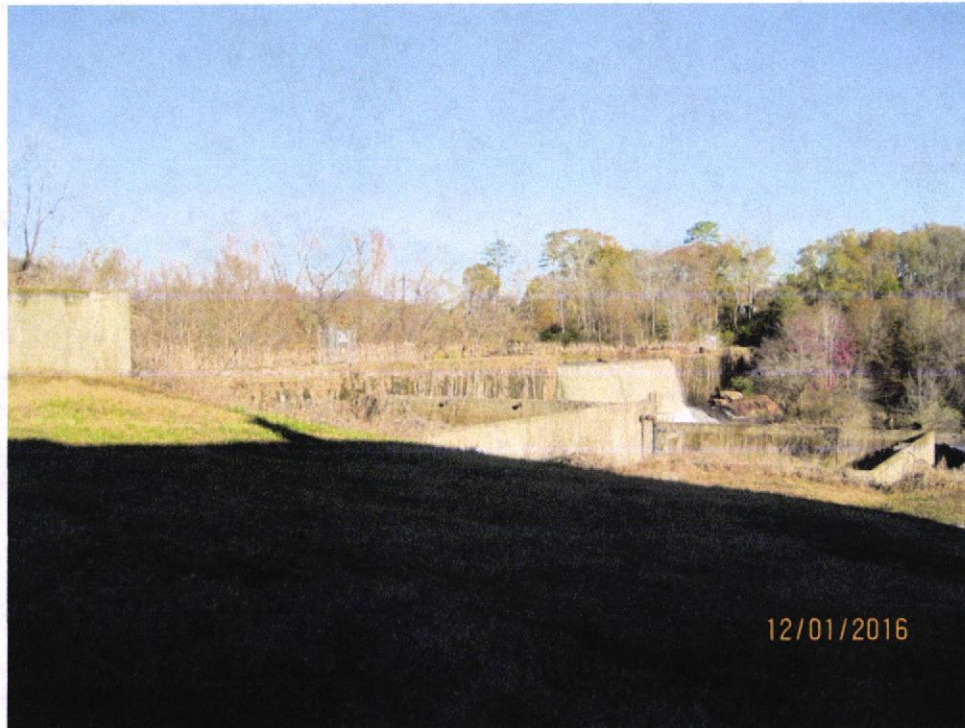
1. Overall view of the dam

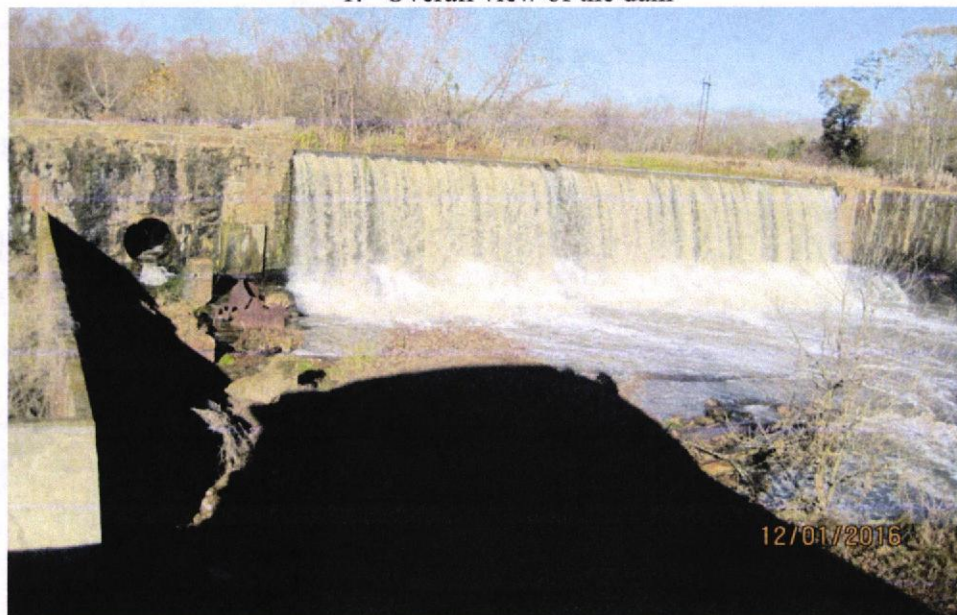
2. Primary spillway, repaired sluice gate and penstock

- ii. Animal activity observed? None observed
- iii. Any obvious alterations or repairs made? Yes, the permitted repairs to the sluice gate were observed. A few small cracks were observed in the concrete surface. Monitor these to ensure that they do not worsen.

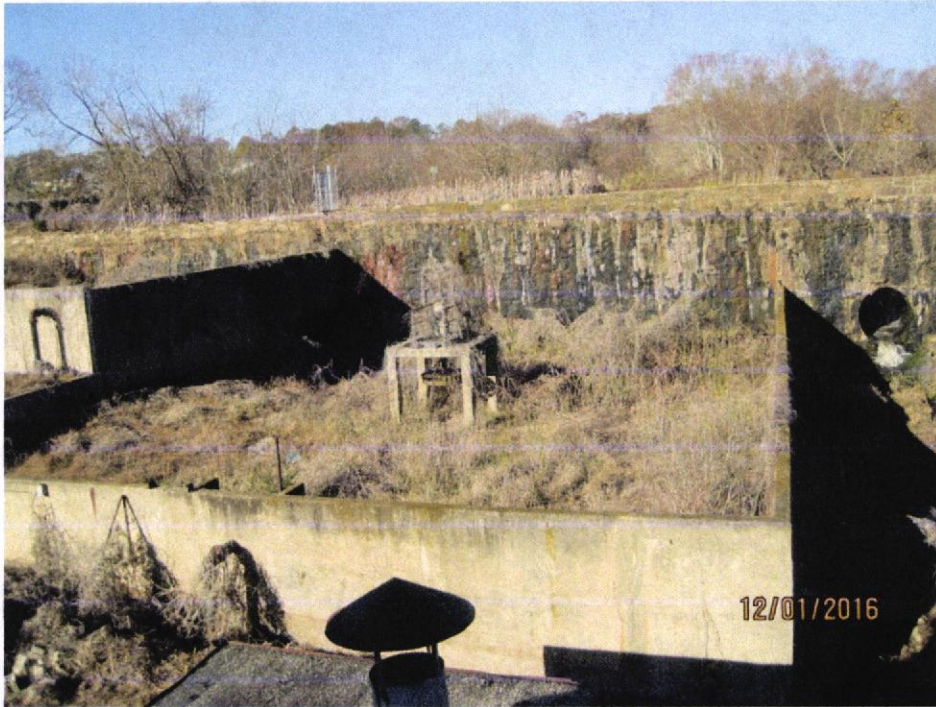
3. Seepage and ochre present on the right face of the dam

- vii. Any seepage observed? If so, describe location, flow rate, and any turbidity or color within the flow: Yes, flowing seeps were observed at multiple locations on the right and left sides. According to Dr. Hargett, the ochre has been tested and found to contain hazardous constituents. See Section IV, Item 3.

3. Excessive seeps were observed on both the right and left downstream face of the dam. The seepage has been tested by the owner and hazardous constituents were present in the samples. These components may be detrimental to the mortar joints and could possibly accelerate the deterioration of these joints. These areas must be examined by a licensed SC professional engineer and a plan developed to address these issues.

- Multiple areas of seepage were observed throughout the downstream face and toe of the dam on both the left and right side. According to laboratory results provided by the Conestee Foundation, the test samples of the seeps and ochre contain high levels of hazardous constituents. The volume of flow as well as the presence of hazardous constituents may be detrimental to the mortar joints and fissures currently present and may accelerate the deterioration of these joints. As part of the detailed inspection, these areas must be evaluated to determine whether it is affecting the safety of the dam and a plan developed to address these concerns.

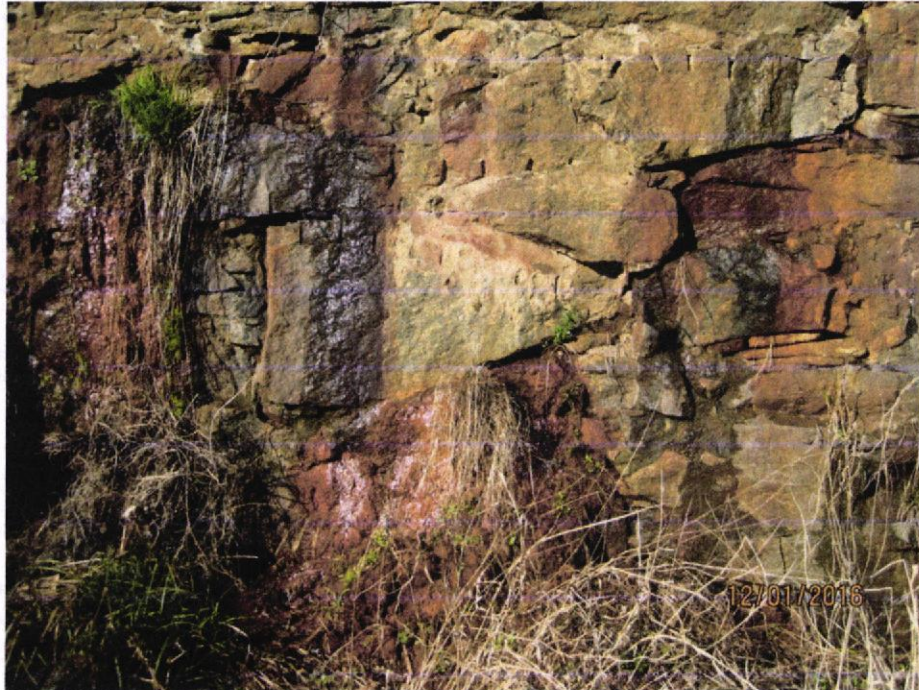
4. Closer look at the seepage and ochre present on the right face

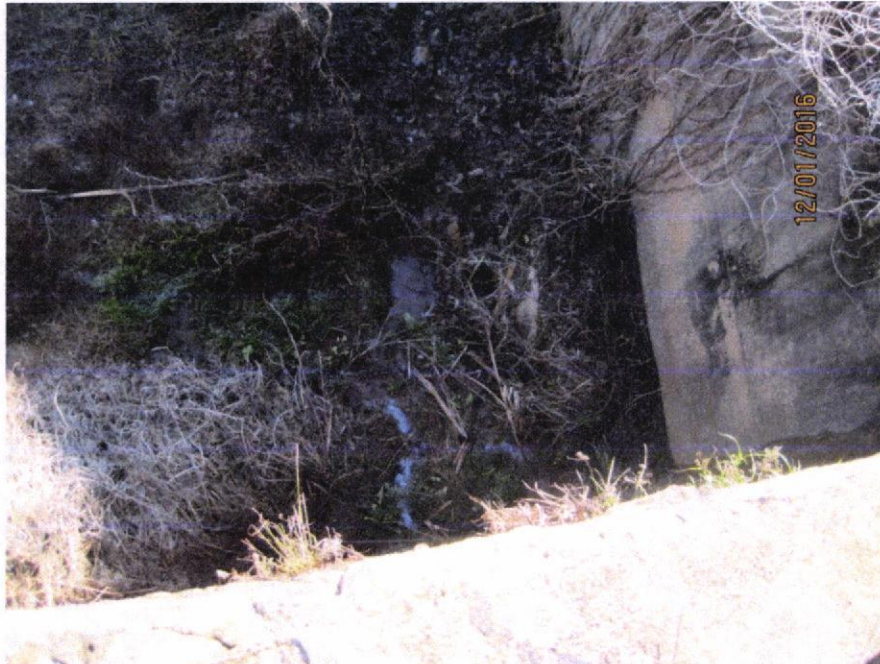
5. Seepage flows along the right toe

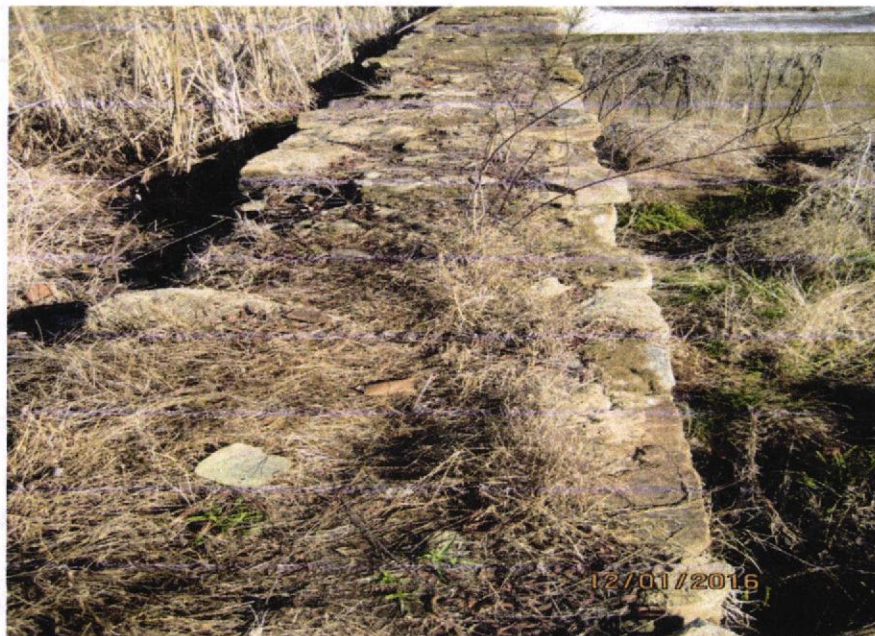
6. Dam crest

- i. Vegetation (grass, trees weeds)? Vegetation was observed growing out of portions of the masonry. This vegetation should be removed.
- ii. Animal activity observed? None observed
- iii. Any obvious alteration or repairs made? None observed
- iv. Erosion noticed on crest? No erosion was observed; however, deterioration of the mortar in some spots was observed. This should be monitored to ensure that the situation does not worsen.
- v. Any visible settlement, misalignment or cracks? Cracks in the mortar were observed.

- Deterioration of mortar between joints and along the crest of the dam was observed. Continue to monitor these areas to ensure that the deterioration does not worsen to a point that would affect the structural stability of the dam. As part of the detailed inspection, these areas must be evaluated.

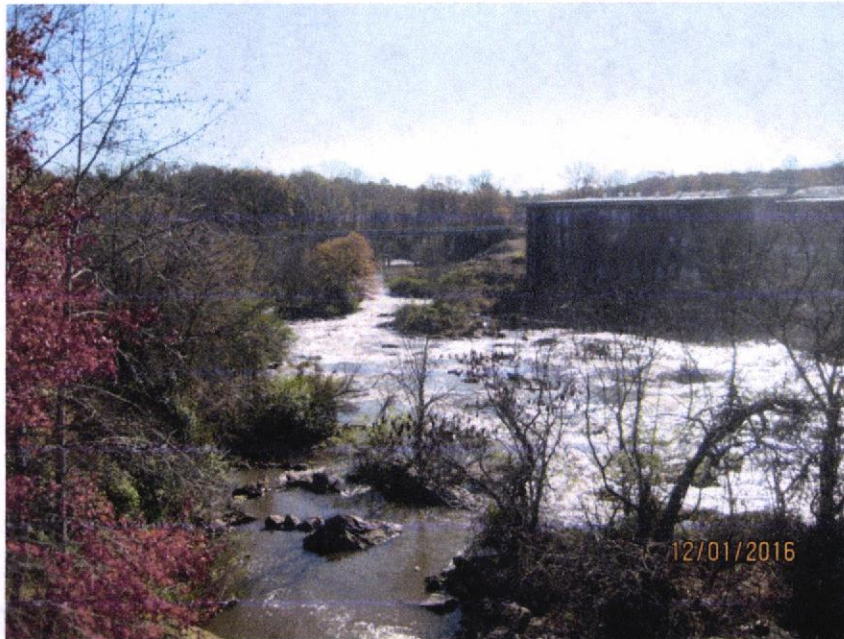
7. Downstream view from the dam

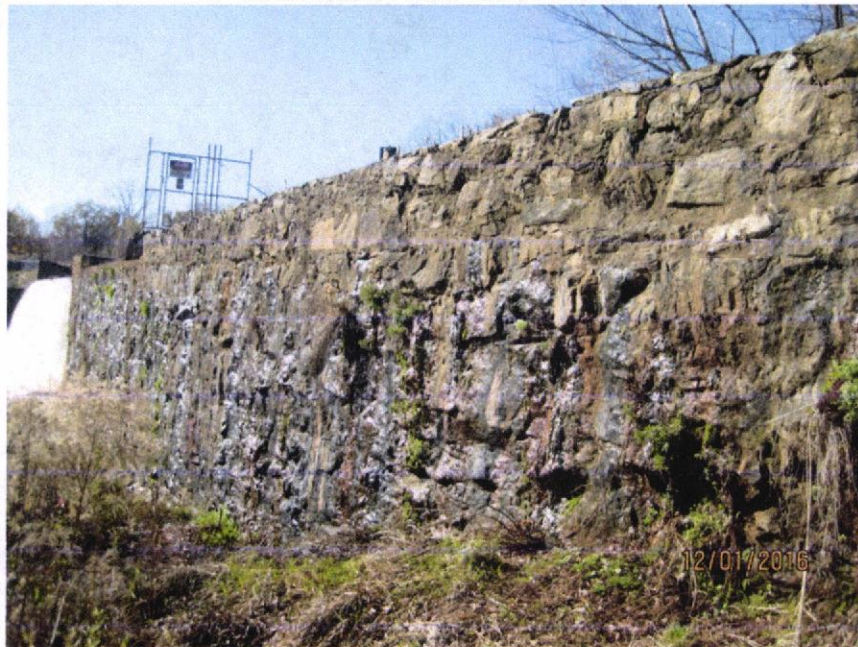
8. Seepage and ochre present on the left face

- iv. Erosion observed on down stream slope? No erosion was observed; however, deterioration of the masonry face was observed on the left side along the toe. Portions of the face were missing near the areas of seepage.

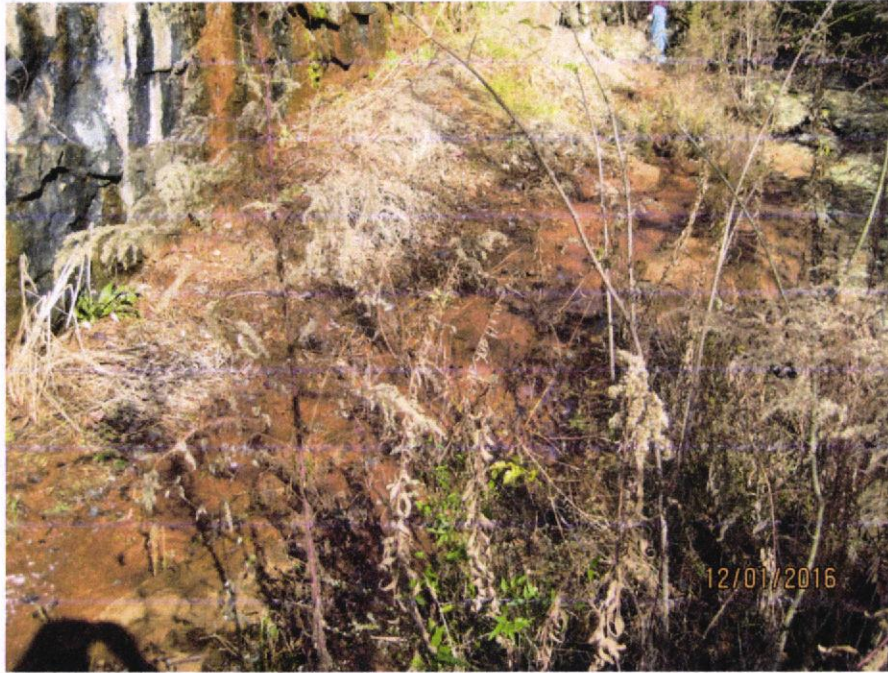
9. Seepage flows along the left toe of the dam

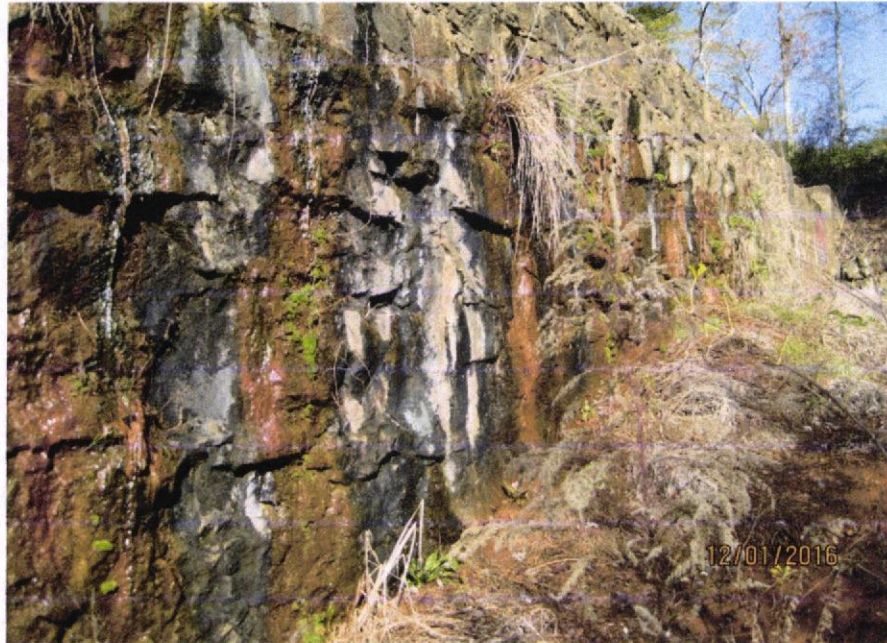
10. Closer view of the seepage and ochre along the left face
