Subject: **Inspection of LAKE CONESTEE DAM, D2876, Greenville County,
Significant Hazard Class**

CONESTEE LAKE DAM : D2876

Dams Preliminary Inspection Form

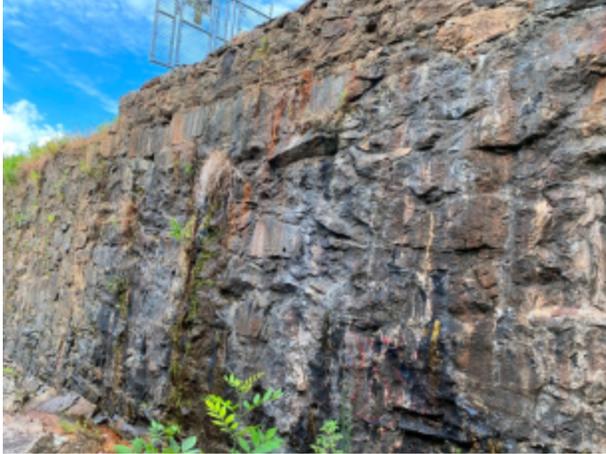
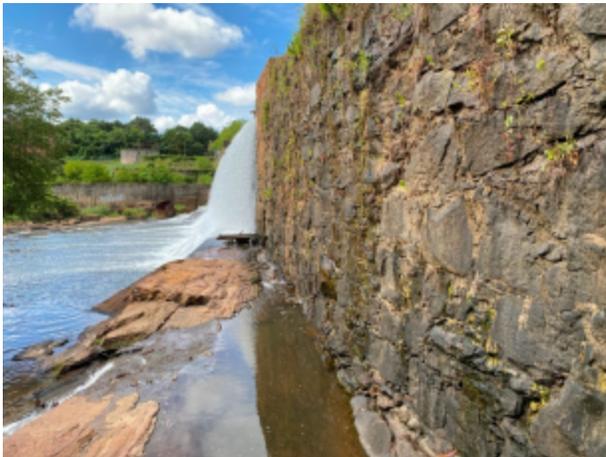
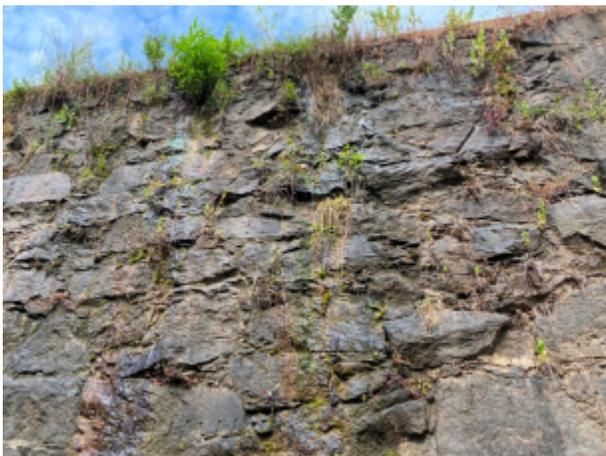
The previous SCDHEC inspections on December 18, 2014, December 1, 2016, December 11, 2019 and August 18, 2022, noted numerous active seeps and potential deterioration of the masonry joints throughout the downstream face on the both the left and right side

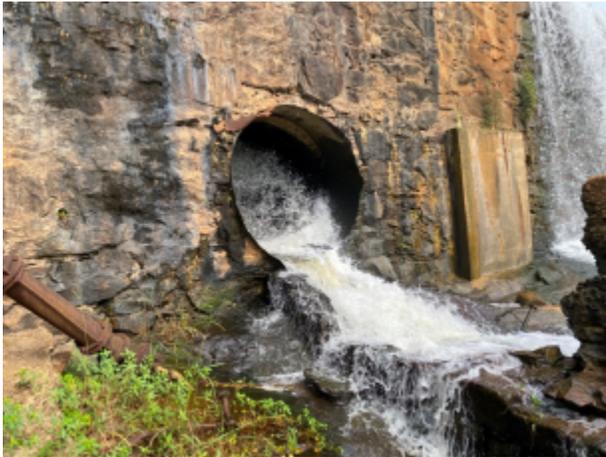
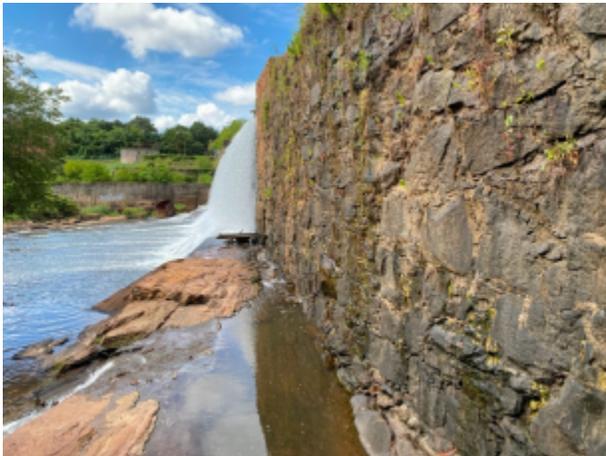
The previous SCDHEC inspections on December 18, 2014, December 1, 2016, December 11, 2019 and August 18, 2022, noted numerous active seeps and deterioration of the masonry joints throughout the downstream face on the both the left and right side. A recent engineering study was submitted on April 19, 2019 by Kleinschmidt and the report noted "Numerous active seeps were observed along the entire length of the downstream face of the dam. Most of these seeps appear to be transporting fine sediment (silt and clay) resulting in an ochre coloration to the seeps and the accumulated materials where the seeps flow across the bedrock at the base of the dam. These accumulated translocated materials have been analyzed and documented to contain high concentrations of heavy metals previously detailed in this report." Due to the movement of fine sediments containing potentially hazardous constituents, a repair plan should be developed to address and control the seepage through the dam.

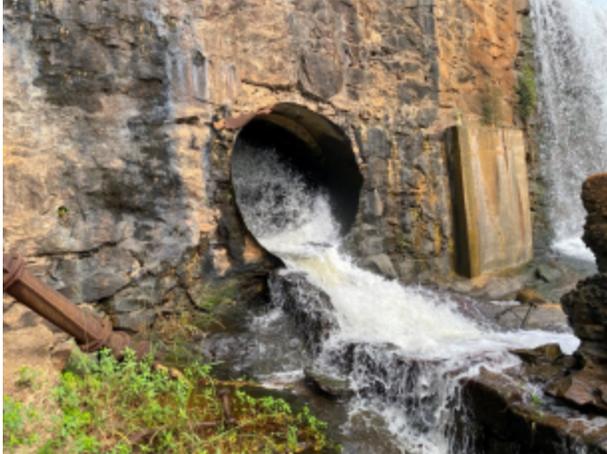
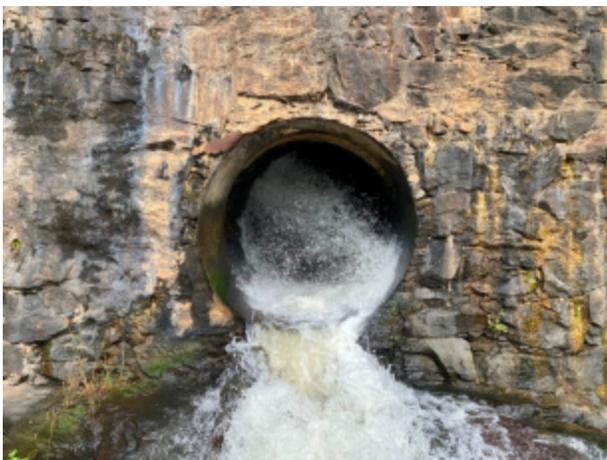
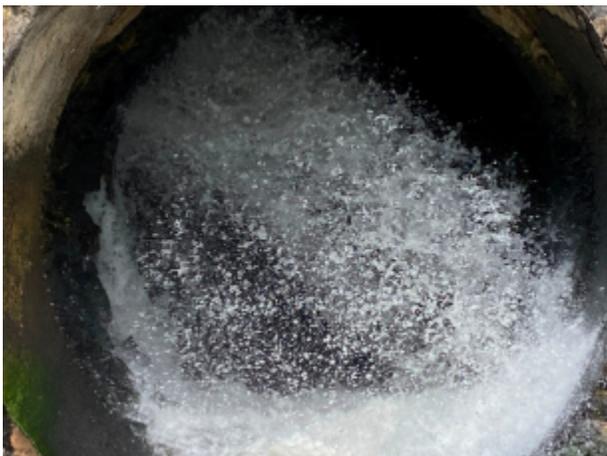
A temporary replacement plate was added on the penstock orifice in 2001. The Kleinschmidt report stated: "The timber plate installed in 2001 against an existing timber frame to stop uncontrolled river flow through the penstock orifice allows flow through the orifice estimated at less than 3-5 cfs. The plate was intentionally designed to allow this discharge so as to provide a minimum flow in the river after the repair in June 2001. These existing timber frame, believed to be at least 110 years old, is in an undetermined condition. The flow of water around the temporary plate will continue to erode the timber seals. Once these wooden seals fail, there will be an increase in flow. The volume of flow could transport sediment and contaminants downstream of the dam. If the flow is great enough or if the bulkhead plate were to fail or be displaced, then there could be a repeat of the loss of the impoundment and release of sediment that occurred from June 2000 to June 2001, when the lake reservoir drained, and the river eroded a "canyon" through the lakebed." At the time of the inspection, the flows through the penstock were above normal from previous site visits. Due to the concerns associated with the previous repairs and the potential for an uncontrolled release of water and sediment, engage a professional engineer to evaluate the penstock and to develop a repair plan to permanently seal the 8 ft diameter penstock orifice.

- Engage a professional engineer to evaluate the penstock and to develop a plan for any necessary repairs pursuant to their direction

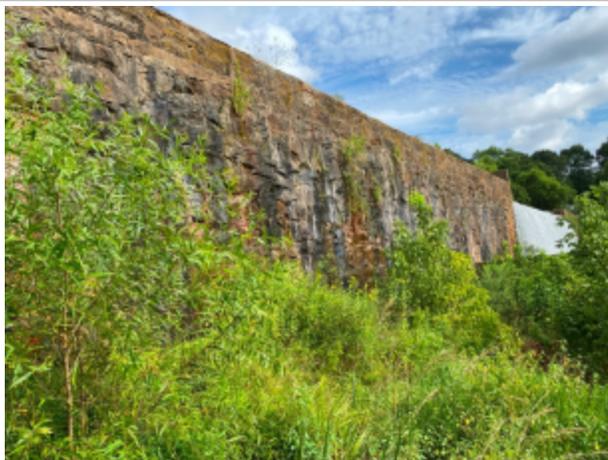
Cut and remove the brush and woody vegetation along the right downstream face so this area can be easily accessed to monitor the seepage in this area.

-Cut and remove the tall brush and woody vegetation behind the right section of the dam so the area can easily viewed and observed for any changes.

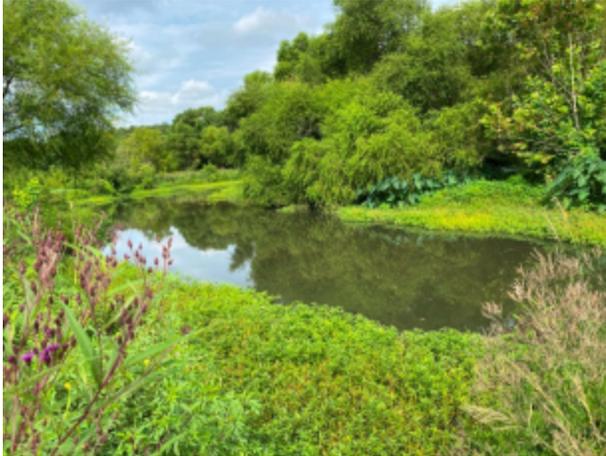
Approach area was free of debris and trash at the time of the inspection. Continue to monitor this area for any future accumulation of debris and remove as necessary.

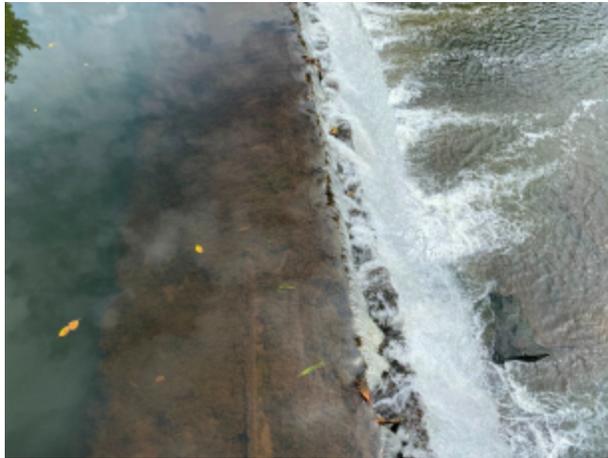
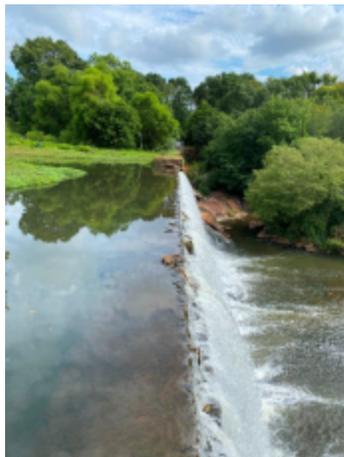
Monitor the crest of the weir where the concrete intersects with the masonry on the primary spillway on the 12 inch lip on the downstream side.
