LAKE CONESTEE DAM EVALUATION OF ALTERNATIVES REPORT

**The Conestee Foundation, Inc.
Greenville, South Carolina**

Kleinschmidt

Project 2001002
October 2019

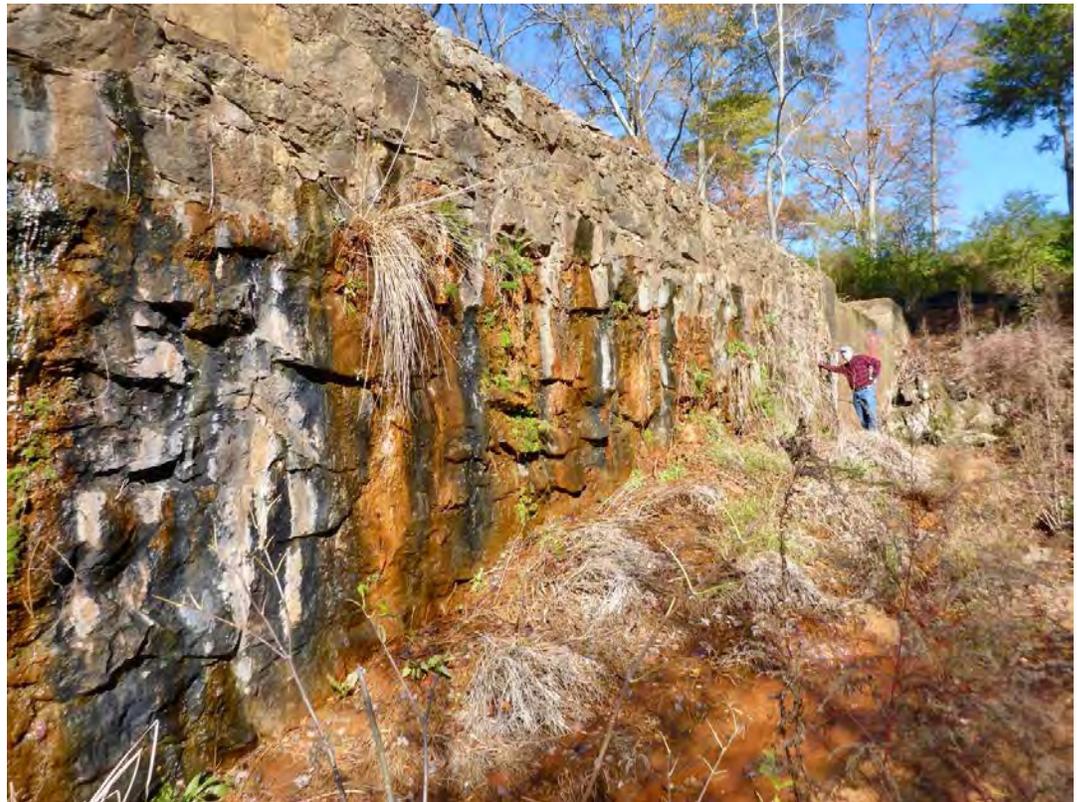
3. **Seepage through the dam must be minimized to the extent possible.** Lake Conestee Dam has numerous seeps on its downstream face, at all elevations. Some of these seeps can be seen in Figure 18 below. Much of the discoloration shown in the photos is a result of the high concentration of heavy metals translocated with fine sediment particles through the cracks and fissures in the stone masonry structure. At numerous locations along the toe of the dam, on both the north and south flanks of the structure, these seeps have resulted in a substantial accumulation of sediment deposits highly contaminated with constituents of concern. Where these materials are washed into the river by precipitation or seepage, is considered an unpermitted discharge subject to regulatory action. Measures to control seepage and the transport of contaminants through the existing dam, and through any proposed dam must be implemented to mitigate future releases of hazardous substances.

FIGURE 18 SEEPAGE ON DOWNSTREAM FACE OF LAKE CONESTEE DAM

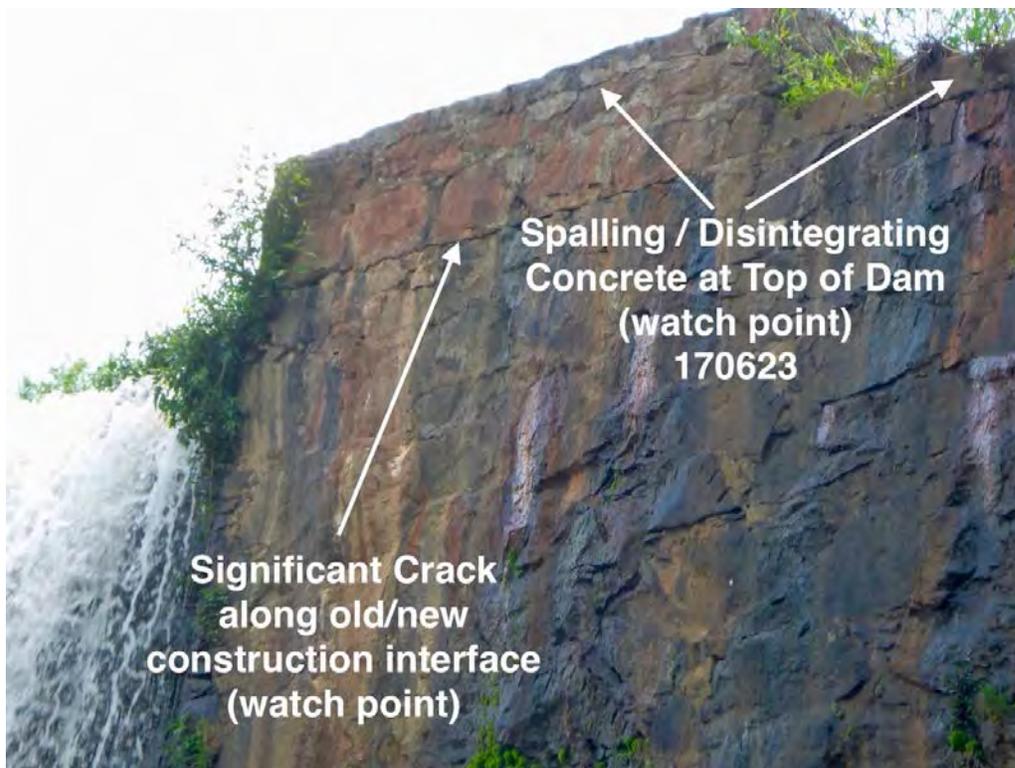
Among the key criteria for performance of a recommended alternative is the cessation of hazardous substances through the existing dam via seeps. To satisfy this objective would require installation of an impermeable membrane on the upstream face of the dam to mitigate seepage. That dam face is obscured by lake sediment, and thus would require construction of a large coffer dam system and the removal, treatment and disposal of an extensive body of contaminated sediment. In addition, the placement and anticipated performance of an impermeable seal on the upstream side of the stone masonry structure would be extremely difficult. If the membrane failed, costly replacement would be required.

FIGURE 19 TOP 3 FEET OF DAM IN NEED OF REPAIR

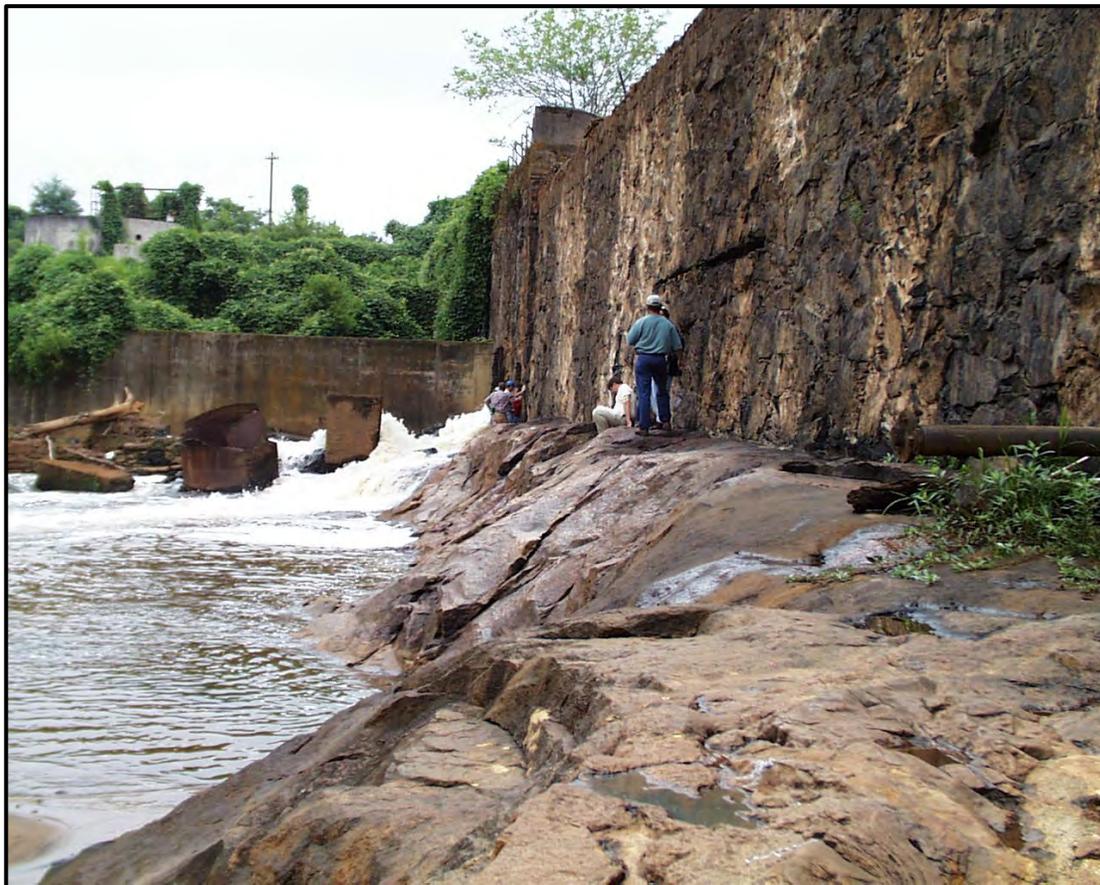
A major diesel fuel spill in 1996 (Colonial Pipeline) destroyed the Reedy River fishery and aquatic habitats in a 30-mile-long reach of the river between Fork Shoals and Lake Greenwood (Greenville Online News 2016). However, since the spill, fish populations have fully recovered; 33 species of freshwater fish are reported from the Reedy River between Lake Conestee and Lake Greenwood (Greenville Online News 2016). The Reedy River now supports typical game and non-game fish species such as bass, catfish, and several sunfish species. SCDHEC issued an active fish consumption advisory for fish taken from Lake Conestee. Aquatic habitats include shoreline wetlands, submerged woody debris and aquatic vegetation in Lake Conestee and riverine habitats (e.g., riffles, runs, pools) downstream of the dam. Immediately downstream of the dam, for approximately 800 ft, the Reedy River is comprised of a bedrock shoal with a steep gradient. The most prominent feature of that reach is a bedrock shelf that drops roughly 8 ft within 30 ft of the dam base (Figure 29).

FIGURE 29 BEDROCK SHOAL CONFIGURATION IMMEDIATELY DOWNSTREAM OF THE EXISTING LAKE CONESTEE DAM

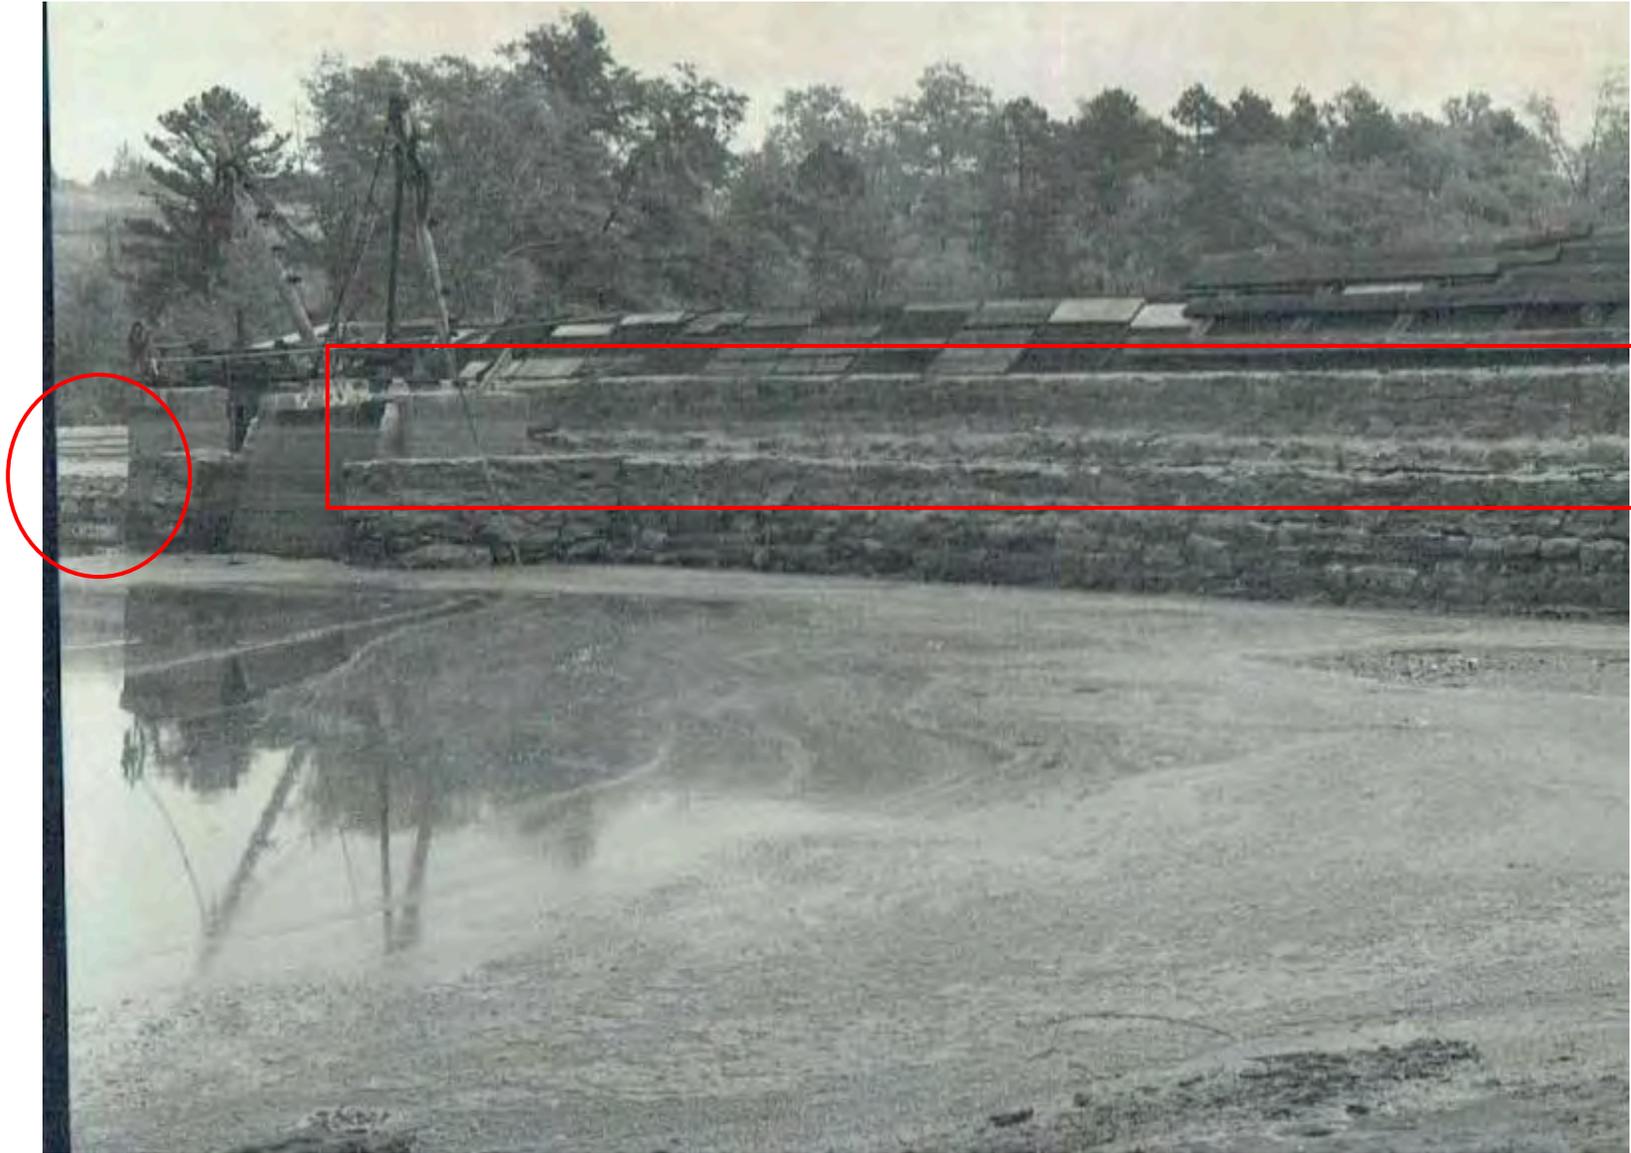
Photo 4.1: 1933. Flashboards atop Right Non-Overflow and on spillway dam (circled); upstream side. Also note masonry added to increase height of dam (rectangle).

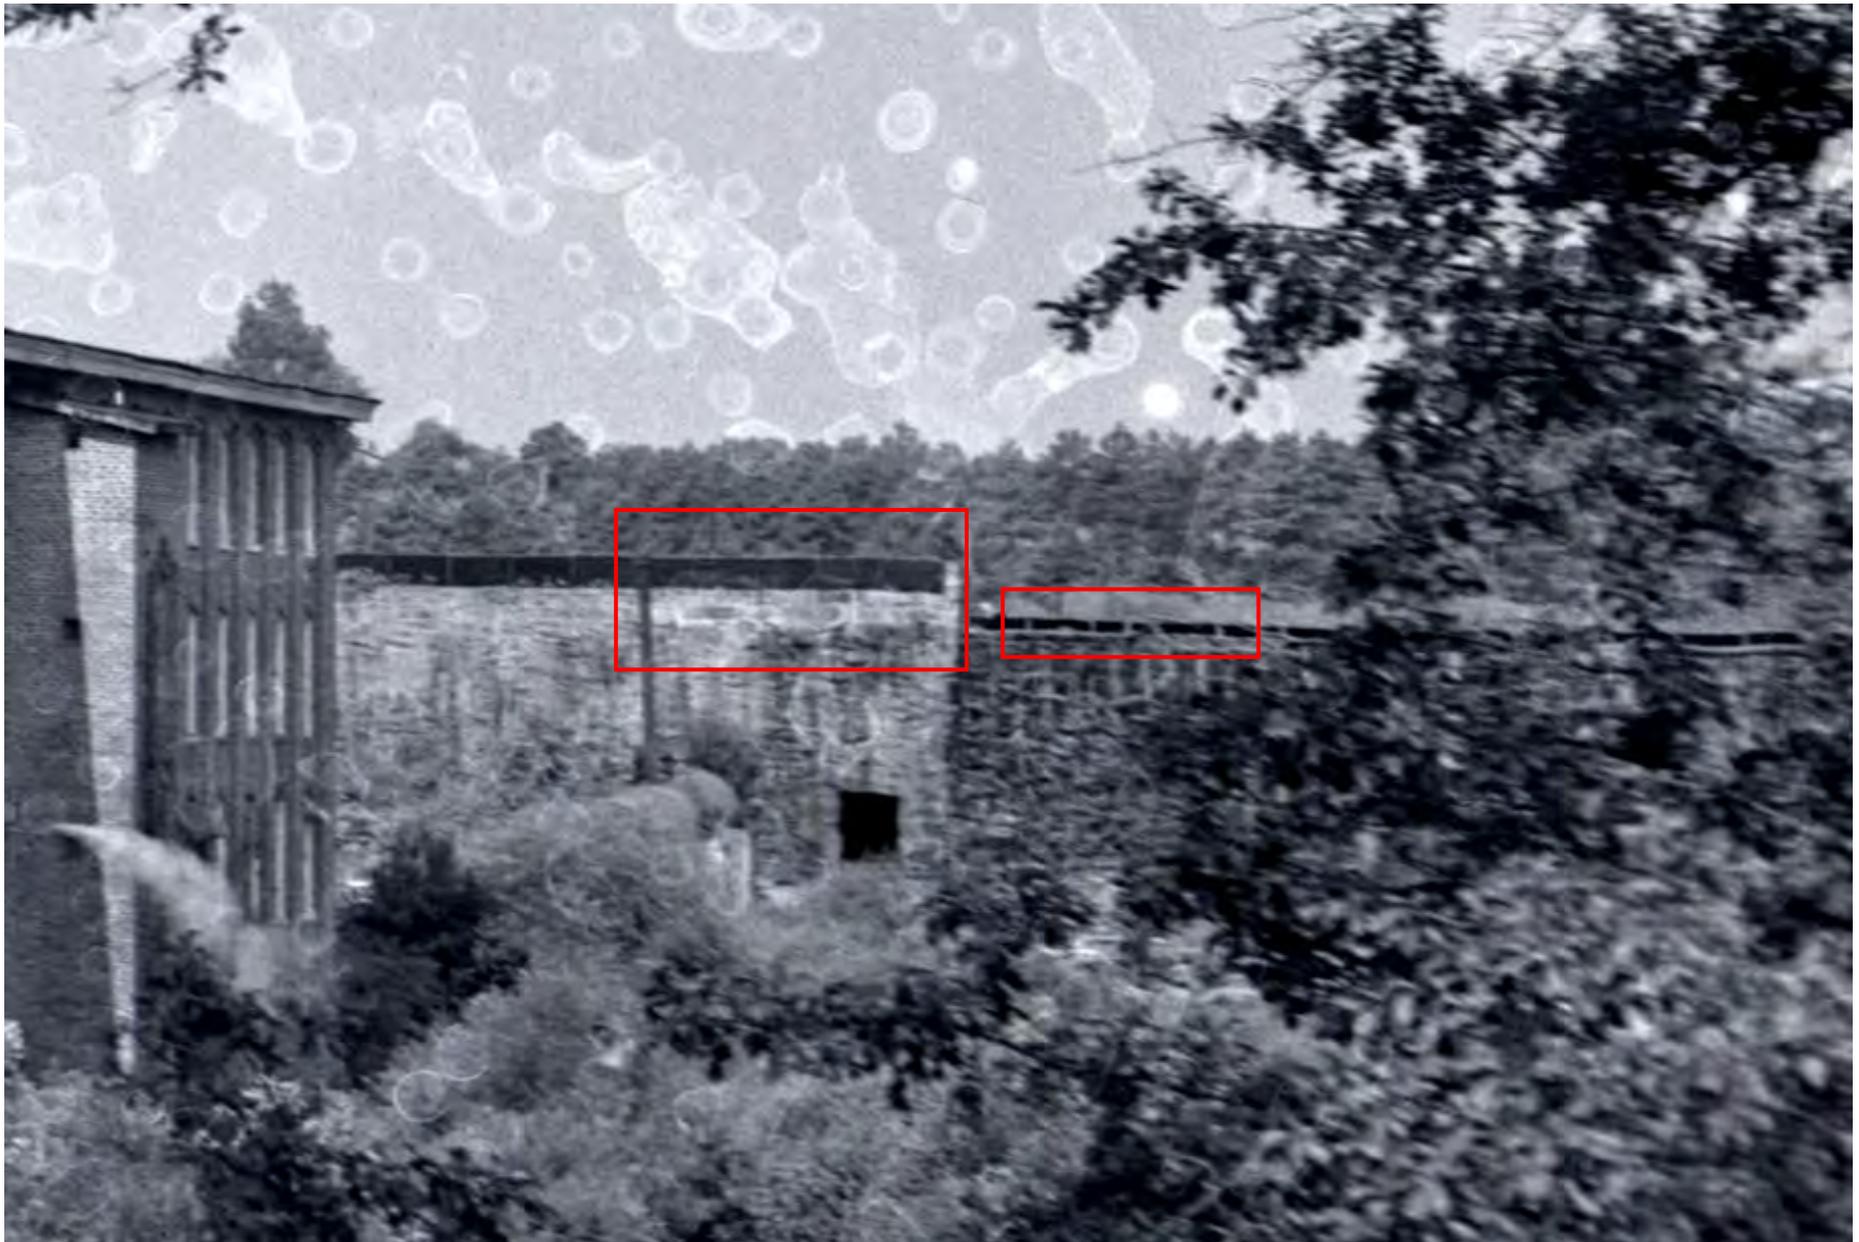
Photo 4.2: 1950s. Note flashboards atop Right Non-Overflow and on spillway dam. Note difference in masonry color on Right Non-Overflow Structure (rectangle) indicating masonry added to increase height of dam.

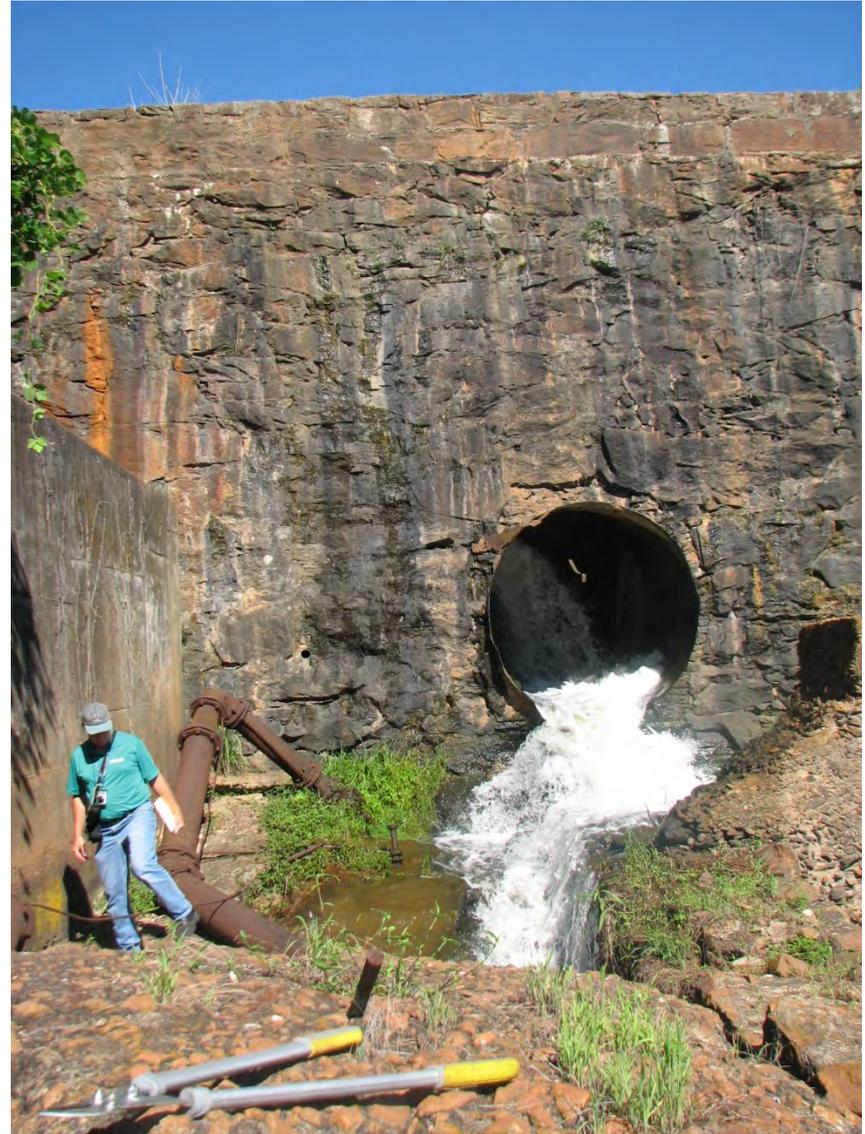
Photo 10: Outlet structure, location of former penstock to mill.

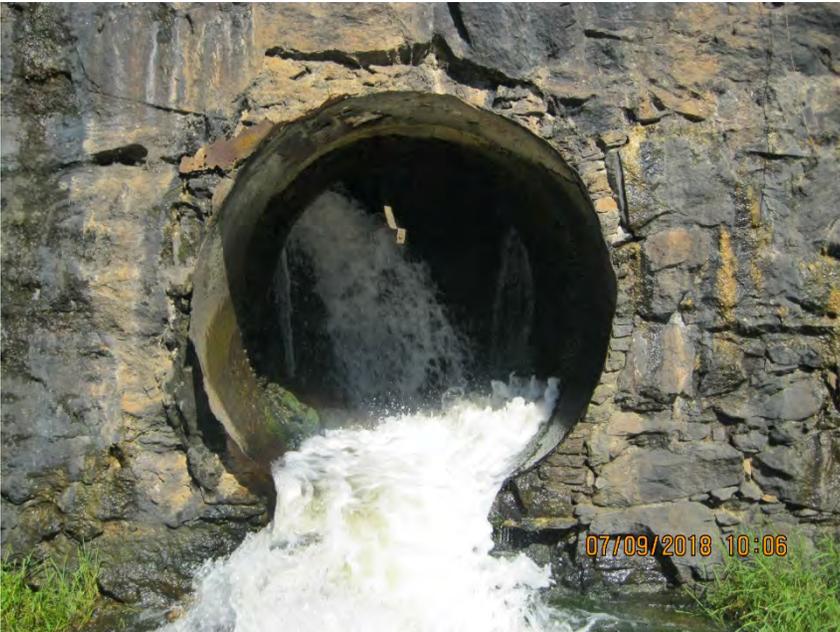
Photo 11: Outlet structure, gate leakage.

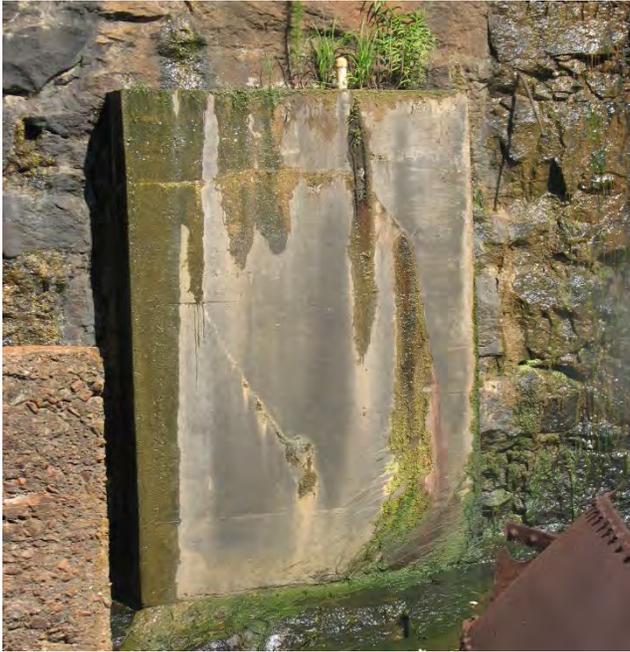
Photo 12: Outlet structure; concrete plug at one of the outlets.

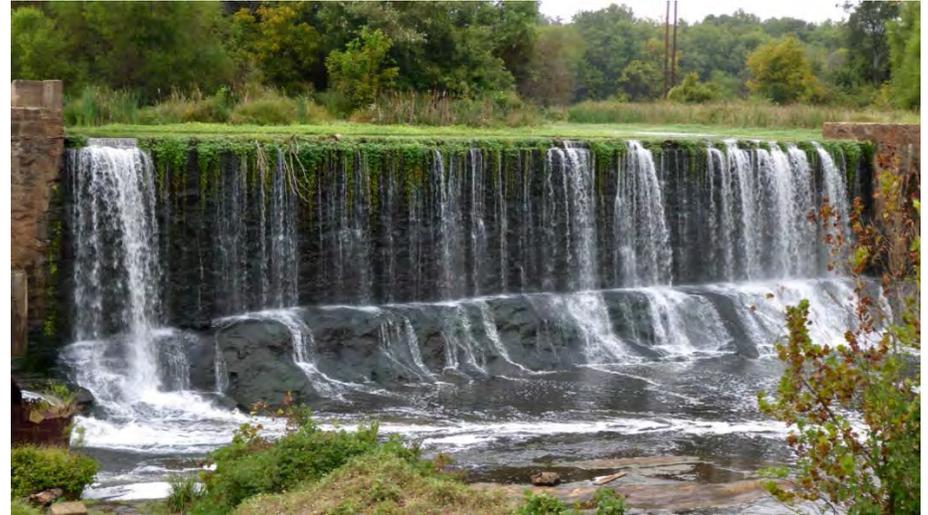
Photo 15: Spillway dam (2016), low crest section showing rock shelf on which dam is founded.

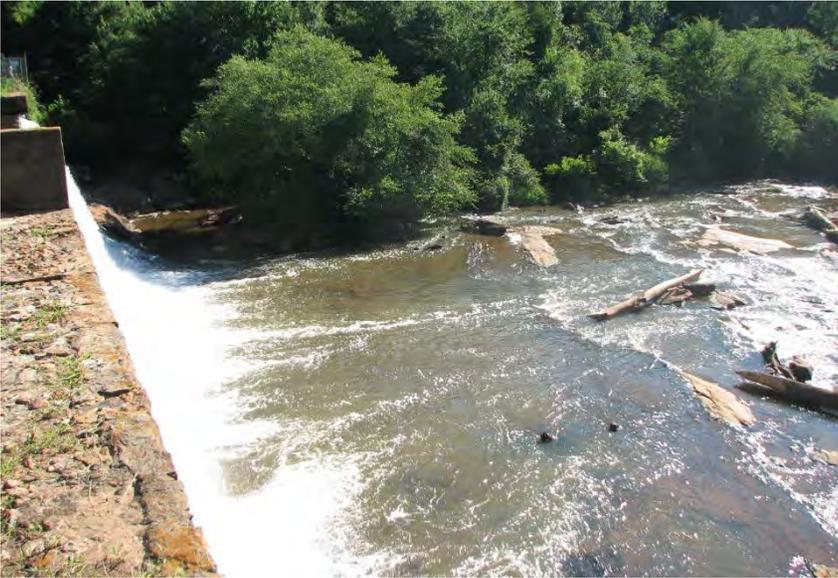
Photo 18: Tailwater conditions at toe of dam.

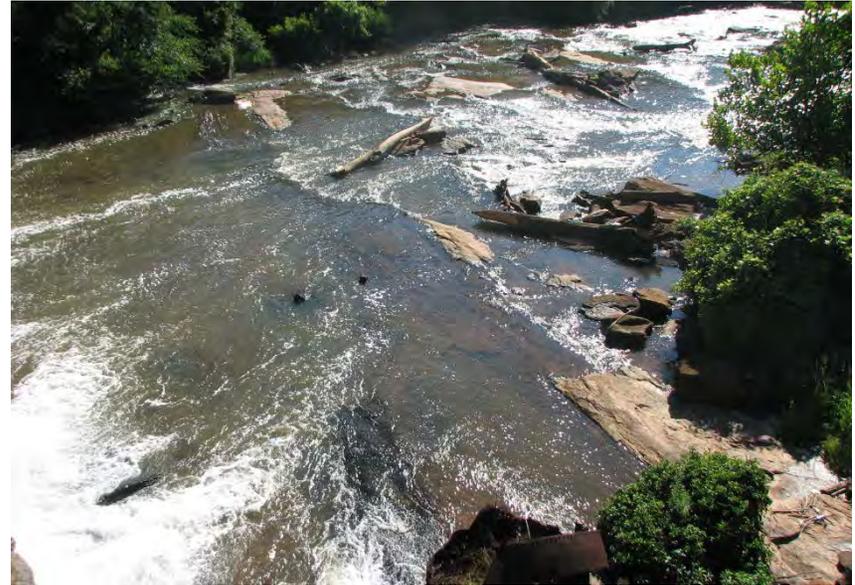
Photo 19: Tailwater conditions downstream of dam.

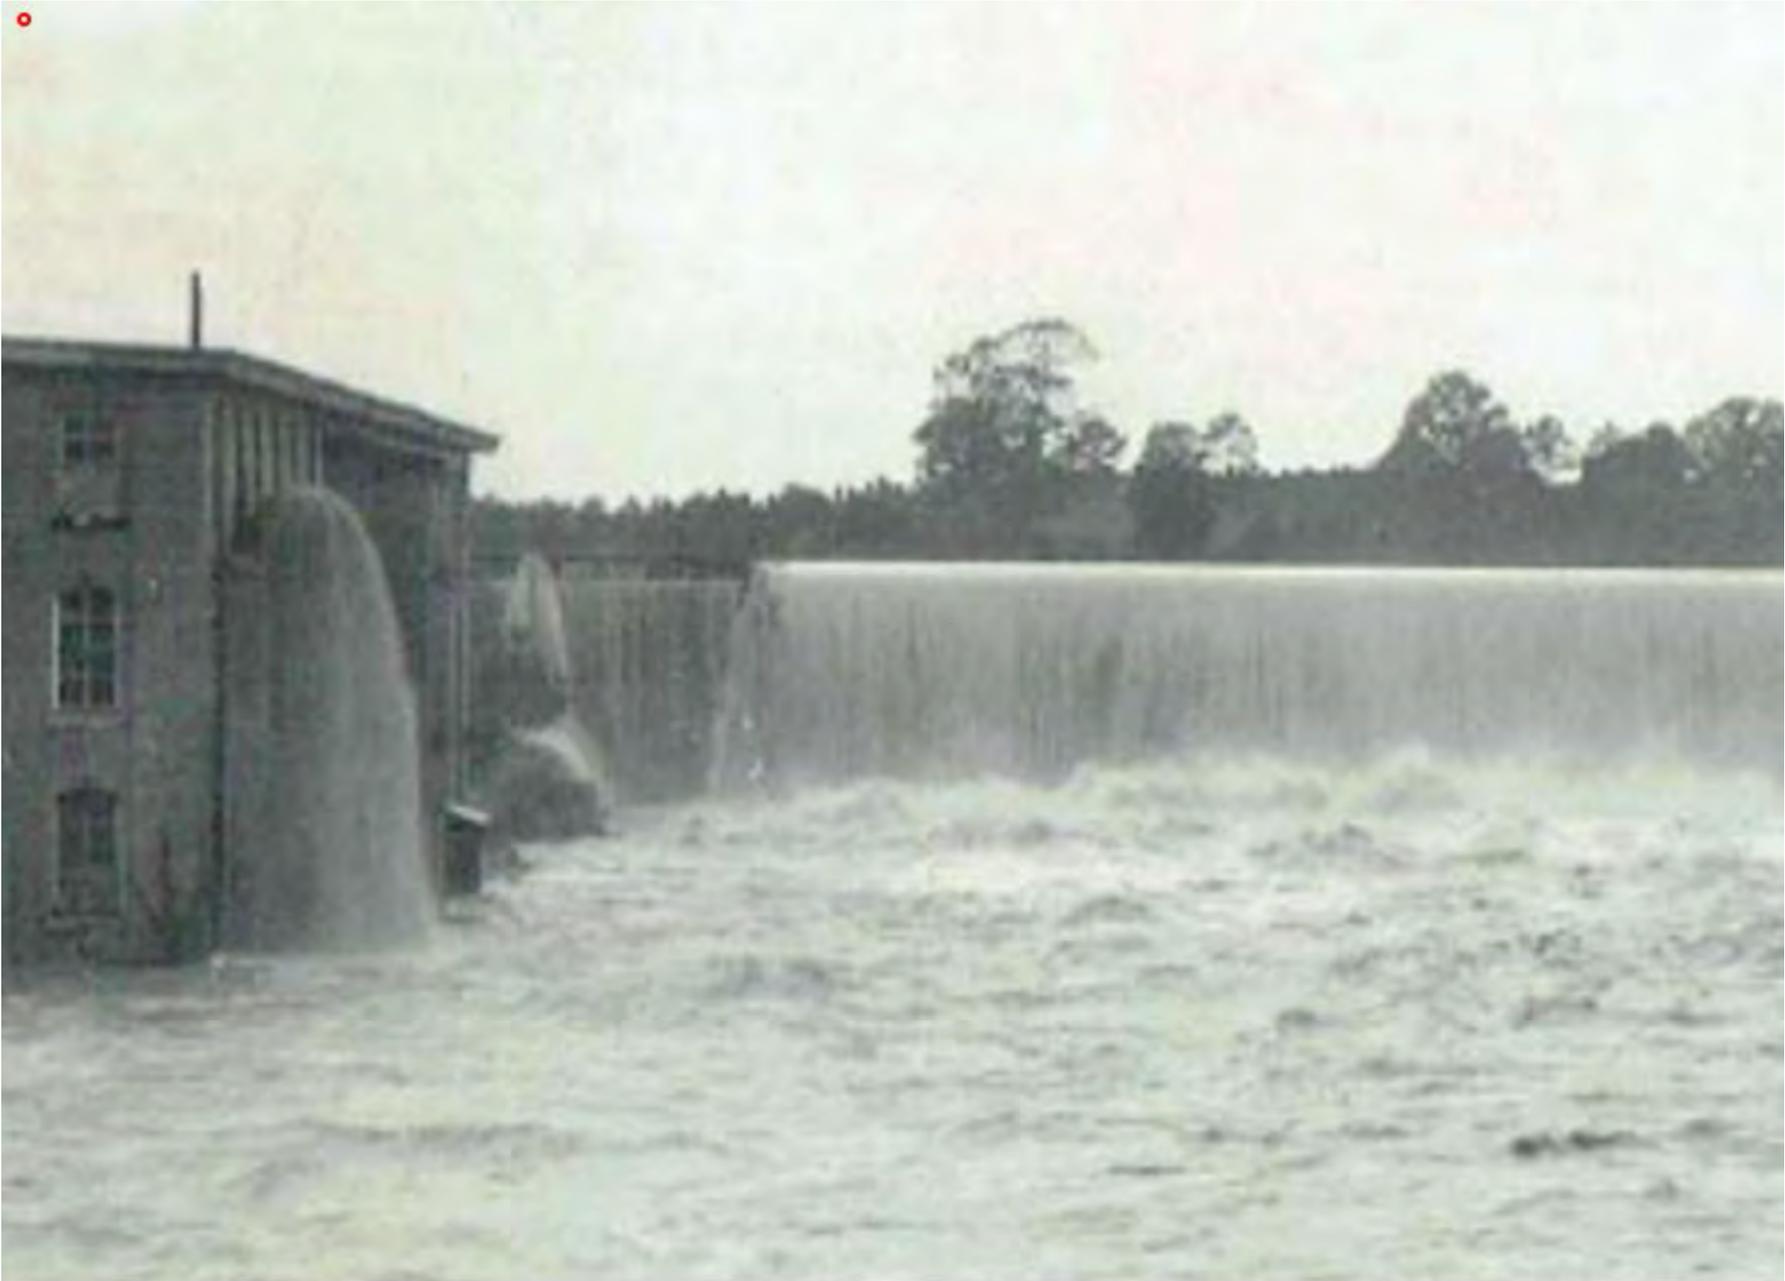
Photo 29: Flood of April 1936. Note flows just starting to overtop flashboards on Right Non-Overflow Structure.
