# SPRING LAKE DAM : D3539

## Dams Preliminary Inspection Form

Start Date: 09/28/2018

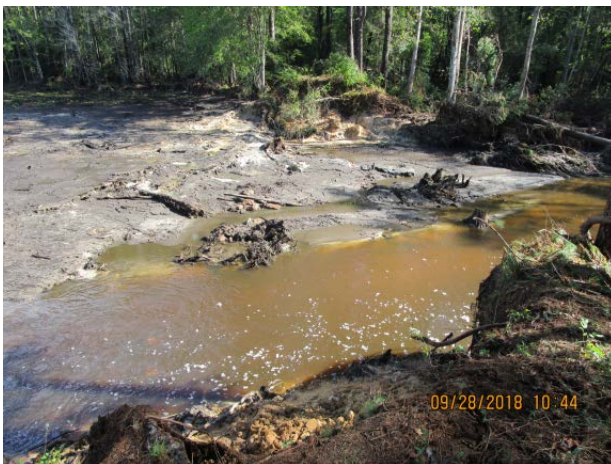
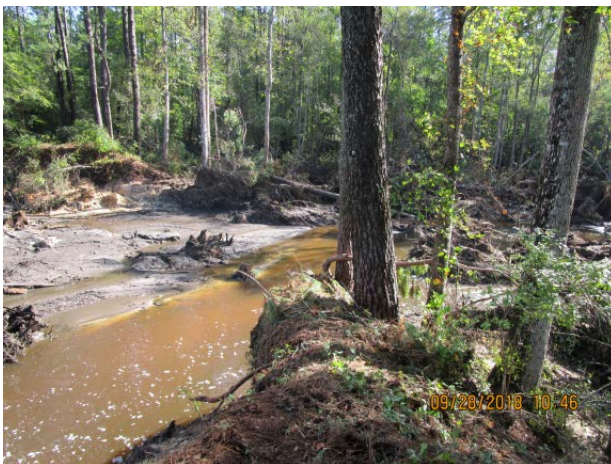
1. Estimate the current level of the water in the reservoir: Breached

Dam was breached as a result of Hurricane Florence. Breach occurred near the left abutment and auxiliary spillway.

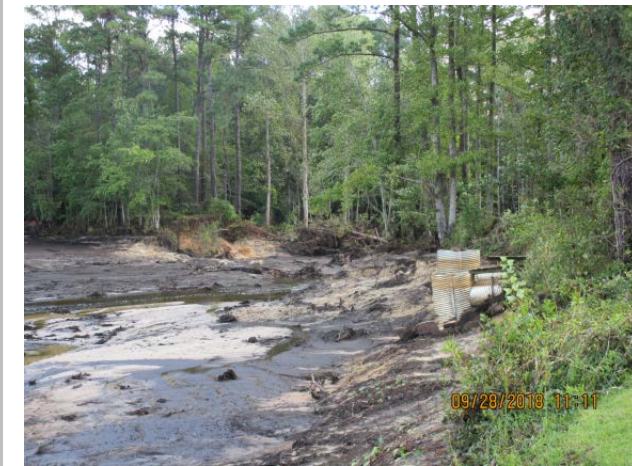
1. Grass Cover	Action Required
Establish and maintain grass coverage along the length of the slope.	
2. Deleterious Vegetation	Action Required
Small trees, weeds, and brush present.	
3. Trees	Action Required
Small and large trees present.	
4. Animal Activity	Monitor
5. Surface Cracking	
6. Subsidence, Sinkhole	
7. Slide, Slough, Scarp	Monitor
Some portions of the upstream slope are very steep. No signs of recent movement of soil, but this should be monitored.	
8. Groins	Action Required
Some brush in left groin.	
9. Erosion	Action Required
Dam breached due to overtopping.	
10a. Slope Protection/Armoring Present?	<input type="checkbox"/> Yes <input checked="" type="checkbox"/> No
10b. (If Present:.) Slope Protection/Armoring	
11a. Alterations/Repairs Present?	<input type="checkbox"/> Yes <input checked="" type="checkbox"/> No

<b>Embankment: Upstream Slope</b>	
<i>11b. (If Present:) Alterations/Repairs Condition</i>	
<i>12. Other:</i>	
<i>13. Embankment: Upstream Slope Condition</i>	Needs Maintenance, Needs Permitted Repair(s)
<b>Violation Determined: 9/28/2018 DAMMAINTREP</b>	
<i>14. Additional Comments (Refer to item number if applicable)</i>	
<b>Concrete/Masonry Dams: Upstream Face</b>	
<i>Is this section applicable for this dam?</i>	<input type="checkbox"/> Yes <input checked="" type="checkbox"/> No
<i>1. Surface Conditions</i>	
<i>2. Condition of Joints</i>	
<i>3. Unusual Movement</i>	
<i>4. Abutments</i>	
<i>5a. Alterations/Repairs Present?</i>	<input type="checkbox"/> Yes <input type="checkbox"/> No
<i>5b. (If Present:) Alterations/Repairs Condition</i>	
<i>6. Other:</i>	
<i>7. Concrete/Masonry Dams: Upstream Face Condition</i>	
<i>8. Additional Comments (Refer to item number if applicable)</i>

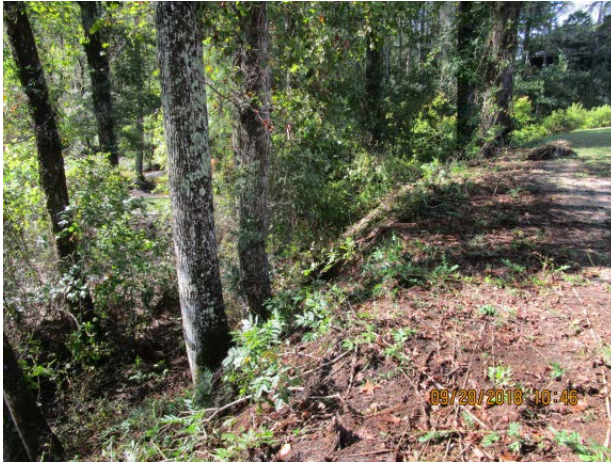
1. <i>Grass Cover</i>	Action Required
Establish grass coverage along the length of the slope.	
2. <i>Deleterious Vegetation</i>	Action Required
Small trees, weeds, and brush present.	
3. <i>Trees</i>	Action Required
Large trees present along the slope.	
4. <i>Animal Activity</i>	Monitor, Investigate
See Question 6.	
5. <i>Surface Cracking</i>	
6. <i>Subsidence, Sinkhole</i>	Investigate
Sinkhole/animal burrow observed a few feet above the end of the left outlet pipe (looking downstream).	
7. <i>Slide, Slough, Scarp</i>	
8. <i>Groins</i>

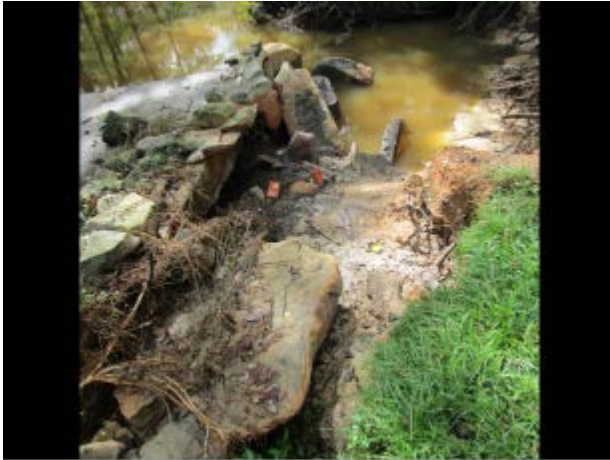
### 9. Erosion

Action Required

Dam breached as a result of overtopping. Erosion also observed on downstream slope, surrounding the right outlet pipe's discharge channel.

Needs Maintenance,  
Needs Permitted  
Repair(s)

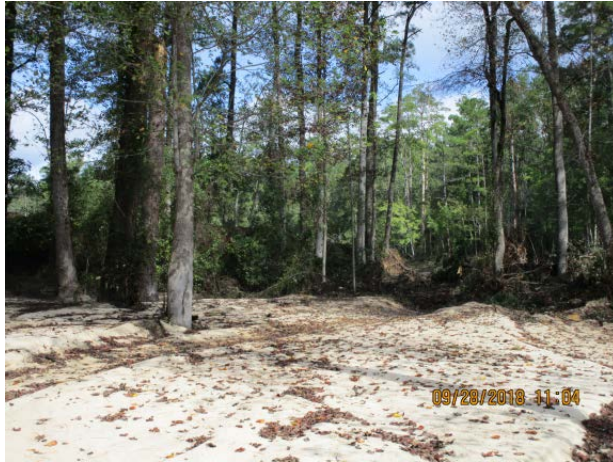
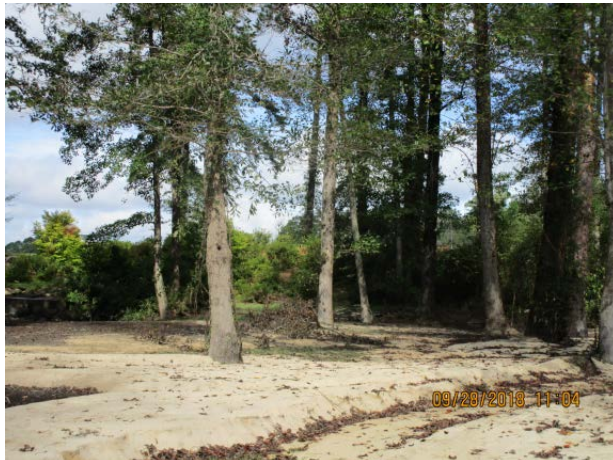
Some large trees and debris from the dam's failure present.

Several large trees present.

Downstream area is largely covered with sediment from the dam's failure.

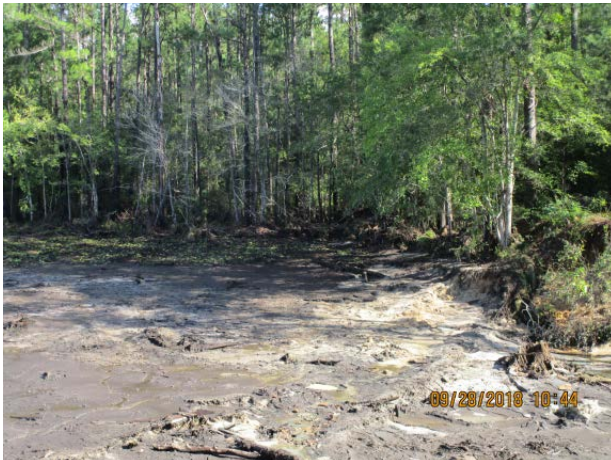
Unable to access auxiliary spillway due to the breach.

<b>Spillways: Erodible Channel</b>	
3. <i>Deleterious Vegetation</i>	Action Required
Small trees, weeds, and brush visible from the accessible area.	
4. <i>Trees</i>	Action Required
Trees visible from the accessible area.

12. <i>Other:</i>	
13. <i>Spillway: Erodible Channel Condition</i>	Needs Maintenance, Condition Prevented Full Inspection
<b>Violation Determined: 10/1/2018</b> <b>DAMMAINTREP</b>

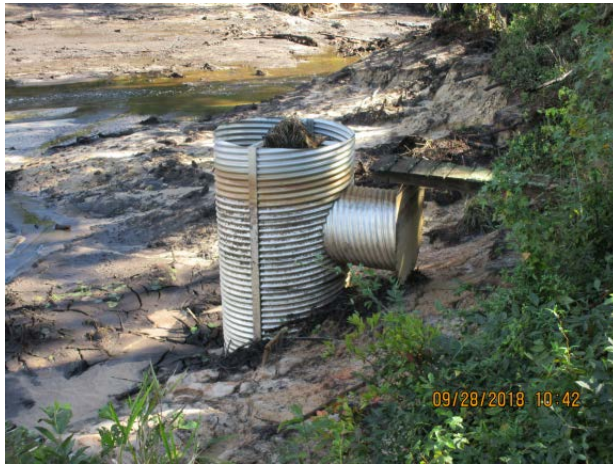
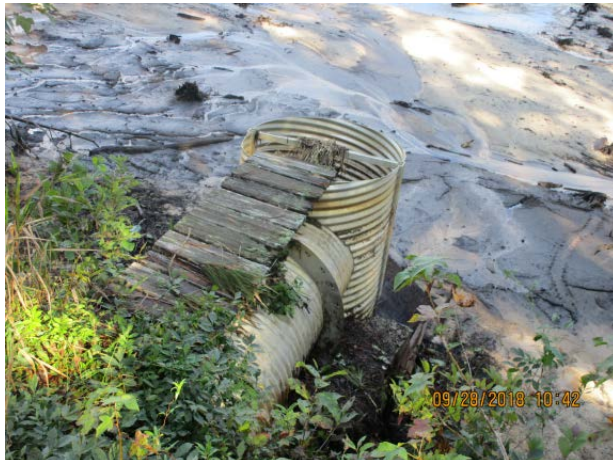
60" CMP: 34.457968, -79.862044

72" CMP: 34.457975, -79.861984

No Deficiency

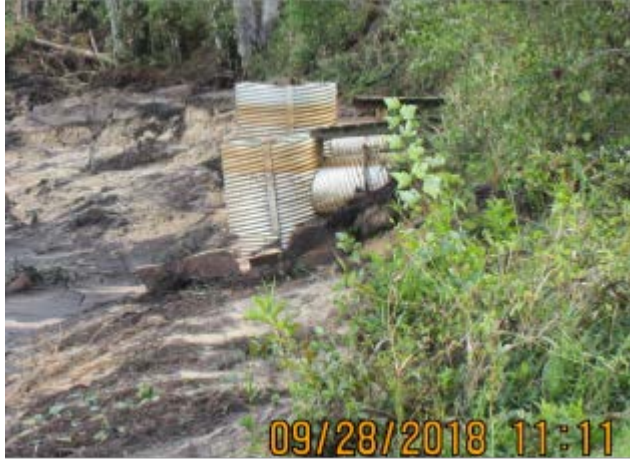
<b>Spillways: Inlet Structure</b>	
<p><i>2b. Intake Structure Types</i></p> <p>Inlet structure to the right (looking downstream) appears to have a large flashboard that can be removed to act as a low level control.</p> <div style="display: flex; align-items: center;">

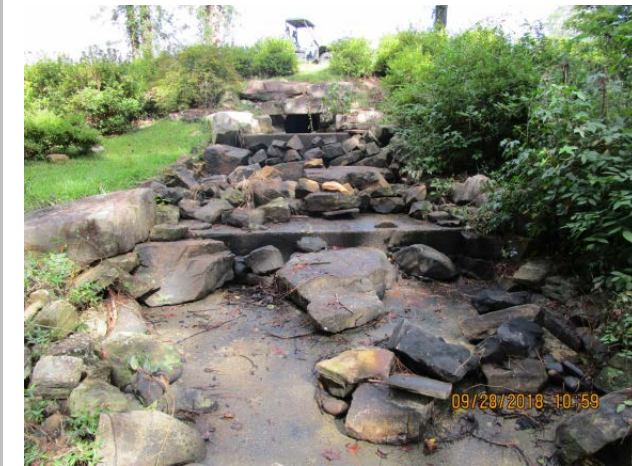
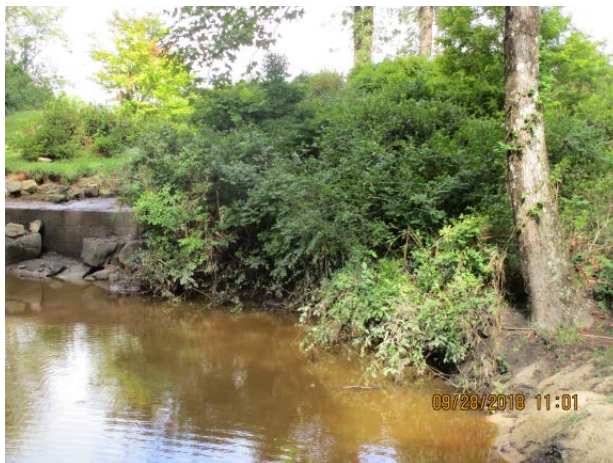
Two pipes present. One was fully submerged.

Left outlet pipe was completely submerged/covered by brush. Unable to observe its condition.

<b>Spillways: Outlet Works</b>	
6. <i>Unusual Movement</i>	Investigate, Action Required
<div style="border: 1px solid black; padding: 2px;">Small sinkhole/animal burrow observed above the left outlet pipe, a few feet up the slope.</div>	
7a. <i>Seepage</i>	<input type="checkbox"/> Yes <input type="checkbox"/> No <input checked="" type="checkbox"/> NA
<div style="border: 1px solid black; padding: 2px;">Dam is breached and holding no water.</div>	
7b. <i>(If Present): Seepage</i>

8. <i>Stilling Basin</i>	Action Required
<div style="border: 1px solid black; padding: 2px;">Erosion of the slope and area surrounding the right outlet's stilling basin.</div>

12. <i>Other:</i>	
13. <i>Outlet Works Condition</i>	Needs Maintenance, Needs Permitted Repair(s)
<div style="border: 1px solid black; padding: 2px;"><b>Violation Determined: 9/28/2018 DAMMAINTREP</b></div>
