January 29, 2018

RE: Inspection of BOWATERS CAROLINA DAM 6 (DHEC ID # D3657)  
York County

# BOWATERS CAROLINA DAM 6 (D3657)

## Dams Preliminary Inspection Form

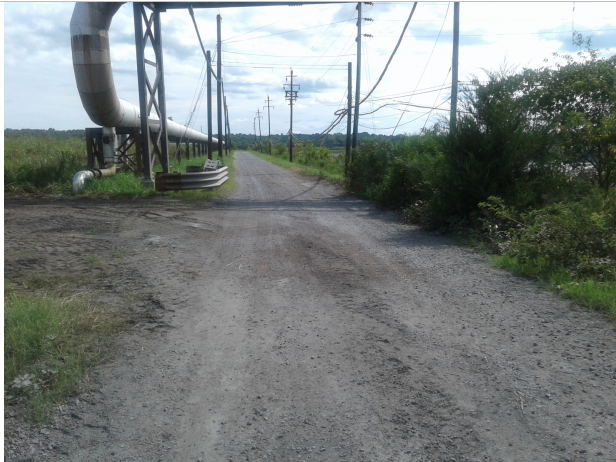
<b>Embankment: Crest</b>	<b>Answer</b>	<b>Violation</b>
<p>1. Grass Cover</p> <p>No Deficiency</p> <p>Top of dam is a gravel road for large truck access.</p>		
<div style="display: flex; align-items: center;">

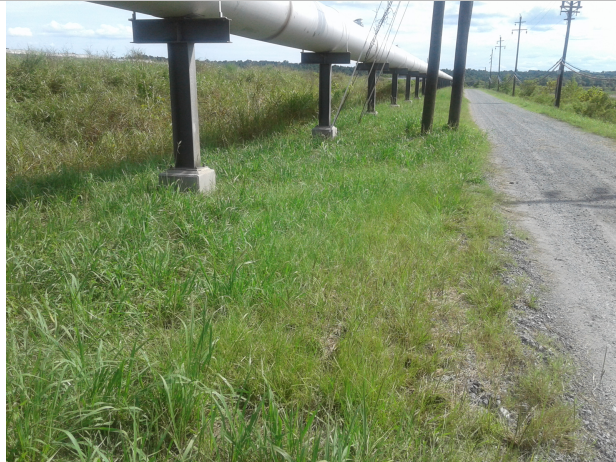
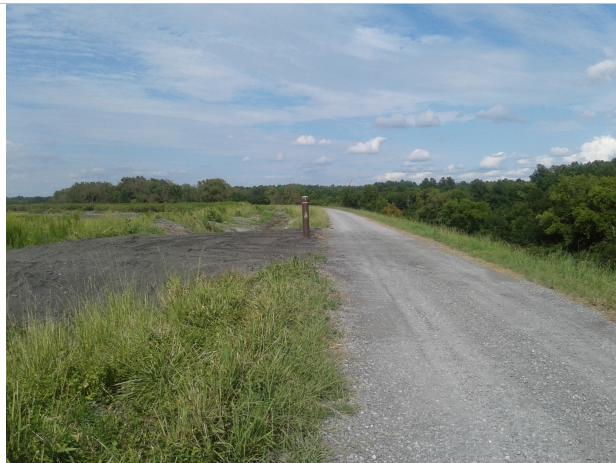
### 1. Grass Cover

#### Monitor

Greater than 70 percent grass cover greater than 6" tall in some places.

Cut and remove brush and woody vegetation on upstream and downstream slopes where necessary. Monitor possible erosion on gravel access road on top of dam where necessary. Maintain/manage vegetation by mowing regularly.

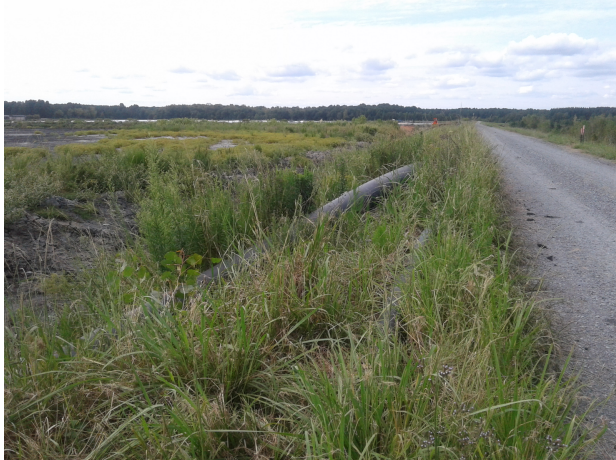
<b>Embankment: Upstream Slope</b>	<b>Answer</b>	<b>Violation</b>
<p>2. Deleterious Vegetation</p> <p>Monitor</p> <p>Vegetation and brush present throughout upstream slope.</p>		
<div style="display: flex; align-items: flex-start;">

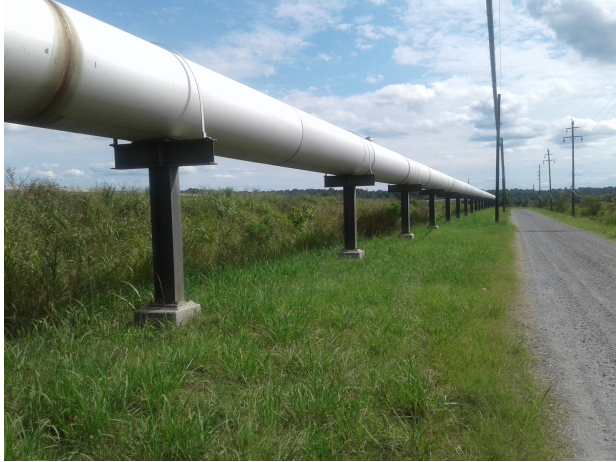
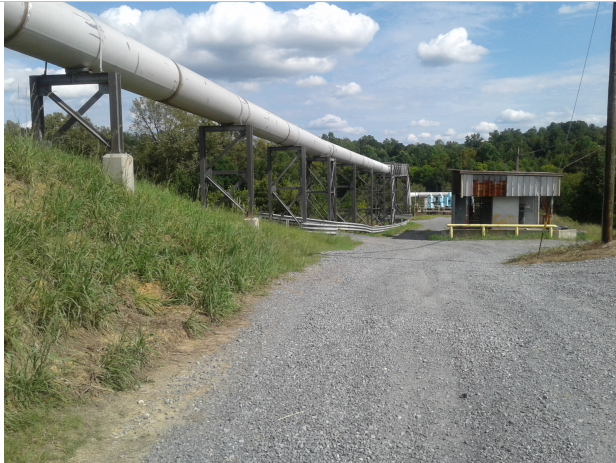
<b>Embankment: Upstream Slope</b>	<b>Answer</b>	<b>Violation</b>
11a. Alterations/Repairs Present?	<input type="text" value="No"/>	
11b. (If Present:) Alterations/Repairs Condition		
12. Other: Large raw water pipeline extends throughout approximately 2000' of upstream slope.

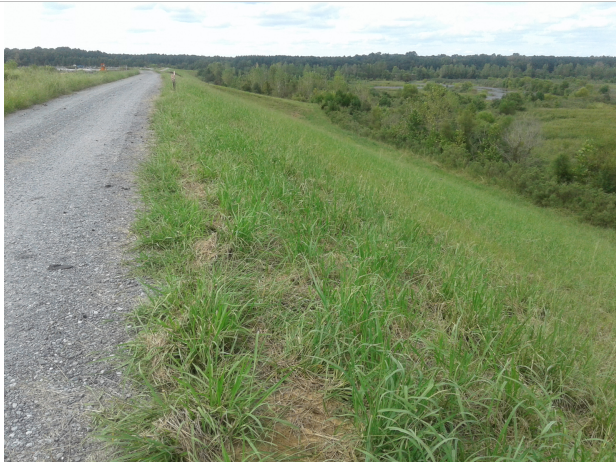
<b>Embankment: Downstream Slope</b>	<b>Answer</b>	<b>Violation</b>
<p>1. Grass Cover</p> <p><b>Monitor</b></p> <p>Greater than 70 percent grass cover with grass taller than 6" in some places.</p>		
<div style="display: flex; align-items: center;">

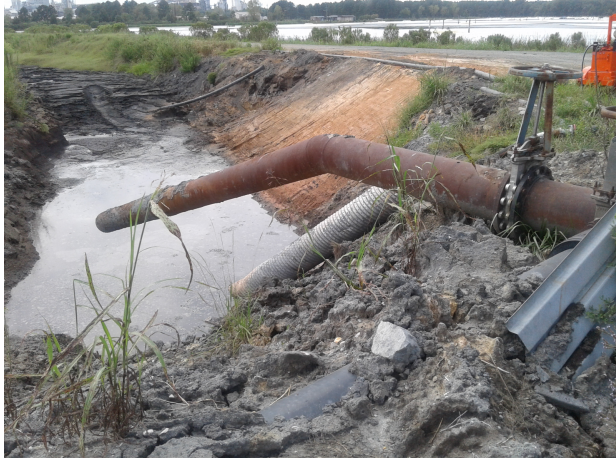
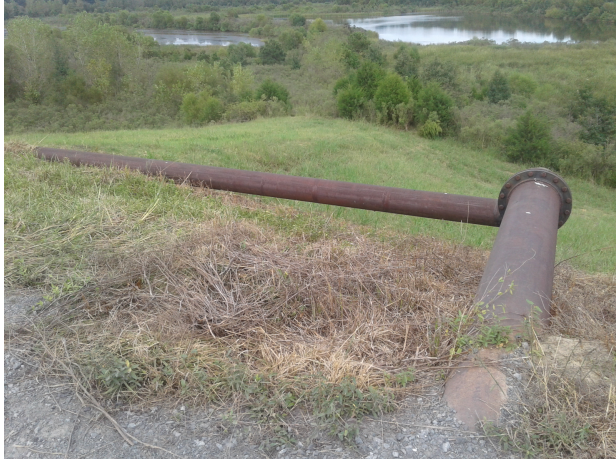
<b>Spillways: Inlet Structure</b>	<b>Answer</b>	<b>Violation</b>
Is this section applicable for this dam?	<input type="text" value="No"/>	
The pond is a dry post-processing sludge basin. 12" DIP siphon system present but not embedded or in use.

Photo Taken: 8/30/2017 4:29:07 PM	
1. Location (34.844106, -80.874968)		
2a. Intake Structure Monitor		
12" DIP siphon		
2b. Intake Structure Types Siphon		
3. Trashrack Not Present		
4a. Low-Level Valve Present?	<input type="text" value="No"/>
