Cane Creek and Little Cane Creek Watershed Management Plan to Address E. Coli Impairment, Oconee County, SC

September 2018 (Rev. April 2020)

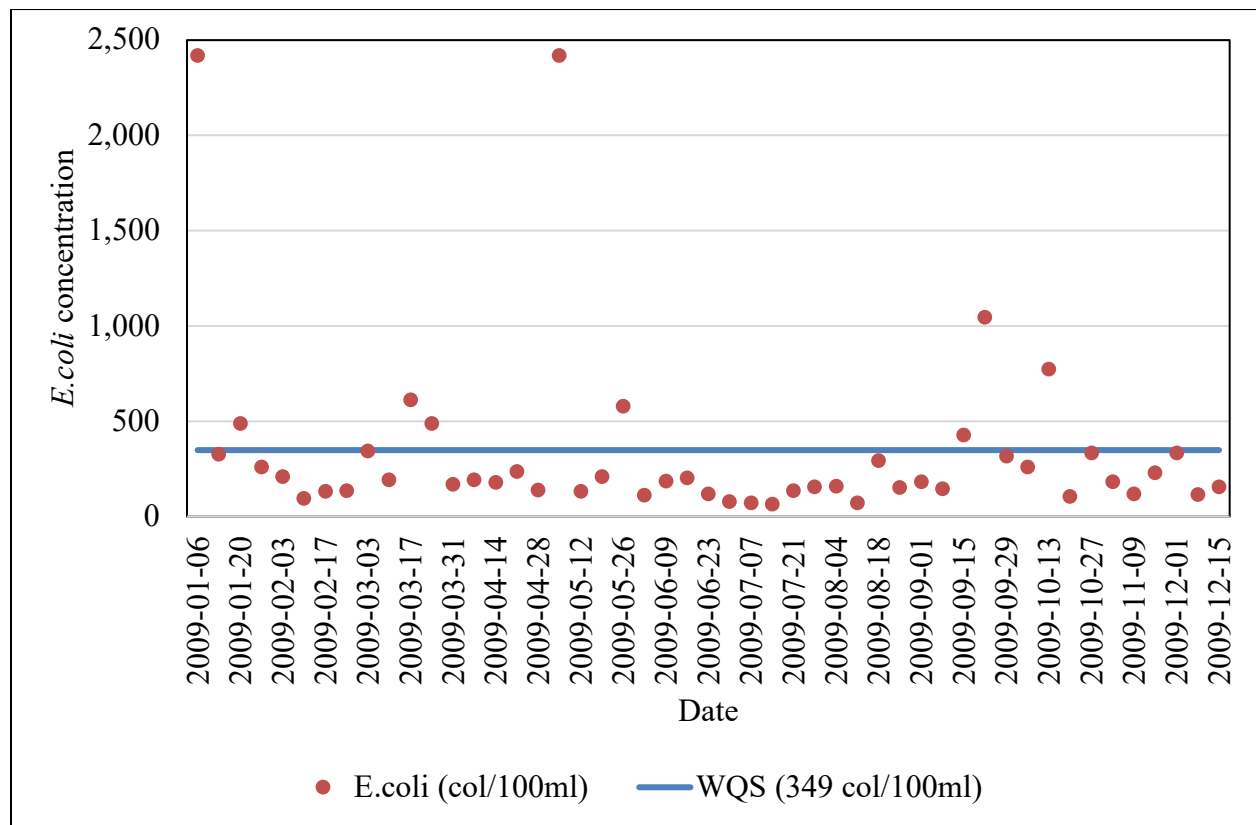
Fig. 4. *E. coli* results at SV-342 on Cane Creek in 2009, plotted against *E. coli* water quality standard for single grab samples (349 col/100mL).

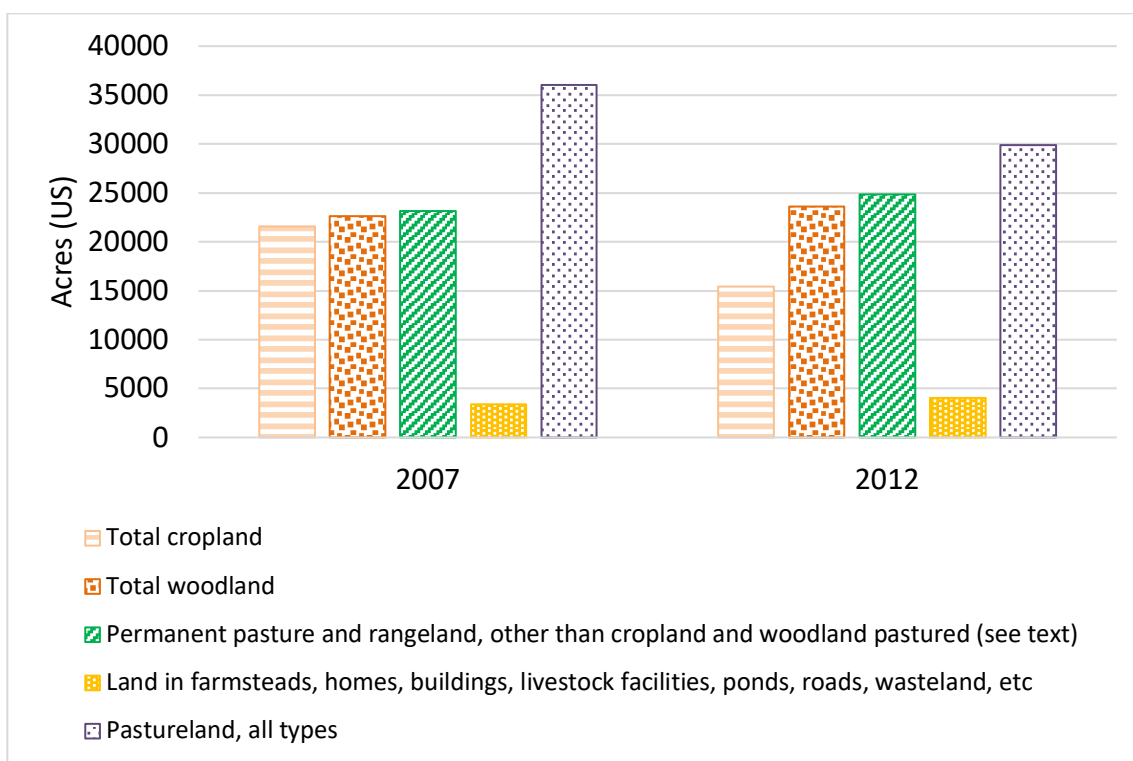
Fig. 7. Land in farms in Oconee County according to use - 2012 and 2007.

The United States Department of Agriculture’s National Agricultural Statistics Service (NASS) reported that the total land in farms according to use in Oconee County in 2007 was 106,729 acres, and this area decreased to 97,736 acres by the year 2012 (Table 5, Fig. 7). Major decline was seen in total cropland and pastureland.

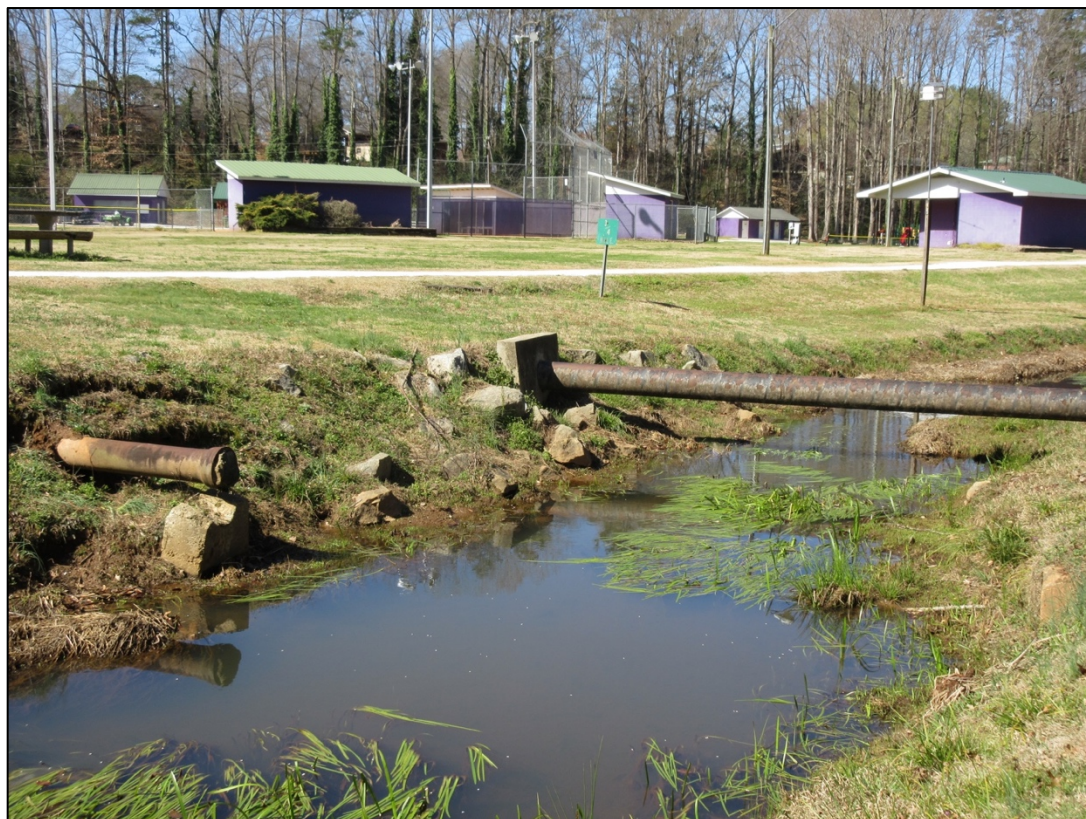
Fig.18. Previously sealed and replacement sewer lines hover just a few feet over unnamed tributary leading to Cane Creek, which runs through Sertoma Field, Walhalla, SC.

documented as a source of overflows to Cane Creek. These occurrences have been noted in the most frequently used public park in the area, Sertoma Field. This public park includes the main sewer line, which parallels and then crosses a tributary to Cane Creek and concrete cinder cones house risers and manholes from the sewer line. Sertoma Field is the most popular and most frequented park in the area, where baseball games, track, disc golf, and other recreational amenities are available to the public, as well as several community festivals such as Walhalla's annual Oktoberfest.

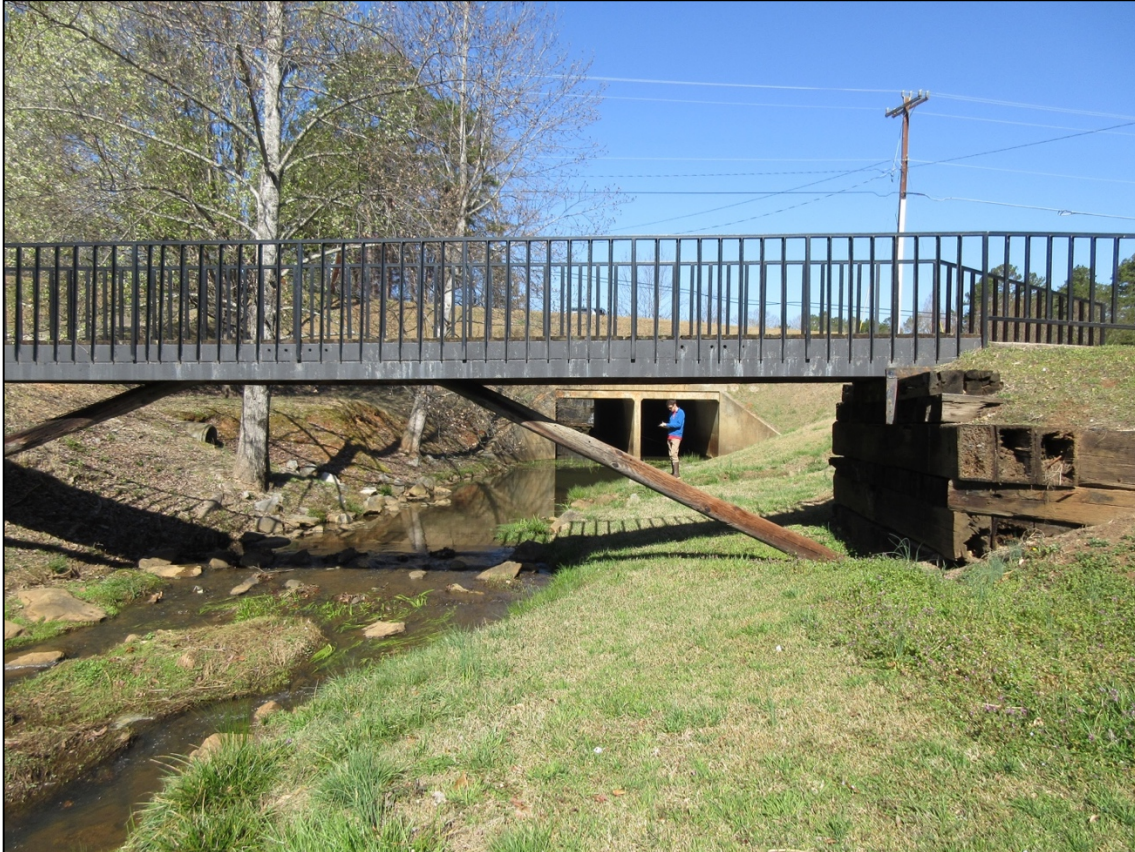
Fig. 19. Tributary to Cane Creek from neighborhood pond, after it passes under Highway 183 and enters into Sertoma Field.

length and for the majority of the year. The tributary is shaded by a few large trees, but predominantly has turf extending to the edge of the low bank (Fig. 19). Though not observed during the development of this watershed plan, stakeholders have stated that this park and adjacent parking lot floods several times per year. The adjacent parking lot is not curbed and is at a distance between 15 and 30 feet from the tributary for its full length. The opposing side includes utilities, walking path, and turf to the edge of the waterway (Fig. 20).

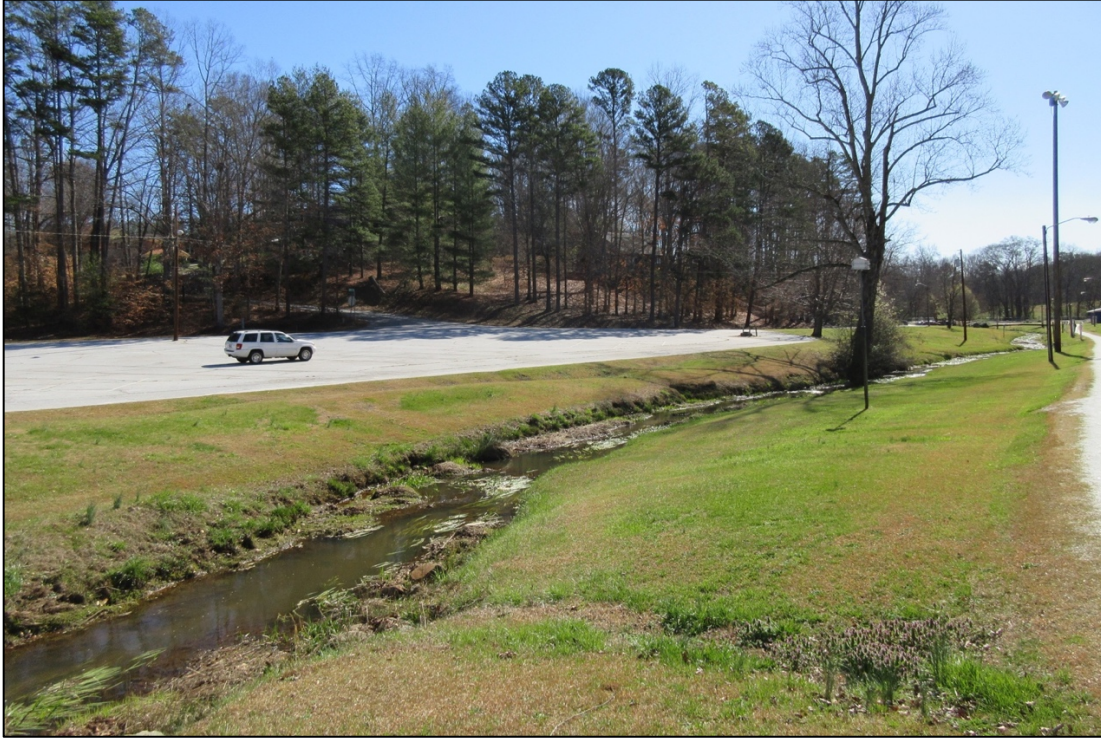
Fig. 20. Unnamed tributary to Cane Creek is managed with mowed turf to the edge of the waterway, with little shading, and excessive growth of aquatic vegetation.

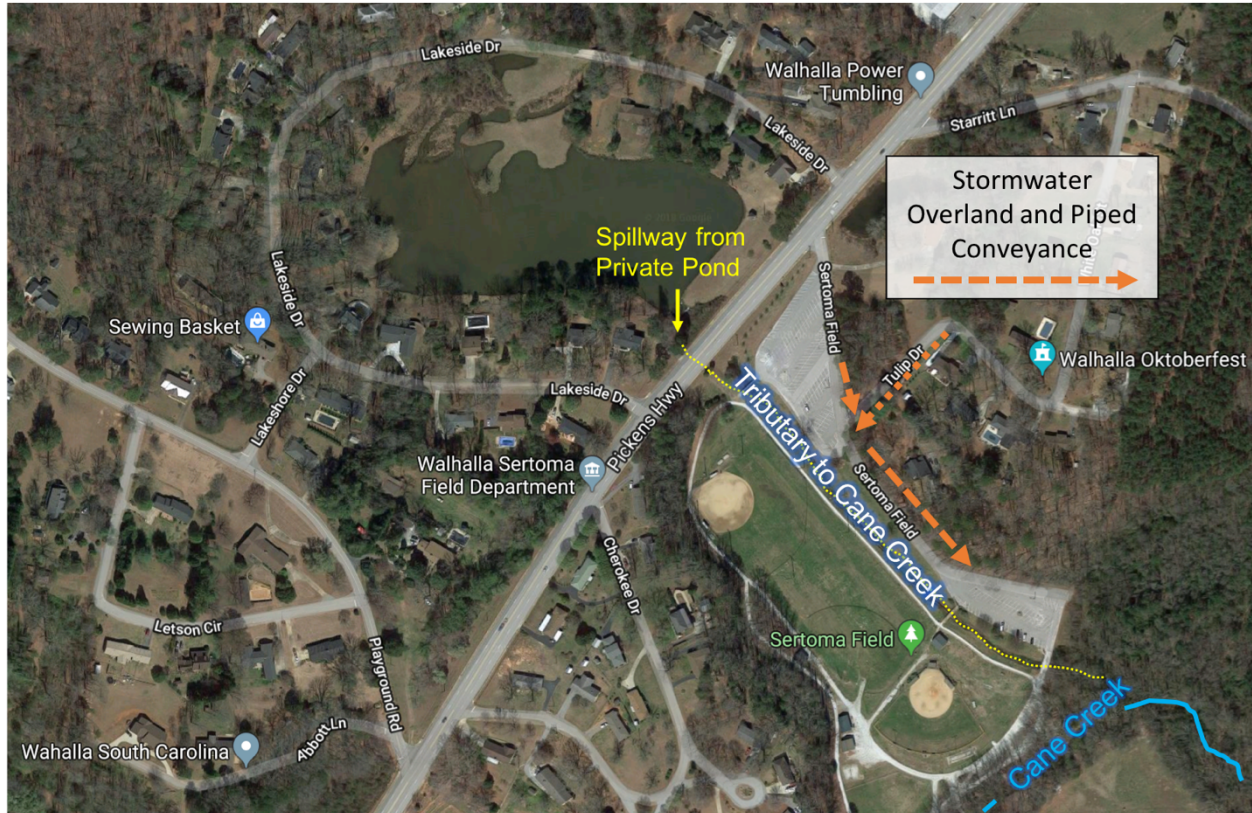
Fig. 21. Sertoma Field and conveyances of runoff and pond input to Cane Creek.

Across the parking lot, a relatively small neighborhood lies uphill, with an access road perpendicular to the park road (Fig. 21). Stormwater infrastructure has been observed as buried under sediment and covered with debris. There is little evidence of maintenance, and stormwater likely bypasses the pipe to flow over land and asphalt to the unnamed tributary and Cane Creek, which flows along the outer perimeter of the park. Residential stormwater can transport fecal bacteria from domestic and feral animals, trash containers, ruminants, wildlife, and septic system leachate.

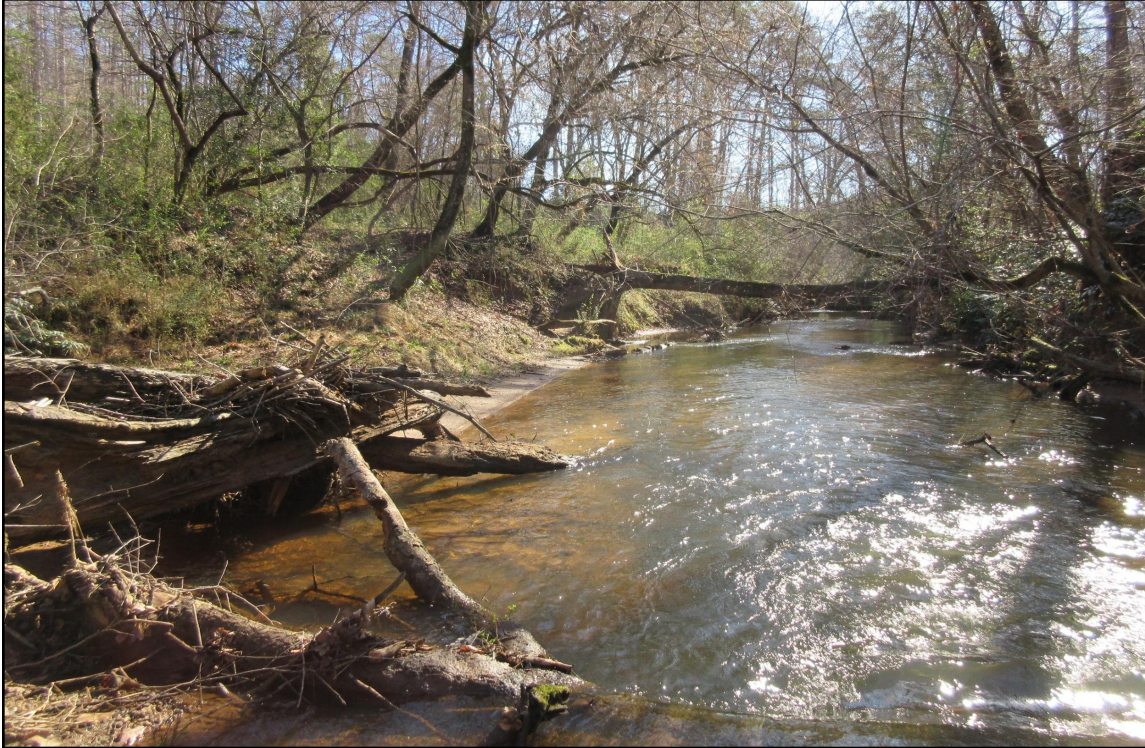
Fig. 22. A corridor of leaning and downed trees in the lower reaches of Cane Creek.

Field observations showed widespread loss of large trees in the riparian corridors of Cane and Little Cane Creeks (see Fig. 22). This was further documented in the land use change analysis that revealed 28% loss of trees within 300' of stream between 2005 and 2015. With loss of large trees, comes streambank failure and streambank sediment deposition into the stream. Furthermore, the large downed trees slow stream flow and remove the natural flushing mechanism that occurs naturally during large storm events.

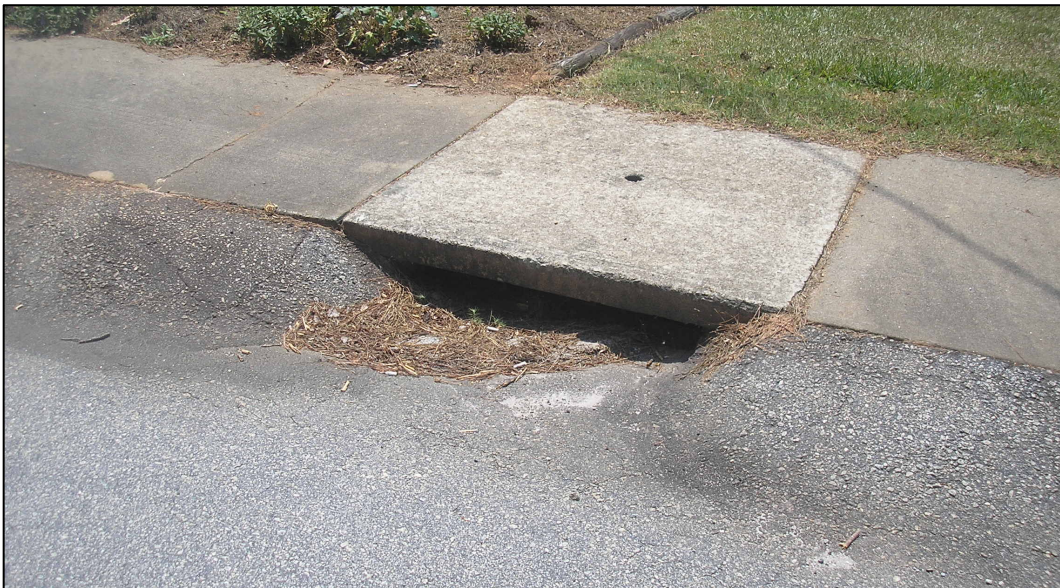
Fig. 25. Catch basin with landscape and natural debris in the basin.

The catch basins within the Cane Creek Watershed are predominantly in Walhalla and all are owned by the SC Department of Transportation (SC DOT). The city currently does not have capacity to vacuum or maintain the interior of these chambers, nor the ownership to do so. It would be an improvement to the quality of receiving waters for annual maintenance to occur, or a schedule developed suitable for the needs of downtown.

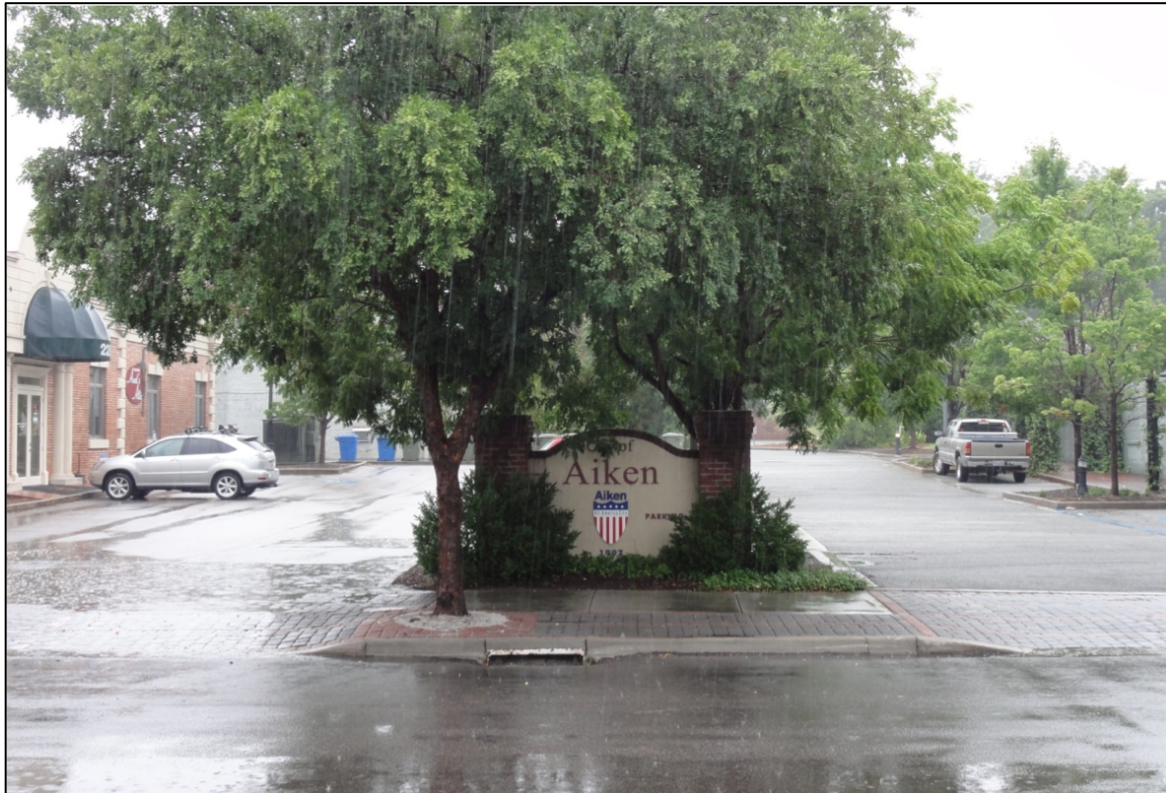
Fig. 28. This image from Aiken, SC demonstrates the ability of a porous asphalt road (right) to quickly infiltrate rain water, in comparison to standard asphalt (left) showing puddles (Source: Calvin Sawyer, Ph.D., Clemson University).

While the porous asphalt is being installed, stormwater infrastructure should be eliminated along the parking lot and collected from Tulip Drive, which is perpendicular to the park road. With the porous asphalt in place, this stormwater will be more effectively treated than traditional pipe collection (Fig. 28).
