# Watershed Plan for Sediment in the North Saluda River and Saluda Lake

December 2018

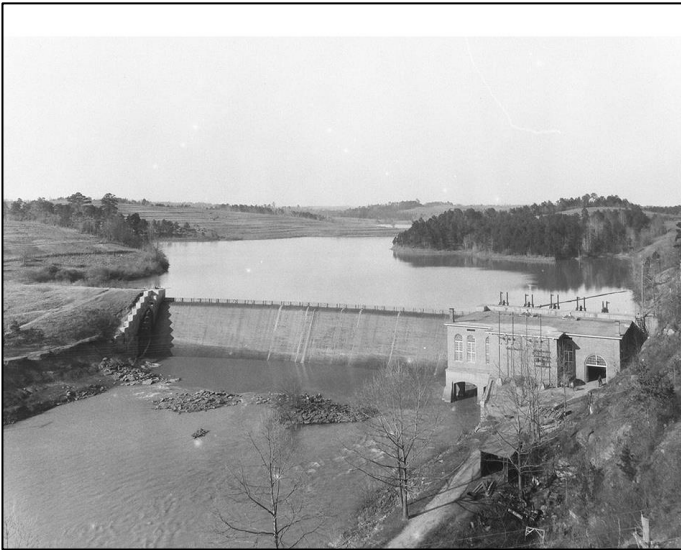
Photo 3. Historic Photo of Saluda Lake Dam

Saluda Lake is the primary source of water for the greater Easley area. Easley Combined Utilities (ECU) supplies drinking water to approximately 13,000 direct customers in Pickens and Greenville Counties and provides wholesale drinking water to four water districts, serving a total population of approximately 80,000 to 100,00 people in Pickens and Anderson Counties. The dam on the Saluda Lake generates hydropower (Photo 3 and Photo4).

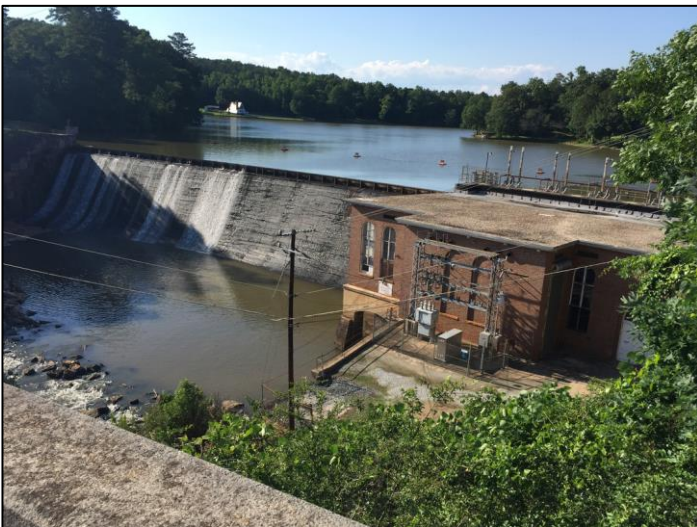
Photo 4. Saluda Lake Dam (2017)

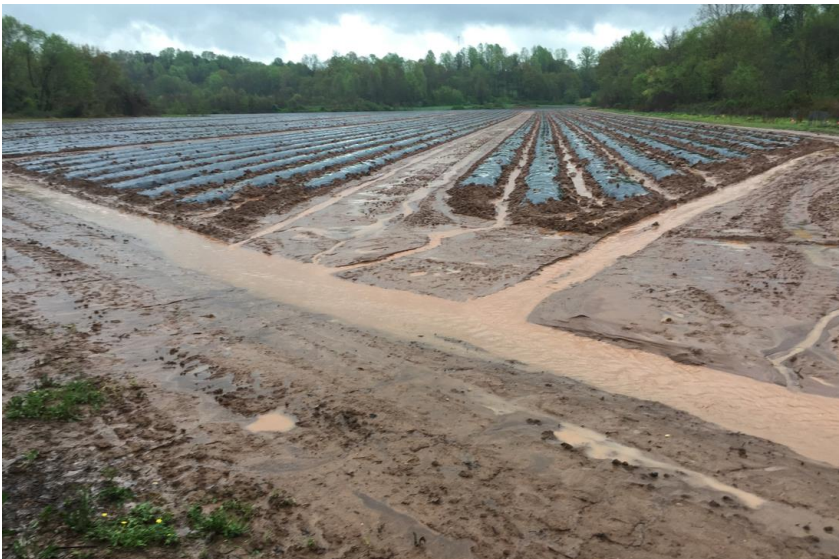
**Photo 8. Runoff from Intensively Managed Row Crop Field Adjacent to the North Saluda River**

Sediment loading from croplands in the North Saluda River – Saluda Lake Watershed, particularly in floodplain areas, is mostly attributed to frequent soil disturbance and poorly stabilized soils that easily erode into nearby streams and rivers during storm events. Plasticulture row crops are even more susceptible to erosion since the plastic acts as an impervious surface that decreases overall infiltration and increases stormwater runoff (Photo 8. Runoff from Intensively Managed Row Crop Field Adjacent to the North Saluda River Other crops with less intensive management such as soybeans, corn and hay, are less susceptible to increased runoff and soil loss.

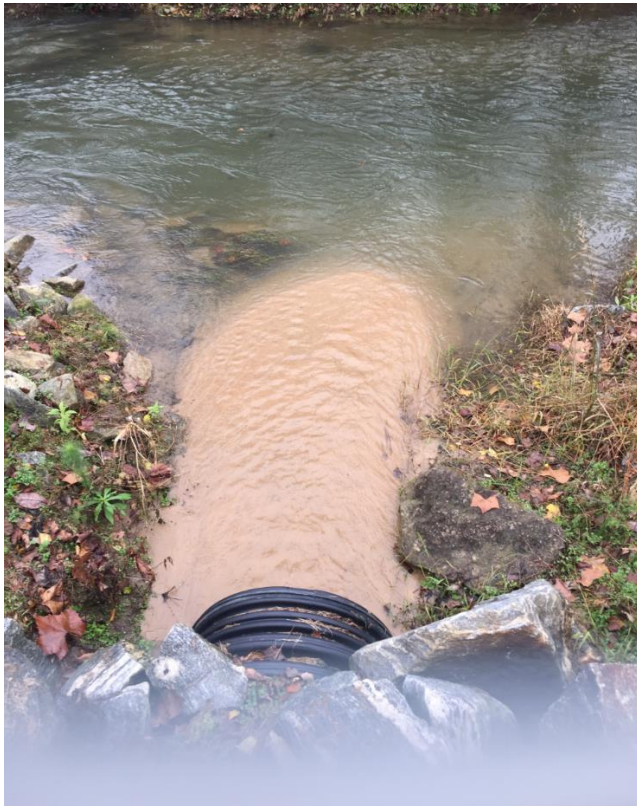
**Photo 9. Sediment discharge to the North Saluda River from floodplain croplands**

A brainstorming session for agricultural sources was held on April 17, 2018 to further evaluate the crop farming activities that can contribute to sediment loading, to utilize stakeholders’ knowledge of farms in the watershed, and to identify agricultural BMPs that help prevent sediment runoff. Attendees included Greenville County Soil and Water Conservation District (SWCD), Greenville NRCS; Clemson Extension, and Save Our Saluda. Agricultural sources including runoff from croplands, animal access areas, and eroding streambanks were discussed along with existing programs to address these sources. Intensively managed croplands in floodplains were identified as appropriate priority areas for restoration due to more intensive management practices and their proximity to the river. The importance of BMPs that can serve the dual purpose of improving soil health and preventing soil loss was emphasized. Cover crops were identified as an accepted and cost-effective BMP to help stabilize and improve cropland soils during the off-season. Other potential BMPs and barriers to implementation were also discussed at the agricultural brainstorm session, further detailed in Section 9.

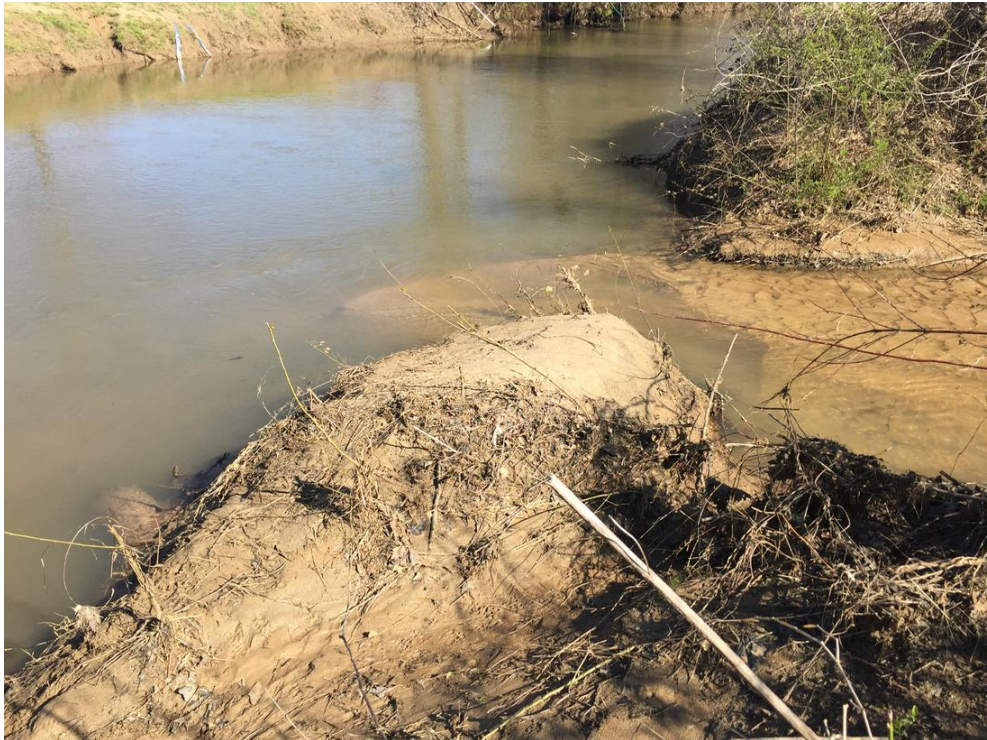
Photo 10. Sediment discharge to the North Saluda River from tributary draining rural agricultural areas

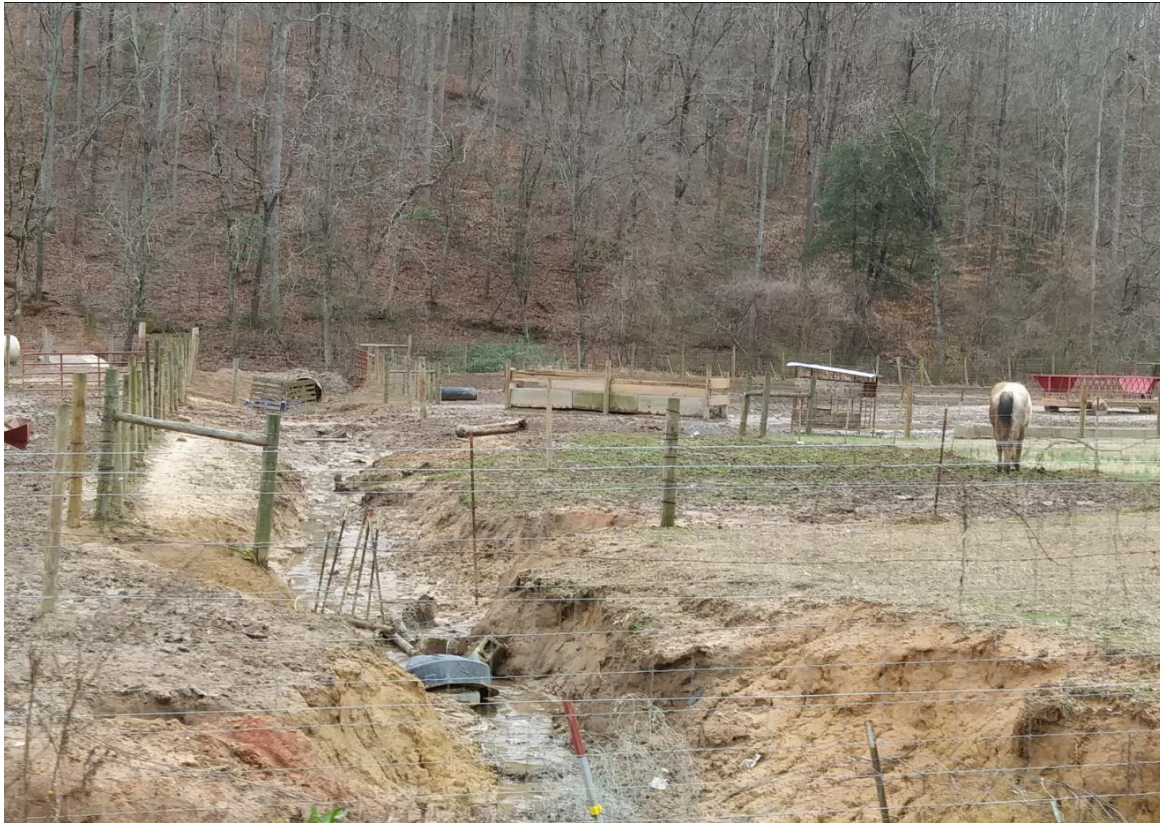
Photo 11. Poorly managed pastureland along a tributary of North Saluda River

A primary source of sediment runoff from pastures comes from trampling of streambanks as animals access streams for drinking. Livestock concentrated in smaller areas such as shaded areas, water sources, or feeding areas, often create bare soil conditions leaving such areas vulnerable to erosions. Collectively, runoff from unstabilized or poorly stabilized pastures, high traffic areas, and stream access locations can cause significant sediment loading to nearby waterbodies (Photos 11 and 12). Pasturelands currently cover approximately 6.2% of the Watershed (about 4,970 acres, Table 1).

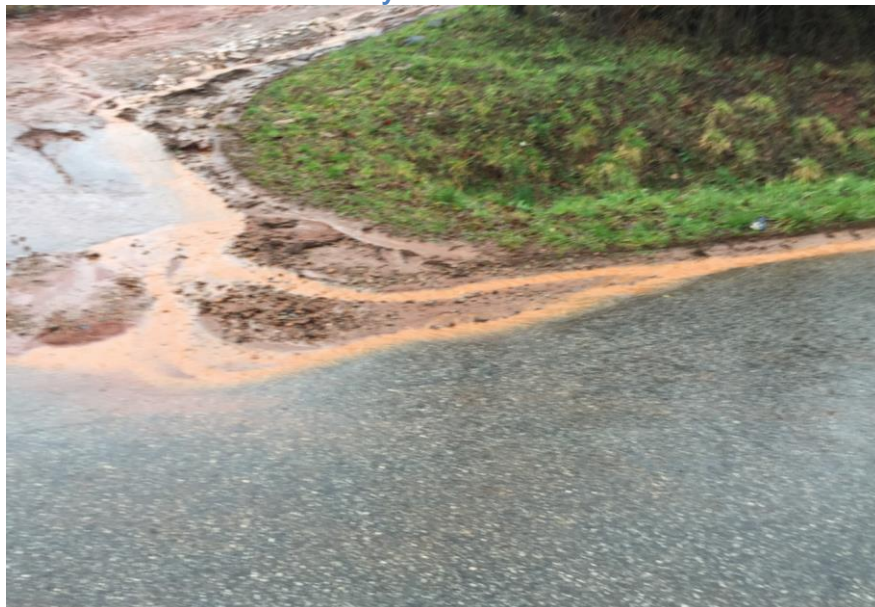
**Photo 13. Erosion from a driveway in North Saluda River – Saluda Lake Watershed**

Most of the County roads and SC Department of Transportation (DOT) roads in the Watershed are paved. There are very few dirt roads. However, there are many dirt driveways that erode and cause sediment to be transported into waterways during rain events.

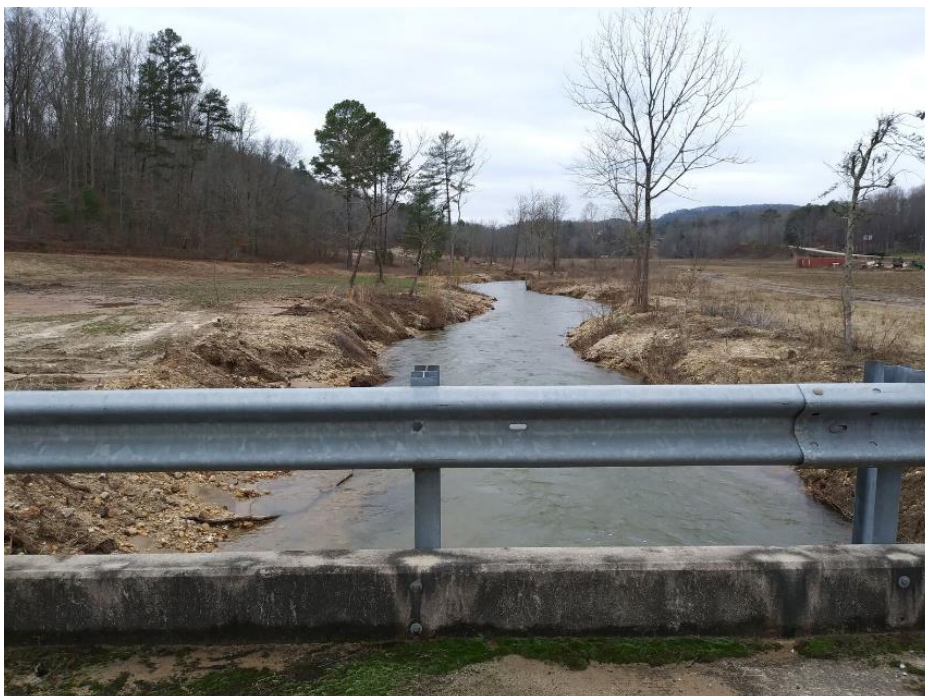
**Photo 14. Unstable streambanks and lack of riparian buffer on the North Saluda River**

Streams and rivers in southeast Piedmont areas have cut through legacy sediments leaving deep and wide stream channels with overall larger-than-historic channel capacities. Consequently, overbank flows occur less frequently now than they once did due to historic accelerated sedimentation and subsequent channel expansion (Ruhlman and Nutter, 1999). A decreased frequency of overbank flows means that sediment carried during stormflow is less often redistributed in adjacent floodplain areas. Streams and rivers in the Lower North Saluda and Doddies Creek-Saluda Lake subwatersheds have undergone similar land use and channel response patterns. Streambank instability and erosion is not uncommon along stream and river reaches in lower Piedmont regions of the Watershed, particularly on or near agricultural properties (Photos 14-16)

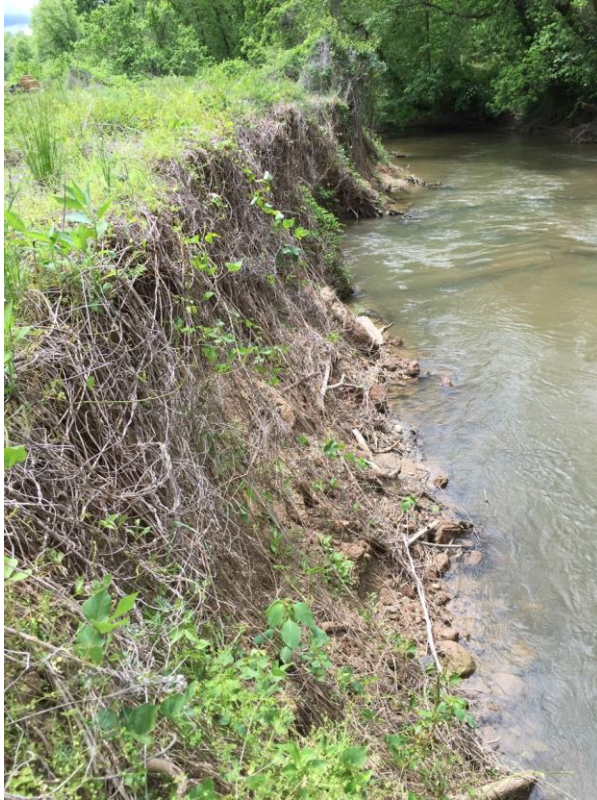
**Photo 15. Unstable, incised streambank on the North Saluda River lacking adequate riparian buffer and covered in kudzu vines**

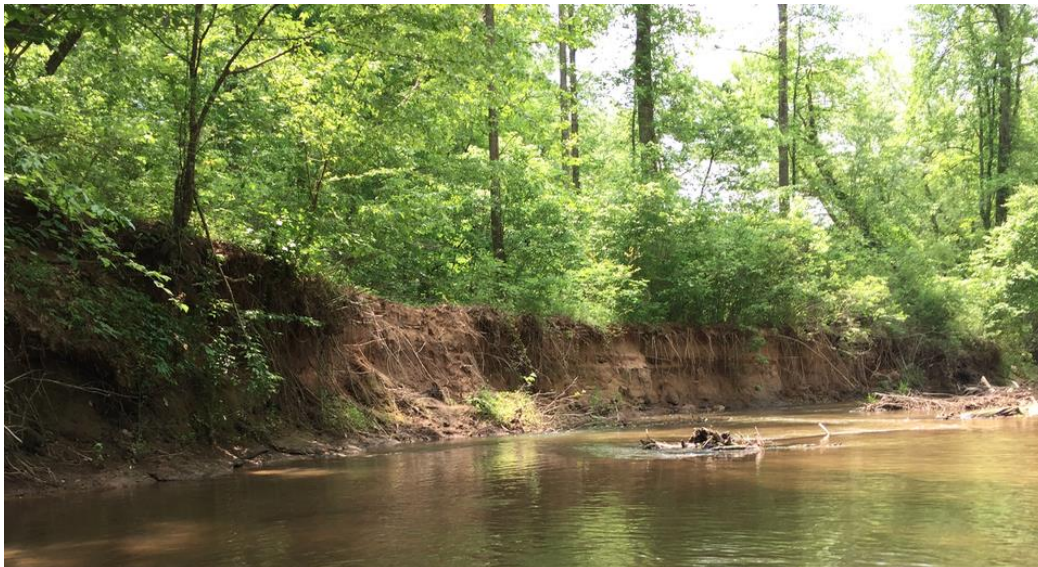
**Photo 16. Streambank erosion and channel expansion (incision and widening) on the North Saluda River**

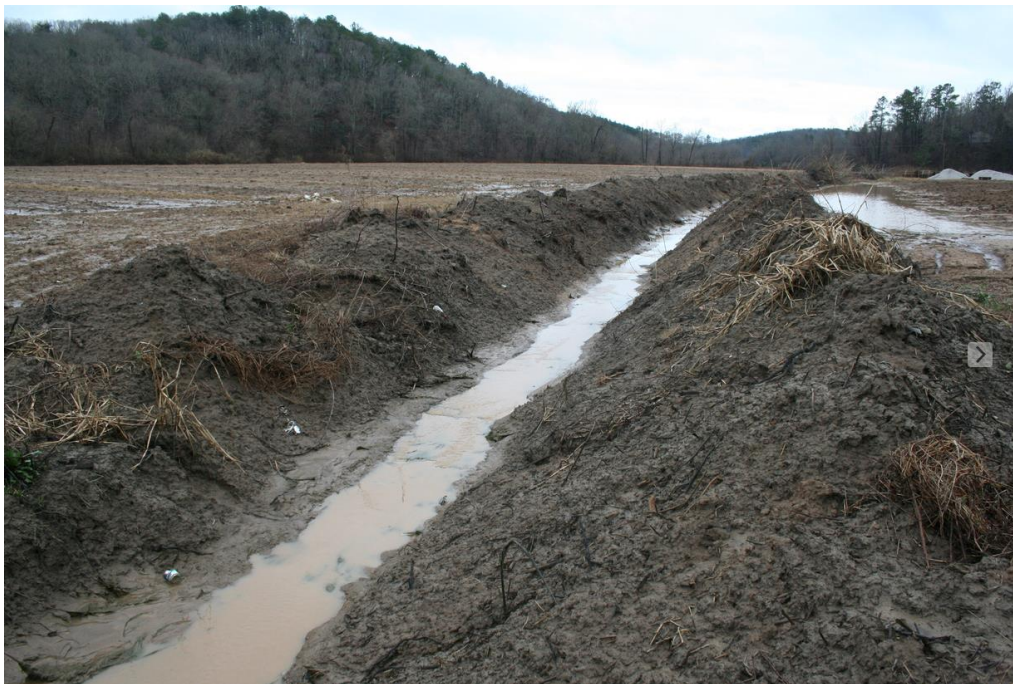
**Photo 17. Small channelized tributary stream in the North Saluda River floodplain**

Streams and rivers in agricultural floodplain areas are regularly dredged to remove sediment and to harvest sand for use in farming areas (Photos 17 and 18). While dredging itself is not a source of sediment, it affects stream dynamics and sedimentation distribution patterns in the Watershed. Dredging removes eroded soil/sediment from drainage systems; however, it can be very harmful to streams and rivers and can lead to channel instability, headcutting, increased water velocity and scour, increased stream bank erosion, elevated suspended sediment and turbidity levels, rapid downstream sediment deposition, and damage to aquatic environments. Channelization and dredging alter channel morphology and result in the disconnection of streams and rivers from adjacent floodplain systems, diminishing their ability to capture, detain, and filter floodwaters. Furthermore, continued soil loss from floodplains where crops are grown diminishes soil quality and can exacerbate drainage problems over time. BMPs to improve infiltration and minimize runoff can help reduce the need for dredging for drainage purposes.

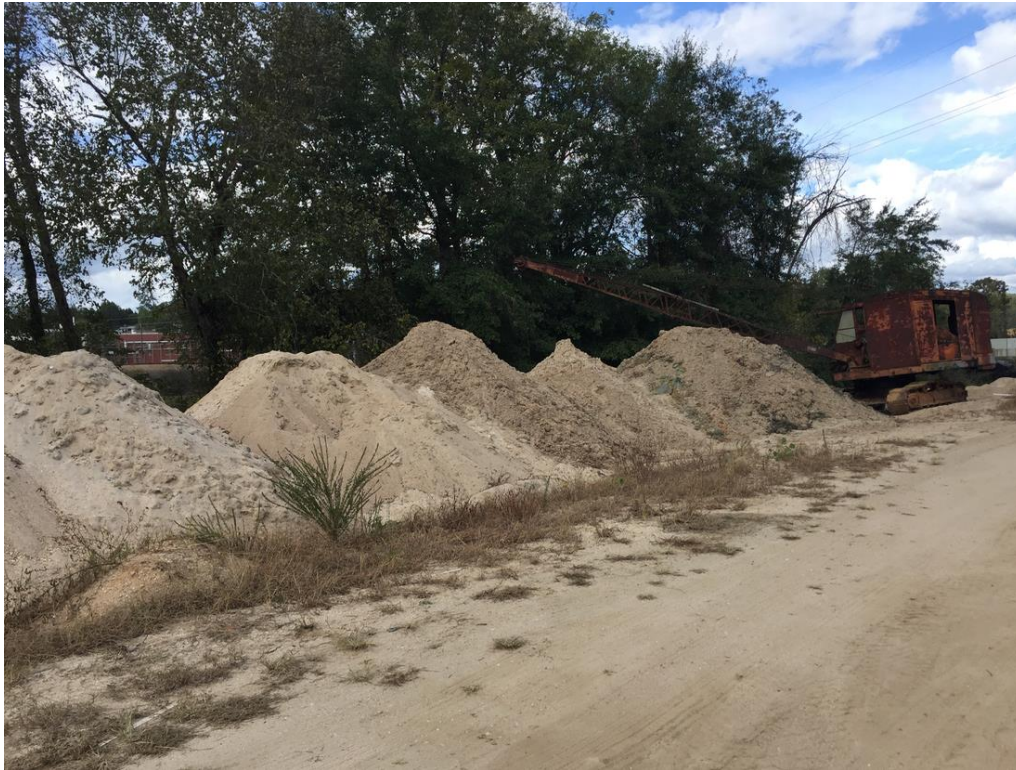
Photo 18. Dredging operation on the bank of the North Saluda River

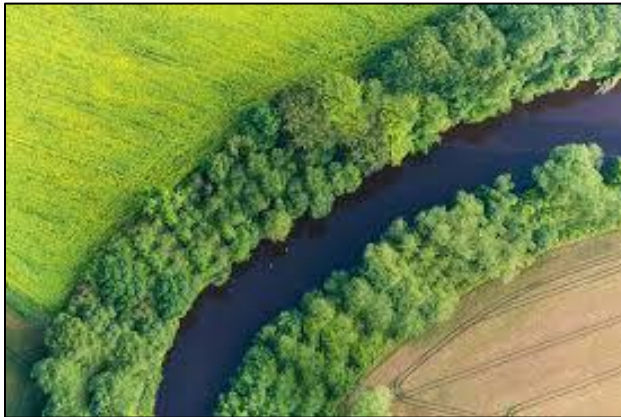
Photo 19. Crop Farm Best Management Practice - Riparian Buffer

***Riparian buffers** are vegetated areas next to streams, rivers, and wetlands that provide protection from the impacts of adjacent land uses. They can trap sediment and other pollutants thereby providing stream and water quality protection. Riparian buffers also help provide streambank stabilization, flood control, wildlife habitat and other valuable ecosystem benefits.*

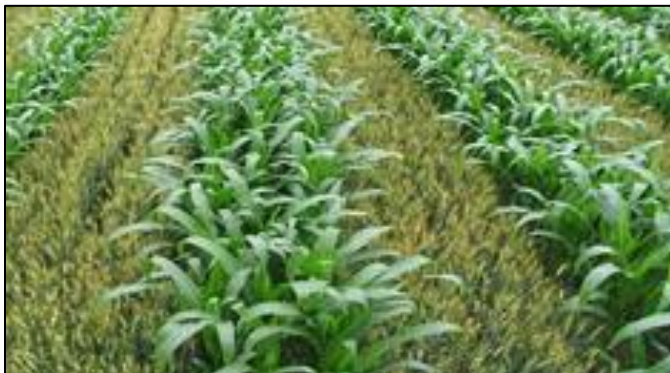
Photo 21. Crop Farm Best Management Practice – Intercropping

***Intercropping** is growing two or more crops in close proximity to each other to prevent erosion, improve soil and water quality, and provide pest management benefits.*

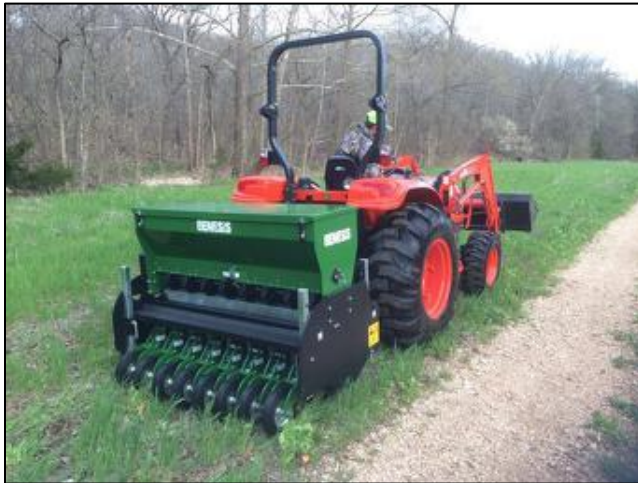
Photo 22. Crop Farm Best Management Practice – No Till Seeding

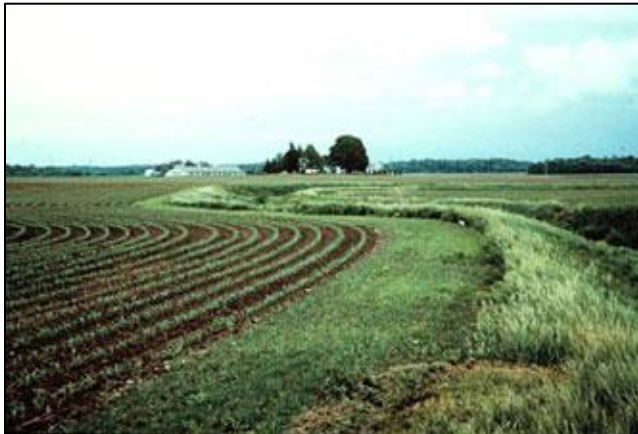
Photo 23. Crop Farm Best Management Practice – Vegetated Filter Strips

*A vegetated filter strip is a strip of herbaceous vegetation that filters runoff and removes contaminants before they reach water bodies such as streams and wetlands or water sources. They help reduce soil erosion and protect water quality, among other benefits.*

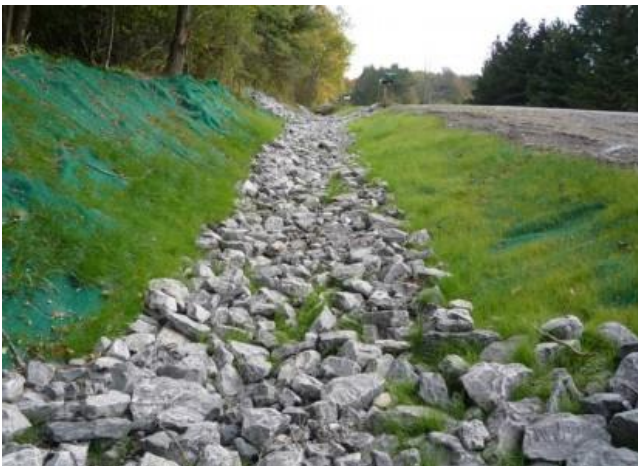
Photo 24. Crop Farm Best Management Practice – Ditch Stabilization

*Ditch stabilization involves vegetative and/or structural measures to stabilize drainage ditches and prevent erosion and sedimentation from entering downstream waterbodies.*

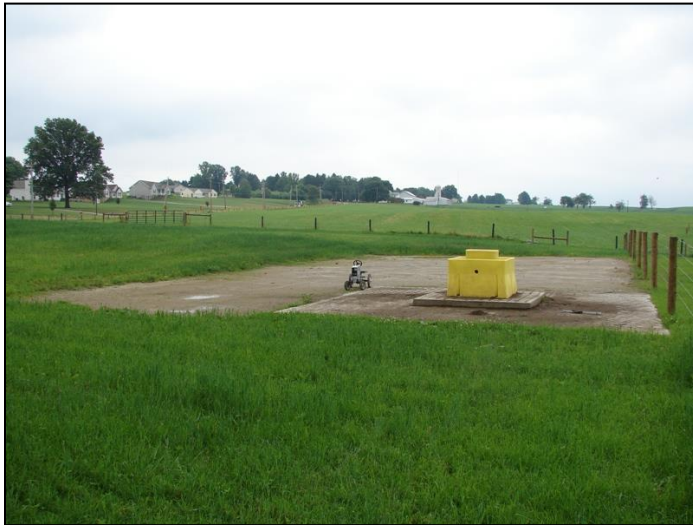
Photo 26. Livestock Farm Best Management Practice – Heavy Use Area Stabilization

*Heavy use area stabilization is the stabilization of areas frequently and intensively used by people, animals or vehicles by establishing vegetative cover, surfacing with suitable materials, and/or installing needed structures to protect or improve water quality.*

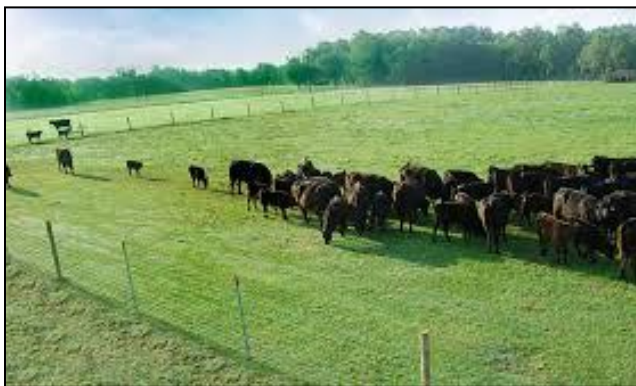
Photo 27. Livestock Farm Best Management Practice – Cross Fencing

*Cross-fencing divides an area to allow rotational grazing of animals. Rotational grazing can help control erosion and prevent sediment runoff, increase pasture yields, improve pasture quality, provide a healthier plant community, better livestock health and performance, and reduced costs to the landowner while providing pasture management flexibility.*

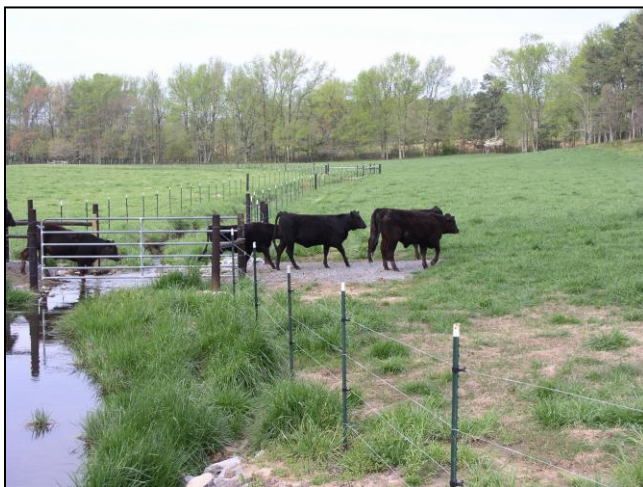
Photo 28. Livestock Farm Best Management Practice – Stream Crossings

*Stream crossings provide a hard, stable area where livestock or equipment can cross streams without damaging the streambed or banks thereby maintaining a higher riparian area/stream quality. They help keep farm water cleaner which can provide health benefits to animals and crops. Stream crossings with stream bank fencing are cost-effective BMPs that can help protect and improve water quality.*

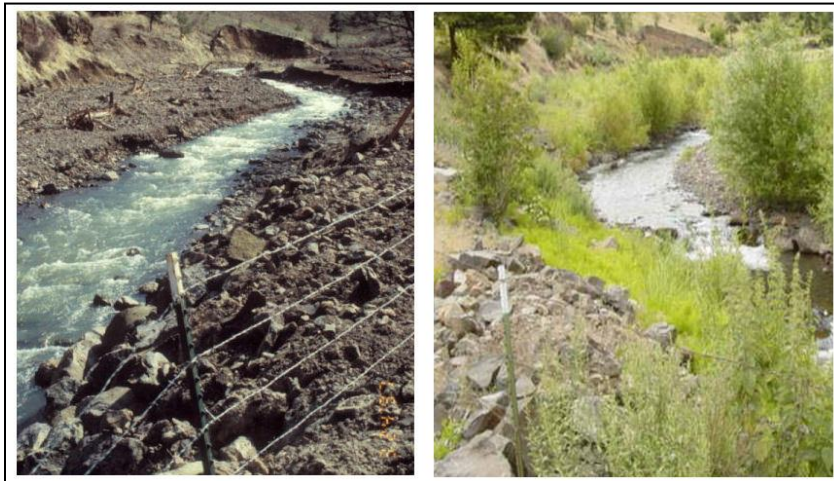
Photo 29. Crop and Livestock Farm Best Management Practice – Stream Stabilization

*Streambank stabilization refers to vegetative and/or structural treatment(s) used to stabilize and protect banks of streams, lakes or other waterbodies to prevent the loss of land and reduce the downstream effects of sediment resulting from bank erosion.*

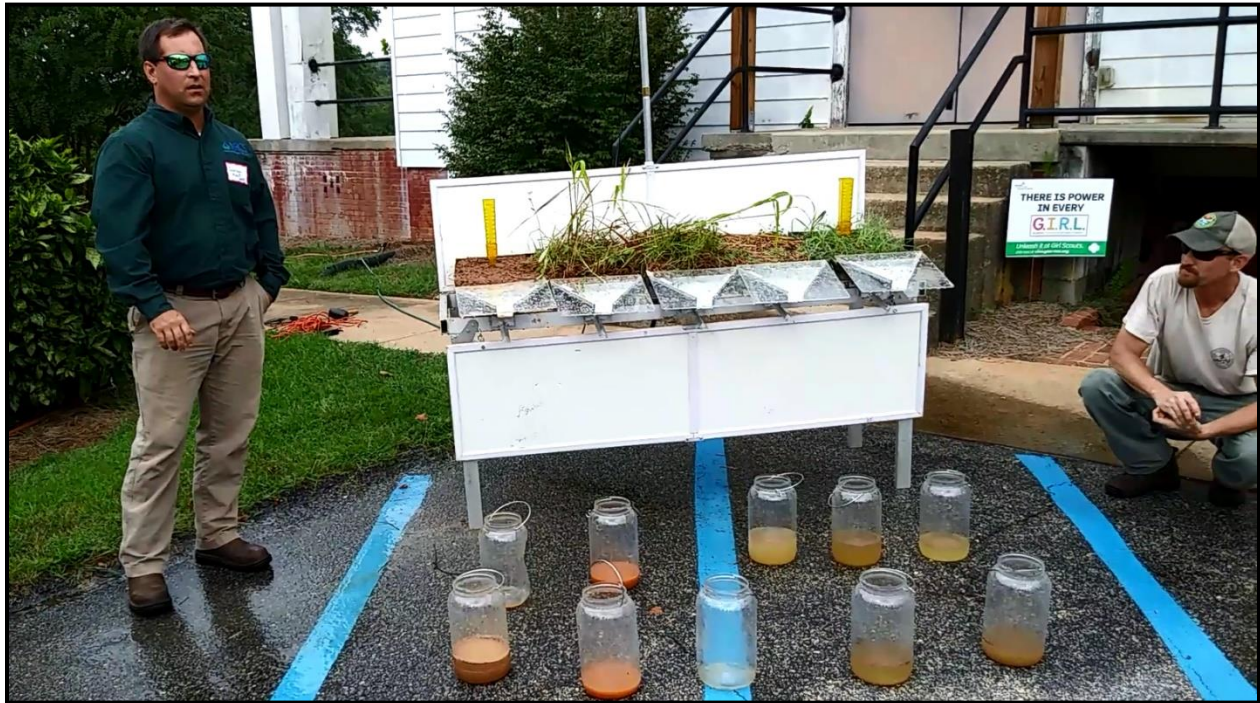
Photo 34. Rainfall Simulator Demonstration at Soil Health Workshop

A workshop entitled “Boosting Soil Health for Crop Productivity” was held on September 12, 2018 in the Watershed that focused on soil health and runoff prevention for croplands (Appendix G). The workshop included presentations from Save Our Saluda, a USDA/NRCS Conservation Agronomist, and a regional farmer who implements sustainable practices. A demonstration of a rainfall simulator on various cover crop types was given by SCDNR, with support from the South Carolina Forage and Grazing Lands Coalition.

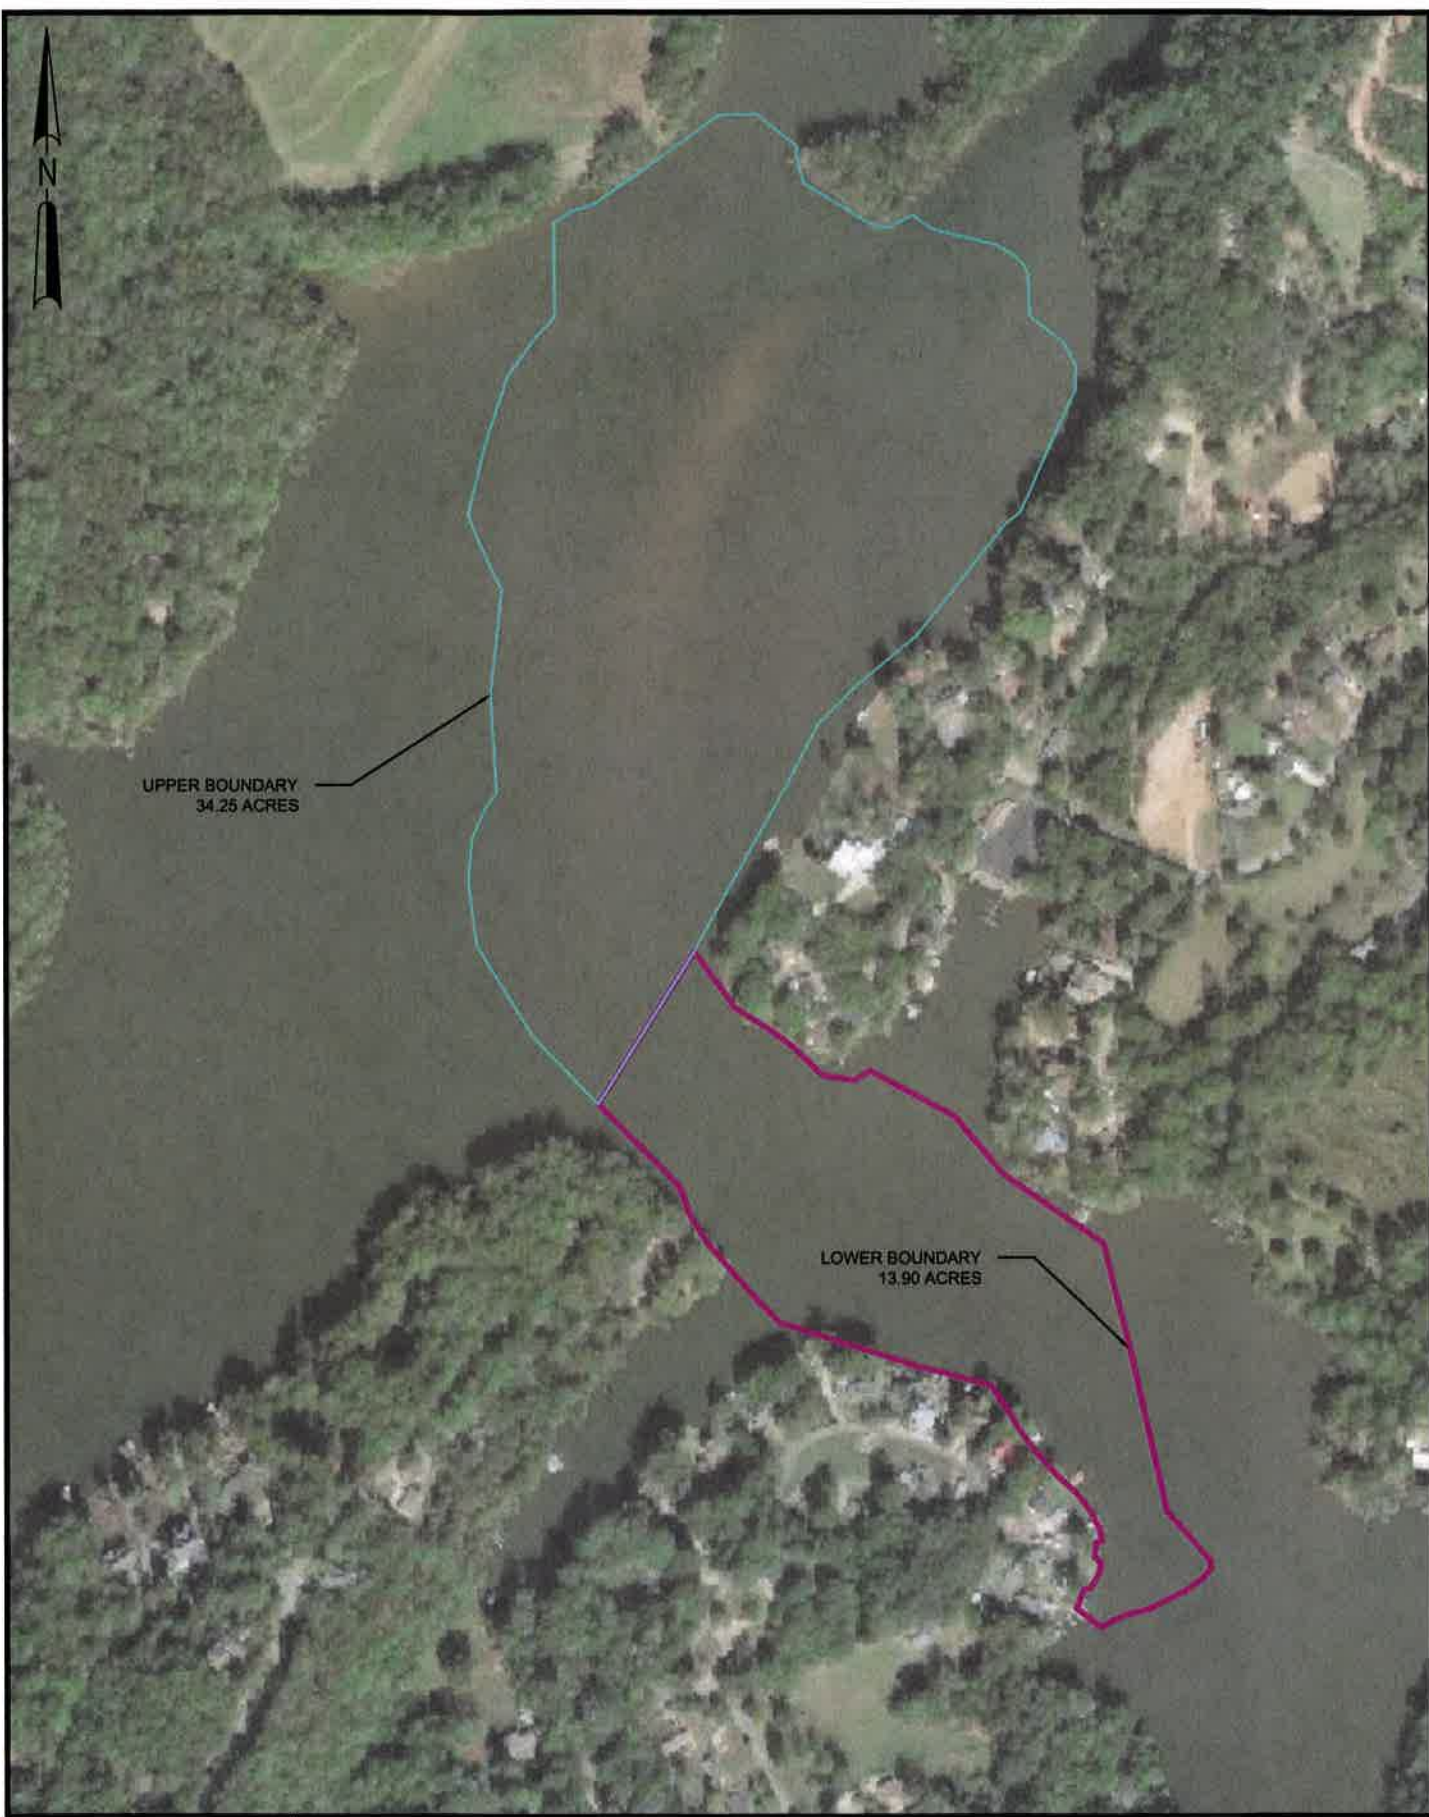
Next, a contour elevation overview map of the 2018 survey was created. The two record survey surfaces were used to create cross-section views. The cross-section view provides an instant comparison of the two surveys as both elevations are present in the same viewport. Using the surfaces created from the 2012 survey and the 2018 survey, the volume of sediment deposited since the completion of the dredging was calculated. The overview map and the cross-section lake elevations are presented in Appendix C.

UPPER BOUNDARY  
34.25 ACRES

LOWER BOUNDARY  
13.90 ACRES

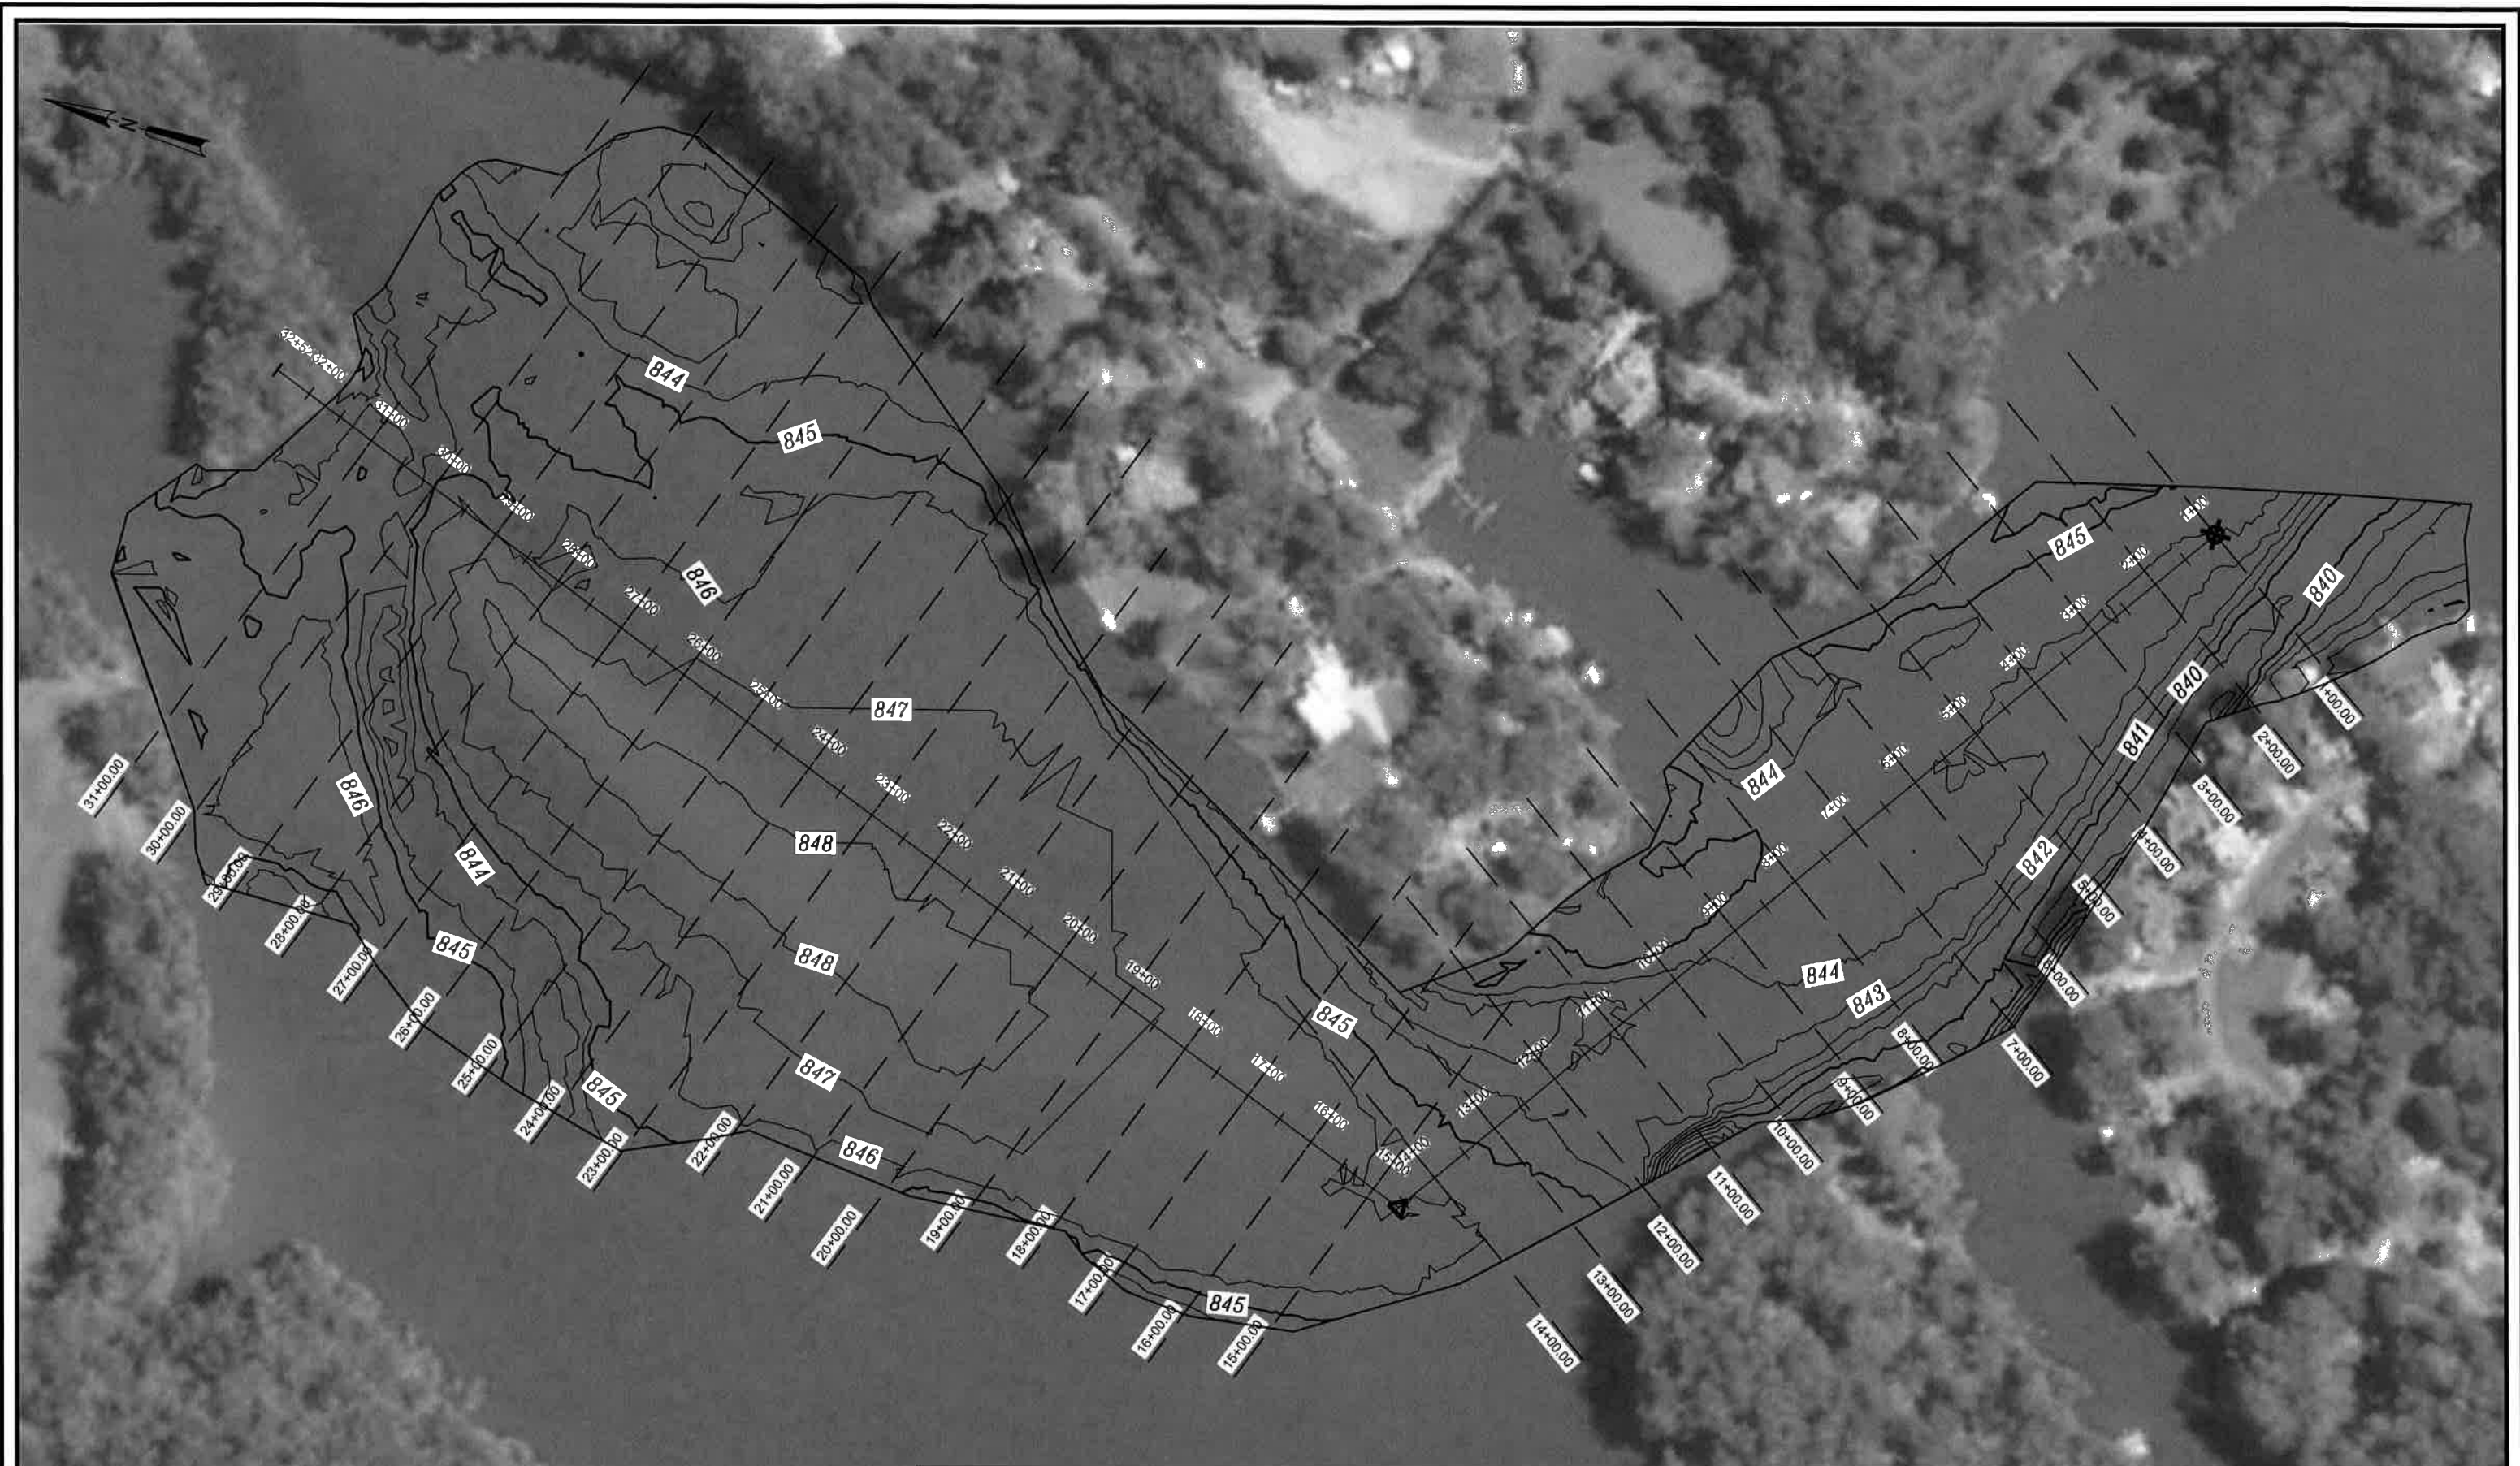
SCALE: 1" = 200'-0"	NOTE: TOPOGRAPHIC INTERVALS REFLECT 2018 SURVEY DATA

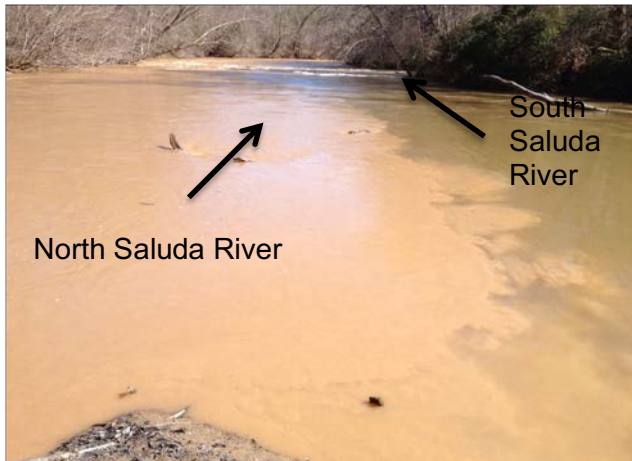
upstream is impaired, aquatic habitat is degraded, and recreation is diminished due to sedimentation, particularly in the North Saluda River (Figure 2).

**Figure 2. North-South Saluda Rivers Confluence**
