ATTACHMENT B
THE CITADEL: WAVE DISSIPATION SYSTEM – OC/SS/BWE/HI REPORT

Re: Wave Dissipation System – OC/SS/BWE/HI
Report – August 28, 2016

This report is The Citadel research team's "OCRM requested" report on the Wave Dissipation System's (WDS's) one-year study at Ocean Club/Seascape (OC/SS), Beachwood East (BWE), and Harbor Island (HI). It is important to mention upfront that the entire study and associated parameters as described in this report are not in line with how the Citadel research team envisioned the study would take place. The research team strongly believes that the fictitious constraints assigned throughout the study period made performing research unreasonable at best and impossible at worst. Had the research team been allowed to perform the research as described in meetings prior to the study and in conversations and reports during the study, a plethora of data would be available and the WDS would be optimized for the site conditions at the sites described in this report.

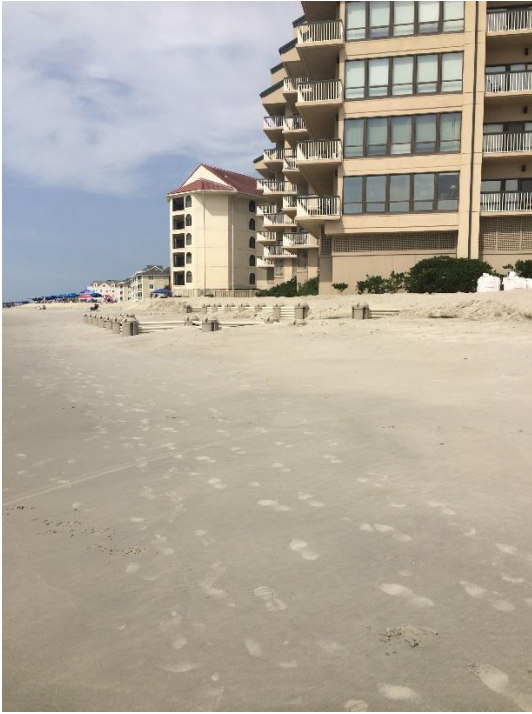
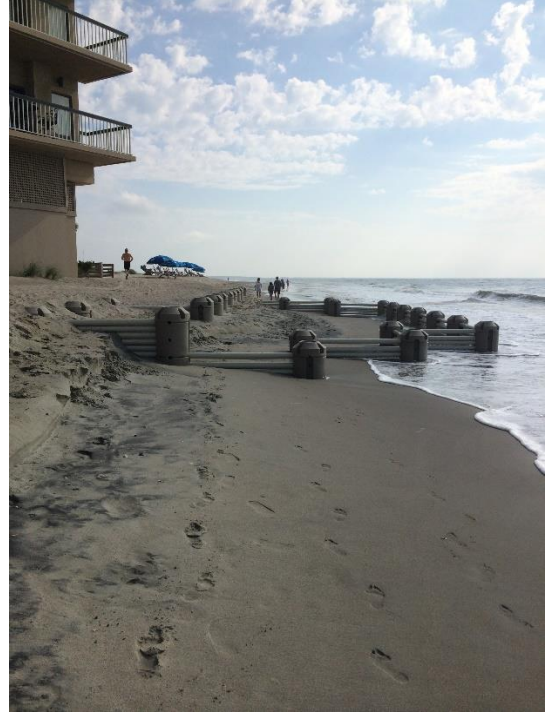
Figure 1. Wave Dissipation System near project start date (photos taken: July 9 (L) and July 19 (R), 2015).

Installation of the WDS at Ocean Club (see Figure 1) began on April 27, 2015 and continued through the end of June 2015. Although we were not happy with how long it took to install the system, it must be noted that this was the first time the system was installed by the chosen local contractor at Ocean Club and that the tolerance for pile placement is very tight given that the horizontal panels must be placed just right so that they lock into the system. The research team was very disappointed in the small number of piles the contractor was able to install per day (4 or less typical; 8-12 expected) and the precision in which they were located. Many piles were placed incorrectly and had to be reinstalled. Another challenging task was the depth to which the back line of the system was installed. The ocean had not completely lowered the back area closest to the building during the initial install and placing all the housing units back there required a construction excavation area that was challenging to work within. In fact, the contractor didn't even install the full originally proposed footprint since installing housing units and horizontal panels along some portions of the back line was deemed unsafe. On the contrary, the piles for the proposed footprint area were installed, but it was decided that the housing units and horizontal panels would be installed at a later time (after the project kickoff meeting) once the beach lowered the beach elevation in that area. OCRM was notified at the appropriate time and the remaining members were added (see Figure 2). There were also general delays by the contractor where they would have to take days off at a time for scheduling conflicts. Regarding scheduling conflicts, please keep in mind that this is a study and the permitting and approval process (although fully justified and understood) leads to scheduling uncertainty for the contractor making it difficult for them to be able to commit to full time installation services. One could argue that permitting should be done earlier, but the issue the team faces there (on a research project; not on future operations for SI Systems, LLC) is that the property owner has to agree to fund the material and installation costs prior to applications being submitted. These applications (at least for the Corps of Engineers' approval process) require detailed surveys that take additional time. By the time all steps are complete, the property owner is likely in a worse position than when they originally considered doing the study and the team is unfortunately left at the mercy of the contractor's available time.

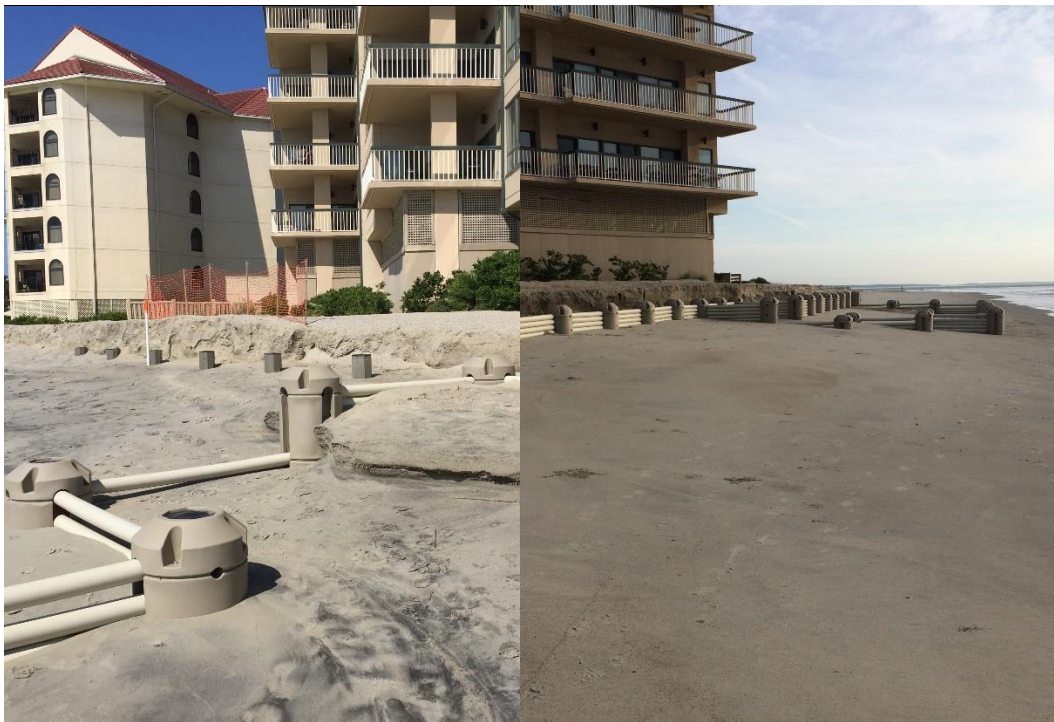
Figure 2. Wave Dissipation System prior to (8/14/15) and after (9/3/15) installation of horizontal panels in area where piles were not covered with housing units during initial construction. Note exposed piles following erosion event on left.

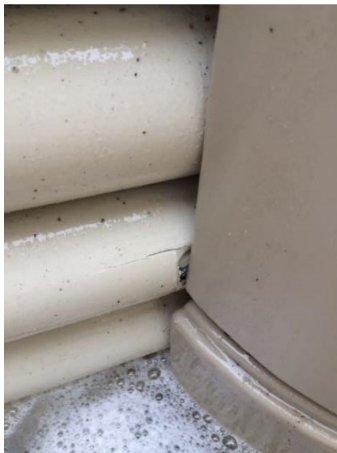
Figure 5. Cracked panel following direct wave hits associated with extreme tides.

Given the significantly larger wave impacts at OC versus those at the other research sites, the horizontal panels took a beating and the ends of the panels, where they bear on the housing units, and wear down over time. Hence the research team spent time during the third quarter trying several different spacer types made of different materials on the front line of the WDS at Ocean Club during the third quarter of the study. No structural or system changes were made in the process, but the horizontal panels were removed and reset during low tide to see if they would spin less in the slots when the spacers were built of different materials and installed differently.

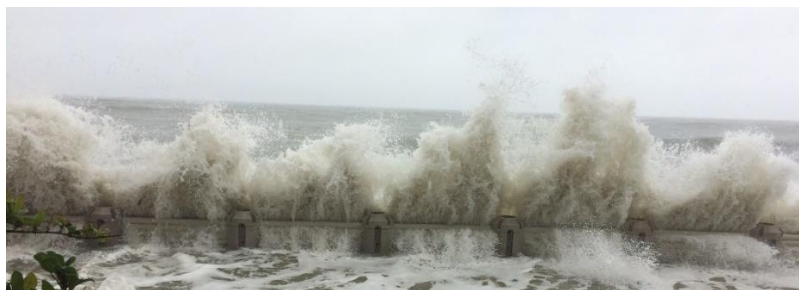
Figure 6. Breaking wave hitting area of WDS with only one line of resistance. Significant penetration is expected without controlled fill behind the WDS (see recommendations and conclusions section).

A few negative issues were discovered during the initial portion (1st quarter) of the study. Issue number one was that The Citadel research team and SI Systems, LLC did not, amongst themselves, appropriately communicate the need for the coupling reinforcement (discussed in the Seascope studies of 2013-2014) for all horizontal panels in the project. The Citadel position was that all WDS panels that would see direct hits from breaking waves would need this reinforcement. SI Systems, LLC only placed the coupling reinforcement in the front wall under the assumption that the back wall would not be hit directly by breaking waves but by the run up after the breaking wave (i.e., by broken waves). The back wall was hit by breaking waves and a few panels cracked during the study (at the ends as expected and as discussed in the Seascope studies of 2013-2014). This failure mechanism was listed during the first study as the theoretical controlling mechanism for the panels when couplings were not added. Figure 5 shows one cracked panel. Figure 6 shows the back line receiving breaking wave demands.

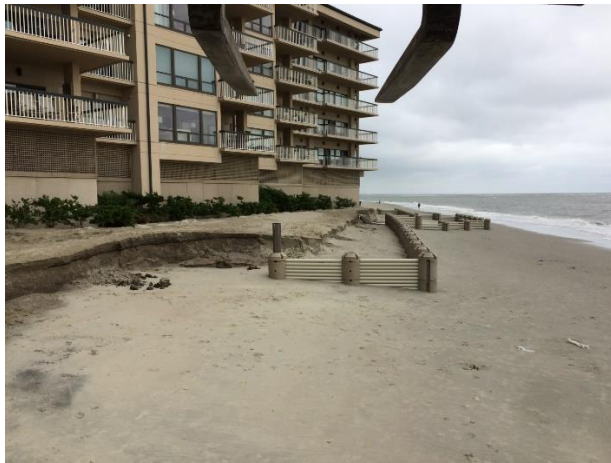
Figure 7. Advancing scarp adjacent to WDS and insufficient return of WDS (9/23/15). This figure shows how the WDS is intended to work where the scarp line behind the system is reduced relative to the adjacent property. Had the third tier as proposed been provided prior to this figure, the scarp line at the building corner would have been further from the building.

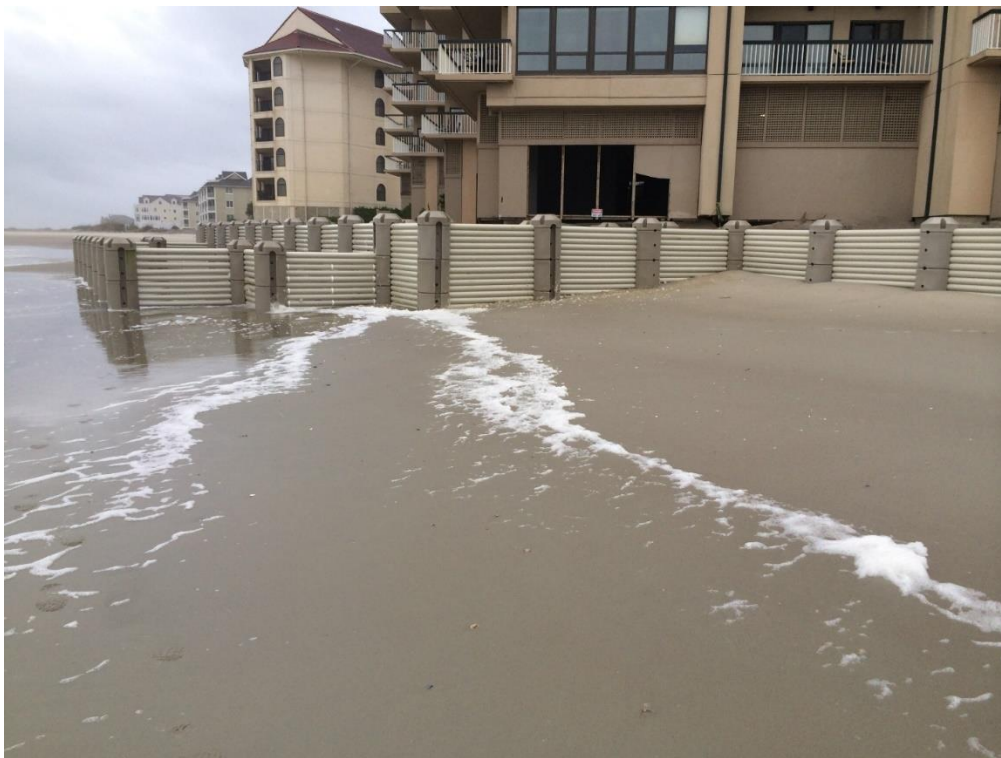
Figure 8. 2nd quarter configuration on site (with all proposed modifications except full extension to the property line as necessitated by the lowering beach; photo taken: 11/19/15).

Figure 8 shows the completed WDS installation on site as of 11/19/15. Note that the third tier (2nd line of resistance in picture was added as shown in Figure 9). The system was also extended closer to the property line relative to the 1st quarter of the study.

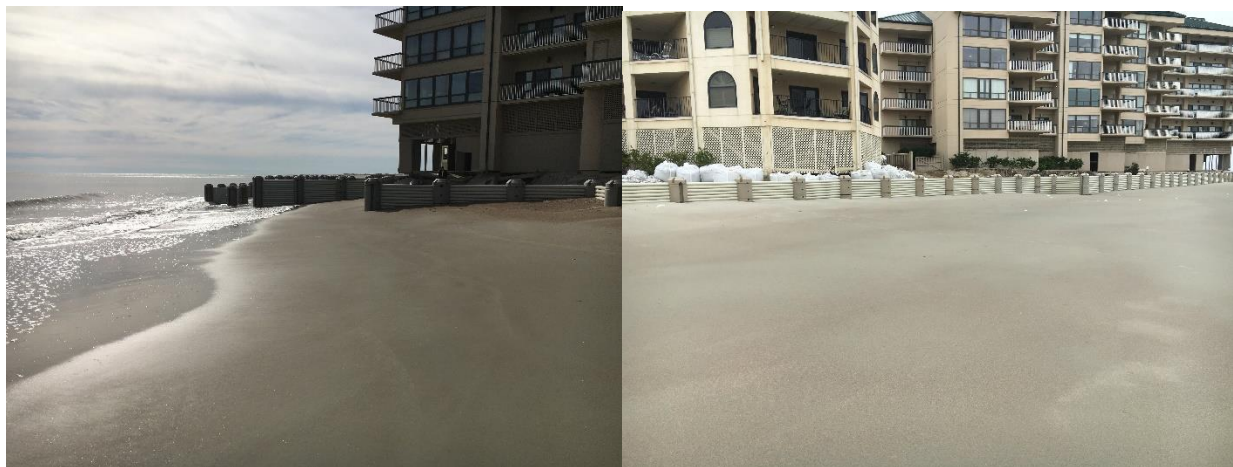
Figure 10. OC north extension (1-14-16) and Seascape during installation yet prior to 3rd tier completion (1-9-16).

Ocean club was extended closer to the property line and the Seascape system was installed during third quarter as well. Construction (in two phases) began on December 1, 2015 and ended on February 3, 2015 (see Figure 10).

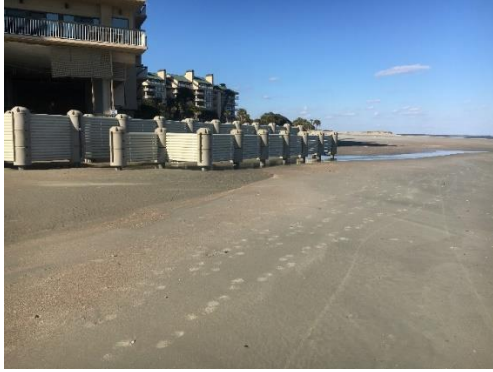
Figure 12. Severe beach lowering at OC prior to pile lowering (picture taken 2/25/16).

During the 4th quarter of the study, The Citadel recommended a 2 ft reset of many piles downward as the beach had reached its most severe lowering to date (see Figure 12). Although the system is extremely self-healing after significant erosion events (see Figure 13), around mid-April 2016 and mid-May 2016 the piles in the row closest to the ocean in front of the building and much of the entire back row (around the building corner) were lowered 2 ft to improve performance. The back row piles were also spliced using a bolted pile segment with new housing units to keep the top of the pile near its originally installed elevation (see Figure 14). The bolted pile segments performed optimally for the remaining portion of the study period discussed in this report.

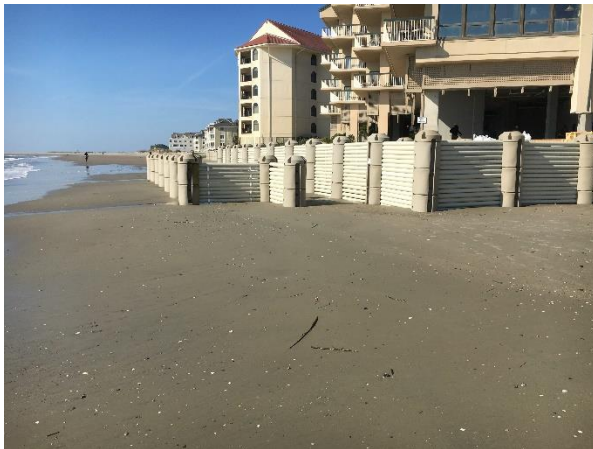
Figure 13. Self-healing of WDS (picture taken 3/7/16).

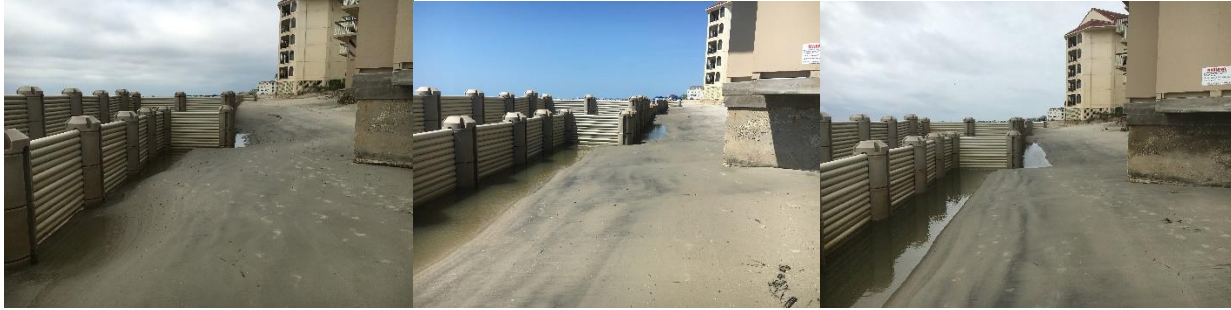
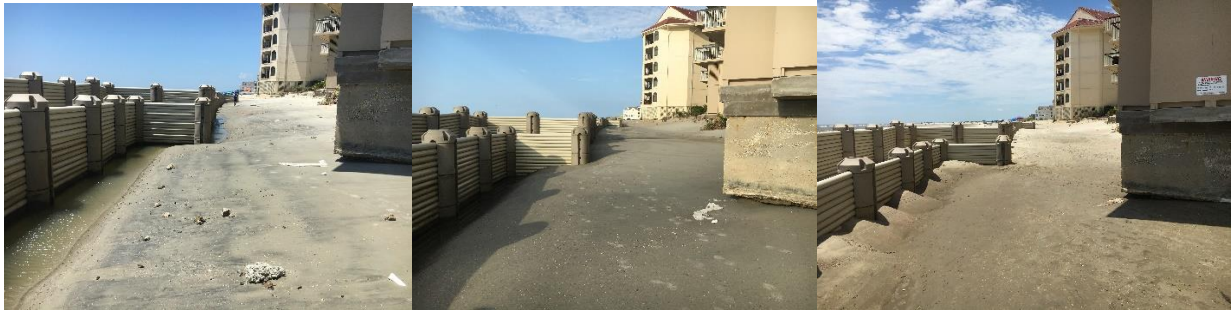
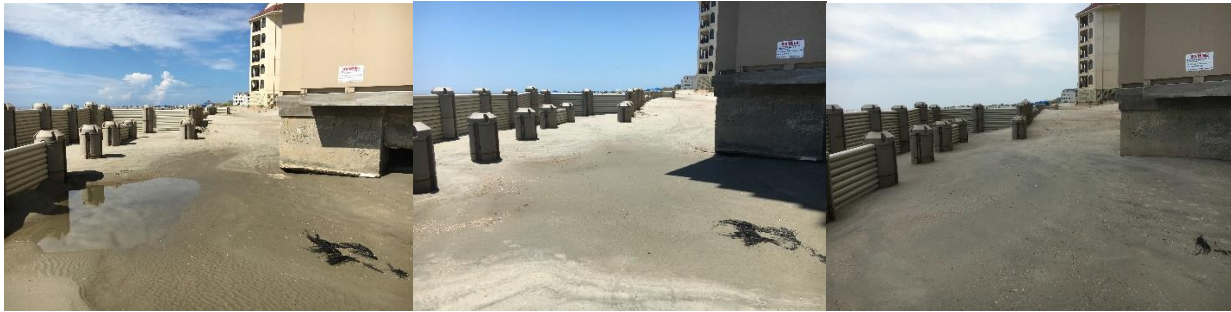
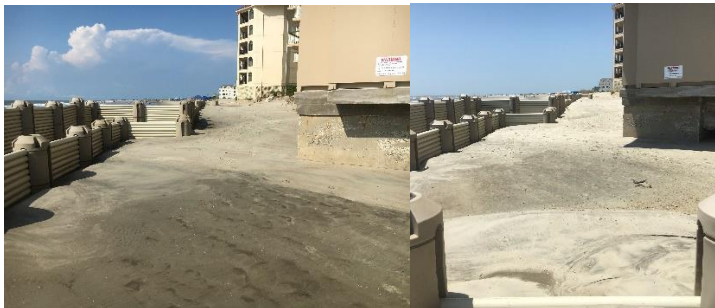
Figure 15. WDS self-healing and accretion following severe erosion event with trenching at WDS line.

As a final note regarding the WDS at OC, just to show how the system performs over a monthly cycle, Figure 15 presents 11 pictures taken over a one and one-half month period where significant erosion, self-healing, and accretion can be clearly seen. If The Citadel had not received the letter stating the study must end on July 28, 2016, they would have recommended dune rebuilding given the huge amount of accreted sand flowing on the test site at that time (similar to BWE recommendation made in December 2015 which was denied by OCRM).

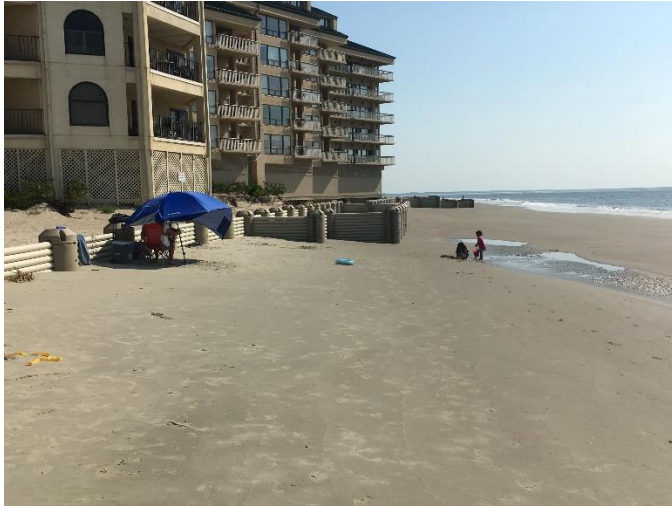
Figure 16. Typical Seascapes performance during study (picture taken 6/3/16).

Throughout the entire study, The Citadel research team was very happy with the WDS performance as installed *without modification* at Seascapes. Figure 16 shows the typical condition of the WDS on site and Figure 17 shows the significant accretion on site at the end of July 2016.

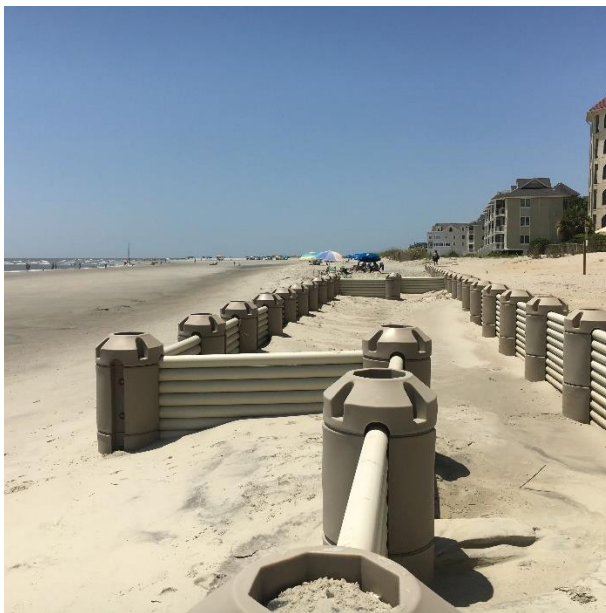
Figure 17. Seascapes performance at end of July 2016 (picture taken 7/30/16). Note significant accretion.

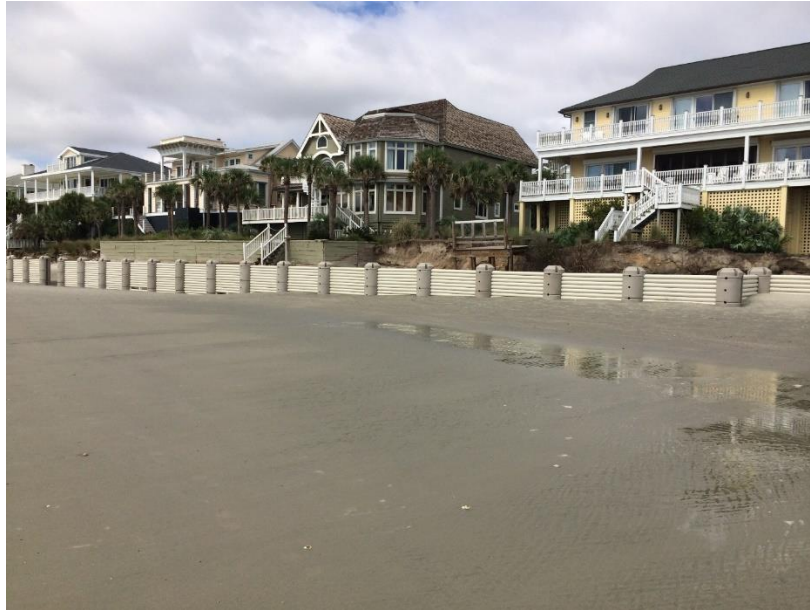
Figure 18. Wave Dissipation System at Beachwood East (10/11/15).

Installation of the WDS at Beachwood East (see Figure 18) began on July 28, 2015 and continued through October 20, 2015. We were not happy with the required installation time which was extended as a result of the overall length of the system, coordination with an existing illegal revetment on the project site, working between tides in a relatively low lying area, overall scheduling with the available contractor, and most importantly, issues with the installation which included an improper elevation at the south end and a lack of openings in the housing units to allow them to fill with sand and water.

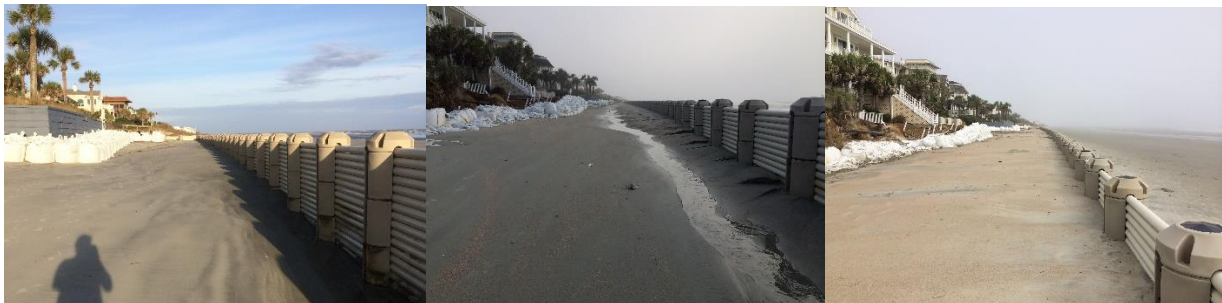
Figure 21. Significant accretion through the WDS during the 2nd quarter. The figures from left to right are dated 11-30-15, 12-8-15, and 12-24-15.

Noticing the enormous level of accretion (as shown in Figure 21) and the research team forecast for several more weeks of accretion, Dr. Mays acted quickly and notified OCRM that the team wanted to test (as shown clearly during the previous Seascape study) that the sand accreting behind the system could be pushed back to allow the homeowners to reclaim the sand they lost from the 1,000 year event, to rebuild the dune to its initial configuration prior to the 1,000 year event, and to allow the removal of sandbags (which served no purpose) that the homeowners bought as added protection after the 1,000 year event damage to their property. It seemed like a perfect win-win for the research team and the community. However, OCRM did not allow the research team to prove that it could function in this capacity. This was disappointing since it is very important to prove that the system can perform as advertised.

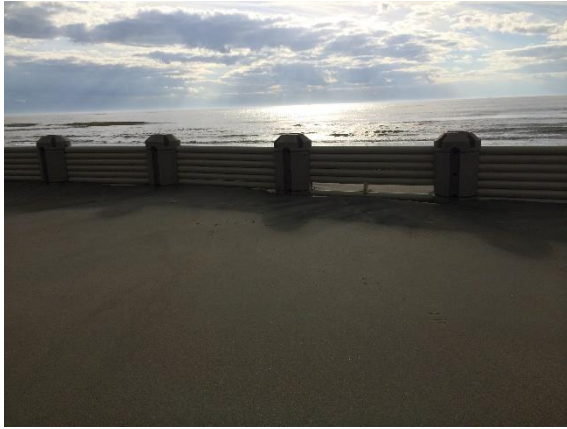
Figure 22. Typical opening used as Beachwood East.

During the first two weeks of the 2nd quarter, the team quickly discovered that closing all of the slots was causing the trench to quickly subside. A period of massive accretion in front of and behind the system then began and the team quickly provided slots and removed select panel locations for three days to more quickly expedite the accretion behind the wall (see Figure 21). The lightweight, dynamic components making up the system allowed for this action. All slots and openings were then closed to slow the release of the accreted sand. The slots were 4 inches high and placed in every 10th panel (on average) over part of the system length. The slots were placed at or above grade (see Figure 22).

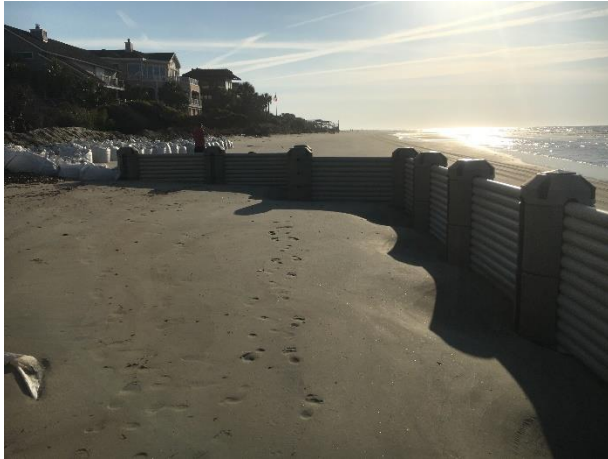
Figure 23. Sandbag extension on north end to allow for access to sandbags behind the WDS and provide closure to sea turtle access.

With the trenching issue unresolved due to permission denied by OCRM for the vertical panel installation study (which would have been extremely economical) and funding not available to do one of two larger secondary Citadel recommendations which included either lowering the entire system (very expensive) or adding a 2nd tier and opening up the first tier (even more expensive and similar to OCs initial installation), the research team decided to simply watch the system during the final two quarters of the study period covered in this report. The only modification applied in the final two quarters of the study was to extend the wing wall on the north end of the site during turtle season due to concerns that a sea turtle might otherwise get trapped behind the system (see Figure 23).

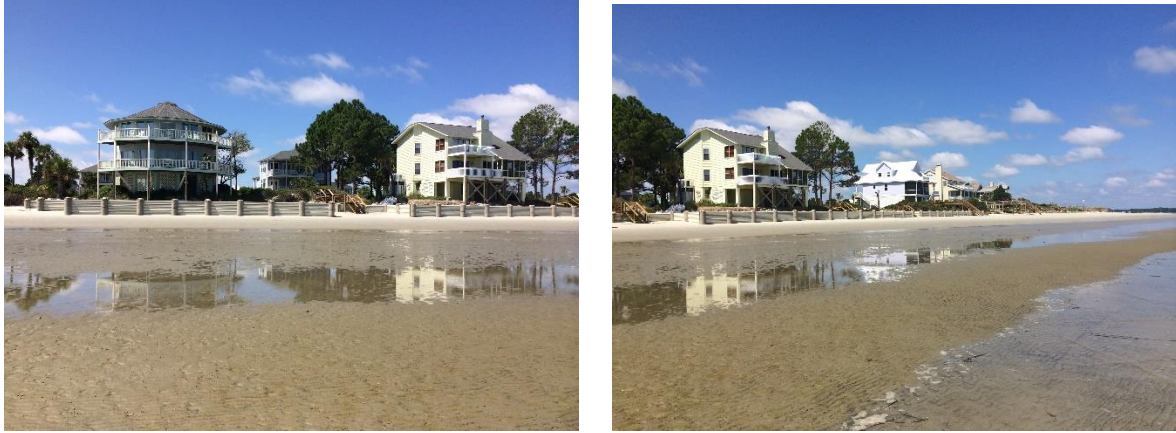
Figure 24. Wave Dissipation System near project start date (photos taken: August 8, 2015).

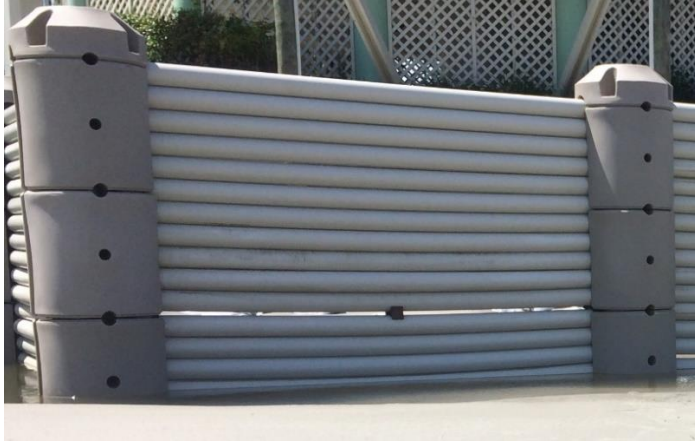
Figure 26. Close-up of typical spacer used in the study.

It was decided that the baseline WDS would have no spacers (see Figure 26) between horizontal panels at project initiation. Although at first, there was some accretion, the wave energy was not strong enough to push it more than three ft or so beyond the WDS (see Figure 27). This led to an unacceptable low space (relative to the accreted area) beyond the accreted sand. It should be noted that the horizontal panel system at Harbor Island was designed to be over two times as flexible as the one installed at Ocean Club (and Seascapes in 2013-2014). This flexibility alone did not provide adequate “breathing” of the ocean such that a more uniform distribution of accreted sand fell behind the system. For that reason, the research team added some trial spacers to encourage more natural sand accretion behind the system. The initial result of the added spacers was an improved distribution of sand behind the system as shown in Figure 28.

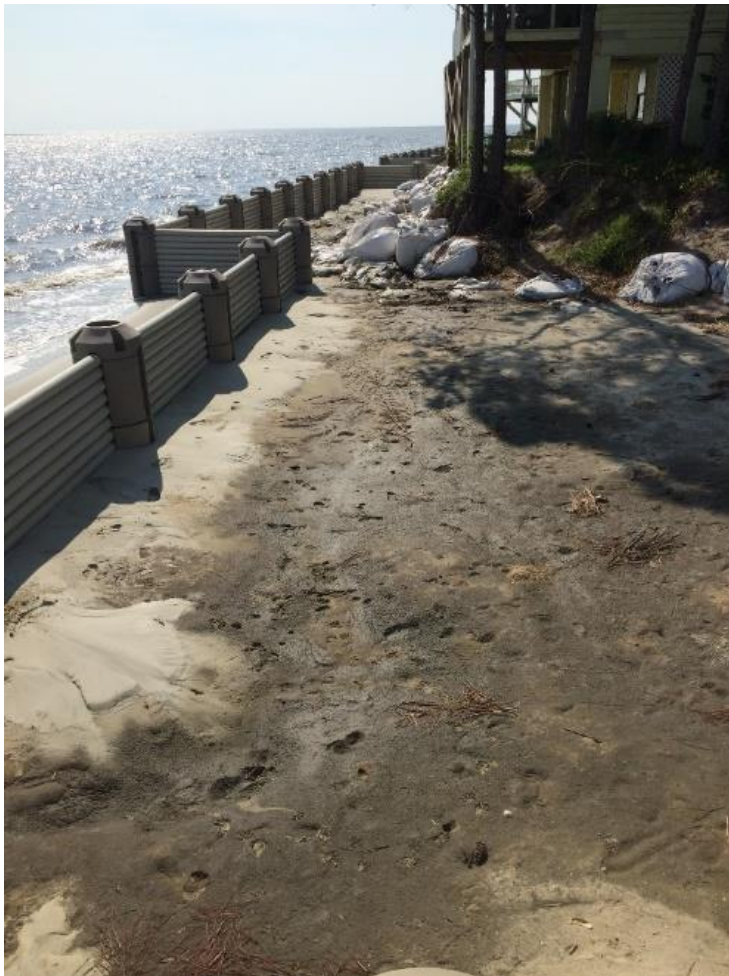
Figure 27. Initial, very localized, accretion (typical with no spacers) behind WDS (photo taken: 7/17/15).

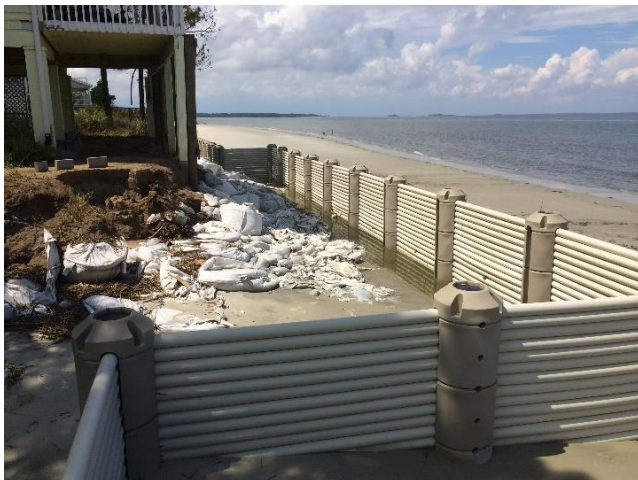
Figure 29. Typical temporary trench issue on site (caused by scour as water exists the WDS and insufficient spacers; photo taken: 9/8/15).

Soon after, the site developed what has been the biggest issue at Harbor Island. As the beach lowered and the added spacer elevations became too high (relative to the beach profile) to allow for exit water to efficiently leave the area behind the WDS, a trench developed directly under the system (See Figure 29).

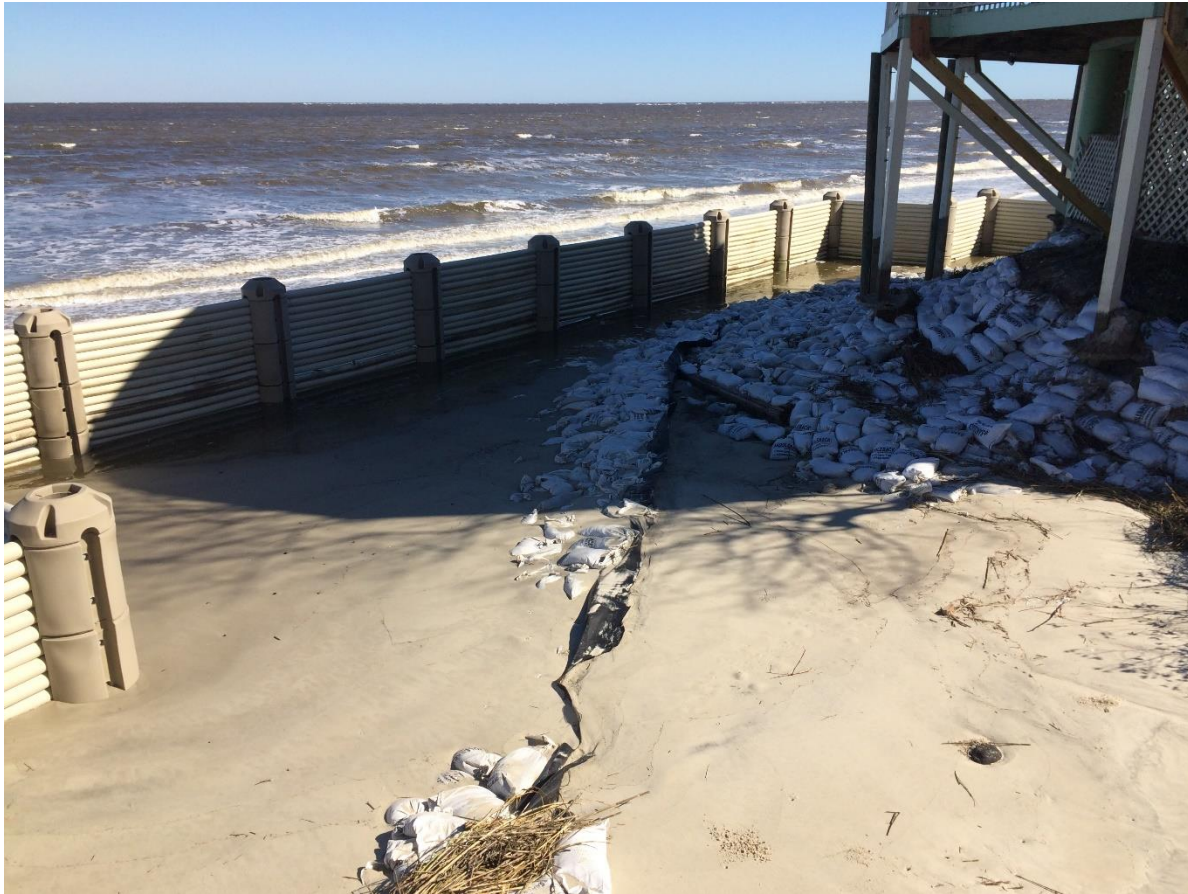
Figure 30. Typical trench issue on site (caused by scour as water exits the WDS and insufficient spacers; photo taken: 11/20/15).

Figure 30 shows the typical trench on site as of 11/20/15. Spacers were located and several locations during the second quarter of this study and it was determined that they are not the ideal solution to trenching. They help at times but they must be constantly adjusted with changing elevations. It should be noted that the entire study area did not trench significantly. The side toward the Hampton's residence didn't trench like the rest of the study area.

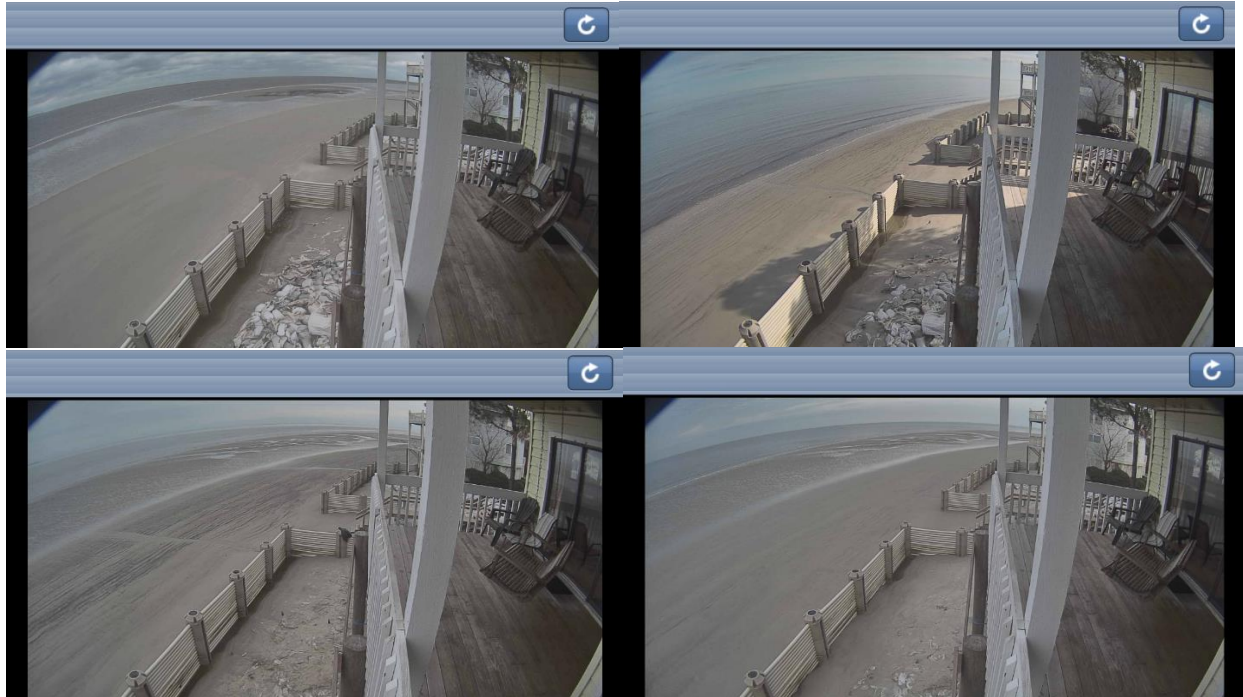
Figure 31. Typical trench self-healing and accretion over a three day period (January 25-January 27, 2016). Note bags being covered by accreting sand.

Although the trench remained a temporary issue throughout the 3rd and 4th quarter, it was not present for most of the study and when it did form it was self-correcting over the next few tide cycles as shown in Figure 31. During a site visit purposely made when the trench appeared to be at its deepest level, it was found to be less than 2 ft deep.

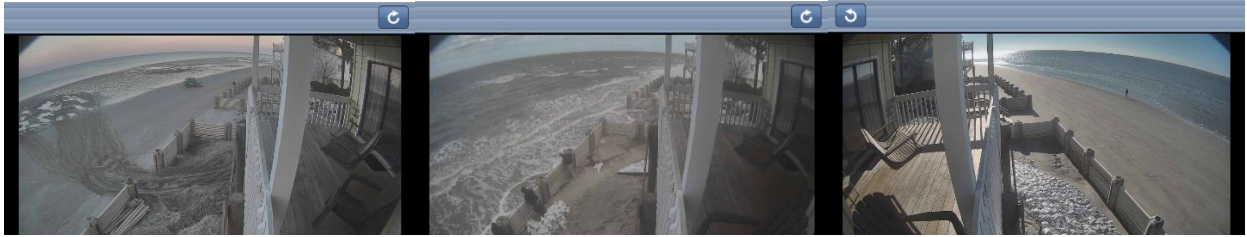
Figure 32. Scraping behind WDS at Gardner's residence (February 29 – March 4, 2016).

The new scarp location was assessed after the scraping (entire month of February; see Figure 32) was completed and it was determined that the WDS needed extensions. Being as study, the team proposed using alternate materials for the vertical members back into the retreated scarp line (see previous discussion regarding 1,000 year event) since these members wouldn't affect the study, would save thousands of dollars (no funding was available), and could be added more quickly since the plastic elements would require a custom special order be placed. OCRM denied this request and the team was told that all the material would have to be the same as installed for all other vertical elements.

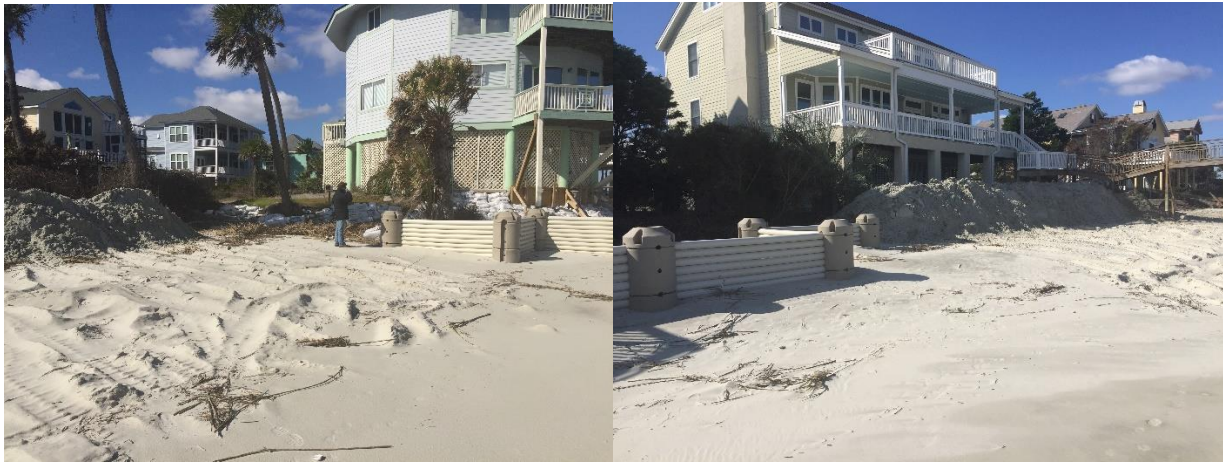
Figure 33. Typical scraping adjacent to WDS (February 5, 2016).

Figure 33 shows the typical scraping size used for the island at participating home sites. The scraping was a pile of sand 12 to 15 ft wide by 5 to 6 ft tall on average.

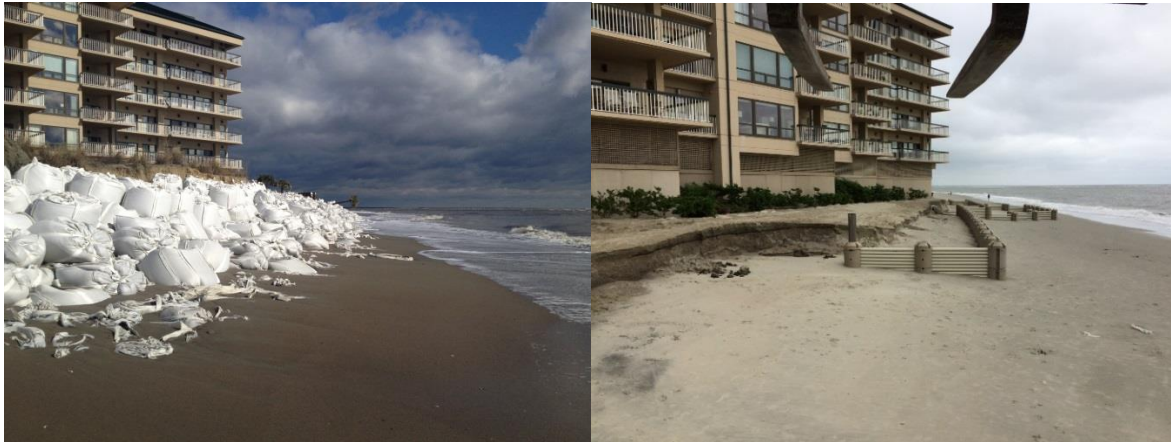
Figure 34. Sandbags and WDS providing erosion and building foundation protection.

Although Figure 34 shows clearly the aesthetic benefit of the WDS, the situation with sandbags can very quickly deteriorate as sandbags fall apart, fall over, or become buried as dynamic surf pounds the bags. Although the home and building owners are ultimately responsible for their removal, the bags often times wind up permanently buried or floating out to sea (see Figure 35).

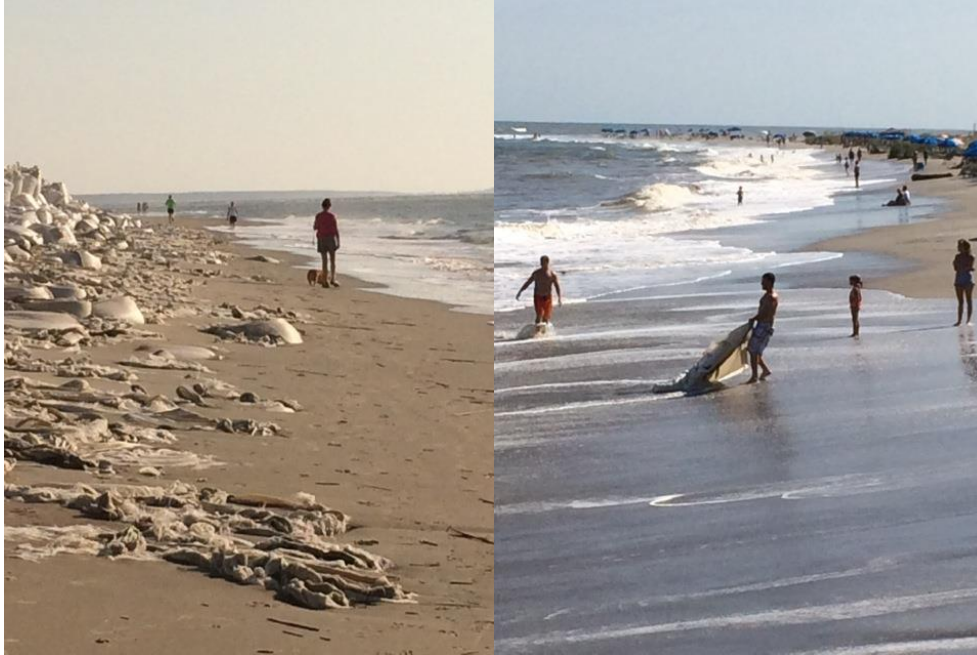
Figure 35. Deteriorated/buried sandbags and individuals pulling sandbags from the surf.

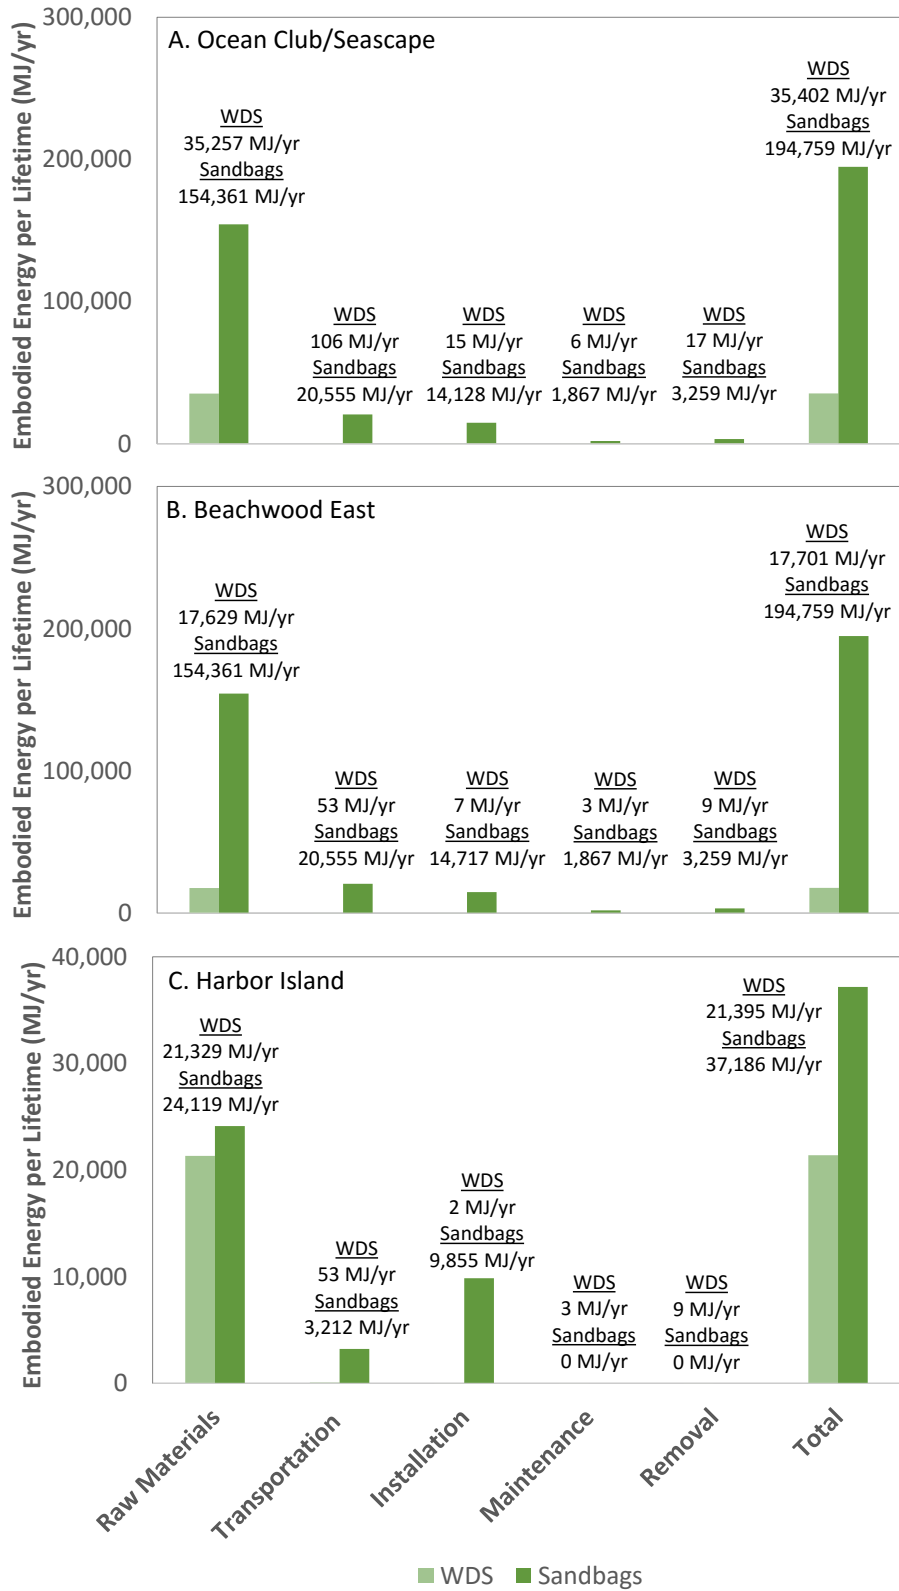
Figure 37. Comparison of life cycle embodied energy per lifetime between WDS and sandbags at (A) OC/SS, (B) BWE, and (C) HI sites. Assumes all components are used for their entire lifetimes.

On a per lifetime basis, the WDS is less energy-intensive than the use of sandbags at the OC/SS, BWE, and HI sites (Figure 37). In fact, at OC/SS, BWE, and HI the WDS embodied energy per lifetime was 82, 91, and 42% lower than the use of sandbags. For both the WDS and sandbags, the primary contributor to embodied energy was the extraction and production of raw materials. Despite the fact that plastics have a considerably higher embodied energy per mass (70 – 103 MJ/kg) than sand (0.1 MJ/kg), the normalized raw materials embodied energy was higher for the use of sandbags, due to the high mass of sand required to protect the shoreline and the short lifetime of the sandbags. Based on these three experimental sites, it is expected that use of the WDS will result in less overall energy utilization (and subsequently CO₂ emissions), as compared to the use of sandbags, for erosion mitigation.
