# Wave Dissipation System

OCRM Staff  
Recommendation

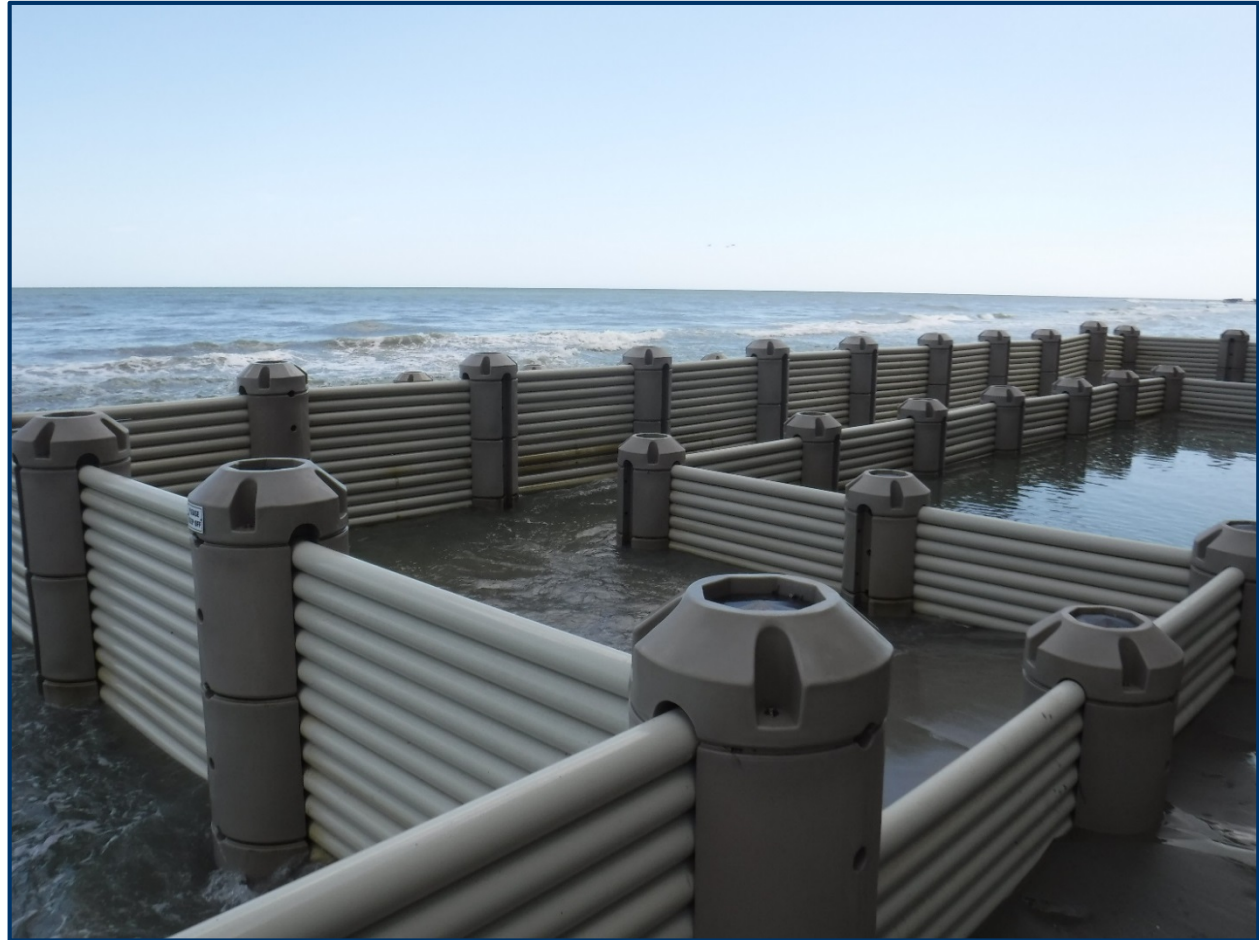
## WDS Structures

- Installed at 4 unique sites: Ocean Club, Seascape Villas, Beachwood East, Harbor Island.
- Vertical Piles & hard plastic casings
- Horizontal PVC
- Spacers

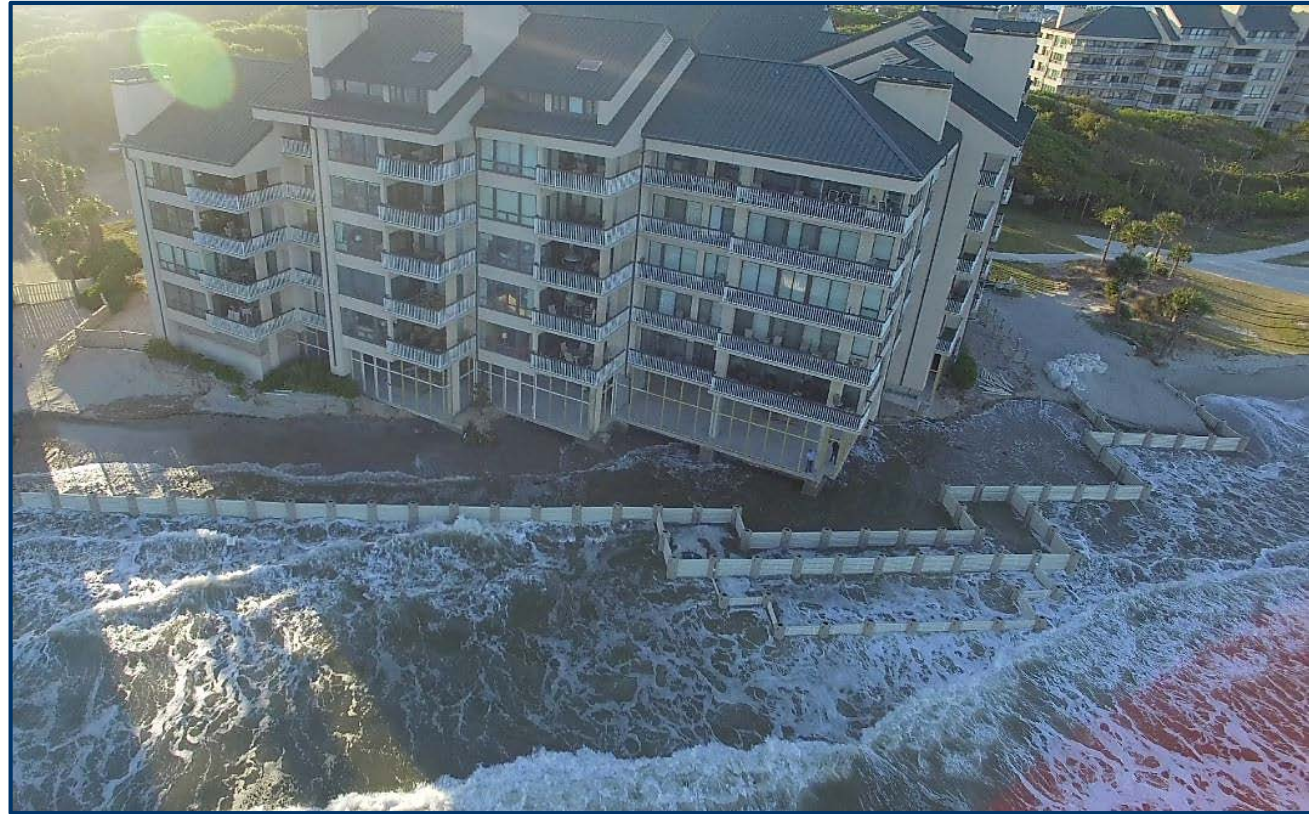
## Ocean Club

- Located in Wild Dunes on Isle of Palms.
- Triple-tier structure
- 256 ft long
- Wave conditions: Extreme loading

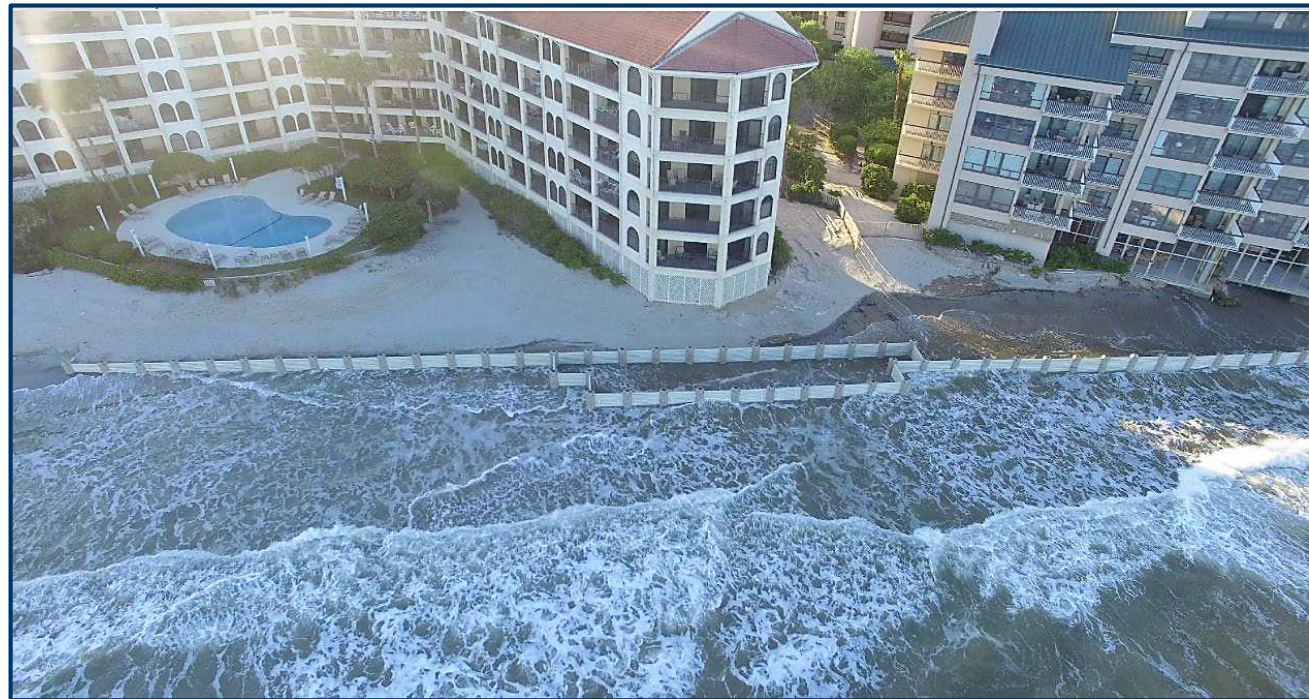
## Seascape

- Located in Wild Dunes on Isle of Palms.
- Double tier structure.
- 120 ft long
- Wave conditions:  
Extreme loading

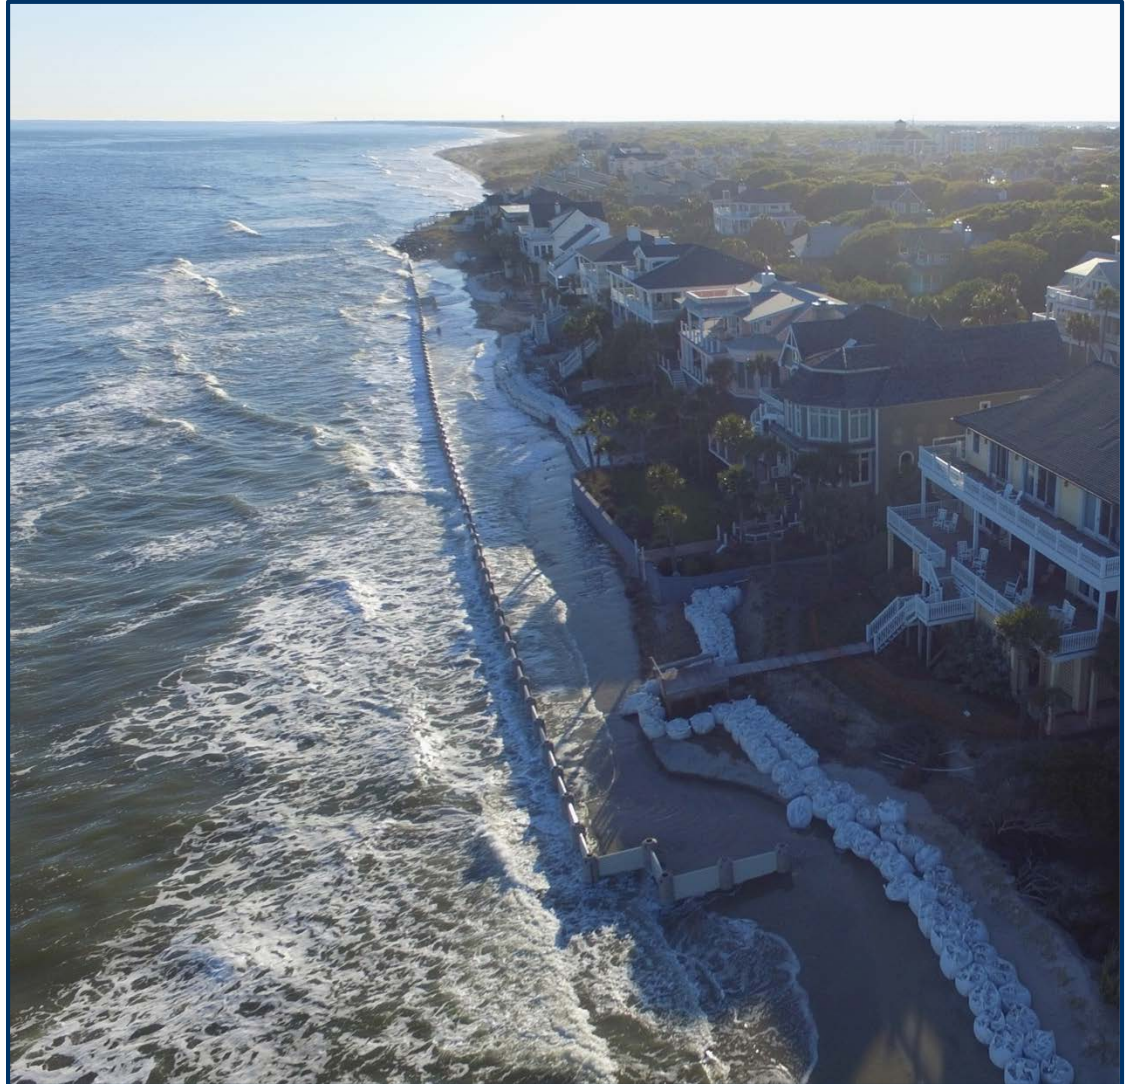
## Beachwood East

- Located in Wild Dunes on the Isle of Palms.
- Seaward of nine houses; 11 – 19 Beachwood East.
- Single tier structure
- Total length: 850 ft.
- Wave conditions: Less extreme than Ocean Club, but more than Harbor Island

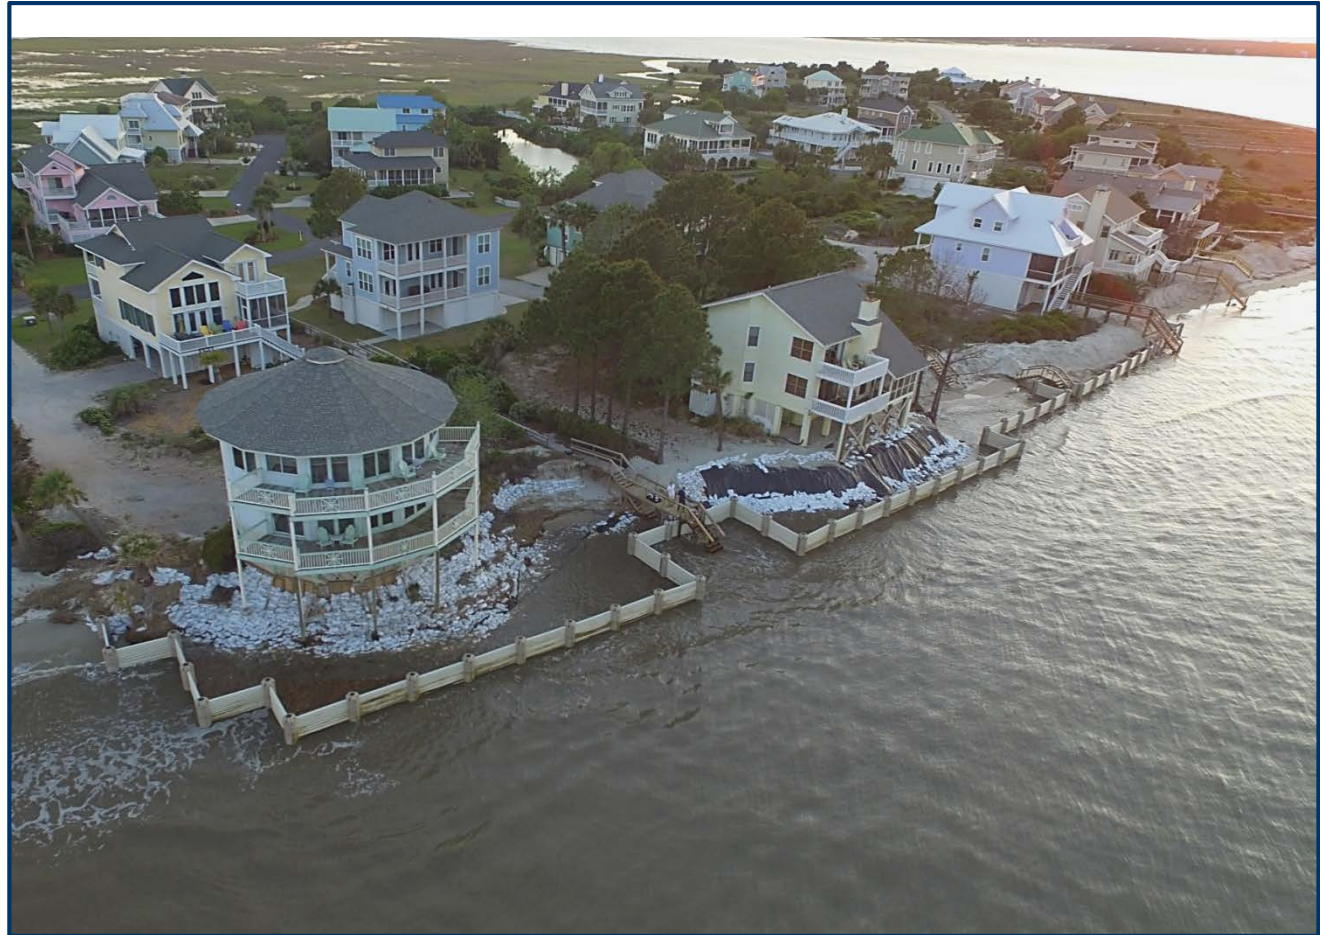
## Harbor Island

- Located on North Harbor Drive; Lots 49, 52, 53, and 56.
- Single tier structure
- Total Length: 400 ft.
- Wave conditions: Less extreme

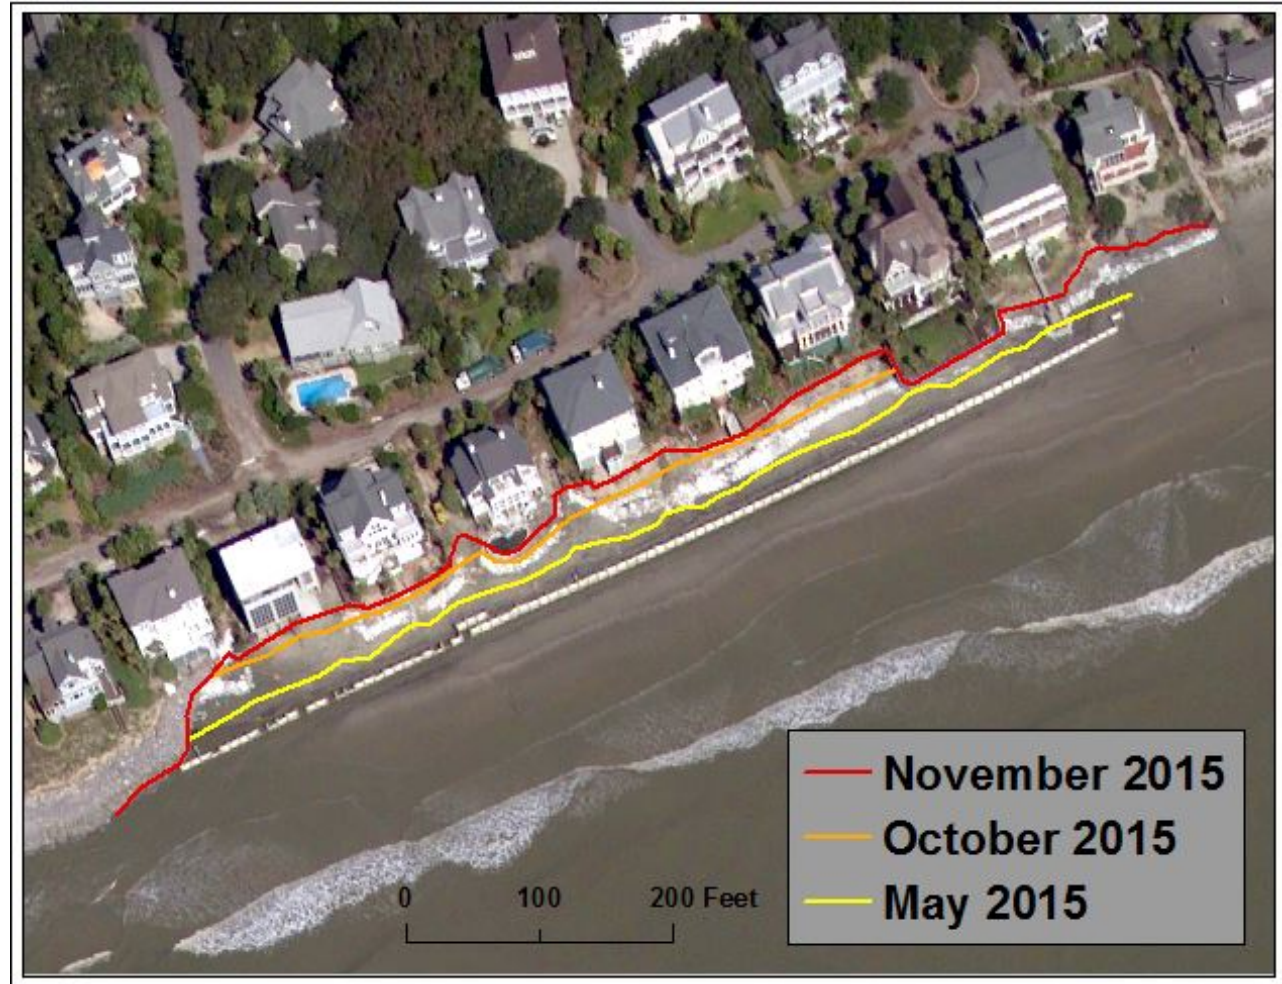
- All sites saw the scarp line retreat landward following the installation of the WDS.
- Emergency orders for sand bags issued for Beachwood East properties on Sept 28<sup>th</sup>, Oct 7<sup>th</sup>, Nov 24<sup>th</sup>, and Dec 17<sup>th</sup> 2015.

Changes to Scarp Line at Beachwood East.  
WDS installation completed September 10, 2015.

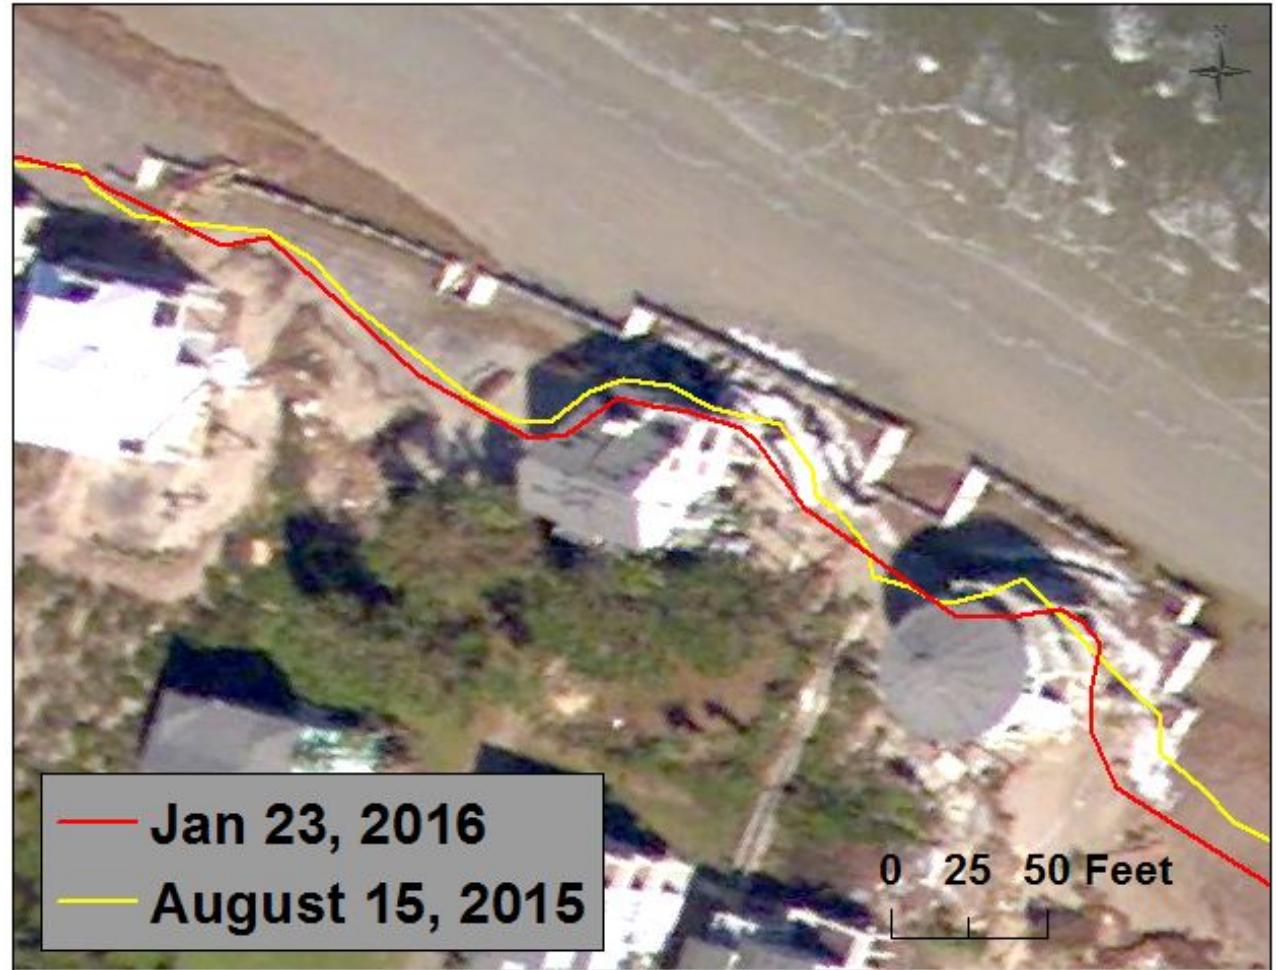
- All sites saw the scarp line retreat landward following the installation of the WDS.
- Emergency orders for sand bags issued for Harbor Island properties on Sept 30<sup>th</sup> and Oct 7<sup>th</sup> 2015.

Changes to Scarp Line at Harbor Island.  
WDS installation completed June 3, 2015.

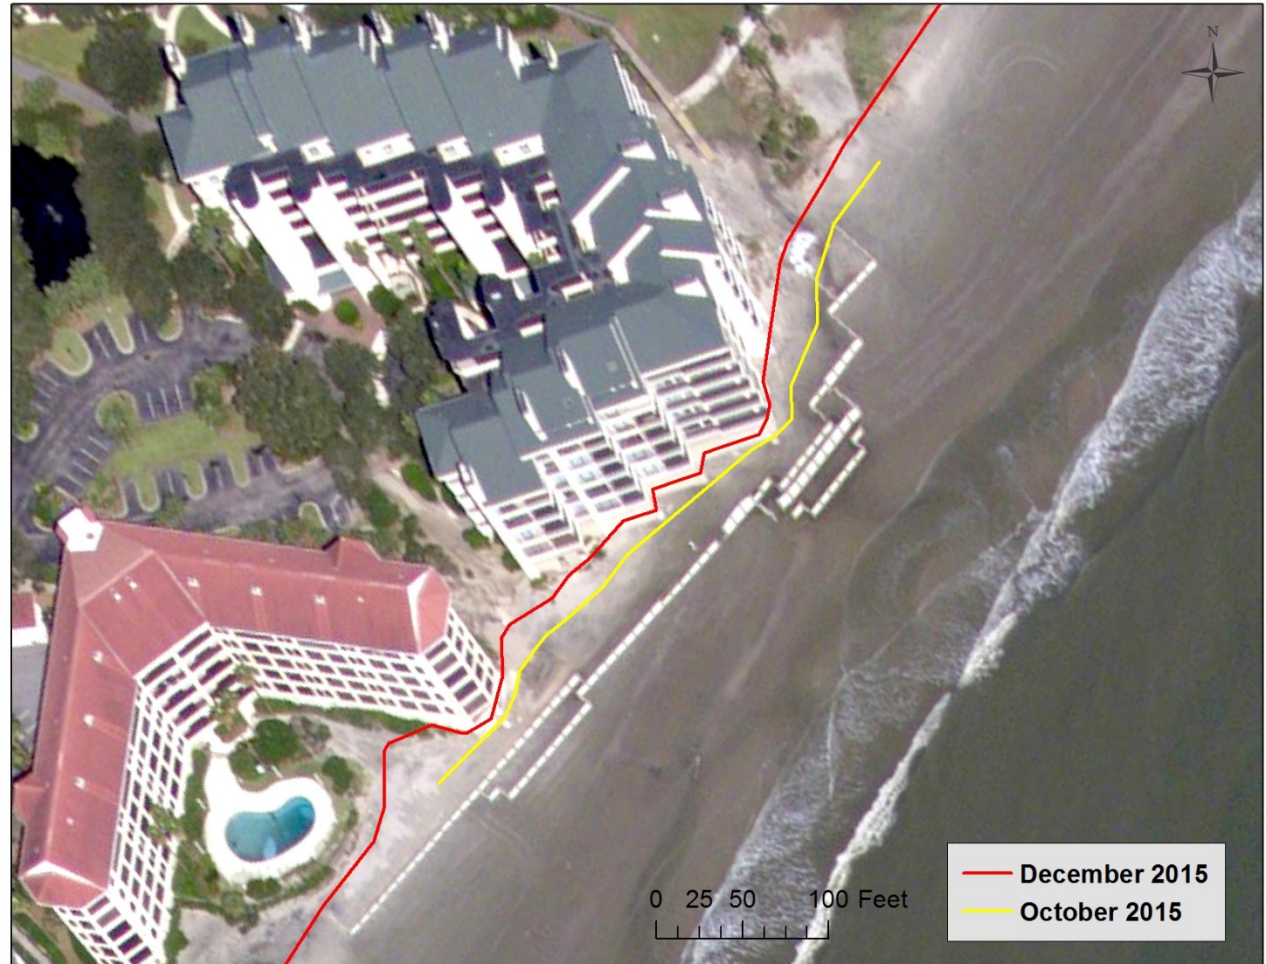
- All sites saw the scarp line retreat landward following the installation of the WDS.
- Emergency orders for sand bags issued for Ocean Club on Sept 28<sup>th</sup> and Dec 18<sup>th</sup>, 2015 and Feb 19<sup>th</sup>, 2016

**Changes to Scarp Line at Ocean Club and Seascape.**  
OC installation completed June 5, 2015. Seascape installation 1<sup>st</sup> tier completed Dec 2015; 2<sup>nd</sup> tier completed Feb 2016.

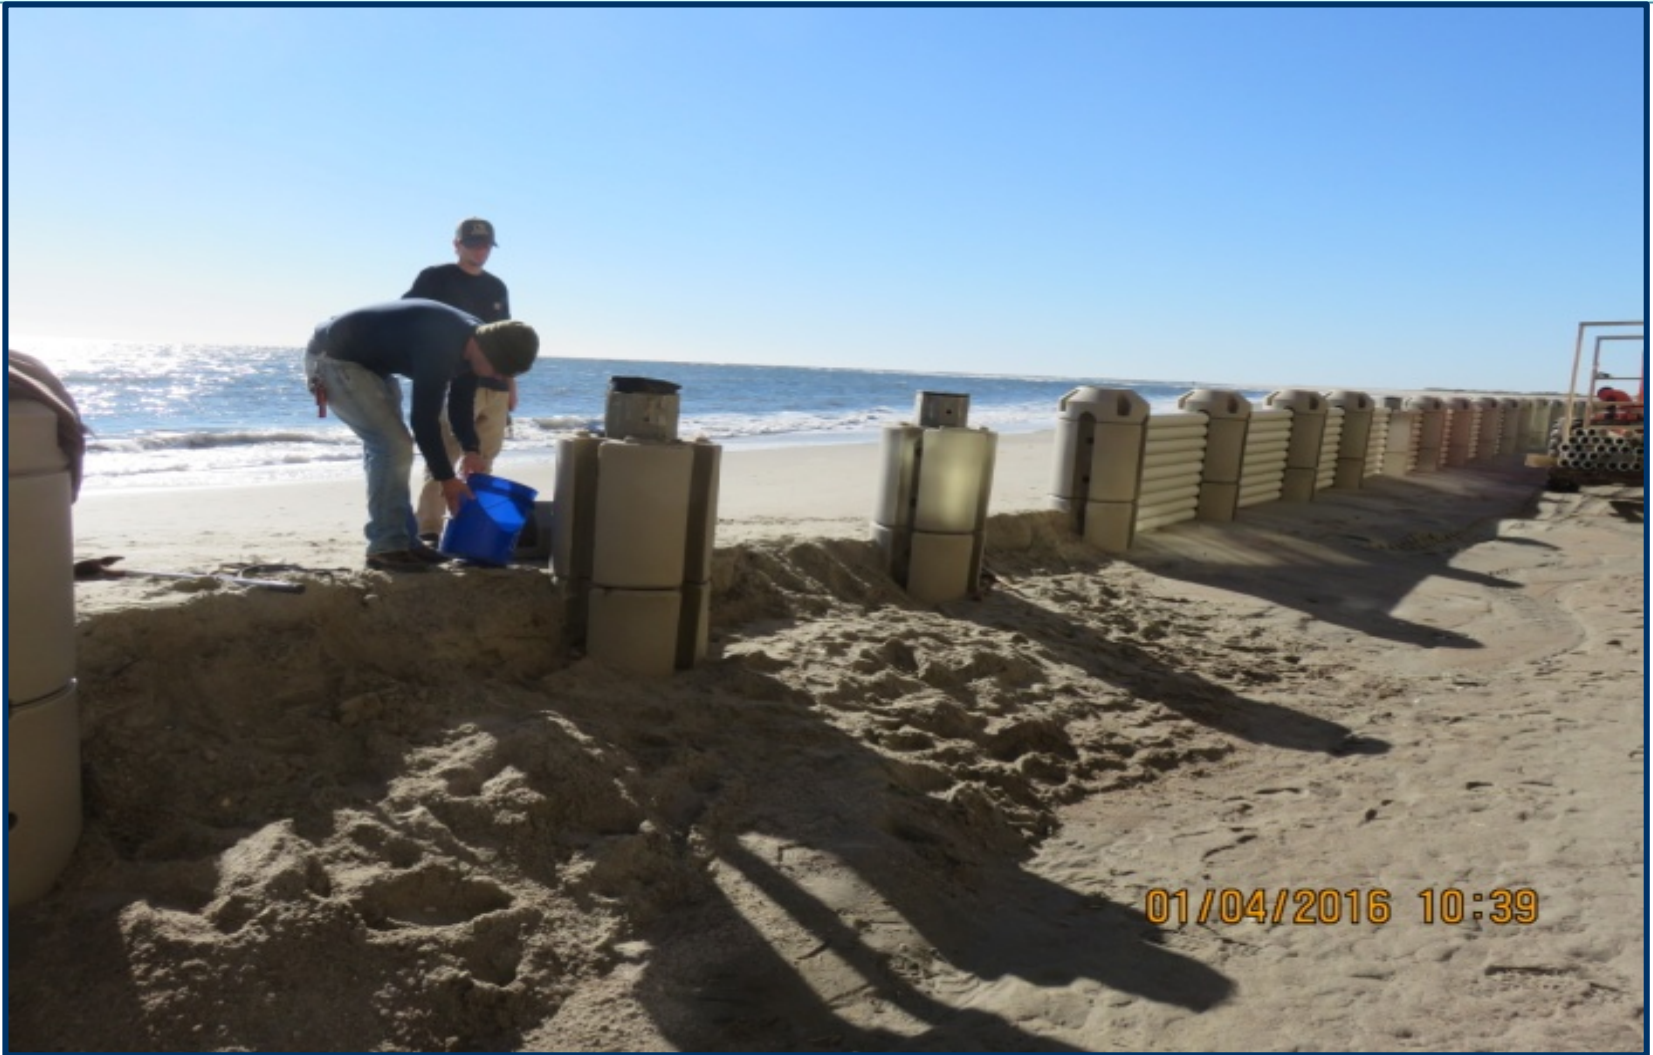
Horizontal panel removal at Ocean Club; January 2016

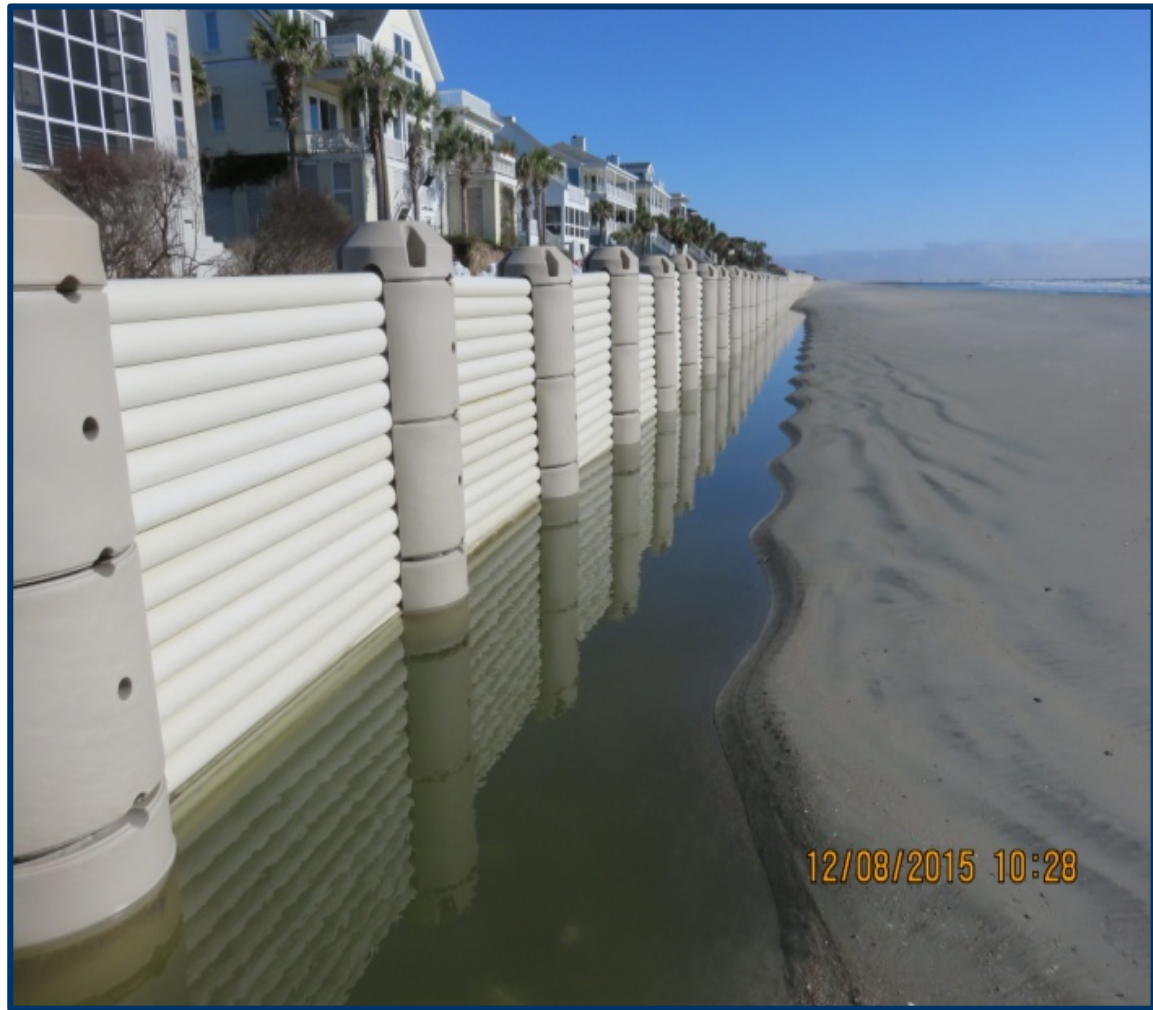
- **Impacts to physical resource**
  - **Scouring or trenching**
  - Periodic excavations to adjust the system.
  - Continued erosion of scarp line
  - Loss of sand volume landward of the WDS and restriction on sand naturally migrating up the beach
- Impacts to Beach Access
- Impacts to Adjacent Properties
- Impacts to Flora and Fauna

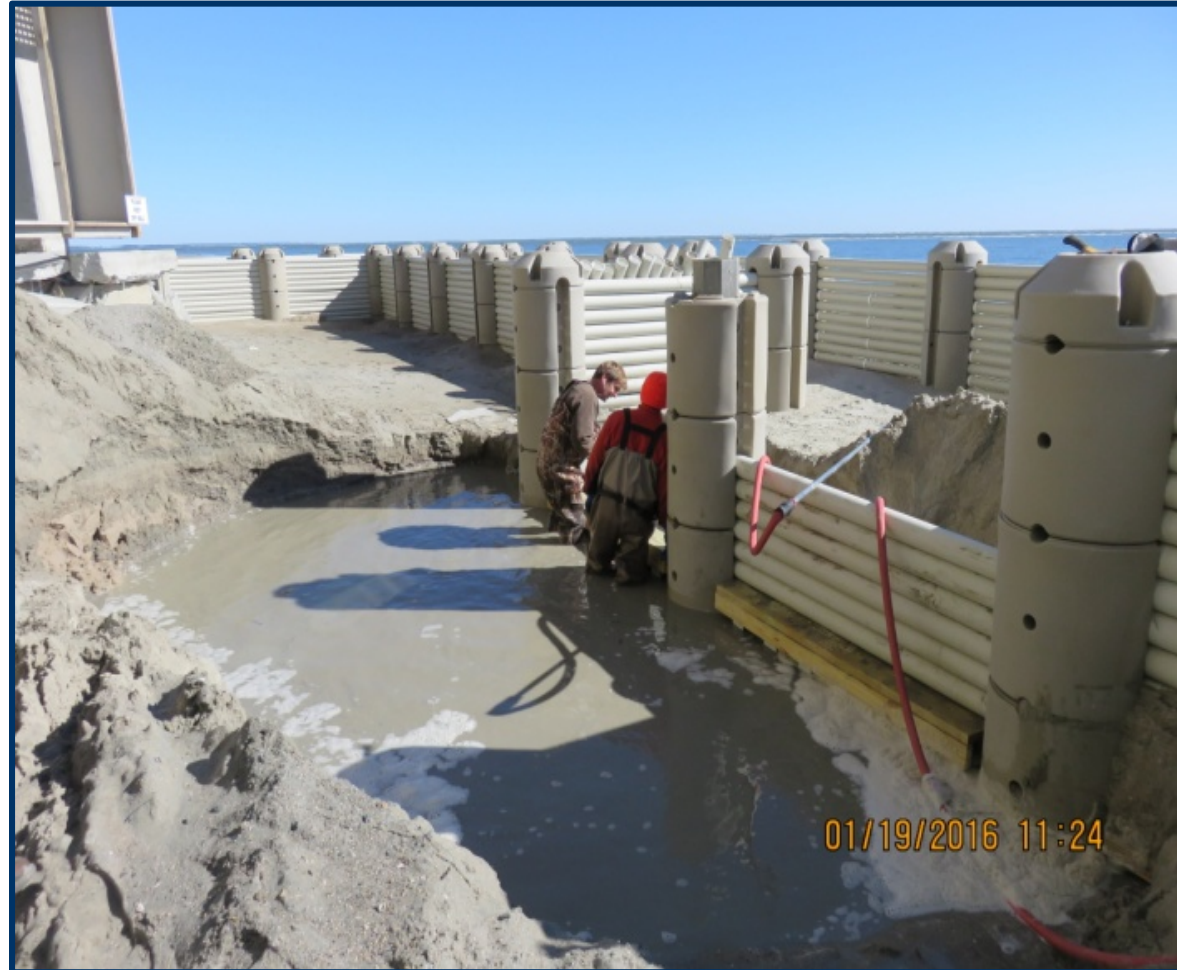
- **Impacts to physical resource**
  - Scouring or trenching
  - **Periodic excavations to adjust the system.**
  - Continued erosion of scarp line
  - Loss of sand volume landward of the WDS and restriction on sand naturally migrating up the beach
- Impacts to Beach Access
- Impacts to Adjacent Properties
- Impacts to Flora and Fauna

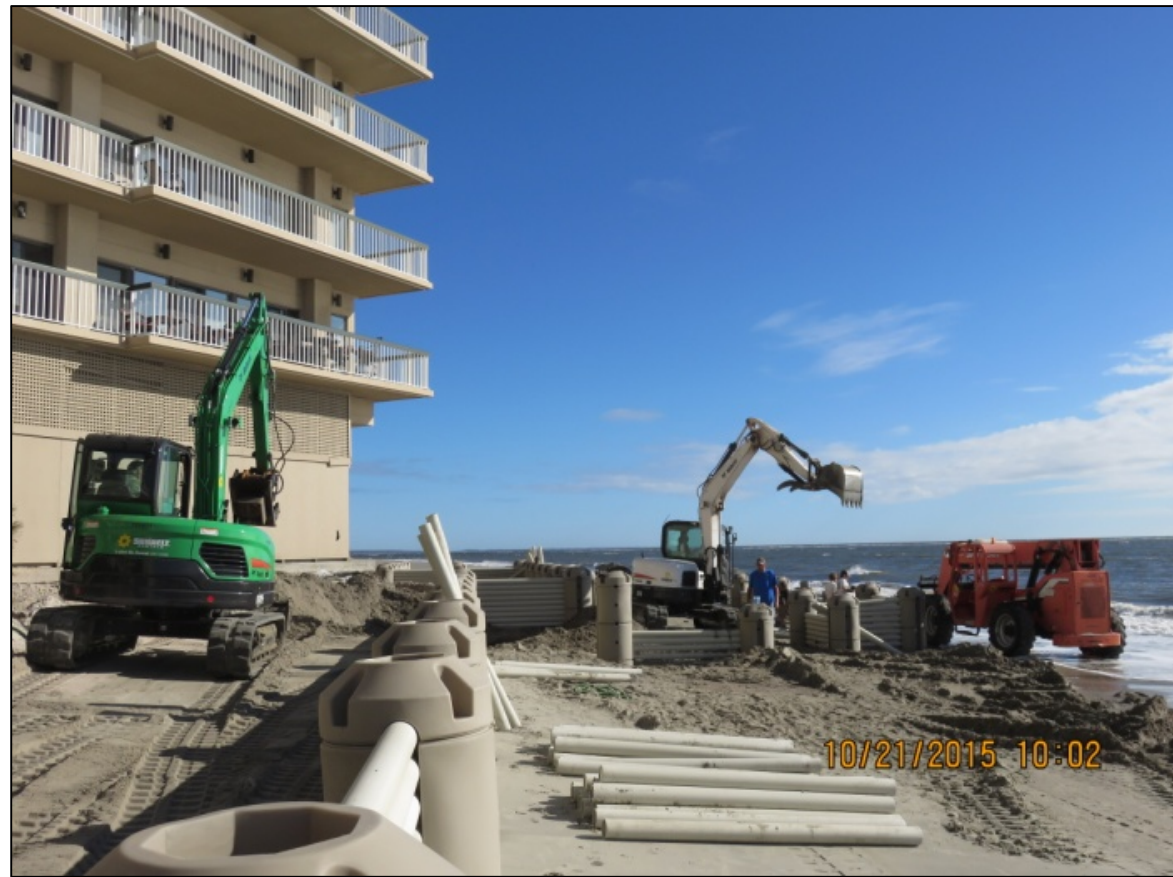
- **Impacts to physical resource**
  - Scouring or trenching
  - **Periodic excavations to adjust the system.**
  - Continued erosion of scarp line
  - Loss of sand volume landward of the WDS and restriction on sand naturally migrating up the beach
- Impacts to Beach Access
- Impacts to Adjacent Properties
- Impacts to Flora and Fauna

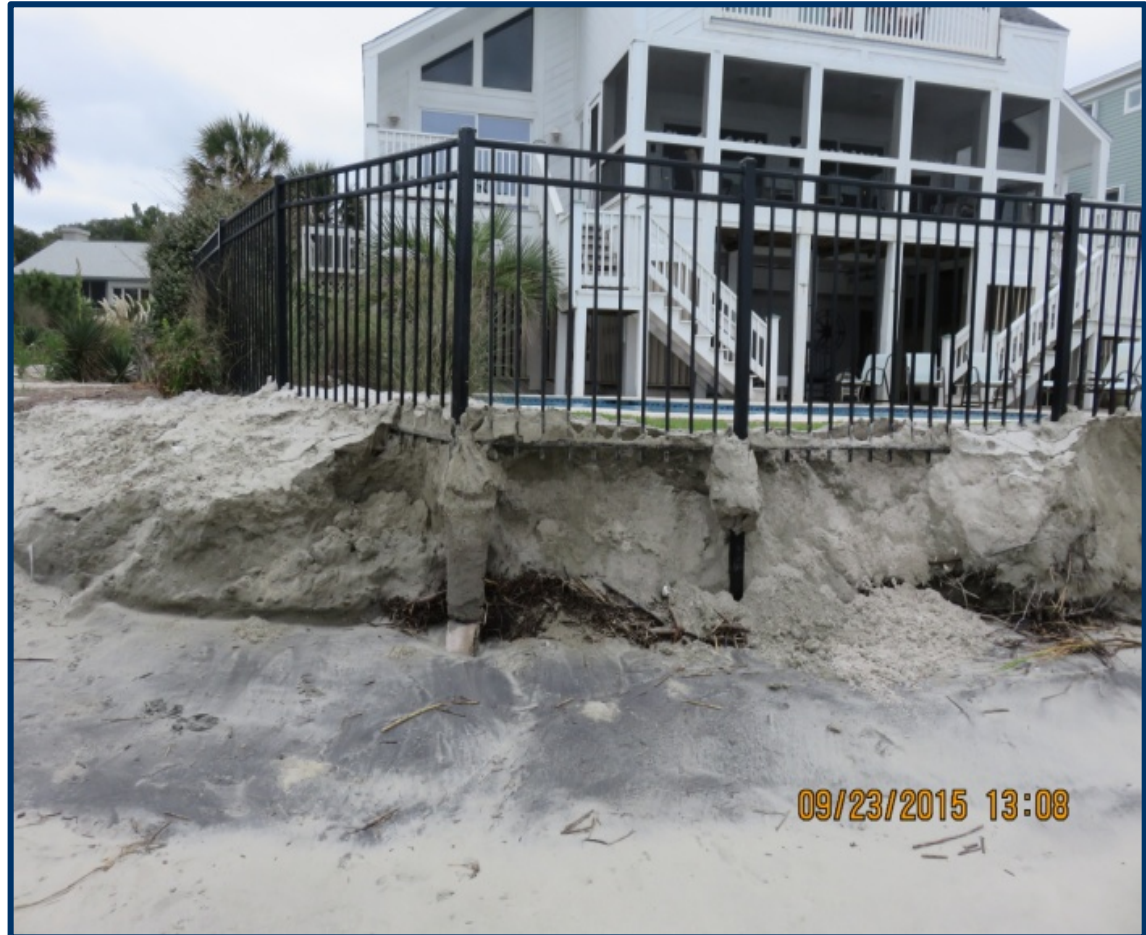
- **Impacts to physical resource**
  - Scouring or trenching
  - Periodic excavations to adjust the system.
  - **Continued erosion of scarp line**
  - Loss of sand volume landward of the WDS and restriction on sand naturally migrating up the beach
- Impacts to Beach Access
- Impacts to Adjacent Properties
- Impacts to Flora and Fauna

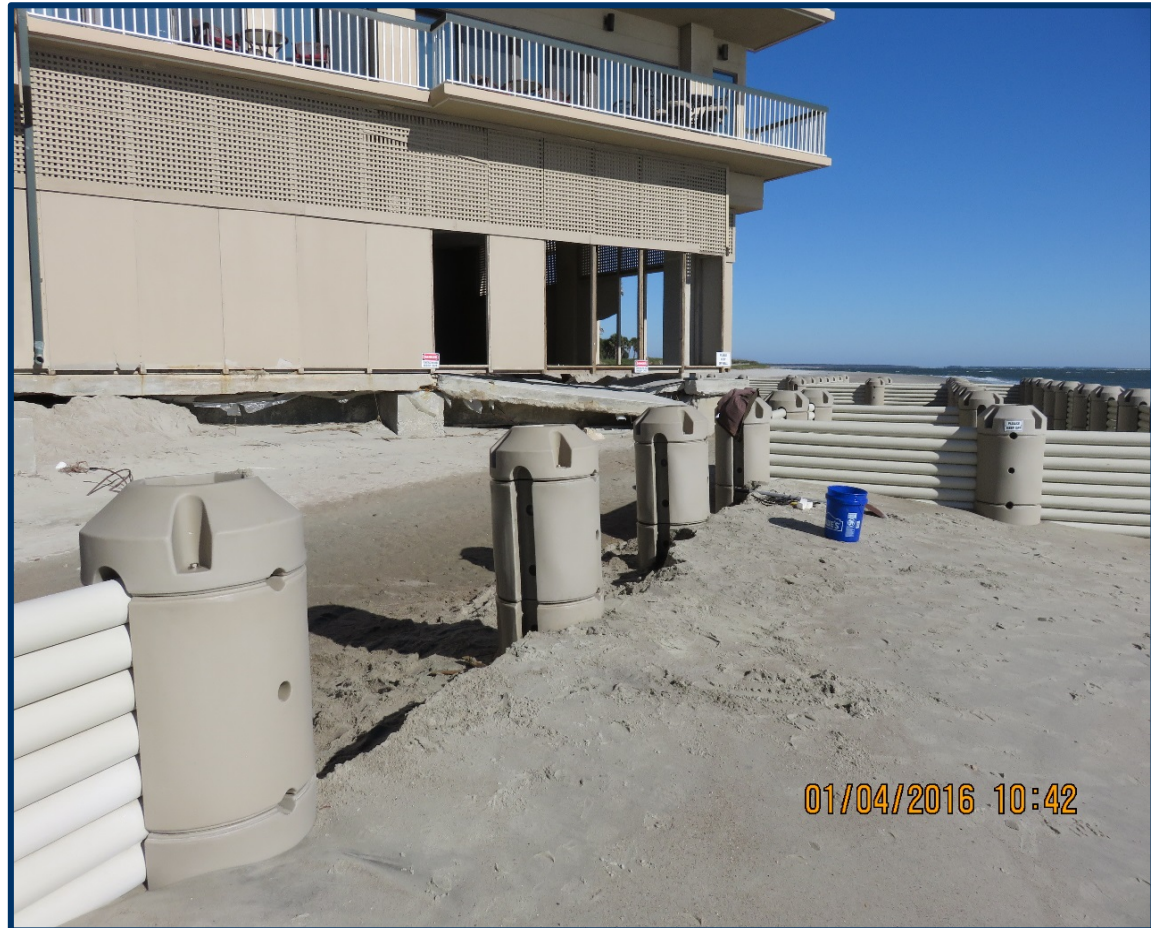
- All four sites saw sand volume decrease landward of the WDS between March and July, while the beach seaward of the WDS accreted sand.
- This indicates that the WDS blocked the natural movement of sand up the beach.

- **Impacts to physical resource**
  - Scouring or trenching
  - Periodic excavations to adjust the system.
  - Continued erosion of scarp line
  - **Loss of sand volume landward of the WDS and restriction on sand naturally migrating up the beach**
- Impacts to Beach Access
- Impacts to Adjacent Properties
- Impacts to Flora and Fauna

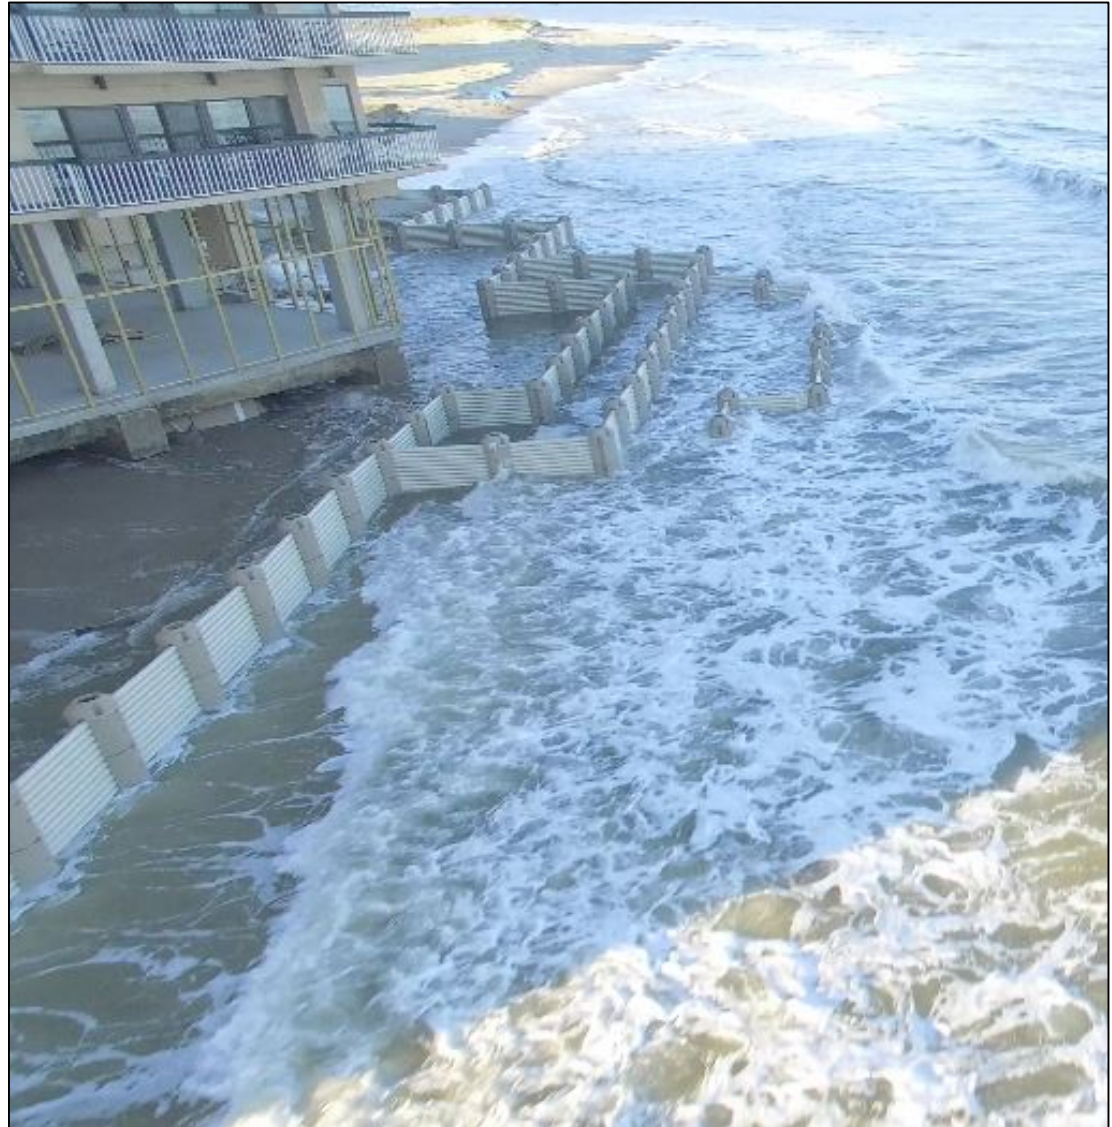
- Impacts to physical resource
  - Scouring or trenching
  - Periodic excavations to adjust the system.
  - Continued erosion of scarp line
  - Loss of sand volume landward of the WDS and restriction on sand naturally migrating up the beach
- **Impacts to Beach Access**
- Impacts to Adjacent Properties
- Impacts to Flora and Fauna

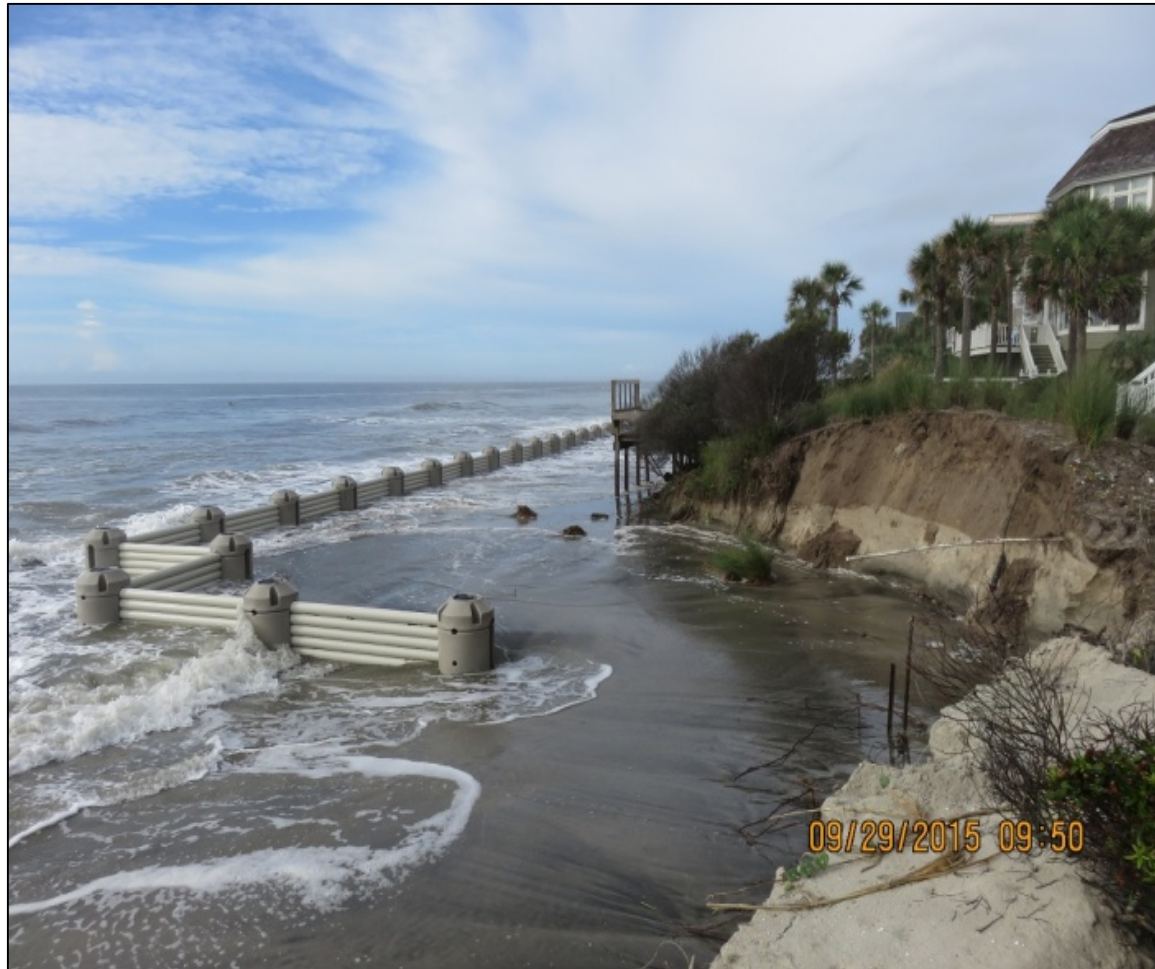
- Impacts to physical resource
  - Scouring or trenching
  - Periodic excavations to adjust the system.
  - Continued erosion of scarp line
  - Loss of sand volume landward of the WDS and restriction on sand naturally migrating up the beach
- Impacts to Beach Access
- **Impacts to Adjacent Properties**
- Impacts to Flora and Fauna

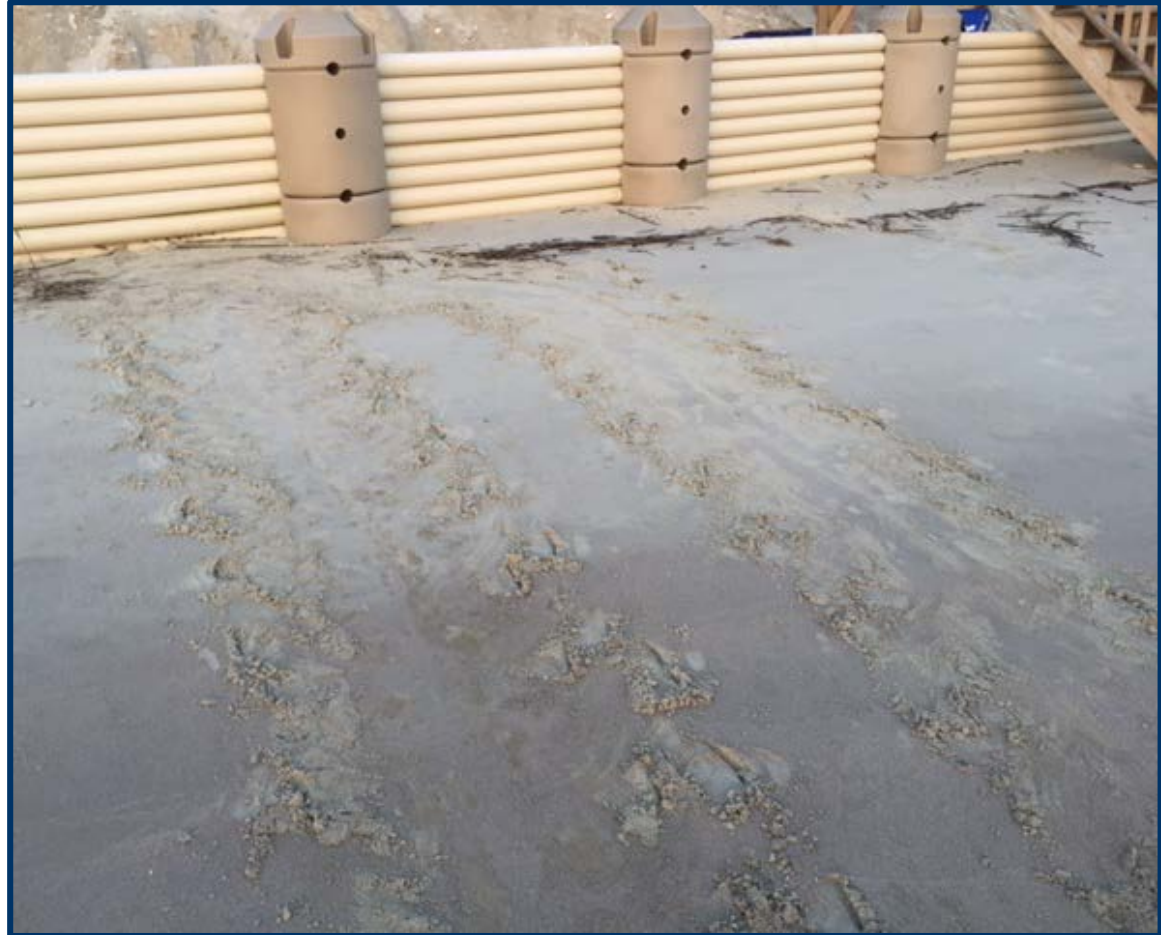
- Impacts to physical resource
  - Scouring or trenching
  - Periodic excavations to adjust the system.
  - Continued erosion of scarp line
  - Loss of sand volume landward of the WDS and restriction on sand naturally migrating up the beach
- Impacts to Beach Access
- Impacts to Adjacent Properties
- **Impacts to Flora and Fauna**
