# Wave Dissipation System

OCRM Staff  
Recommendation

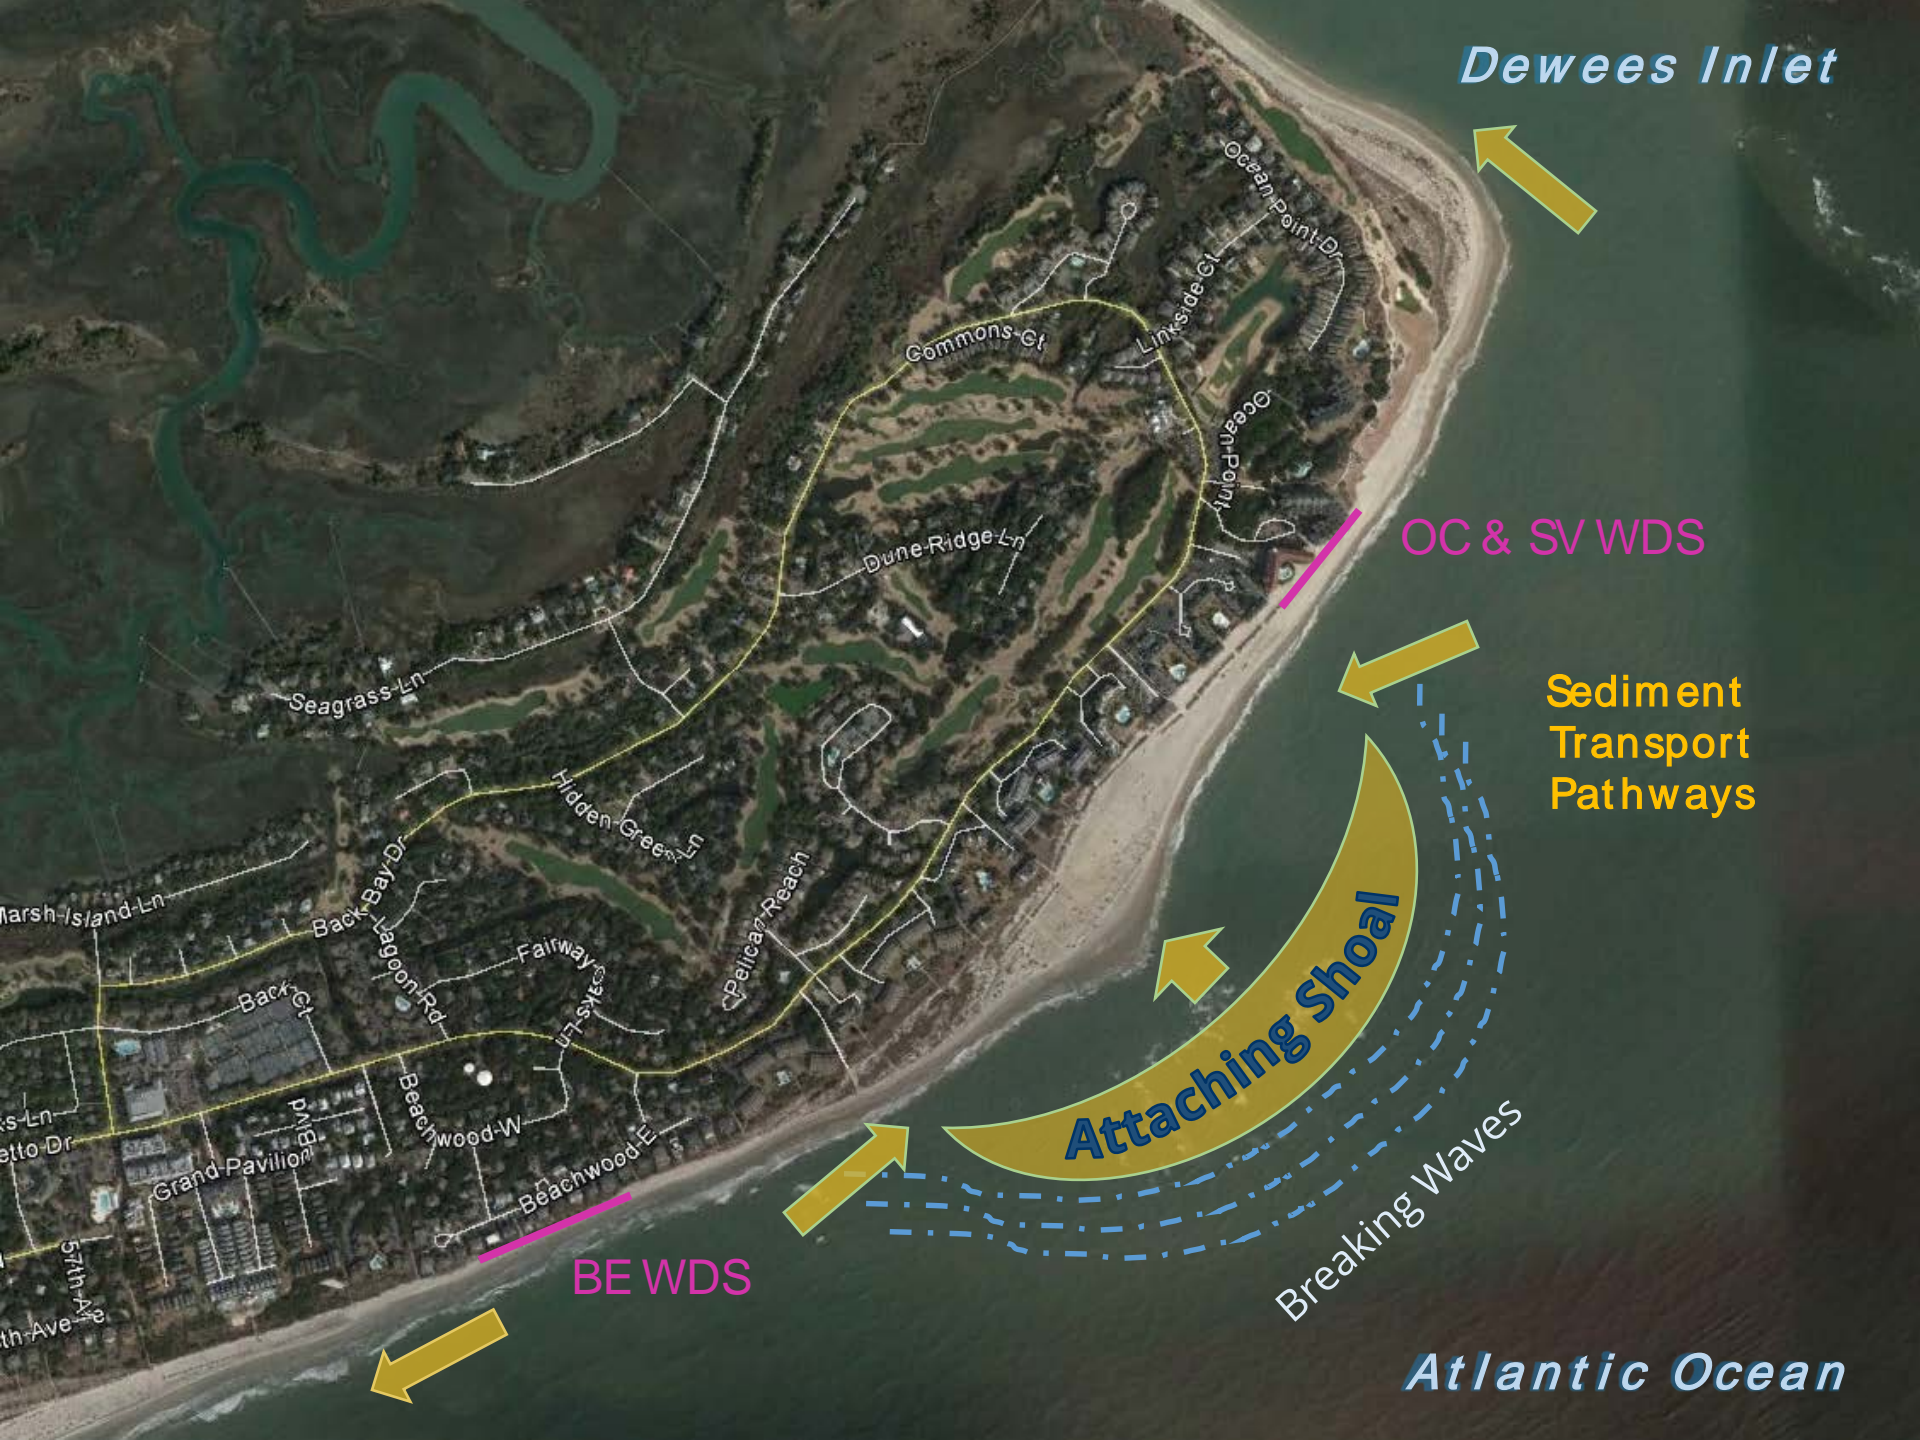
Sediment  
Transport  
Pathways

**Attaching Shoal**

Breaking Waves

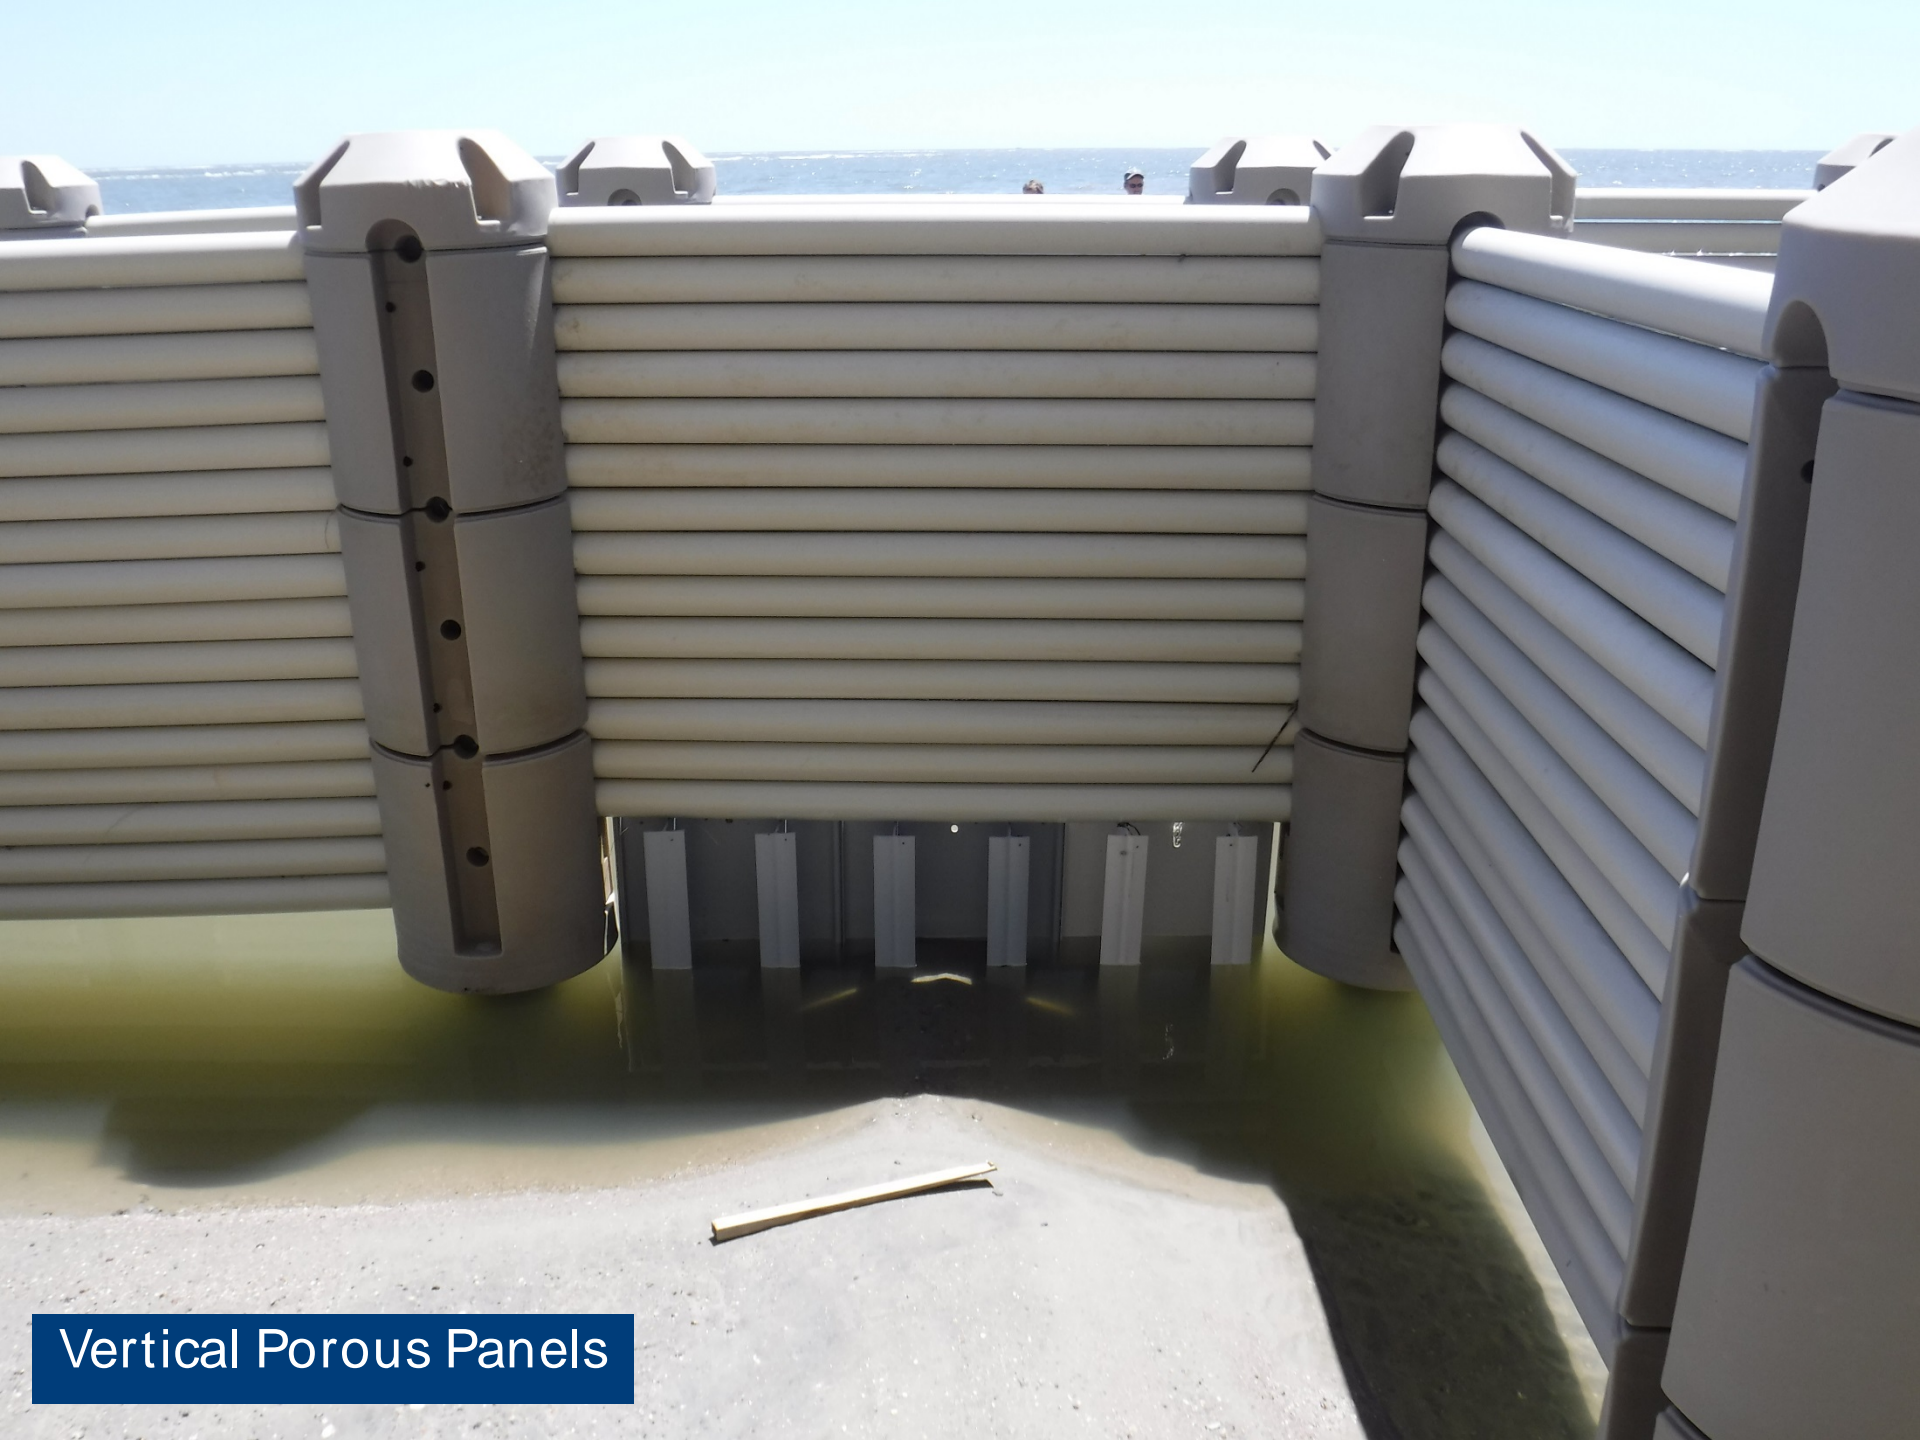
Vertical Porous Panels
