South Carolina Department of Health and Environmental Control

2022 South Carolina Cyanotoxin Distribution Project

Technical Report No. 003-2024

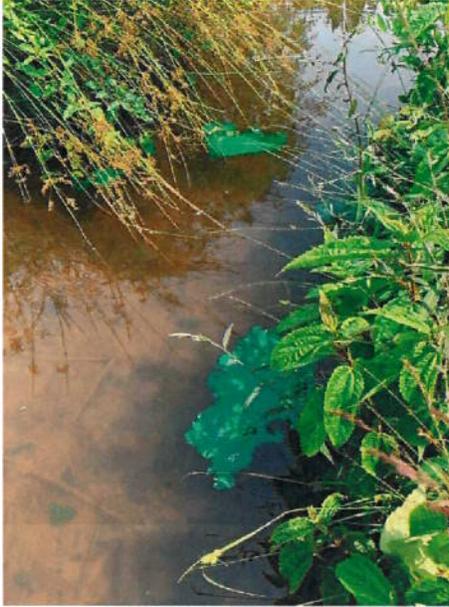
Planktothrix sp. Bloom

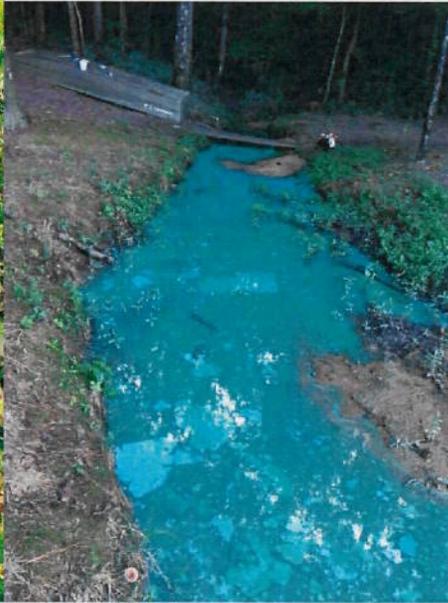
Microcystis sp. bloom

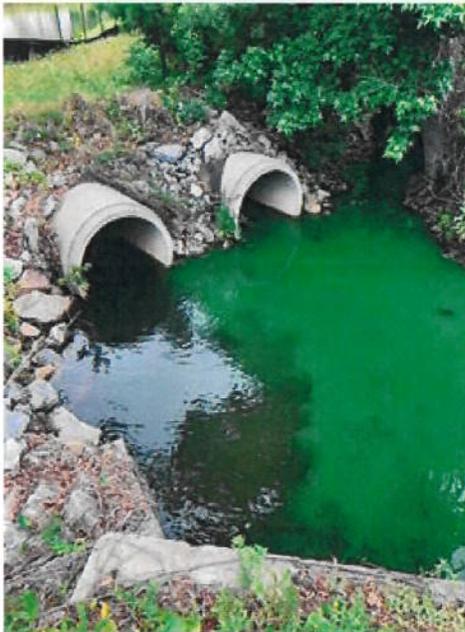
Aphanizomenon sp. Bloom

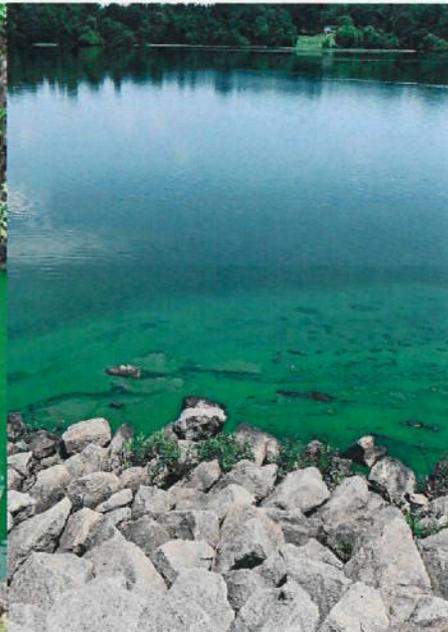
Dolichospermum sp. and *Microcystis sp.* bloom

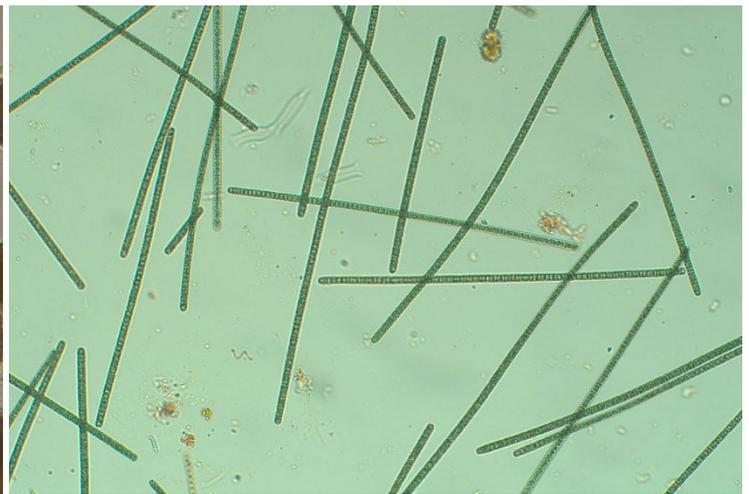
Planktonthrix sp. bloom at Anne Spring Greenway 07/25/2022
