Re: **QAPP Contractor Addendum/SSWP Directive for Free Product Delineation**  
Hilton Head Public Service District, 21 Oak Park Drive, Hilton Head Island, SC  
UST Permit #11399  
Release #2 Reported July 27, 2017  
UST Compliance Inspection Checklist Report received July 27, 2017  
Beaufort County

**SITE MAP**  
**TIER I ASSESSMENT REPORT**  
**HILTON HEAD PUBLIC SERVICE DISTRICT**  
21 OAK PARK DRIVE  
HILTON HEAD ISLAND, SOUTH CAROLINA

**FIGURE 1**  
**Site Topographic Map**  
**Tier 2 Assessment Report**  
**HHPSD**

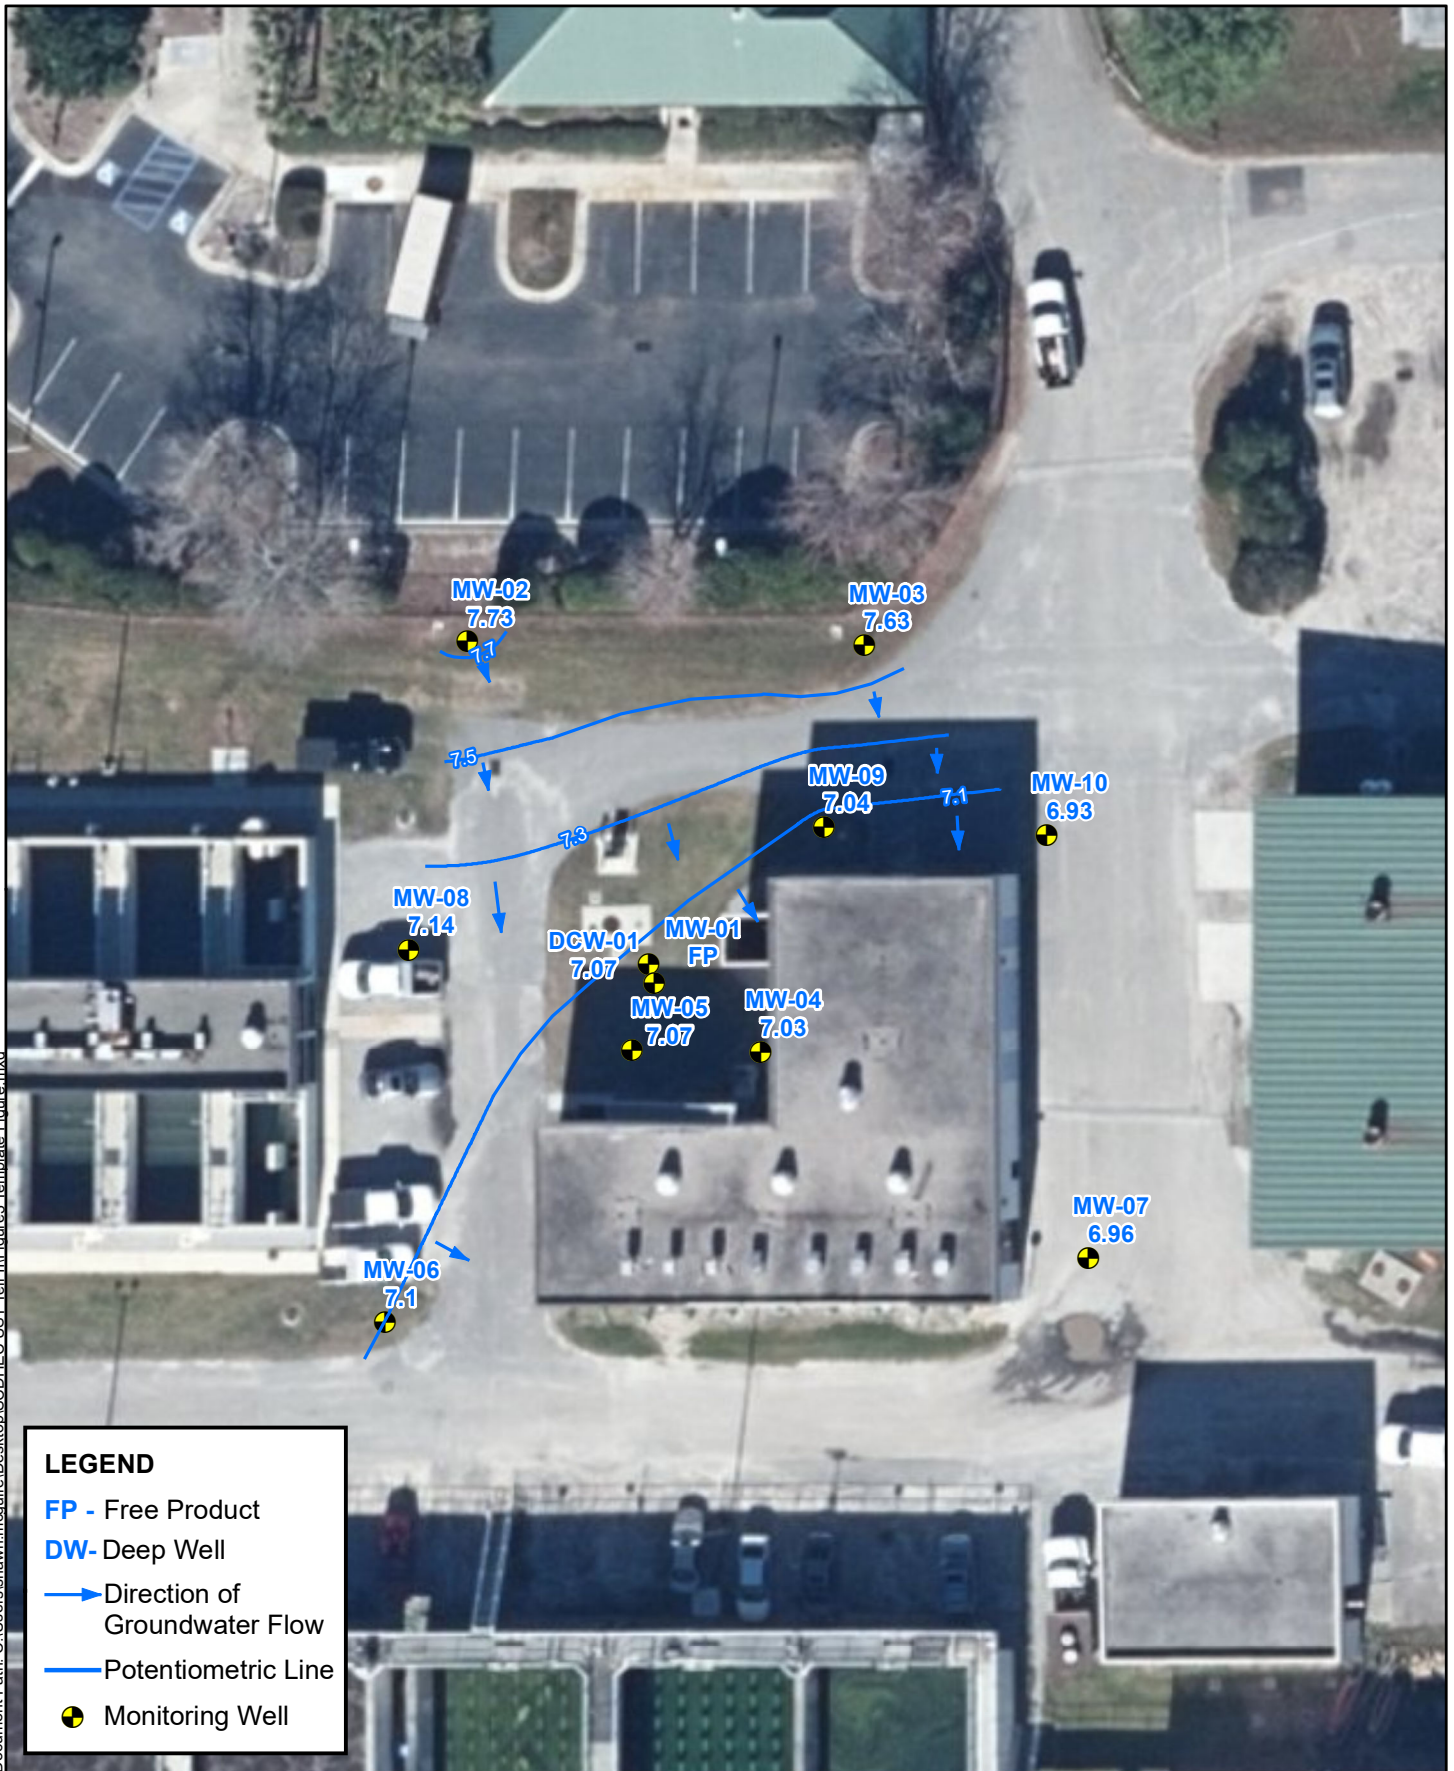
- FP - Free Product
- DW - Deep Well
- Direction of Groundwater Flow
- Potentiometric Line
- ● Monitoring Well

**FIGURE 3**  
**Potentiometric Map**  
**April 2021**  
**Tier 2 Assessment Report**  
**HHPSD**
