NONPOINT SOURCE SUCCESS STORY

South Carolina

Ecological Restoration through Collaboration in the North Saluda Watershed

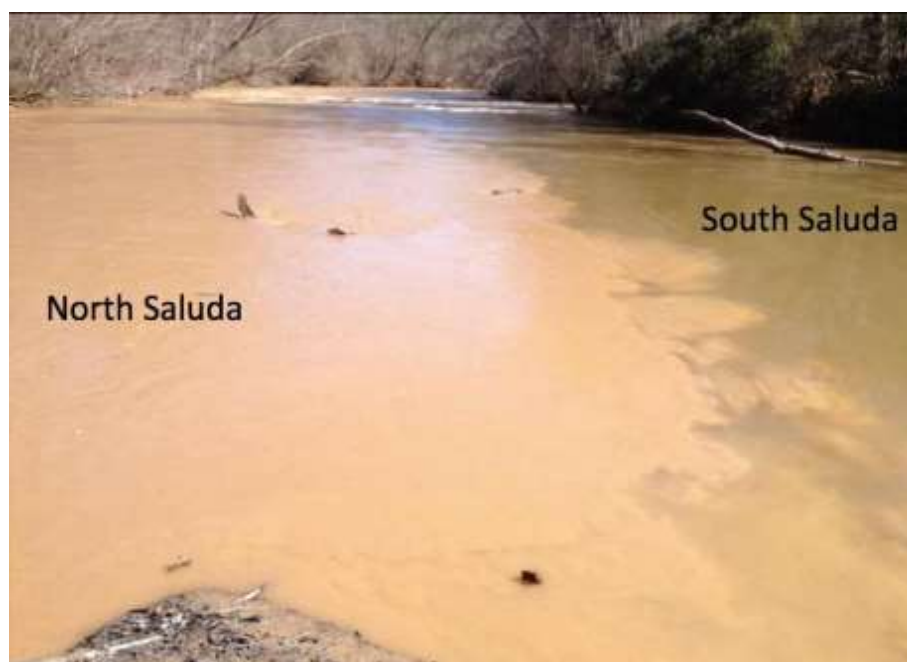
Figure 2. Sedimentation in the North Saluda River

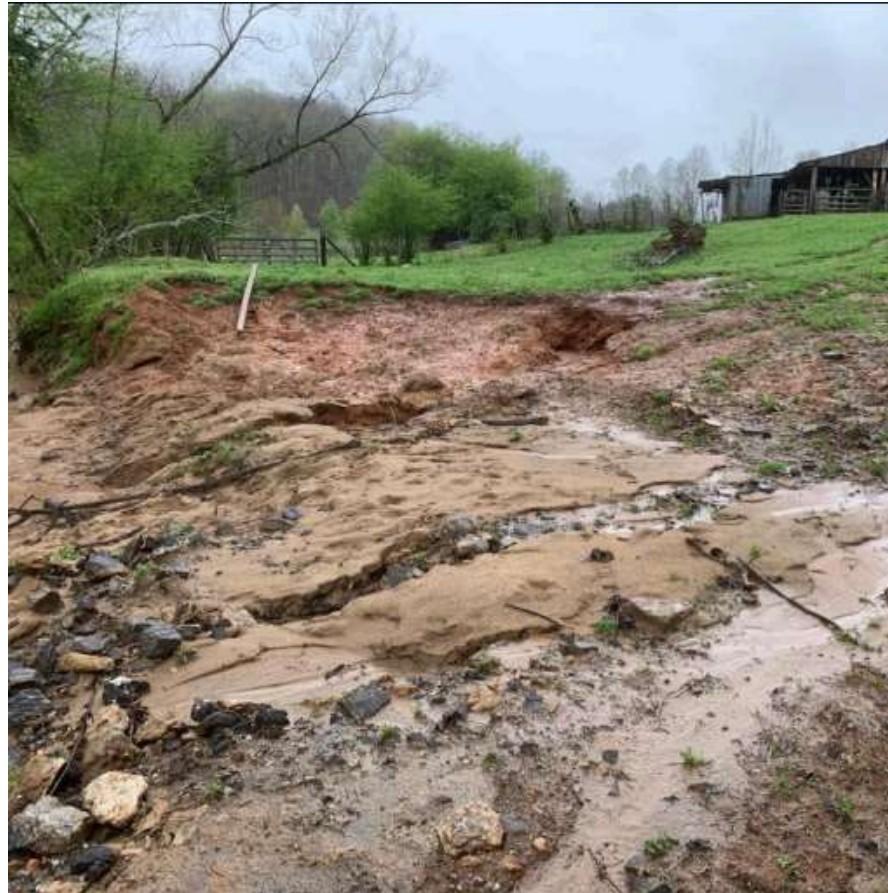
Figure 3. Erosion eliminated streambank buffers

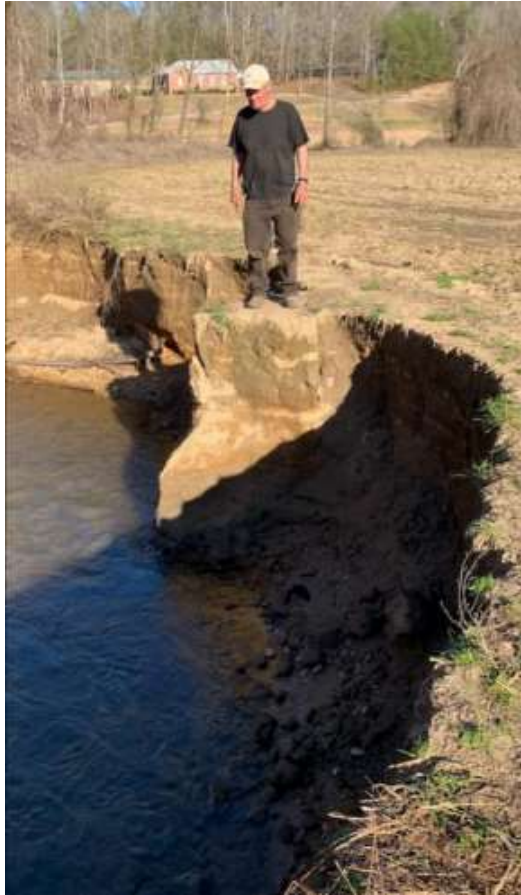
Figure 4. Significant channel erosion

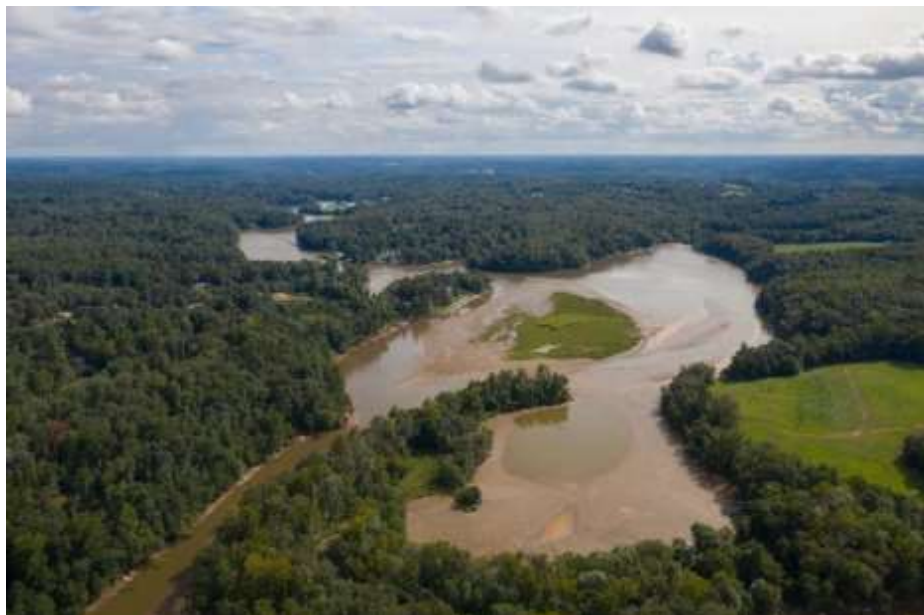
Figure 5. Sediment in Saluda Lake

In 2011-2012, 366,600 cubic yards of sediment were dredged from Saluda Lake at a cost of approximately seven million dollars to Easley Combined Utilities. By 2019, upper parts of the lake had refilled with sediment, and surveys indicated the dredged area of the lake was already two-thirds filled in again (Figure 5). Current sediment removal cost estimates exceed ten million dollars. Understanding the importance of a more sustainable and cost-effective approach, SOS is working to reduce sedimentation and erosion upstream in the watershed through practices such as soil conservation, cover crops, heavy use area stabilization, streambank repair, buffer plantings, and livestock exclusion from creeks (Figures 6-8), as well as educating farmers on the importance of these practices. Many of these practices also have the added benefit of reducing bacteria.
