# **Twelvemile Creek Watershed Plan to Address *E. coli* Pollution, Pickens County, SC**

**MAY 2024**

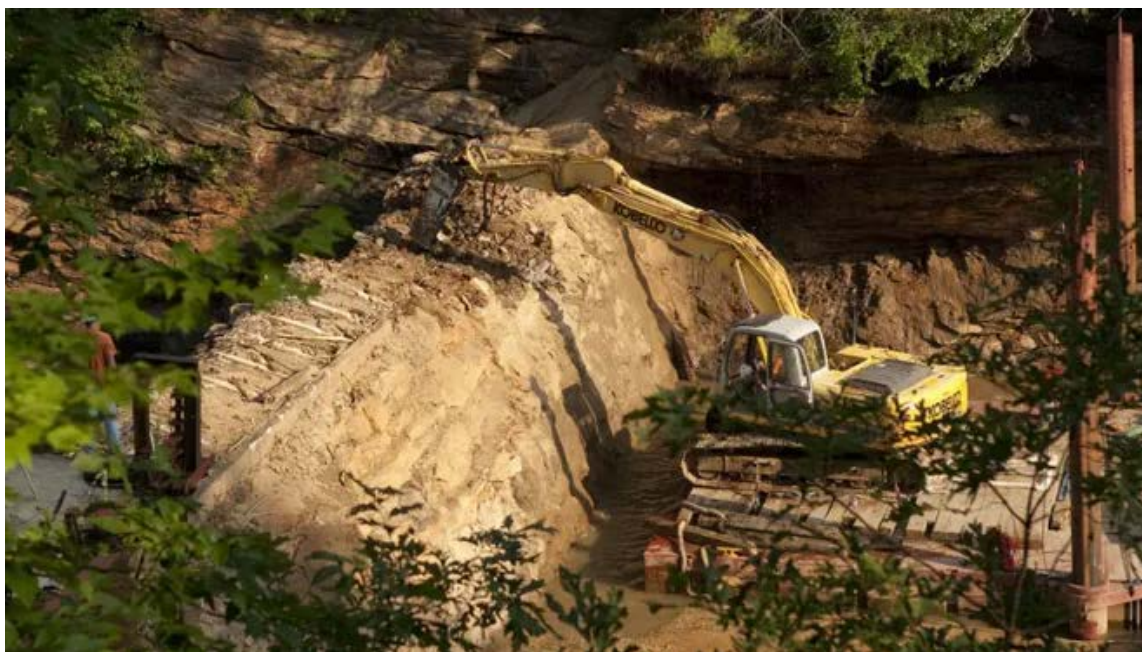
*Fig. 8. Demolition of the Woodside II Dam in July 2011 (Photo: Greenville News)*

The Sangamo-Weston, Inc. Superfund Site included seven disposal areas affected by PCB-contaminated soil and debris. More than 7000 tons of material were removed in the first remedial action, as well as capacitors and other pollution-releasing equipment. Primary contaminants of concern from this site to the Twelvemile and Lake Hartwell affecting soil, sludge, debris, and ground water are volatile organic carbons (VOCs) including PCE and TCE; and other organics including PCBs. In 2009, UF became involved in the Superfund cleanup to ensure that the river was restored to improve aquatic habitat for fish and to provide recreational opportunities. The contaminated sediment was removed from behind two dams known as Woodside I and II, and these dams were dismantled to allow clean sediment to cover remaining contaminated sediment to help naturally restore the river (Figures 8 and 9). Additionally, consultants implemented a stream restoration strategy to create a more natural channel for Twelvemile Creek that included creating a natural stream bank with rock toe, streambank vegetation, rock weirs, rock vanes, boulder placement, and cross vanes (Arcadis US, 2009). The single dam that remains on the Twelvemile mainstem is there to supply drinking water by Easley Central Utilities and to prevent non-native fish from depleting the native fish population.

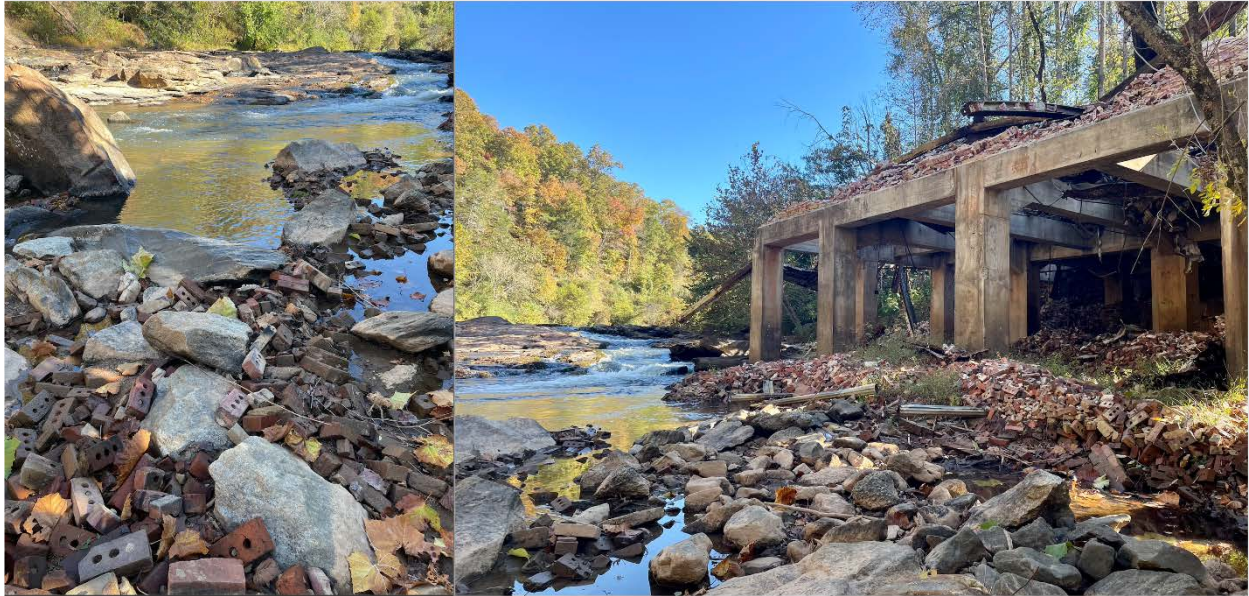
*Fig. 10. The Twelvemile Gorge still shows the industrial history of this area of Pickens County, SC.*

The watershed’s industrial history can also be viewed from the banks of the Twelvemile. As one walks along the creek in the Twelvemile Gorge, Central, SC, there are remains of a closed manufacturing facility (Figure 10). Along the shoreline, there are by the dozens what look like shiny black river rocks in all shapes and sizes (Figure 11). Upon further inspection, it is a very lightweight, scratchy foam material that floats easily, does not hold water, and is able to travel downstream from its original industrial location.

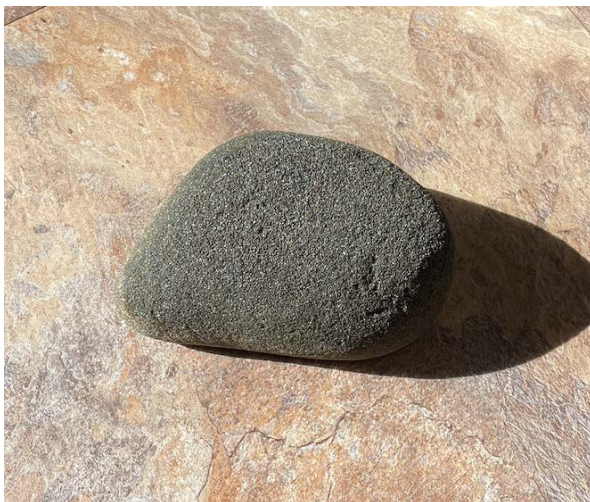
*Fig. 11. An example of the glass foam found in abundance along the shores of Twelvemile Creek within the gorge.*

100% inorganic material used for insulating roofs, walls, and below-grade surfaces such as slabs. It is typically produced in 18”x24” blocks. The high-compressive-strength insulation can be used without flame retardants and hazardous chemicals and is seen as a “green” building product for these reasons and because it can be created using recycled glass (Building Green, 2023). Iron sulfate is used in the manufacturing process, and a small amount of hydrogen sulfide is produced in the process, which is why the material emits a rotten egg smell when scratched. The detriment to the environment and aquatic life were not able to be determined within the scope of this project. The source of this material however was identified as insulation from the decaying facility at the rapids on Twelvemile Creek in the gorge. As the brick outer wall subsides, the rectangular foam insulation is exposed, falls, and is picked up by flood waters.

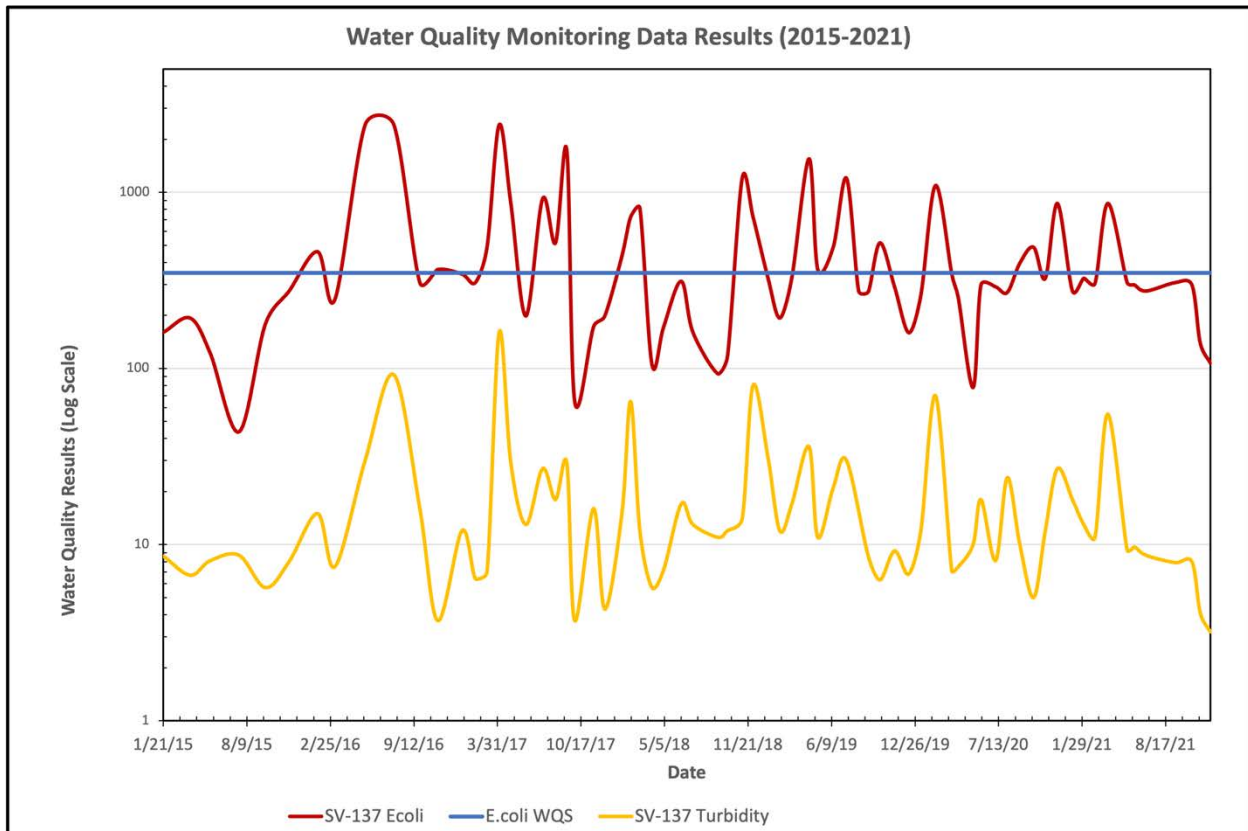
Fig. 14. *E. coli* and Turbidity results at SV-137 Twelvemile Creek, plotted on a logarithmic scale against the freshwater *E. coli* standard for single grab samples (349 MPN/100mL).

This very apparent relationship at SV-137 demonstrated between 2015 through 2021 exists in dry weather conditions. This demonstrates that managing sediment in the watershed, and its impacts on in-stream health and flow, would have great potential to address the exceedances of bacteria that are leading to impairment at this station. Potentially, managing the Twelvemile Creek’s ability to have improved flow rates within its channel could also reduce the levels of bacteria at this site.

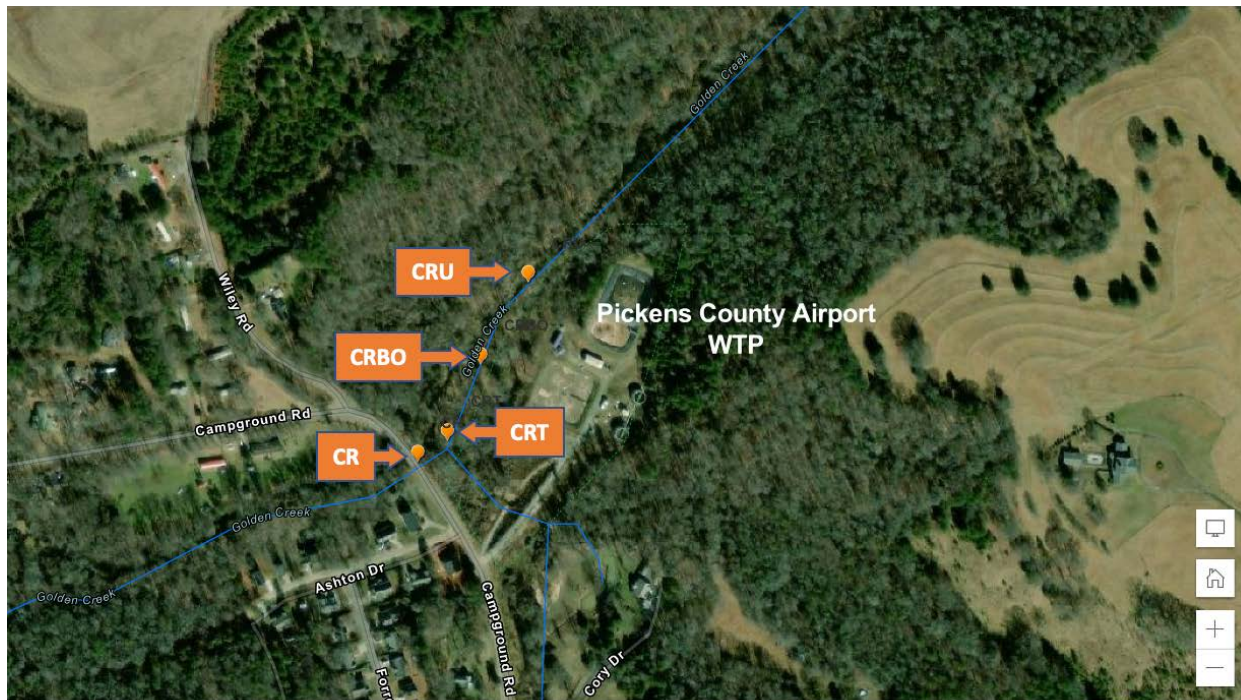
Fig. 15. Campground Road monitoring locations, sampled by the Pickens County Stormwater Department.

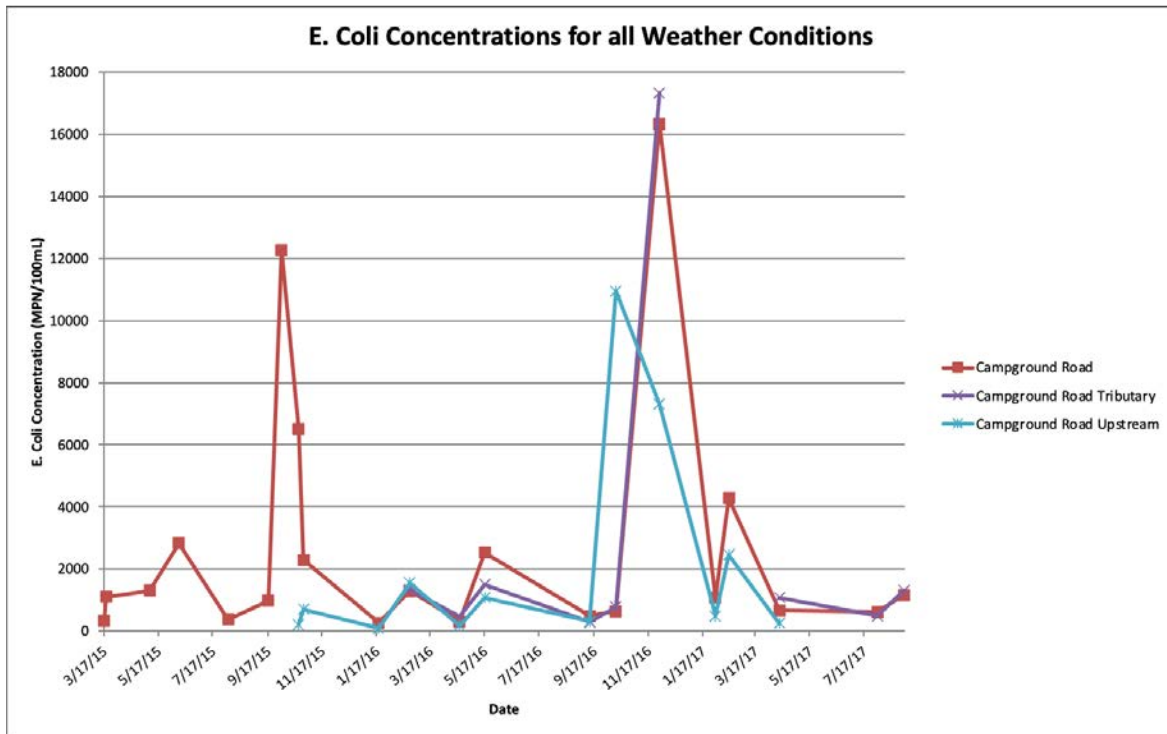
Fig. 16. *E. coli* results on Golden Creek at Campground Road area, Pickens County, SC.

The graphed data in Figure 16 demonstrates that bacteria loading to Golden Creek has the potential to contribute to the *E. coli* impairments observed downstream on the Twelvemile Creek at SV-137. Campground Road Tributary had the highest *E. coli* result of all recorded data 2015-2021 (the data considered for this watershed plan) at 17,330 MPN/100mL (n=14). Eighty-six percent of samples collected on this tributary exceeded the *E. coli* grab sample water quality standard of 349 col/100mL. The mainstem Golden Creek at Campground Road was impacted by the tributary's

discharge, with 85% of samples (n=26) exceeding the water quality standard and maximum recorded result of 16,330 col/100mL. Only seven samples were collected at the Campground Road Before Outfall site towards the later part of this study conducted by Pickens County. Results range from 452 to 1314 col/100mL, and 100% exceed the water quality standard.

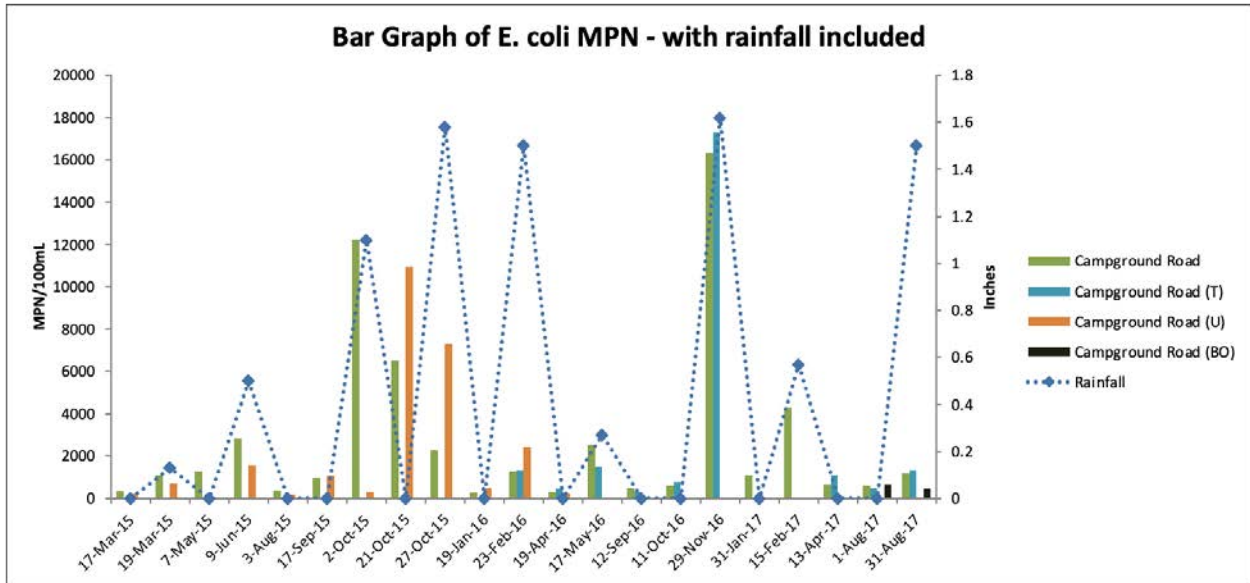
Fig. 17. Rainfall of 1” or more results in the highest E. coli concentrations seen at any site used in the development of this watershed plan.

Figure 17 further shows the impacts of the Campground Road Tributary to the already high *E. coli* at Golden Creek at Campground Road, most especially in the November 2016 wet weather data point. Rainfall greater than 1” is correlated to the highest *E. coli* counts of any monitoring site used in the development of this watershed plan. However, as shown in Figure 18, even dry weather events are greater than the individual grab sample standard (349 col/100mL), demonstrating a need for background pollutant mitigation and efforts that improve the management of wet weather bacteria loads.

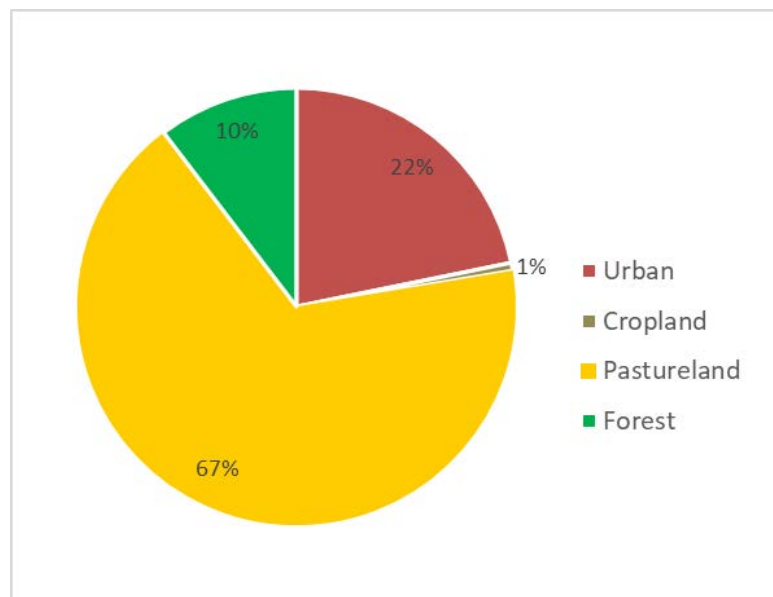
*Fig. 23. Sediment Loading per Land Use*

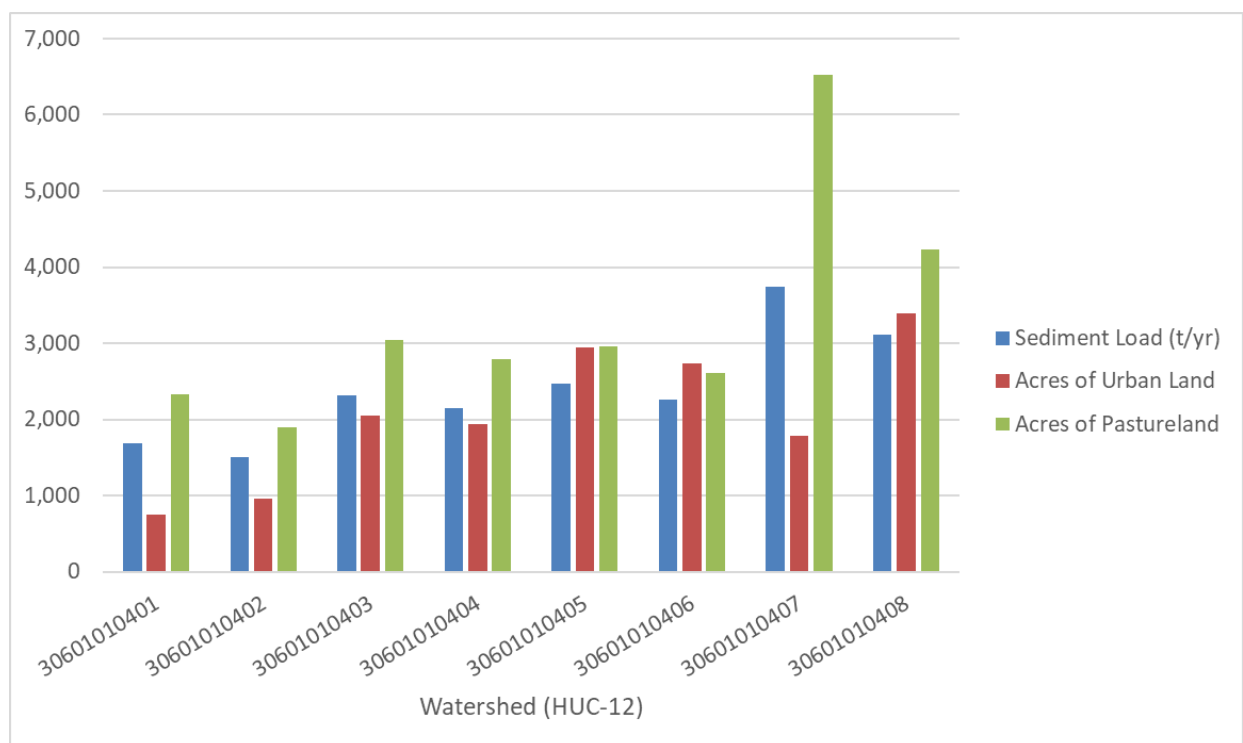
Fig. 24. Comparison between Sedimentation and Land Cover

Urban development is the next largest land-use contributor to sedimentation. Activities most associated with sedimentation from urbanization are land disturbances, channelization of streams, the expansion of impervious surfaces, and increases in stormwater runoff (SC AAS, 2018). Sediment pollution from urban areas is usually linked to mismanaged construction sites, but can also come from streets, yards, and the stream itself. Using the STEPL model for the Twelvemile Creek watershed, sedimentation is predicted as highest in the subwatersheds with higher urban land and pastureland, pointing to urban and agricultural activities as major contributors of sediment pollution in this area (Figure 24).

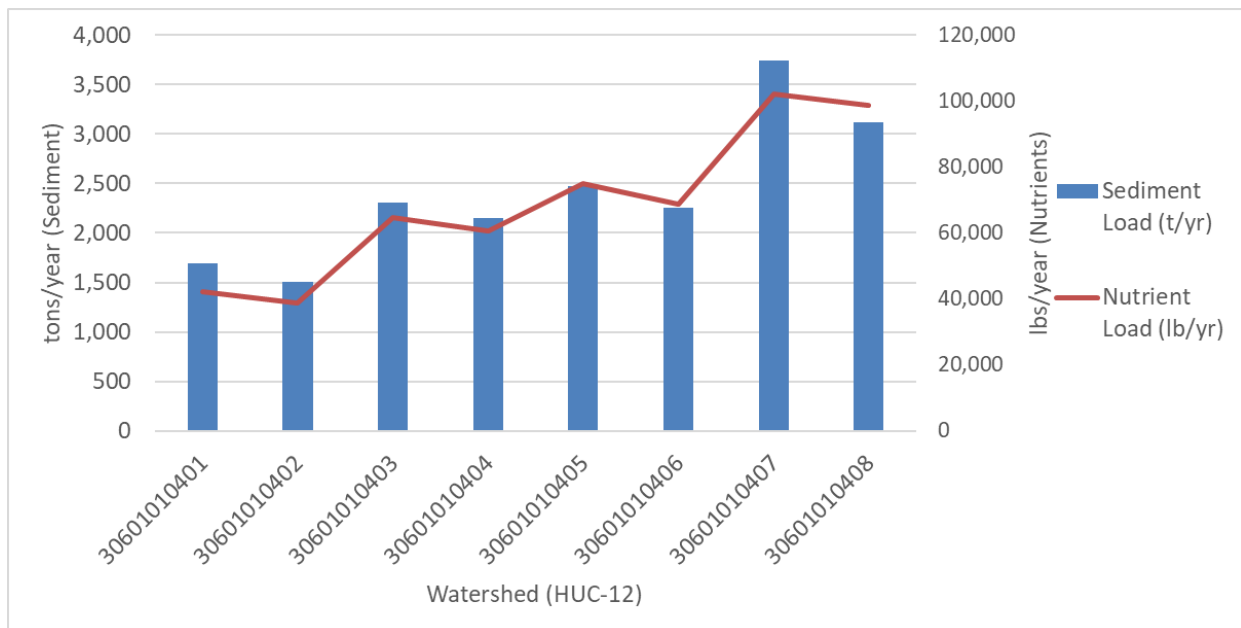
Fig. 27. Comparison between Sedimentation and Nutrient Loading

Sediment transport is a natural process that is exacerbated by land use changes such as deforestation, construction, agricultural practices, and developmental activities that accelerate erosion rates. Sediments contain organic matter, minerals, and nutrients, such as nitrogen and phosphorus. Nutrients are essential for the growth of aquatic plants and algae, but too much of them can cause eutrophication, which is a process that depletes oxygen in water and harms aquatic life. Therefore, where you see increased sediment pollution there is corresponding increased nutrient pollution that further degrades the quality of water for drinking, wildlife, and the land surrounding streams (Figure 27).

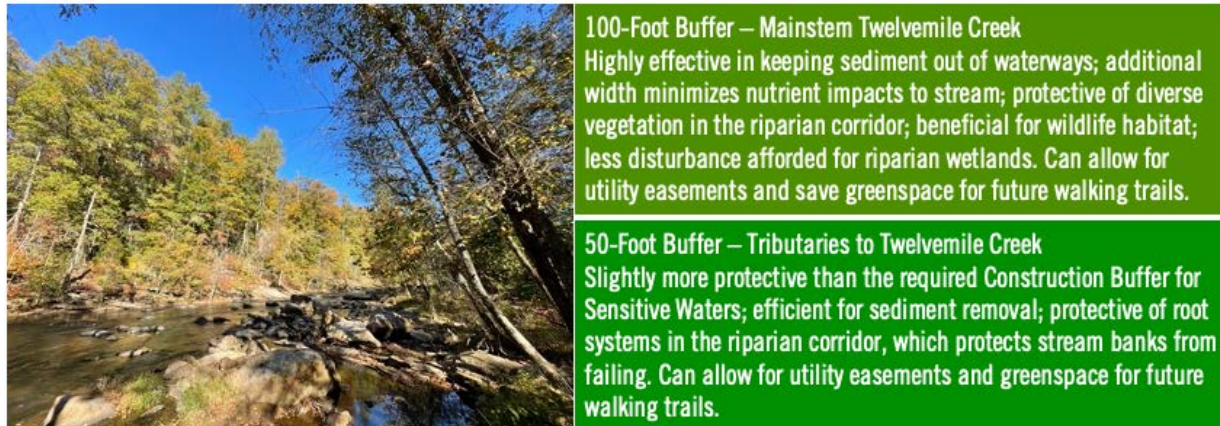
*Fig. 34. Forested riparian buffers are an inexpensive means to proactively conserving stream bank health, protecting water quality, building biodiversity, and providing corridors for wildlife; width is a significant factor to consider in regard to level of protection provided and goals for this watershed.*

mainstem Twelvemile Creek, with its wider stream width, a 100-foot buffer would be protective of the streambanks and manage nutrient and sediment runoff (Sections 3.2 and 3.3), both of which are contributing factors to the persistence of *E. Coli* found in this waterway. Both buffer widths will improve the chances that creeks will access their floodplain, preventing downstream scouring, erosion, and flooding, and building a more resilient watershed in extreme storm events (Figure 34).

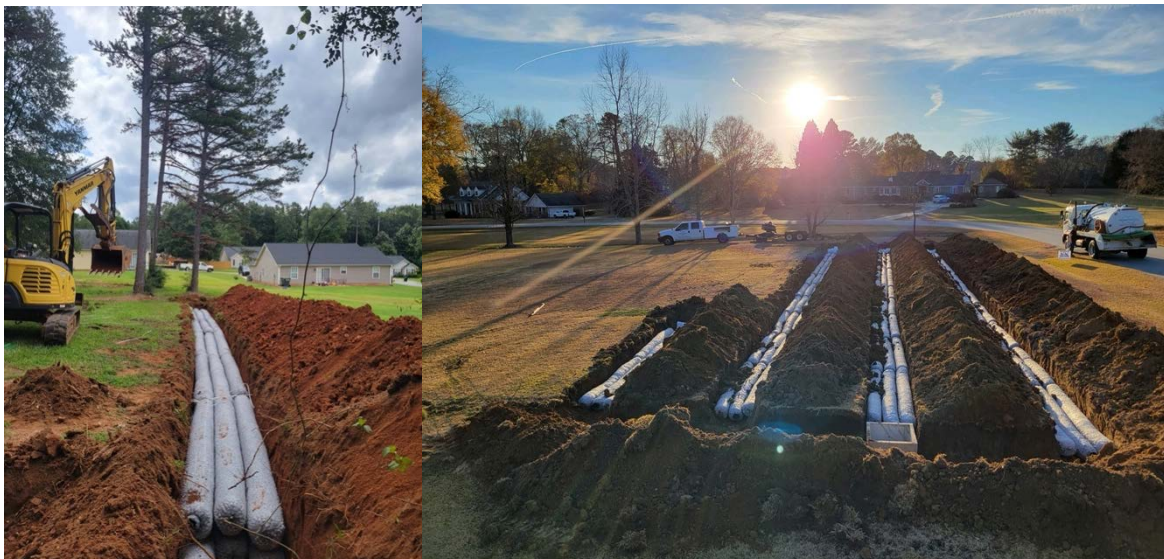
*Fig. 35. Examples of septic repair work in the Three and Twenty Creek watershed, which neighbors the Twelvemile River watershed. (photo provided by Upstate Forever).*

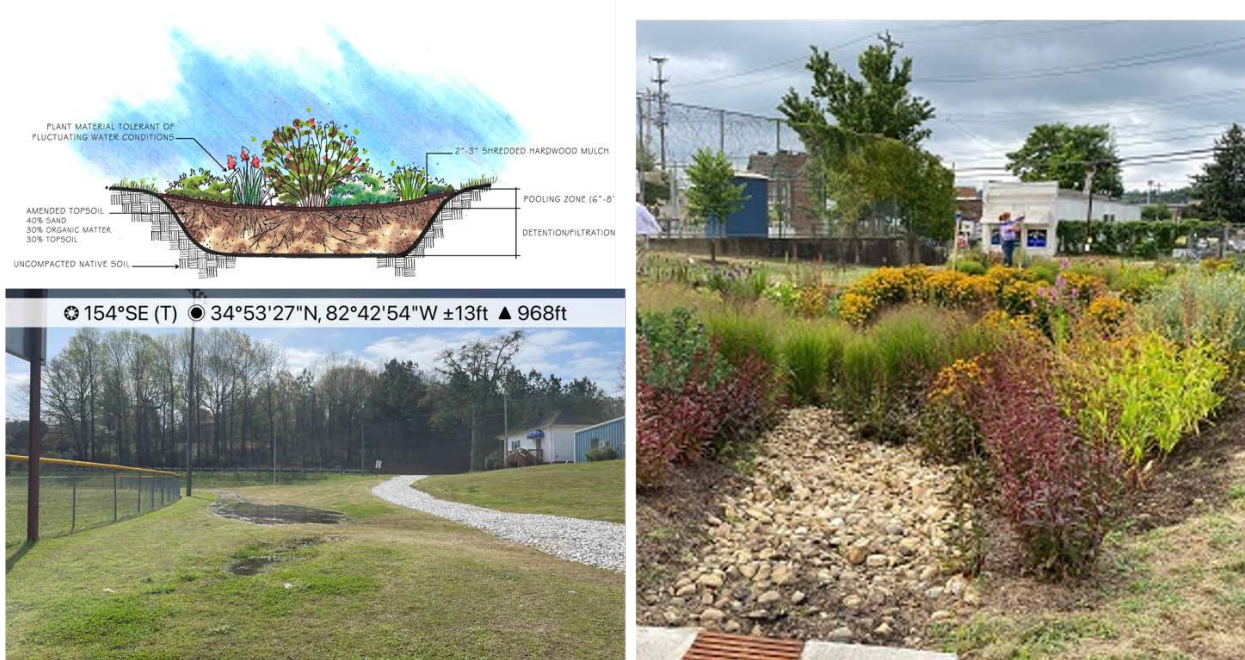
Fig. 39. The creation of a bioswale in this already pooling, low-lying area would provide beautification, stormwater treatment, and be an ideal location for education. Photo credits: Clemson Extension Carolina Clear Rain Garden illustration (top left), [bioretention basin photo from Western Pennsylvania Conservancy](#) (right), low-lying area at Jaycee Park (bottom left).

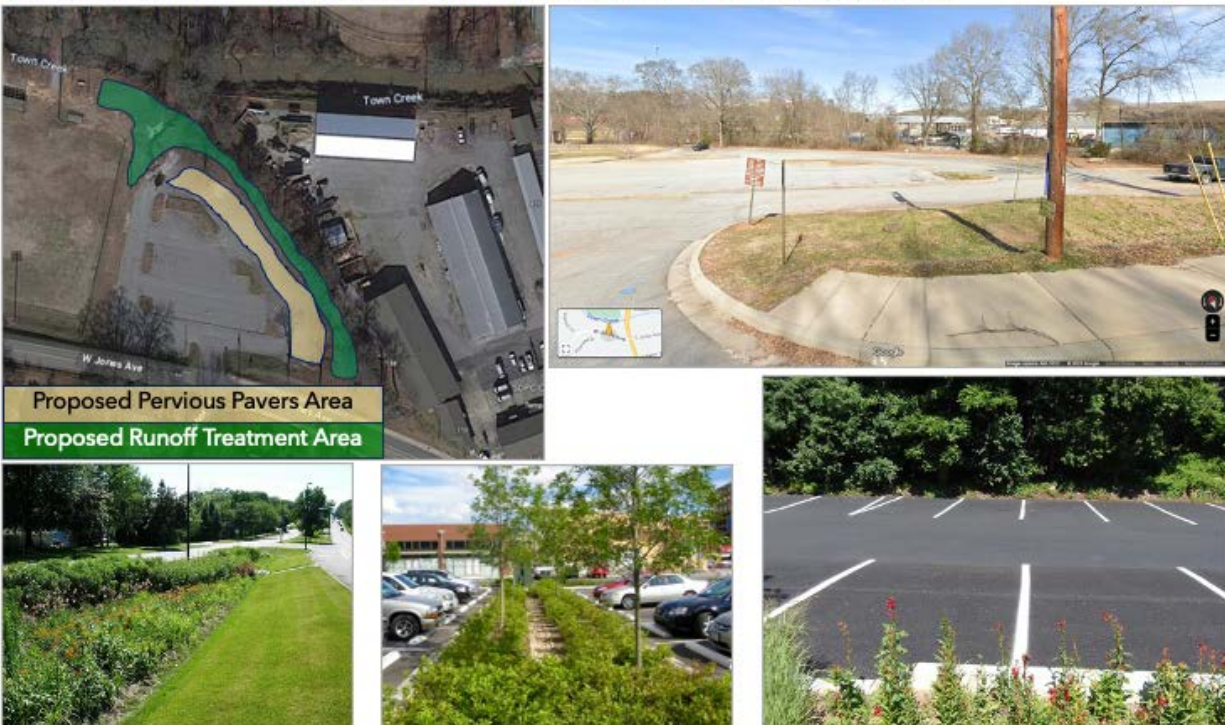
Fig. 41. Overview of large parking area's opportunities for stormwater treatment and retention (top left); street view of existing parking area (top right); example of [porous asphalt use in a parking lot with center drainage and no curbs](#) (bottom right); example of [curbless planted parking lot median with drainage from Pennsylvania State University Sea Grant](#) (bottom middle); example of [bioretention treatment area with curb cut](#) from RK&K (bottom left)

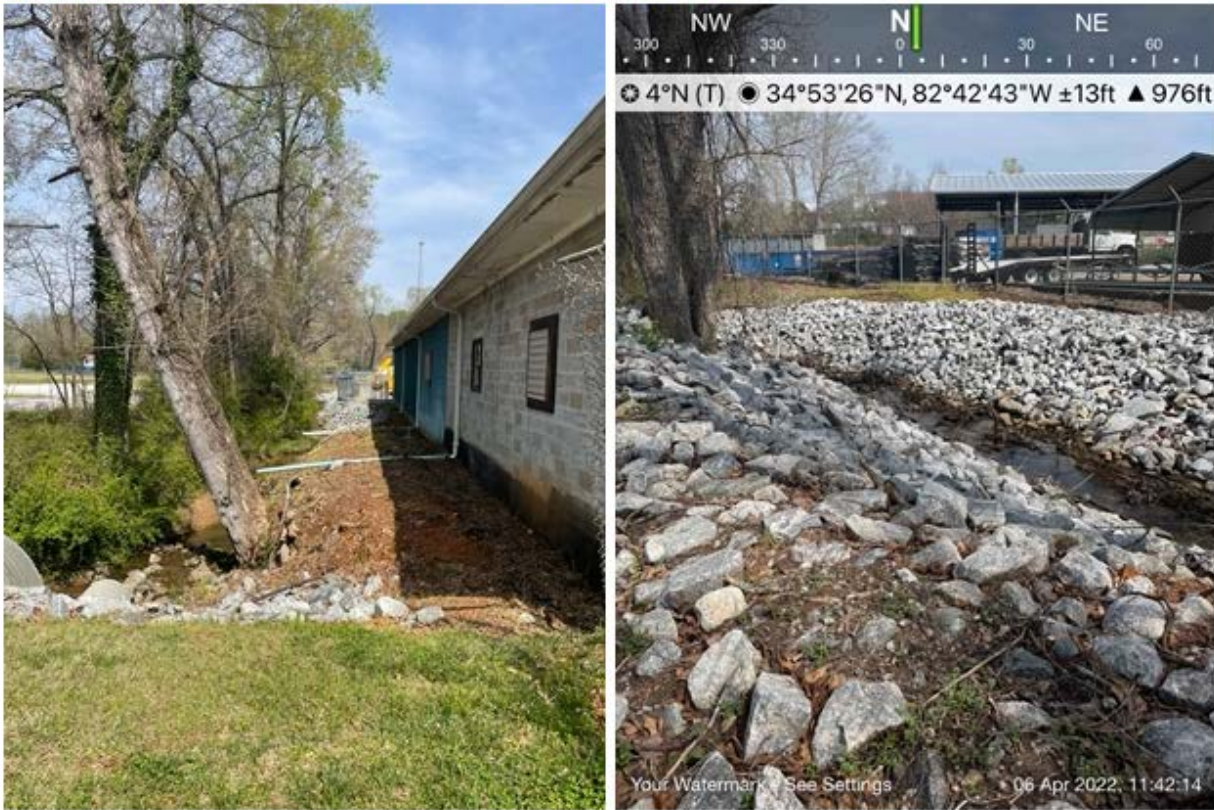
*Fig. 42. Disconnecting impervious surfaces from direct discharge to waterways is a critical stormwater pollution prevention strategy. Within these tight quarters shown in the top left image, a solution may be found to do just that as part of a larger park renovation and stream restoration plan. Restoring the tributary to a more natural state will also benefit pollutant attenuation, in comparison to the existing armoring at the tributary.*

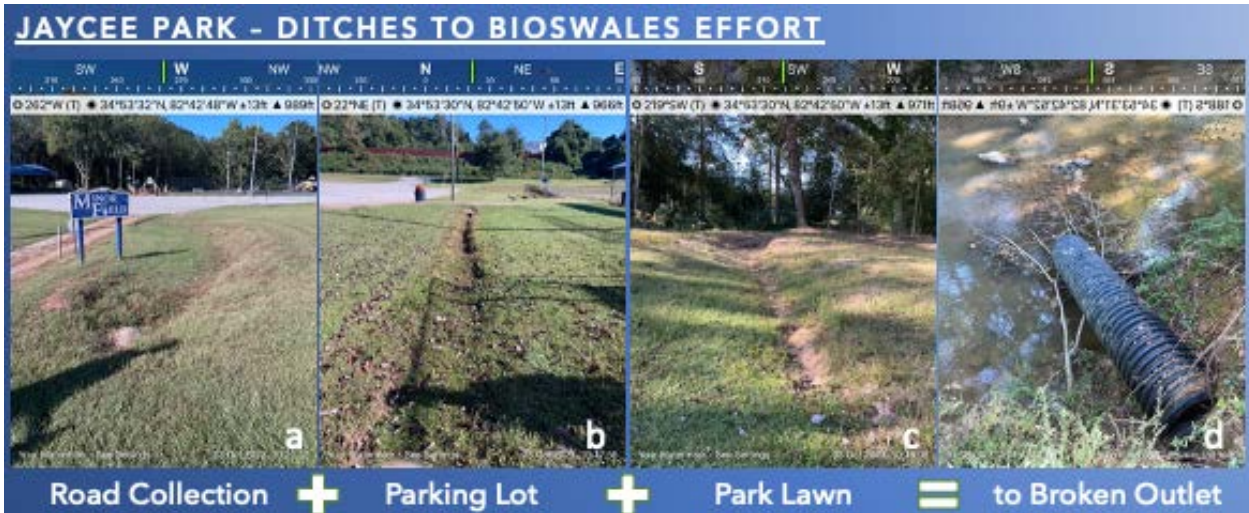
Fig. 43. Treatment train solution to stormwater runoff collection, ultimately reducing stormwater pollution in Town Creek.

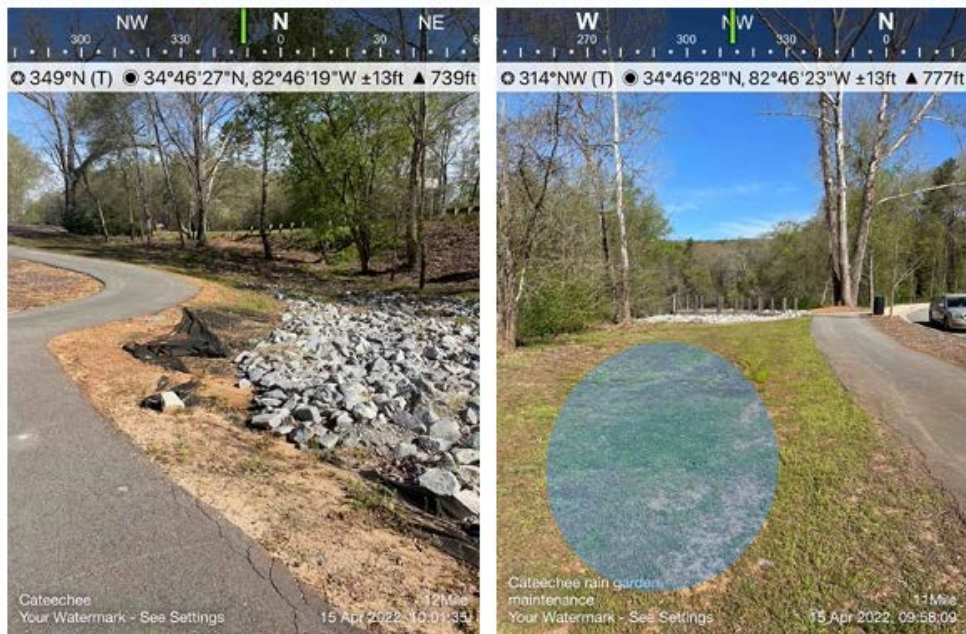
Fig. 45. Two rain garden opportunities for improved stormwater pollution prevention and enhanced groundwater storage. The right most image includes an area depicting the observed low point for stormwater capture and treatment.

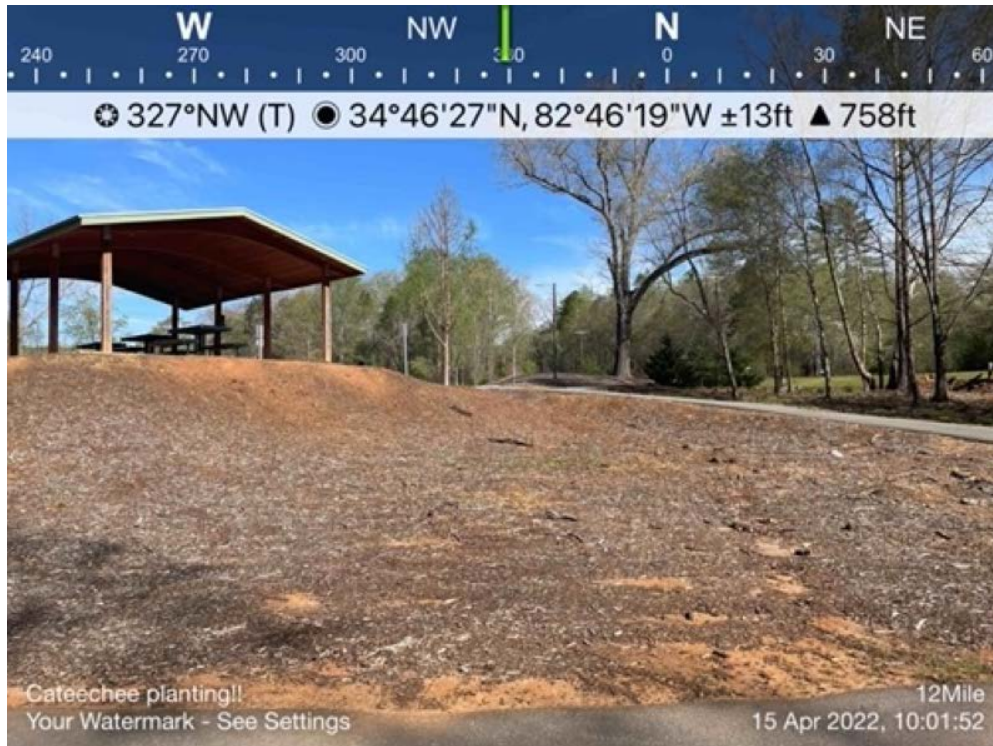
Fig. 46. The picnic shelter at Cateechee Point Park provides a great opportunity to demonstrate low impact landscaping design and ecological improvements that would also better manage the ongoing soil erosion.

The large picnic shelter at the top of this park sits in full sunlight. As shown in Figure 46, the surrounding area is actively eroding and will soon expose the concrete pad and leave it vulnerable for further erosion. In addition, it is likely high maintenance to manage incoming weeds and regularly restore the mulch cover.

This shelter makes for a great demonstration site for low impact landscaping (xeriscaping) that may aid homeowners and businesses in the watershed in better managing soil erosion. The following improvements are recommended for water quality and ecological improvements. The site should first be evaluated to identify the need for regrading. Much erosion has occurred since initial construction, and topsoil may be needed for the recommended plantings to establish. Municipal and county compost, if available, could be a good and free source for organic material to enrich the soils on this hillside.
