PRO DISPOSAL USA (BARNWELL RESOURCES) CLASS 2 LANDFILL

P1TJ-QJAP-426

| Solid Waste - Class 2 Landfill | |
| Reason for Inspection | Routine |

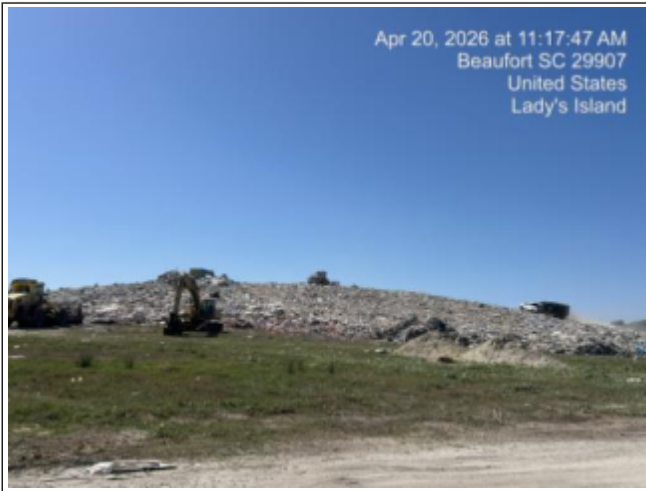
| 16. Working face as small as can efficiently and safely be managed | Yes |

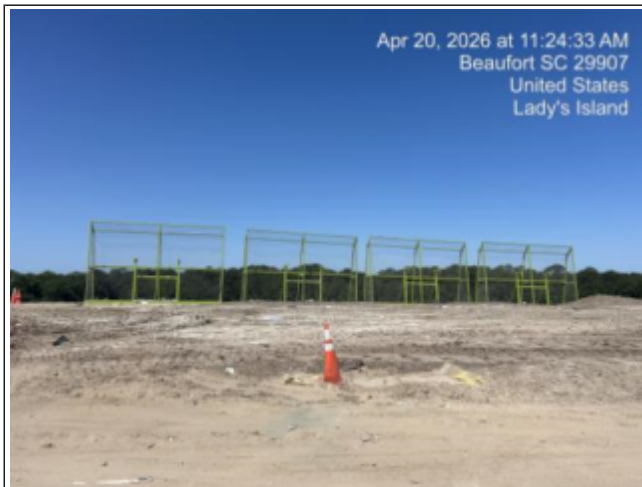
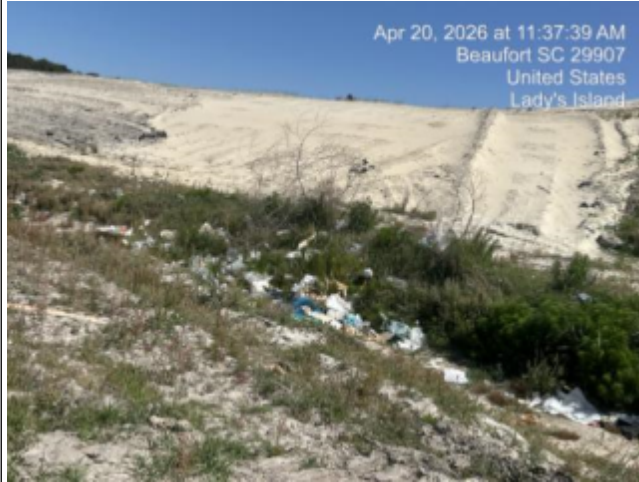
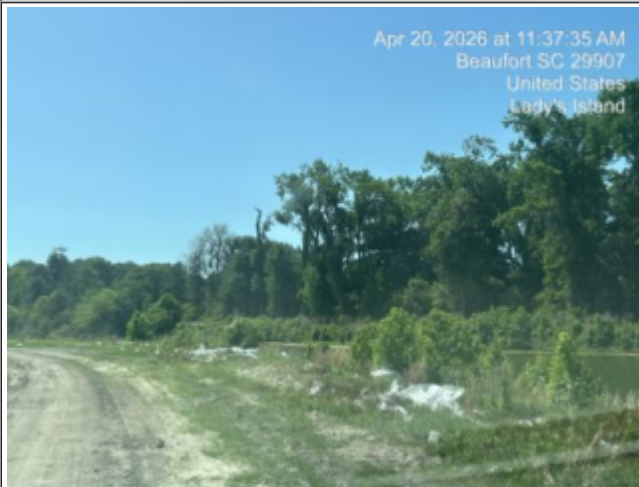
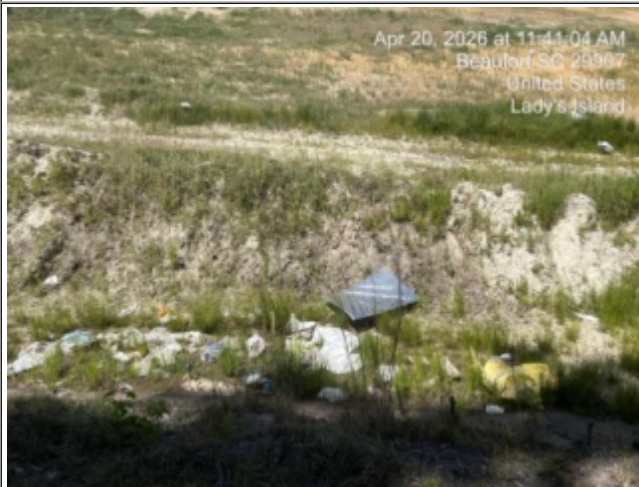
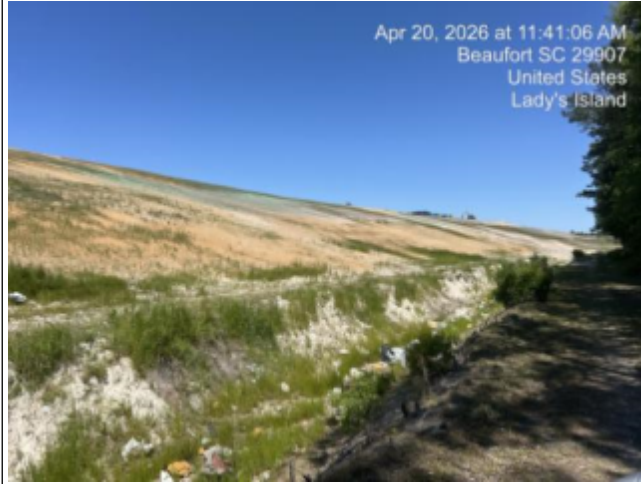
26. Control of Litter No

Litter fences have been installed up top adjacent to working face, but wind blown litter in ditches is still significant.

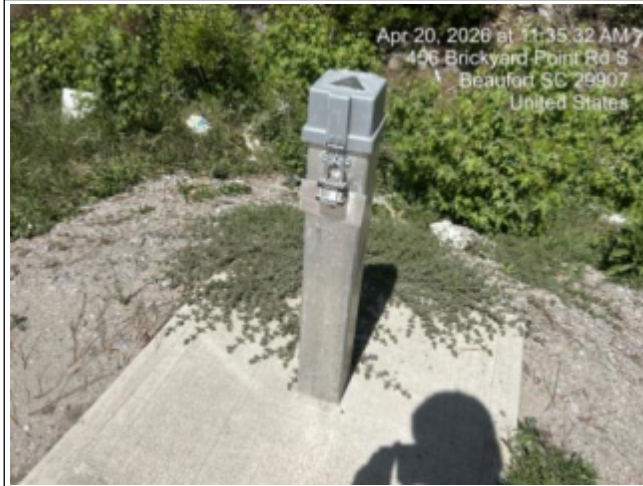
Photo Taken: 04/20/2026 11:35:00 AM
 GPS Latitude: 32.4726027777778
 GPS Longitude: -80.6512
 GPS Altitude: 5.22 meters
 GPS Orientation: 1 degrees

35. Monitoring wells are locked Yes

MW4 noted on last inspection is now locked. New locks on all wells have been installed.

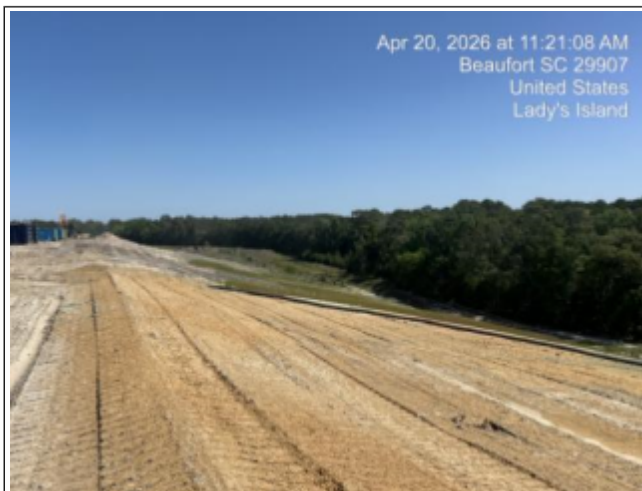
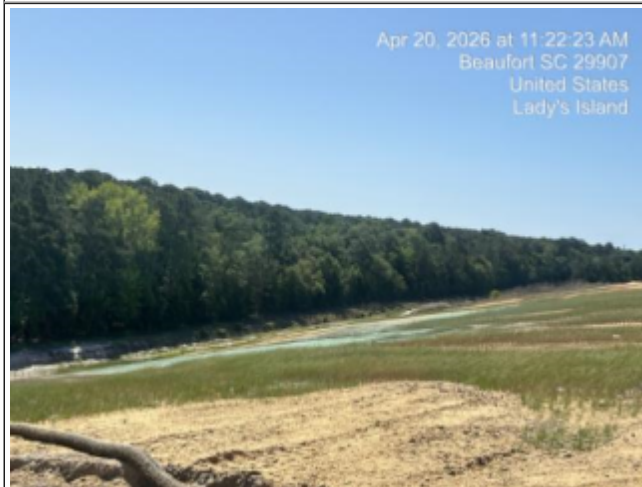
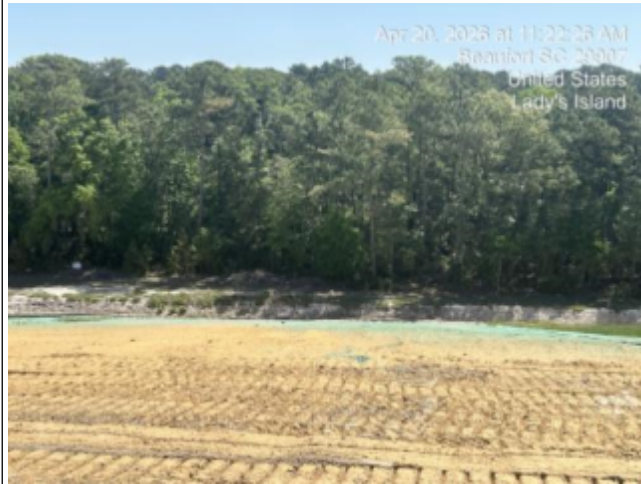
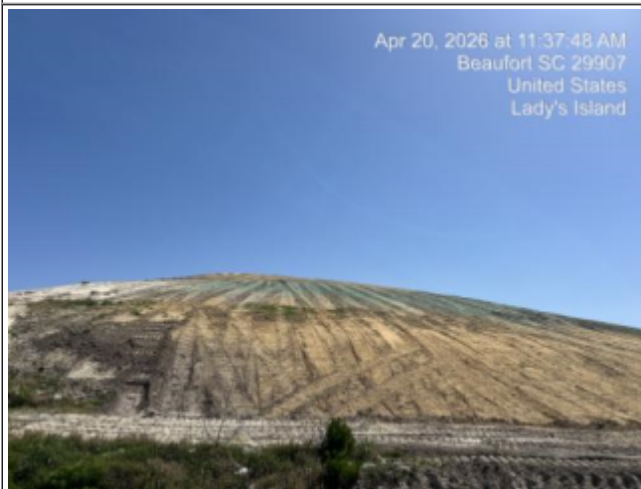
Bare slopes have been hydroseeded and facility has done some manual watering, but lack of rain is making growth slow. Working face will be moved soon to the south end of the landfill peak. Operator states they have chosen a contractor for a gas management system, with final plans due to be presented to Solid Waste and Air teams in Columbia soon for approval.
