PRO DISPOSAL USA (BARNWELL RESOURCES) CLASS 2 LANDFILL

P1TJ-QJAP-426

Solid Waste - Class 2 Landfill	
Facility	
Facility Name	PRO DISPOSAL USA (BARNWELL RESOURCES) CLASS 2 LANDFILL
Date of Inspection	2/12/2026
Time of Inspection	1:55 PM
County	Beaufort
Permit #	072410-1201
Inspection Processing	
Reason for Inspection	Routine
Weather Conditions	Sunny
Temperature	60s
Rainfall in past week	0-0.5
Weather Condition Description	
Last Inspection	01/21/2026
Inspection Detail	
1. Attendant Present	Yes
2. Required signs posted	Yes
3. Inspection of all incoming loads conducted	Yes
4. Unauthorized waste training conducted and documented	Not Inspected
5. No unauthorized waste present	Yes
6. Access controlled	Yes
7. Adequate entrance all-weather roads	Yes
8. Adequate internal all-weather haul roads	Yes

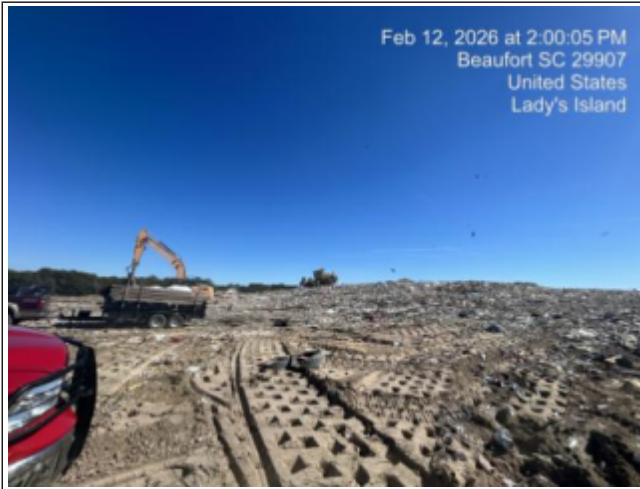
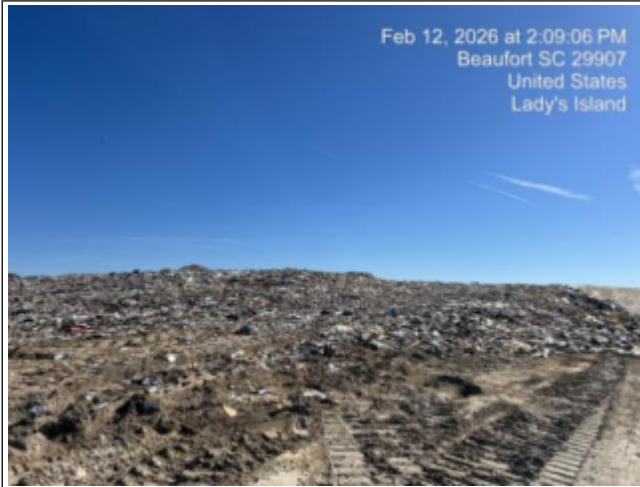
15. Waste spread in uniform layers and compacted to smallest practical volume Yes

Photo Taken: 02/12/2026 02:00:00 PM
 GPS Latitude: 32.47169444444445
 GPS Longitude: -80.6494305555557
 GPS Altitude: 26.26 meters
 GPS Orientation: 1 degrees

Photo Taken: 02/12/2026 02:09:00 PM
 GPS Latitude: 32.47173333333333
 GPS Longitude: -80.64951388888889
 GPS Altitude: 20.3 meters
 GPS Orientation: 1 degrees

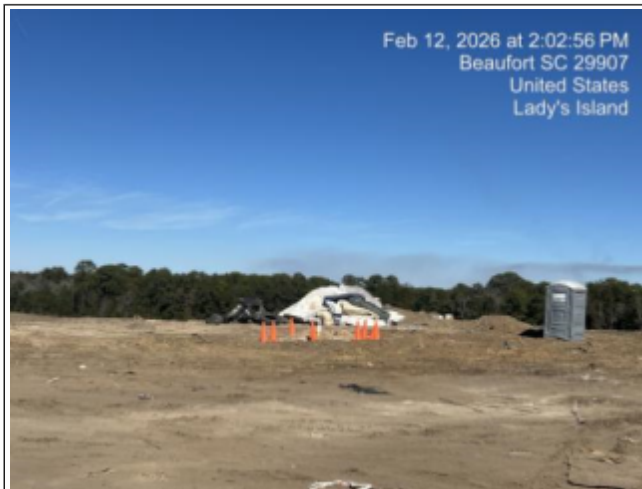
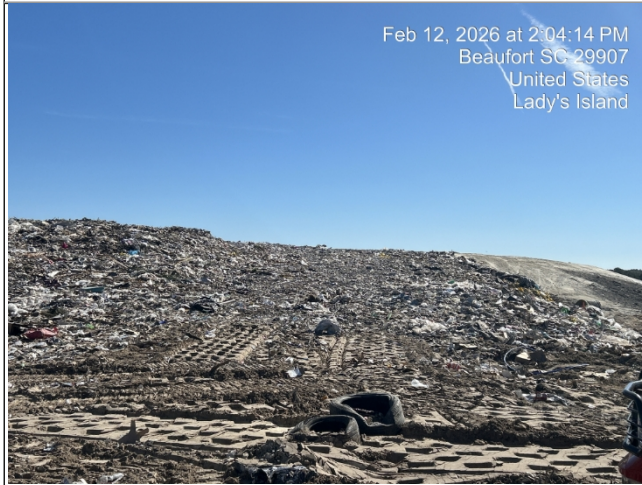
New ramp being built for access to top of landfill before new waste is diverted there. Tarp is now on site for end of day cover of truck turn-around area beside working face. Tarp will be applied at the end of each working day for overnight cover and removed in mornings. The gas monitoring project data has been sent off and the facility should have a decision on gas management going forward by next week.

Photo Taken: 02/12/2026 02:02:00 PM
GPS Latitude: 32.4718888888889
GPS Longitude: -80.64938333333335
GPS Altitude: 25.77 meters
GPS Orientation: 1 degrees

Photo Taken: 02/12/2026 02:04:00 PM
GPS Latitude: 32.4718888888889
GPS Longitude: -80.64938333333335
GPS Altitude: 25.77 meters
GPS Orientation: 1 degrees
