PRO DISPOSAL USA (BARNWELL RESOURCES) CLASS 2 LANDFILL

P1TJ-QJAP-426

Inspector: Colin Scherer

Start Date: 03/19/2026 Completed Date: 03/19/2026

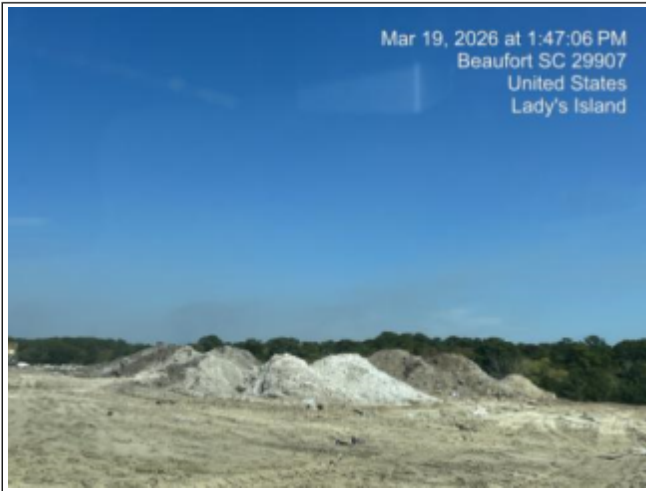
Photo Taken: 03/19/2026 01:47:00 PM
 GPS Latitude: 32.47099444444444
 GPS Longitude: -80.64906944444445
 GPS Altitude: 21.23 meters
 GPS Orientation: 1 degrees

12. > Six inches of soil (long-term and/or intermediate cover) meets regulatory/permit requirements Yes

13. Adequate soil quantity available for cover Yes

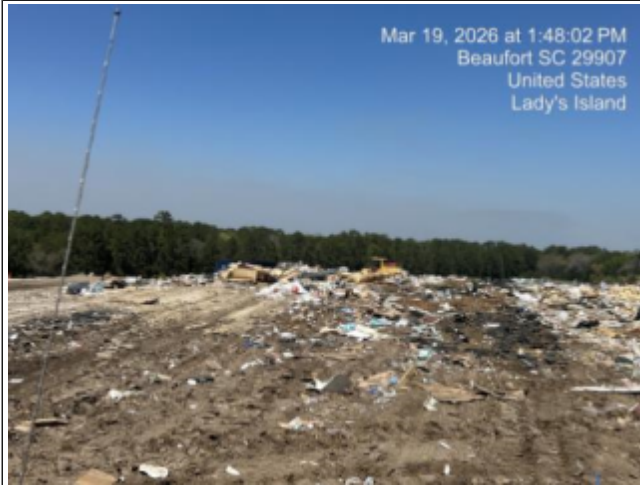
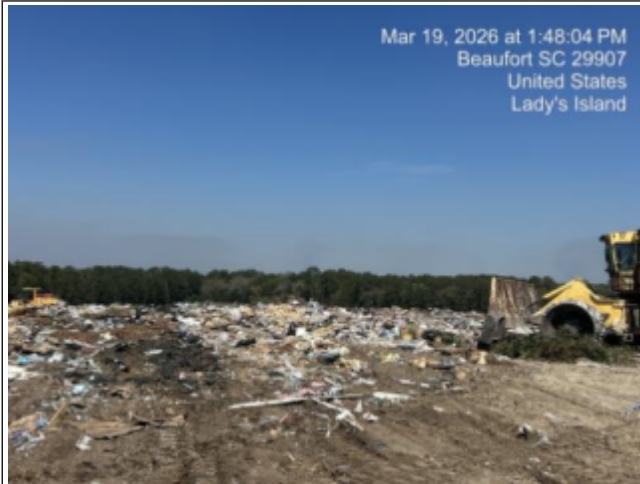
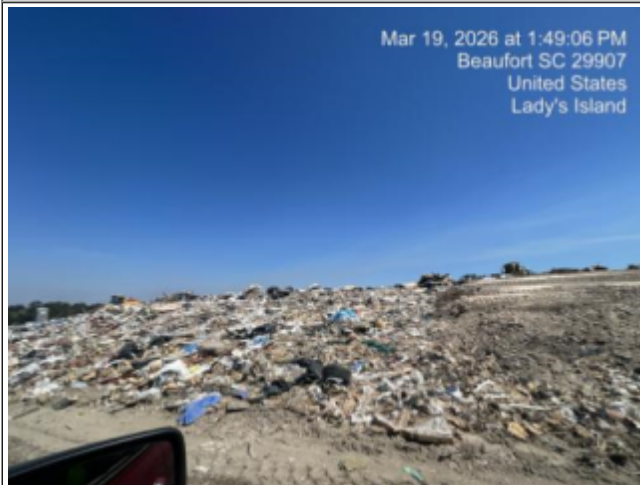
Photo Taken: 03/19/2026 01:48:00 PM
GPS Latitude: 32.47099444444444
GPS Longitude: -80.64906944444445
GPS Altitude: 21.23 meters
GPS Orientation: 1 degrees

14. Working face slope does not exceed 3:1 Yes

15. Waste spread in uniform layers and compacted to smallest practical volume Yes

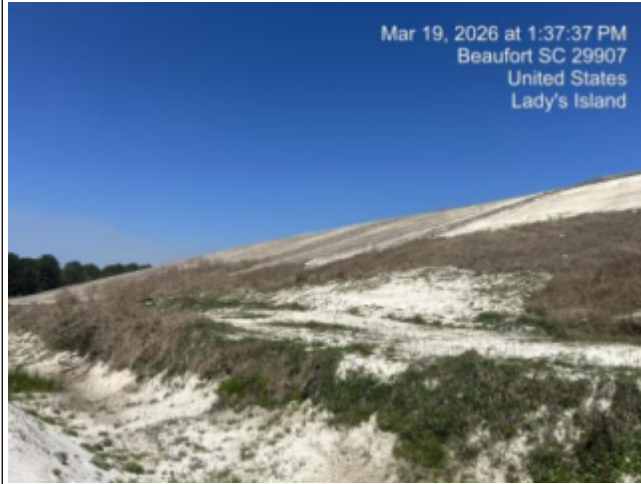
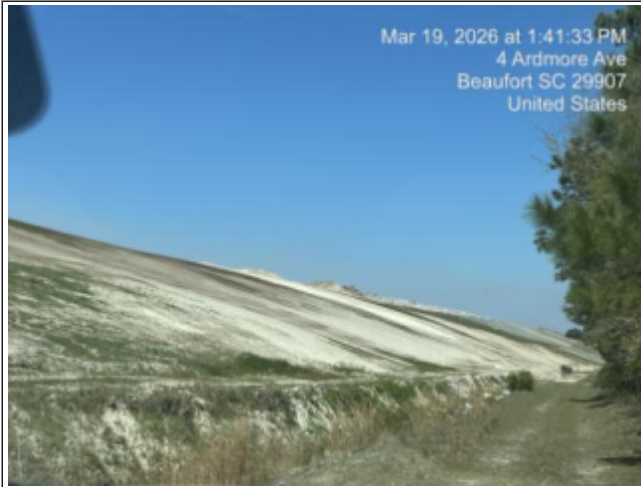
Photo Taken: 03/19/2026 01:37:00 PM
 GPS Latitude: 32.469136111111111
 GPS Longitude: -80.6494888888889
 GPS Altitude: 4.25 meters
 GPS Orientation: 1 degrees

23. Adequate condition of berms/terraces/downchutes Yes

Facility will be seeding bare slopes soon with warmer weather

Work on getting litter under control and seeding bare areas. Operator states facility is getting quotes for gas management system (collection / flares); this could help manage H2S and odors. Current location of fill will be full in a few days, then operator states they are moving working face to peak of landfill and filling until final elevation is reached. Final cap will then be placed up top. Tarp is present for covering thinner truck turn-around area adjacent to working face.

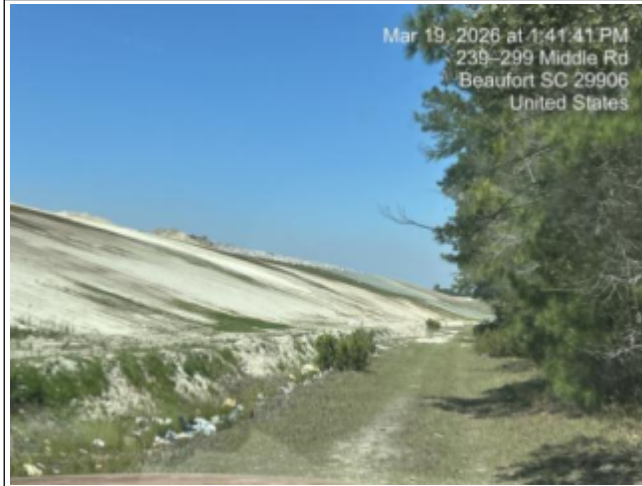
Photo Taken: 03/19/2026 01:41:00 PM
 GPS Latitude: 32.4689305555556
 GPS Longitude: -80.64746111111111
 GPS Altitude: 6.96 meters
 GPS Orientation: 1 degrees

26. Control of Litter No

Blown litter is significant in ditch along eastern edge.

Get litter under control and lock for newest GW monitoring well.

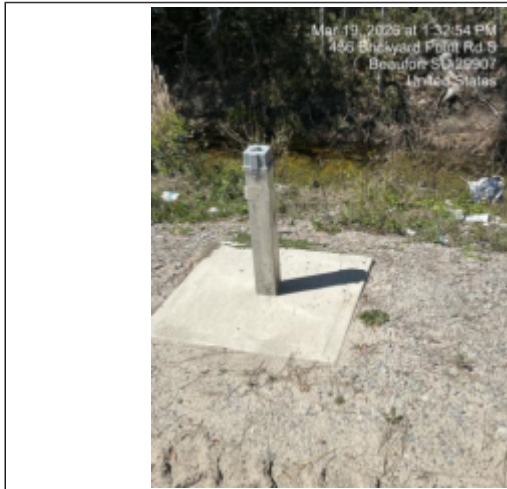
Photo Taken: 03/19/2026 01:32:00 PM
 GPS Latitude: 32.4726527777778
 GPS Longitude: -80.65114722222222
 GPS Altitude: 4.33 meters
 GPS Orientation: 6 degrees

35. Monitoring wells are locked No

Newest well (MW-4) does not have lock yet.
