Twelvemile Creek Watershed Plan to Address *E. coli* Pollution, Pickens County, SC

MAY 2024

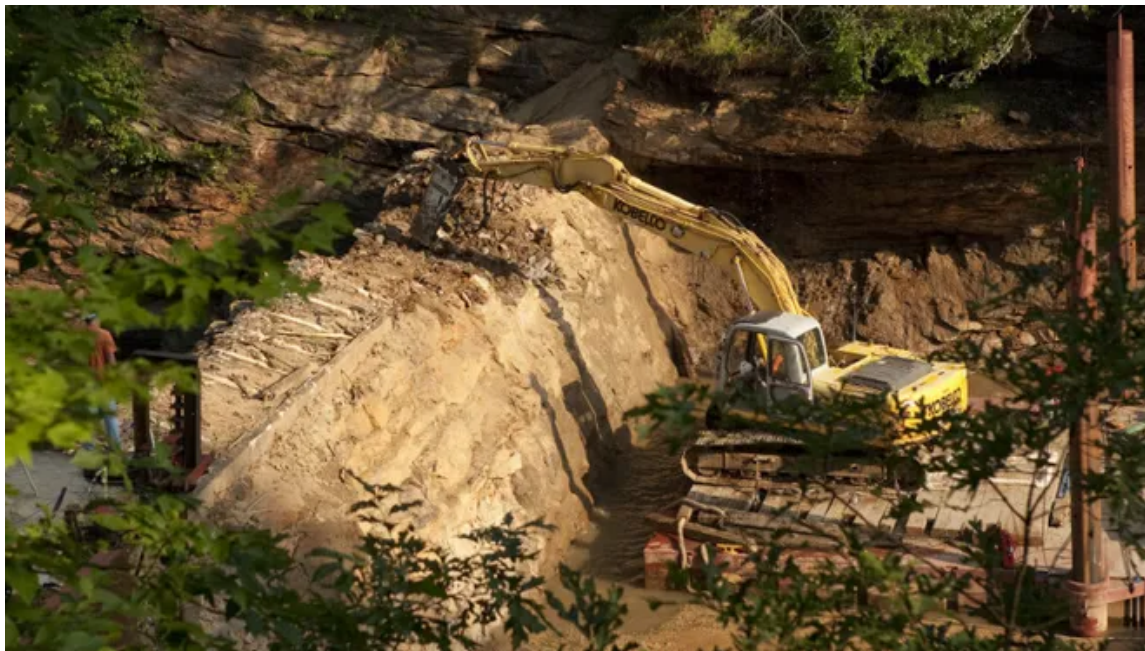
Fig. 8. Demolition of the Woodside II Dam in July 2011 (Photo: Greenville News)

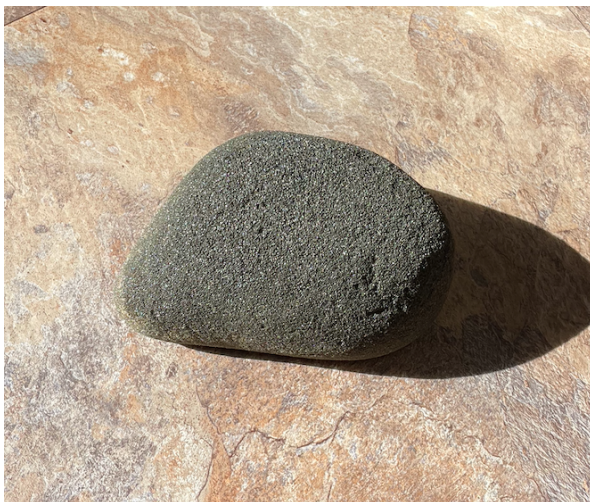
Fig. 11. An example of the glass foam found in abundance along the shores of Twelvemile Creek within the gorge.

100% inorganic material used for insulating roofs, walls, and below-grade surfaces such as slabs. It is typically produced in 18”x24” blocks. The high-compressive-strength insulation can be used without flame retardants and hazardous chemicals and is seen as a “green” building product for these reasons and because it can be created using recycled glass (Building Green, 2023). Iron sulfate is used in the manufacturing process, and a small amount of hydrogen sulfide is produced in the process, which is why the material emits a rotten egg smell when scratched. The detriment to the environment and aquatic life were not able to be determined within the scope of this project. The source of this material however was identified as insulation from the decaying facility at the rapids on Twelvemile Creek in the gorge. As the brick outer wall subsides, the rectangular foam insulation is exposed, falls, and is picked up by flood waters.

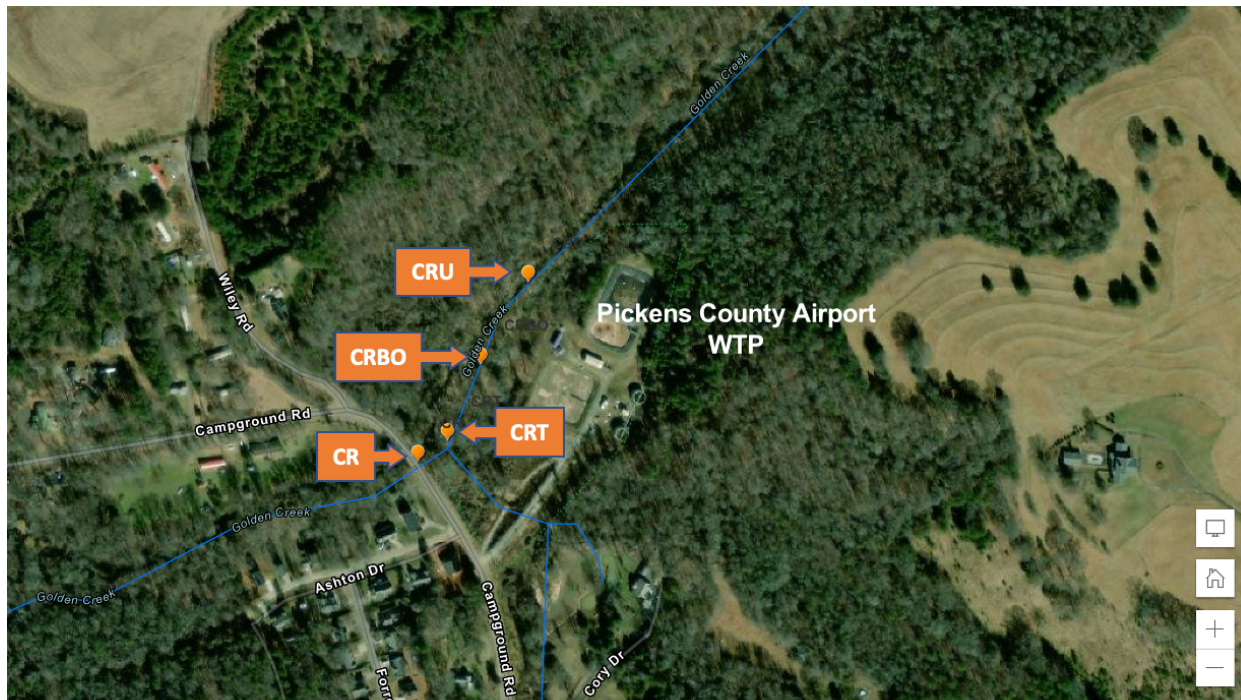
Fig. 15. Campground Road monitoring locations, sampled by the Pickens County Stormwater Department.

- Campground Road (CR),
- Campground Road Upstream,
- Campground Road Before Outfall,
- Campground Road Tributary.

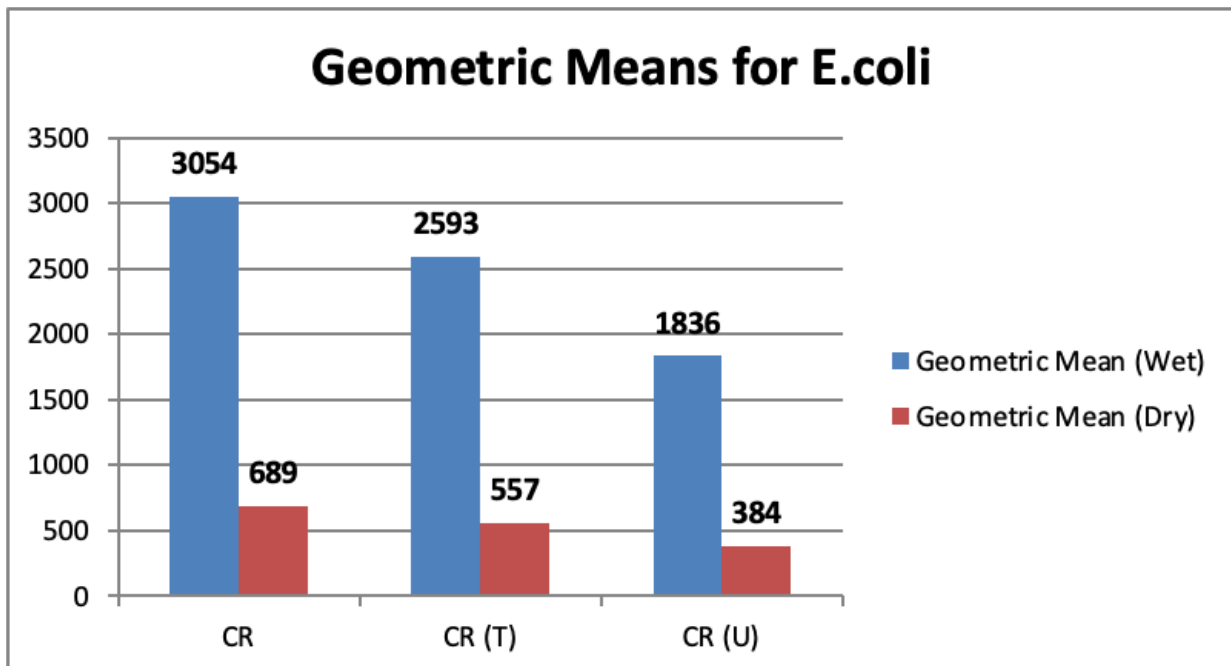
Fig. 18. Golden Creek and the tributary monitored to Golden Creek demonstrate high E. coli bacteria during both dry and wet weather monitoring events, though certainly exacerbated during and after rain events.

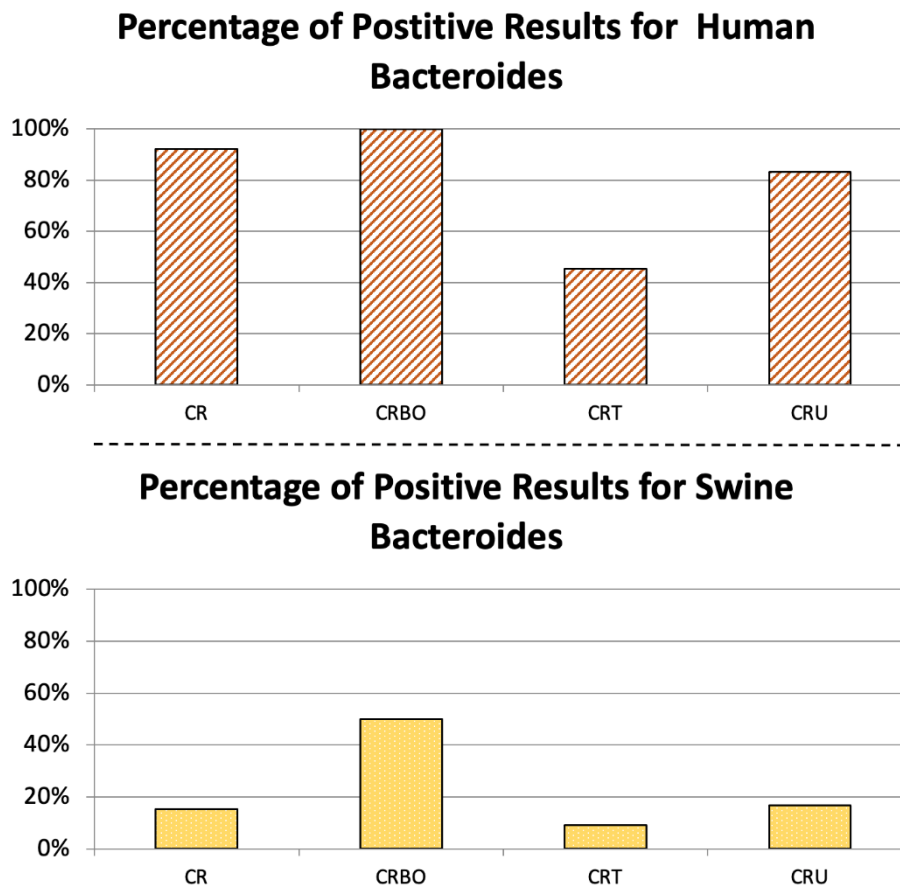
Fig. 19. Considering only monitoring results greater than the single grab sample water quality standard, human waste was the most significantly identified contributor to exceedances, followed by swine.

Results shown in Figure 19 indicate that there was a *near constant input of human fecal waste during the four-year timeframe of this sampling effort at all four monitoring stations*, followed by the positive presence of swine, most notably at the Campground Road Before Outfall site.

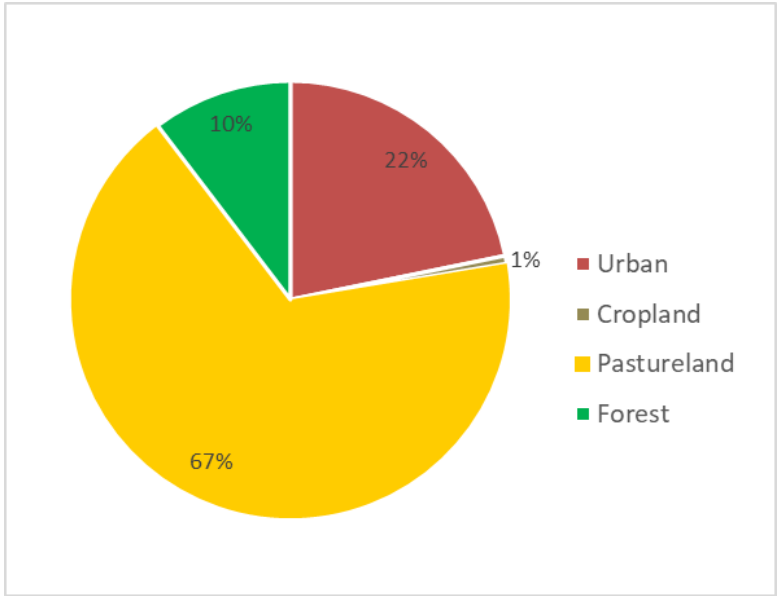
Fig. 23. Sediment Loading per Land Use

Watershed (HUC-12)	Waterway	Sediment Loading (tons/year)
30601010401	Middle Fork Twelvemile Creek	1,689
30601010402	North Fork Twelvemile Creek	1,508
30601010403	Town Creek	2,310
30601010404	Wolf Creek	2,147
30601010405	Rices Creek	2,471
30601010406	Golden Creek	2,259
30601010407	Upper Twelvemile Creek-Keowee River	3,746
30601010408	Lower Twelvemile Creek-Keowee River	3,118

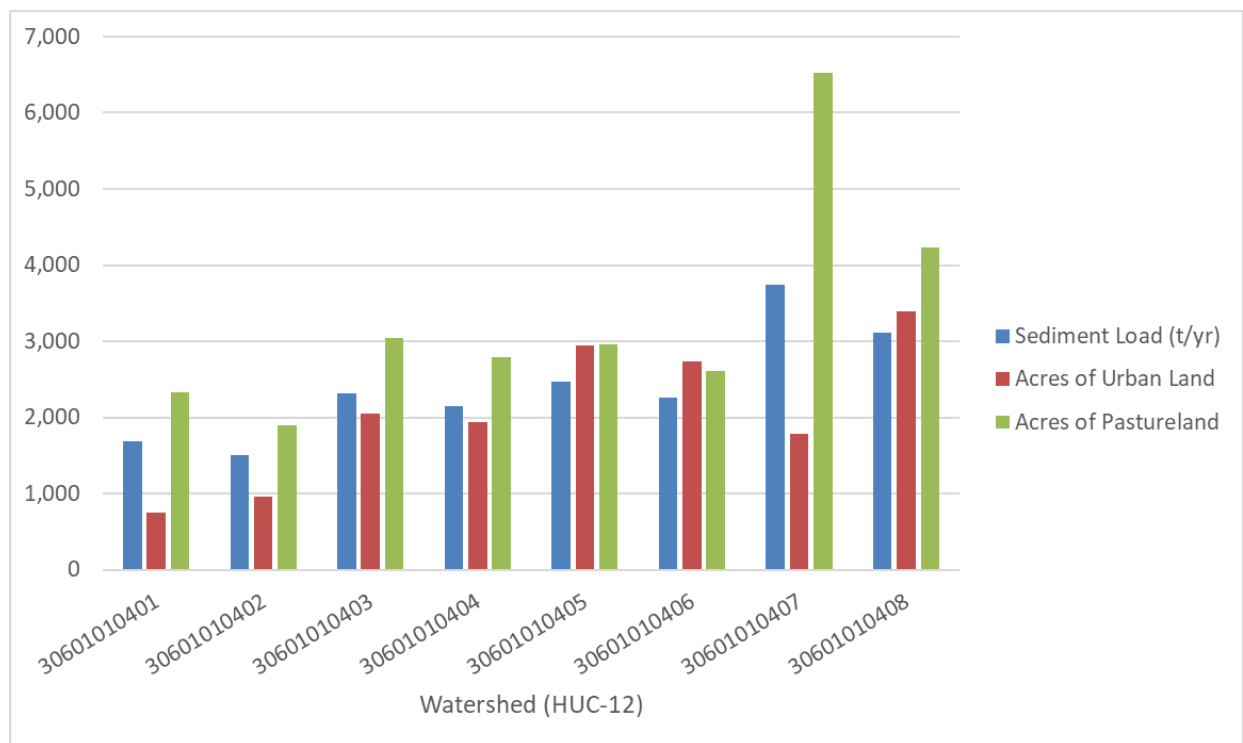
Fig. 24. Comparison between Sedimentation and Land Cover

Urban development is the next largest land-use contributor to sedimentation. Activities most associated with sedimentation from urbanization are land disturbances, channelization of streams, the expansion of impervious surfaces, and increases in stormwater runoff (SC AAS, 2018). Sediment pollution from urban areas is usually linked to mismanaged construction sites, but can also come from streets, yards, and the stream itself. Using the STEPL model for the Twelvemile Creek watershed, sedimentation is predicted as highest in the subwatersheds with higher urban land and pastureland, pointing to urban and agricultural activities as major contributors of sediment pollution in this area (Figure 24).

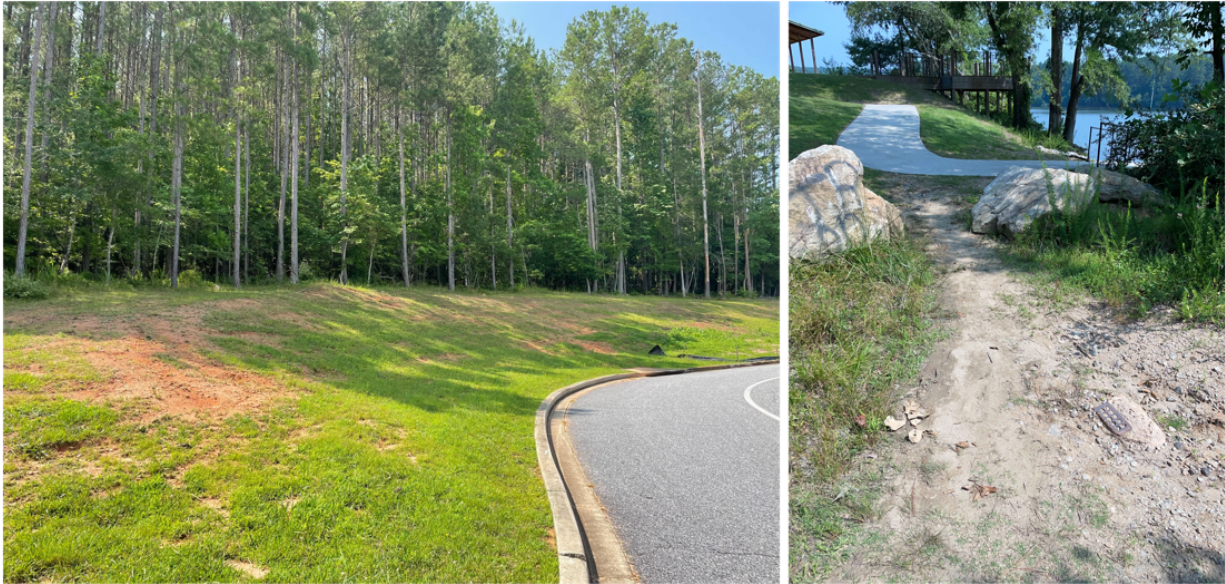
Fig. 25. Sources of sediment are prevalent across the watershed, caused often by issues easily addressed, such as raising mower decks and reseeding, as well as purposeful trail installation and maintenance.

- Failures to manage sediment loss on active construction sites, most notably on single lot construction sites;
- Construction site road access points;
- Unofficial trails being created to access waterways.

The observations of sediment in-stream were previously outlined as related to dam removals and overwhelmed wetland storage. Channelization and undercutting related to urban river syndrome were not observed frequently in this watershed; therefore, the riparian buffers that exist to protect streambanks from failures and collapse are no cost BMPs that should continue to be a priority management solution.

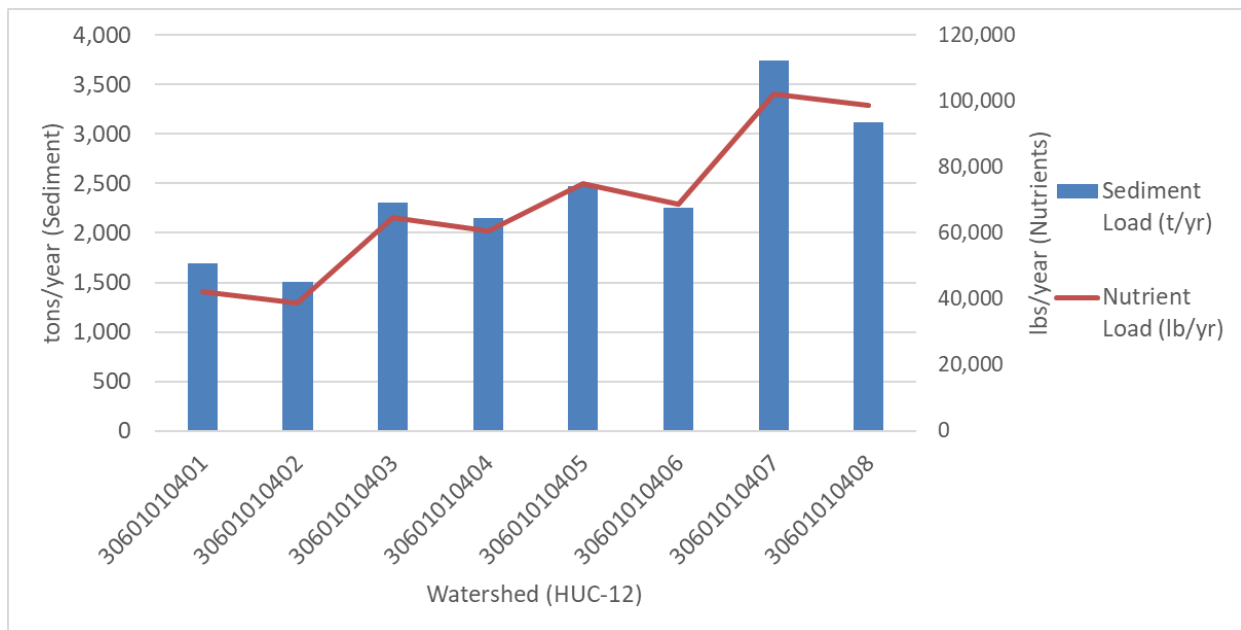
Fig. 27. Comparison between Sedimentation and Nutrient Loading

Sediment transport is a natural process that is exacerbated by land use changes such as deforestation, construction, agricultural practices, and developmental activities that accelerate erosion rates. Sediments contain organic matter, minerals, and nutrients, such as nitrogen and phosphorus. Nutrients are essential for the growth of aquatic plants and algae, but too much of them can cause eutrophication, which is a process that depletes oxygen in water and harms aquatic life. Therefore, where you see increased sediment pollution there is corresponding increased nutrient pollution that further degrades the quality of water for drinking, wildlife, and the land surrounding streams (Figure 27).

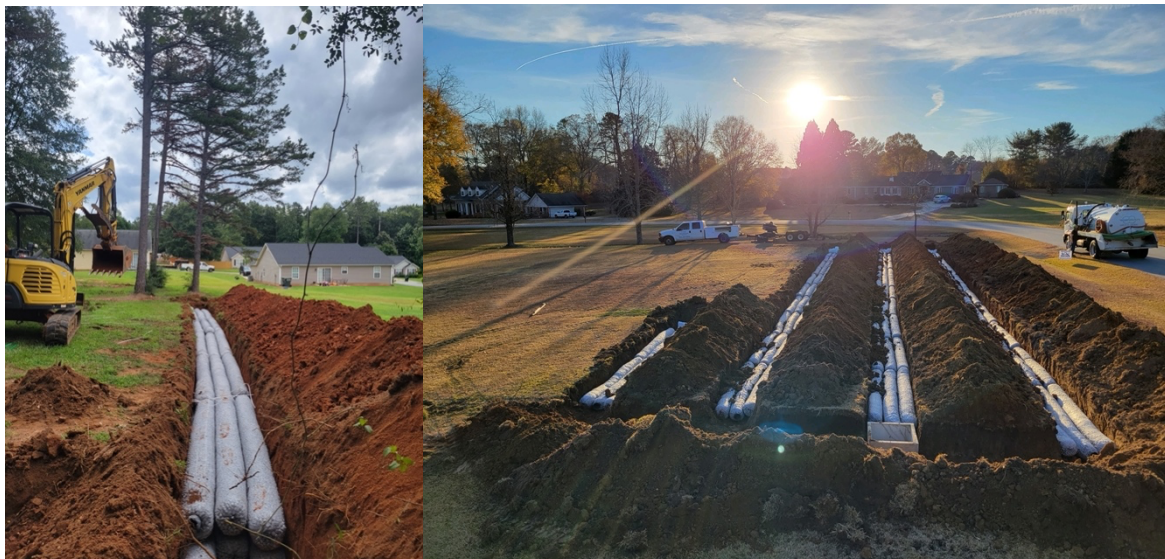
Fig. 35. Examples of septic repair work in the Three and Twenty Creek watershed, which neighbors the Twelvemile River watershed. (photo provided by Upstate Forever).

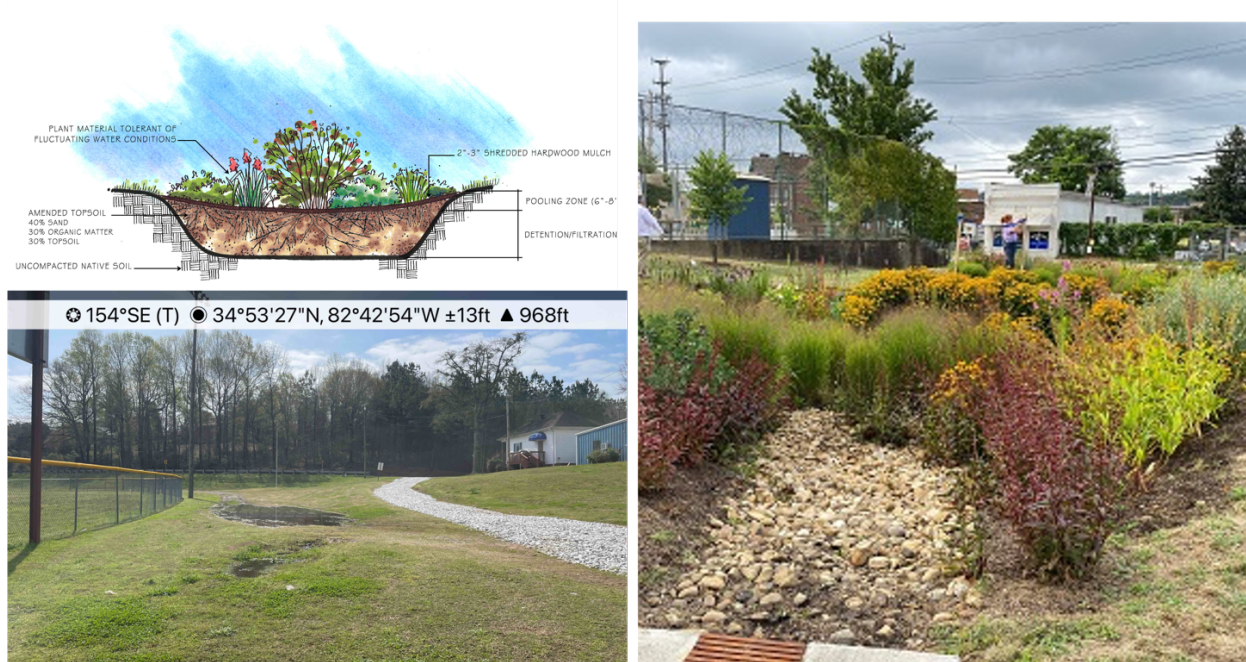
Fig. 39. The creation of a bioswale in this already pooling, low-lying area would provide beautification, stormwater treatment, and be an ideal location for education. Photo credits: Clemson Extension Carolina Clear Rain Garden illustration (top left), [bioretention basin photo from Western Pennsylvania Conservancy](#) (right), low-lying area at Jaycee Park (bottom left).

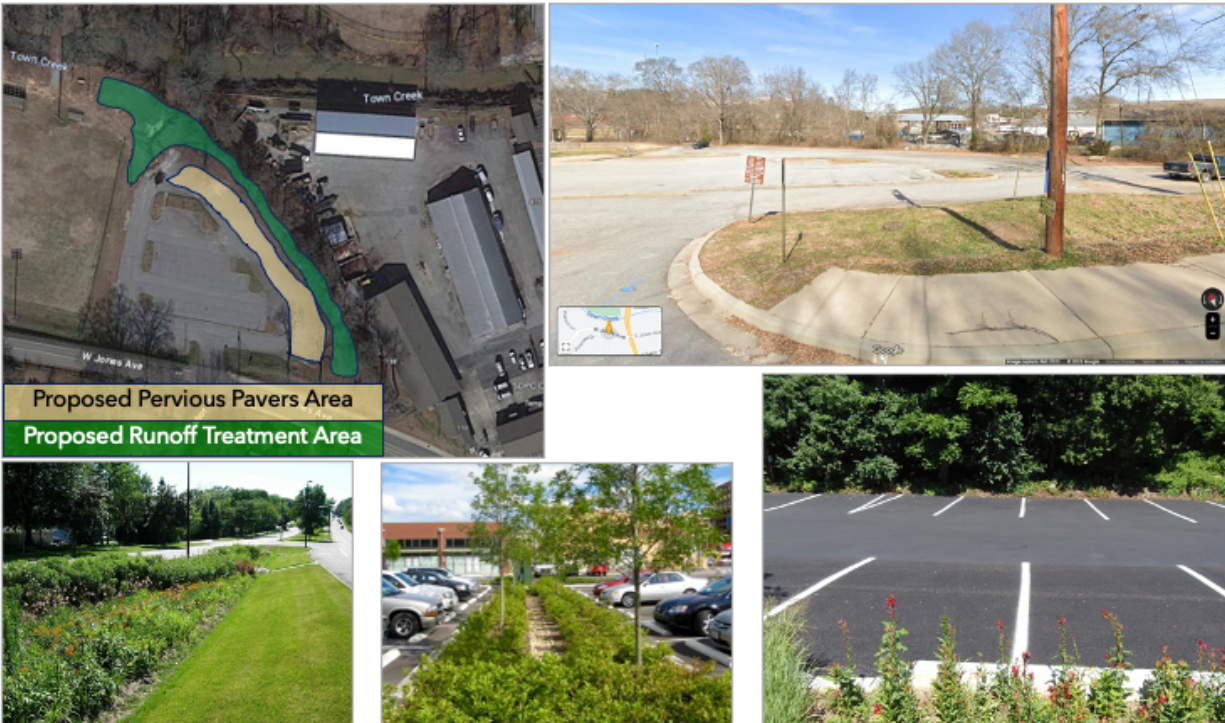
Fig. 41. Overview of large parking area's opportunities for stormwater treatment and retention (top left); street view of existing parking area (top right); example of [porous asphalt use in a parking lot with center drainage and no curbs](#) (bottom right); example of [curbless planted parking lot median with drainage from Pennsylvania State University Sea Grant](#) (bottom middle); example of [bioretention treatment area with curb cut from RK&K](#) (bottom left)

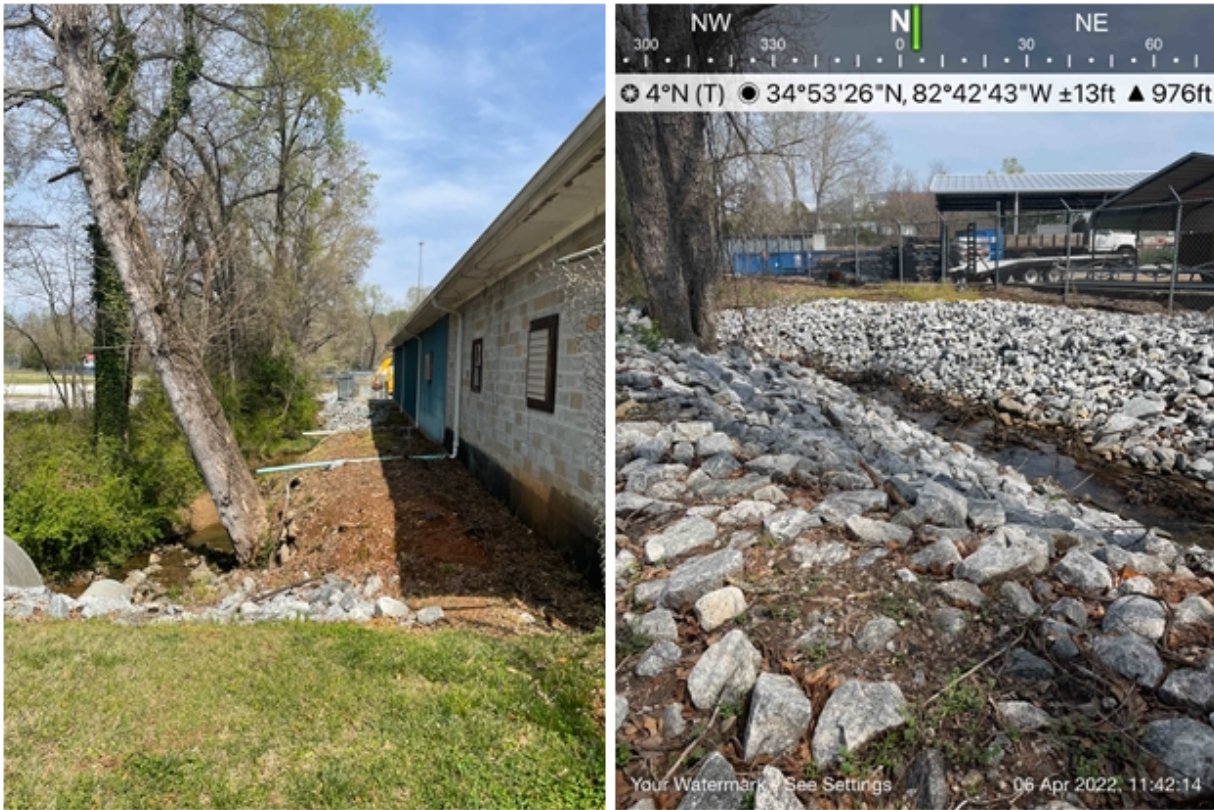
Fig. 42. Disconnecting impervious surfaces from direct discharge to waterways is a critical stormwater pollution prevention strategy. Within these tight quarters shown in the top left image, a solution may be found to do just that as part of a larger park renovation and stream restoration plan. Restoring the tributary to a more natural state will also benefit pollutant attenuation, in comparison to the existing armoring at the tributary.

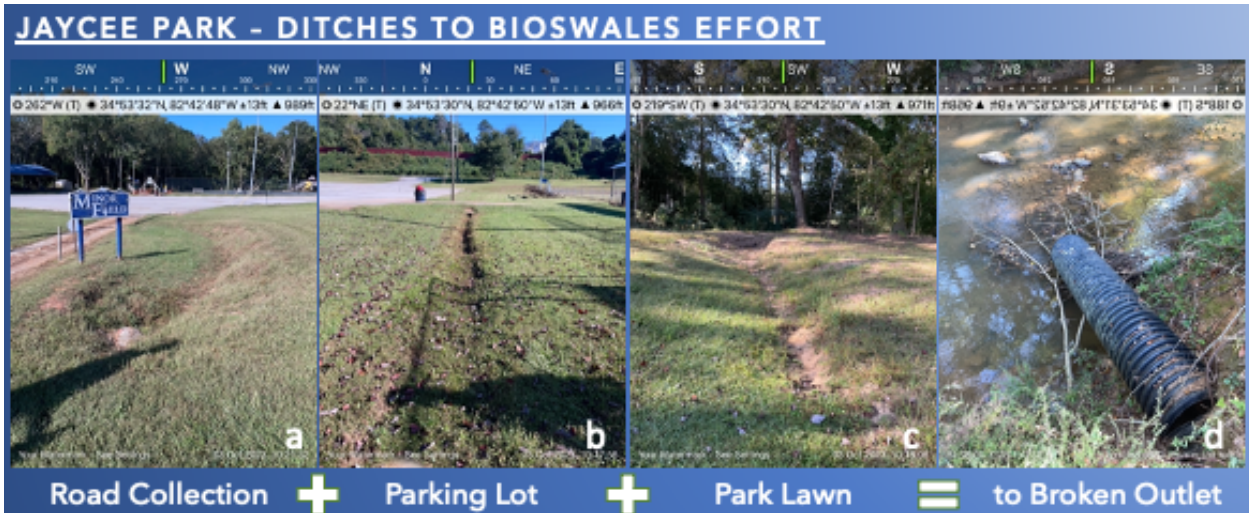
Fig. 43. Treatment train solution to stormwater runoff collection, ultimately reducing stormwater pollution in Town Creek.

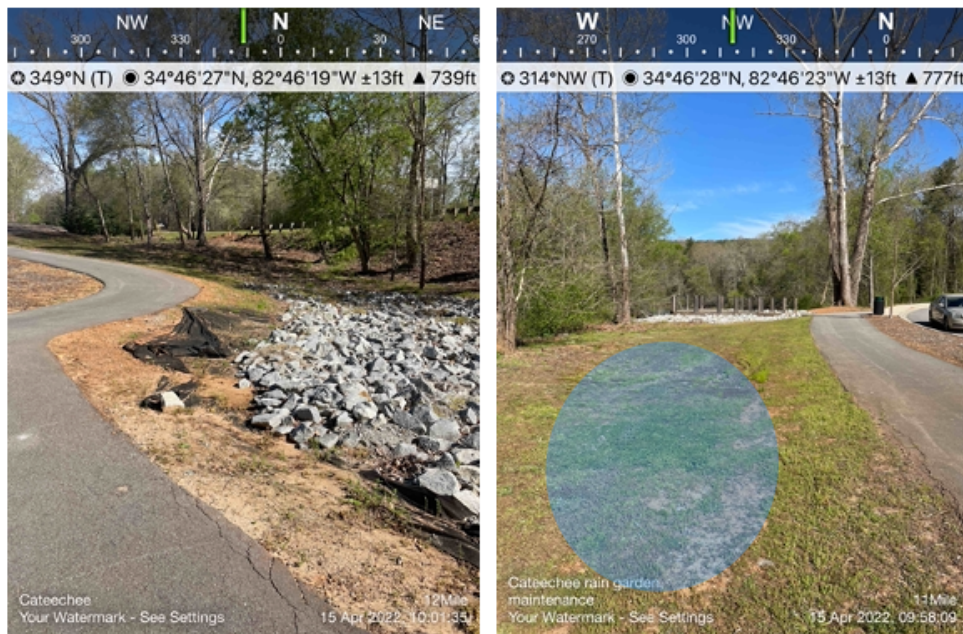
Fig. 45. Two rain garden opportunities for improved stormwater pollution prevention and enhanced groundwater storage. The right most image includes an area depicting the observed low point for stormwater capture and treatment.

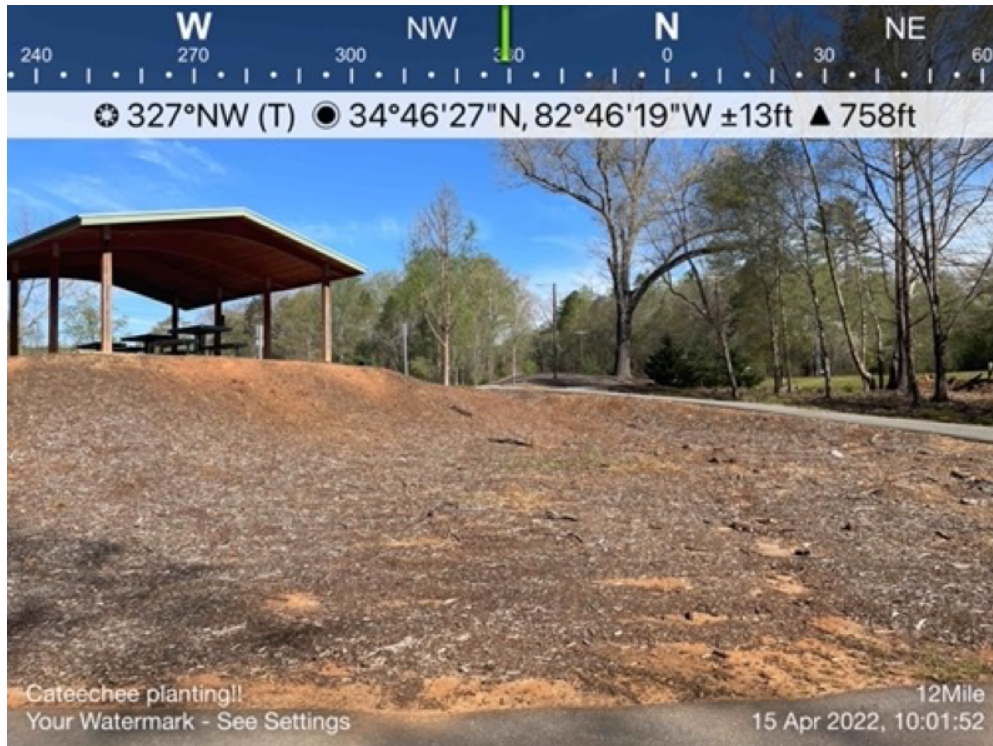
Fig. 46. The picnic shelter at Cateechee Point Park provides a great opportunity to demonstrate low impact landscaping design and ecological improvements that would also better manage the ongoing soil erosion.
