Subject: Free-Product Recovery Plan – Revision 4
Lewis Drive Remediation
Plantation Pipe Line Company
Belton, South Carolina
Site ID #18693, "Kinder Morgan Belton Pipeline Release"

Figure 1. Product Thickness Map
 Lewis Drive Remediation Site
 Belton, South Carolina
 Site ID #18693 "Kinder Morgan Belton Pipeline Release"

Attachment A
Lewis Drive Remediation
SCDHEC Progress Update
Presented January 22, 2018

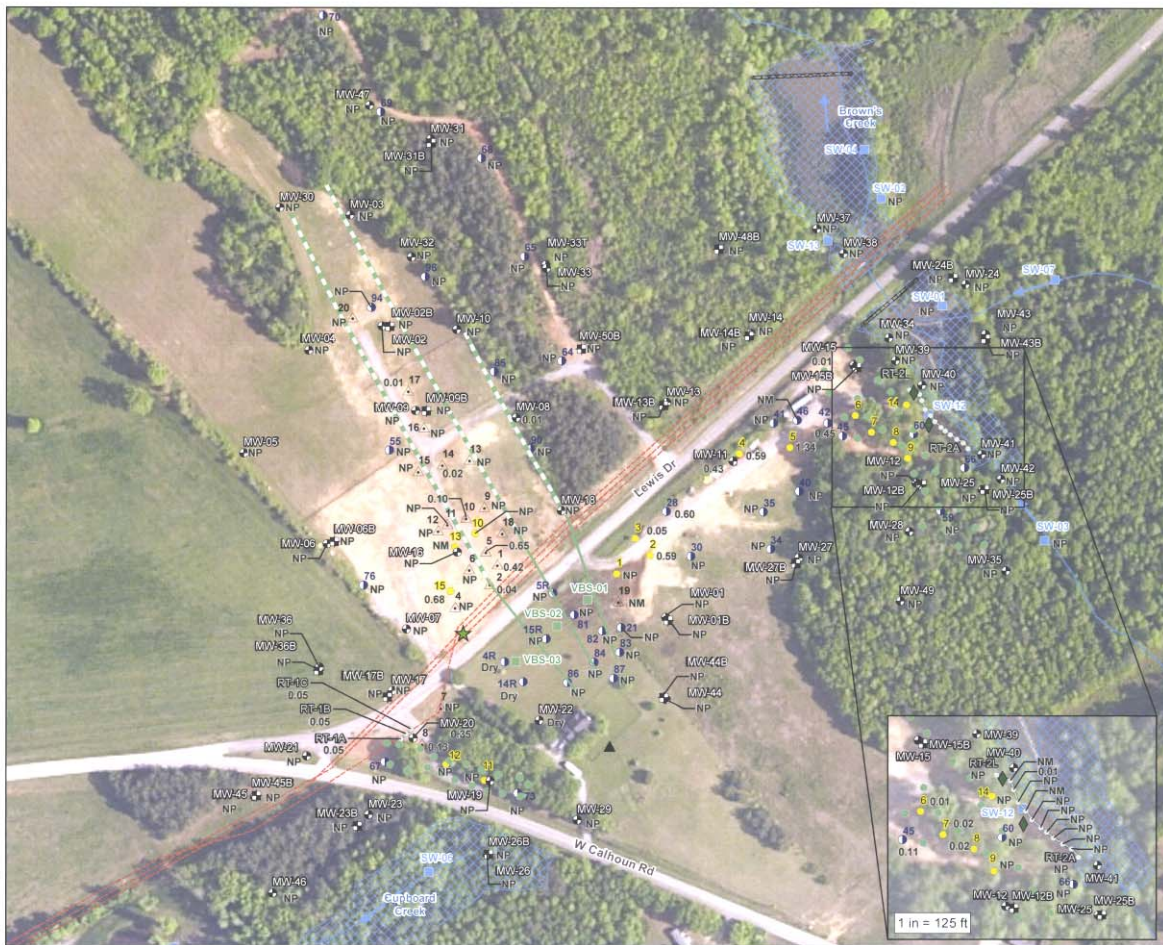
- LEGEND**
- ★ Release Point
 - ⊕ Monitoring Well
 - ⊕ Bedrock Monitoring Well
 - ◆ Seep Location
 - ⊕ Recovery Sump
 - ⊕ Piezometer ("R" indicates Replacement)
 - ⊕ Recovery Well (4-inch diameter)
 - ⊕ Vertical Bedrock Sparging Well
 - ⊕ Vertical Saprolite Sparging Well
 - ⊕ Surface Water Sampling Location
 - ▲ Septic Tank
 - ⊕ Recovery Trench Extraction Point
 - Recovery Trench
 - Surface Water Flow Direction
 - Horizontal Sparging Well Riser
 - Horizontal Sparging Well Screen
 - Pipeline
 - National Hydrography Dataset Stream
 - ⊕ Delineated Wetland
 - ⊕ Beaver Dam
 - ⊕ Detail Area
- 0.43 Product thickness in feet as of 12/21/2017 and 12/27/2017
- NP No product detected
- NM Not measured

Based on water level gauging data from December 27, 2017, there are 22 features at the Lewis Drive site with greater than 0.01 foot of product and a 2-inch or greater diameter (Table 1 and Figure 1). Of those, four are monitoring wells, seven are recovery wells, seven are recovery sumps, and four are recovery trench risers. Table 1 presents the recommended product recovery method for each feature according to the guidelines above.

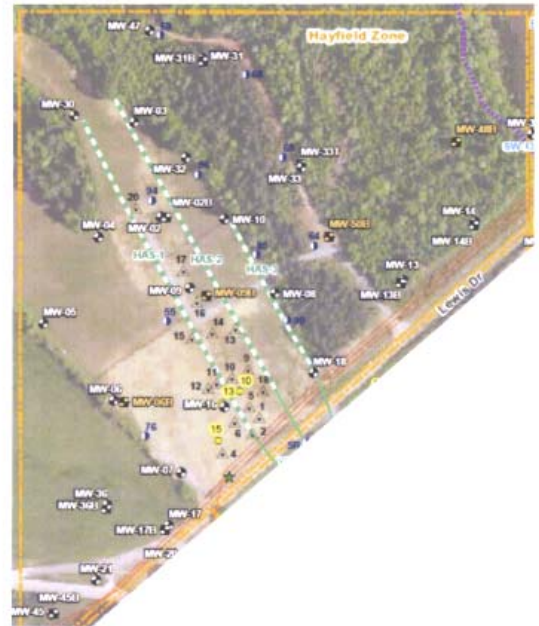
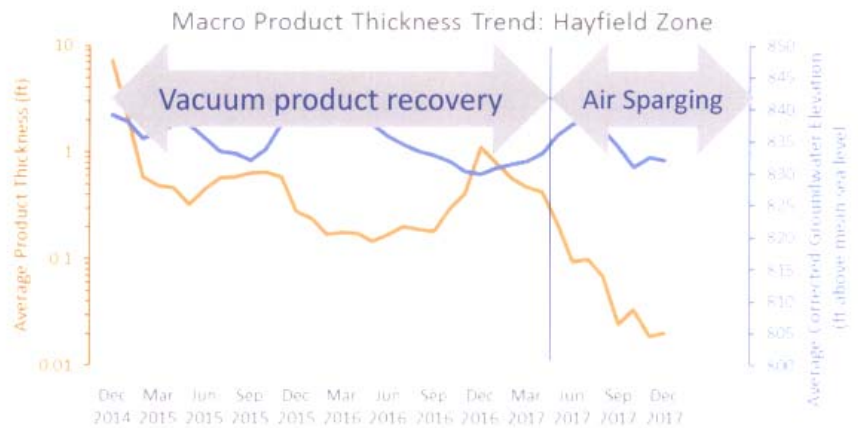
Hayfield Zone

Horizontal sparging wells

Quantity: 3

Average total length: 905 ft

Average screen length: 615 ft

Design flow rate: 0.75 scfm/ft of screen

- Started sparging at 0.05 scfm/ft on May 6, 2017
- Increased 0.02 scfm/ft each week through December 2017
- Flow rate in December 2017: 0.53 scfm/ft of screen

Average reduction in product thickness: **95%**

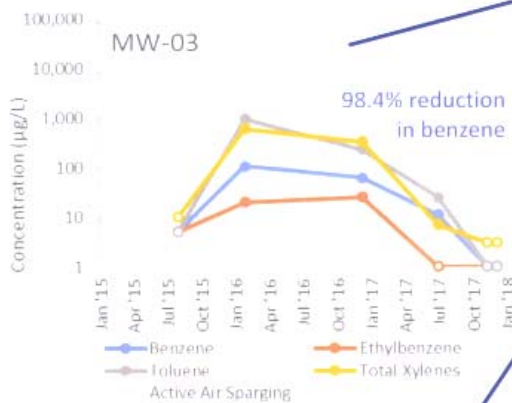
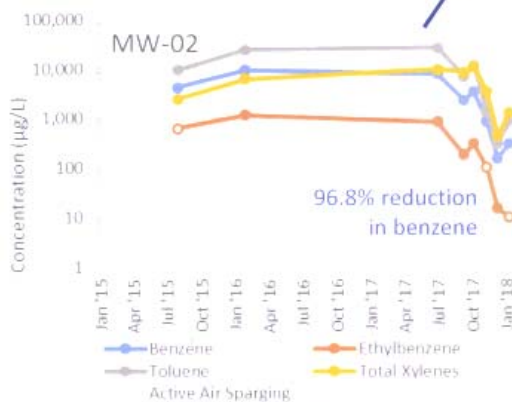
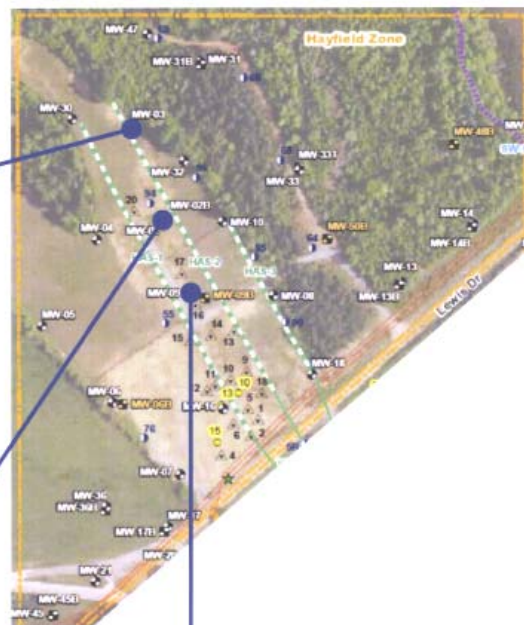
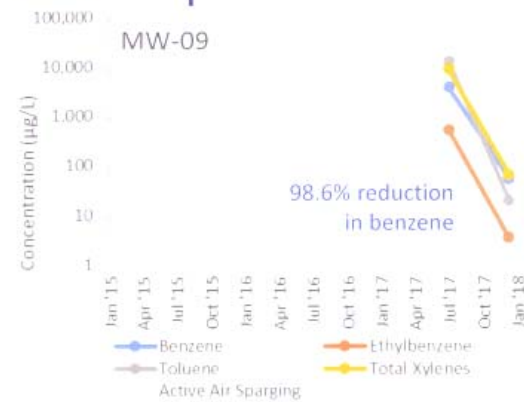
Hayfield Zone Dissolved

97.9% average
reduction in
benzene

Note: Open circles denote that the compound was not detected; non-detects are plotted at the reporting limit.

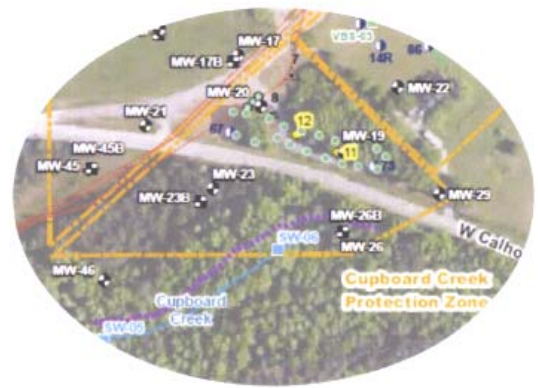
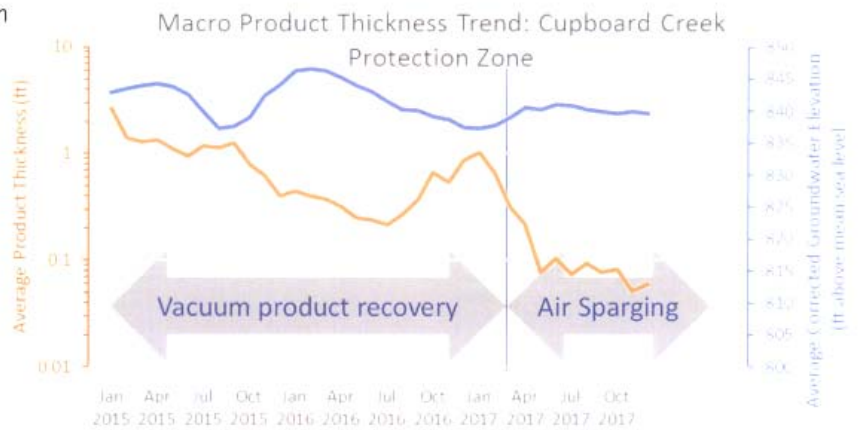
Vertical sparging curtain

Quantity: 19

Average depth: 19 ft

Screen length: 2.5 ft

Design flow rate: 15 scfm each

- Started air sparging at 1 scfm on March 6, 2017
- Increased 1 scfm/week in March to 4 scfm
- Maintained 4 scfm through June
- Increased to 6 scfm July to October
- Increased 1 scfm/week in November to 10 scfm
- Flow rate in December 2017: 10 scfm each

Average reduction in product thickness: **81%**

Furthermore, product thickness data presented at the meeting in Columbia (Attachment A) indicate that the air sparging curtains established in the Brown's Creek Protection Zone and Cupboard Creek Protection Zone have halted migration of product toward these surface water bodies and there is no further risk posed by remaining product at the site. Indeed, air sparging has reduced product thicknesses by 95 percent in the Brown's Creek Protection Zone and by 81 percent in the Cupboard Creek Protection Zone.

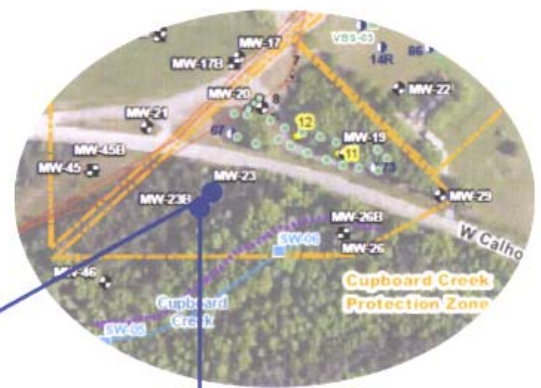
Cupboard Creek Protection Zone Dissolved

Note: Open circles denote that the compound was not detected; non-detects are plotted at the reporting limit.

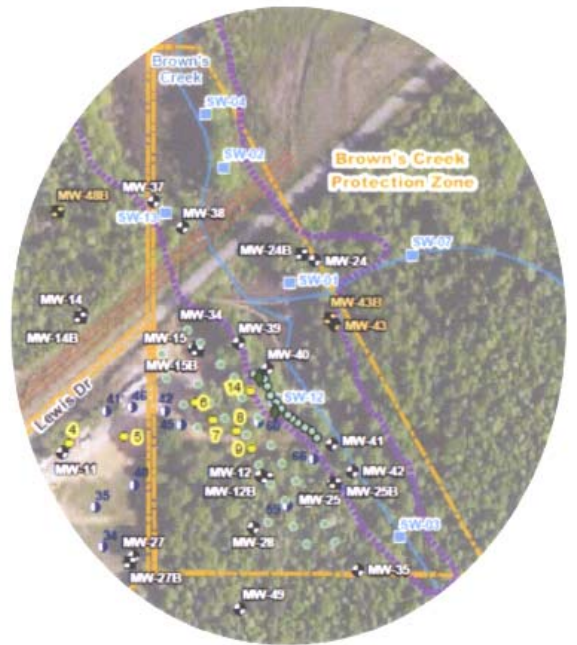
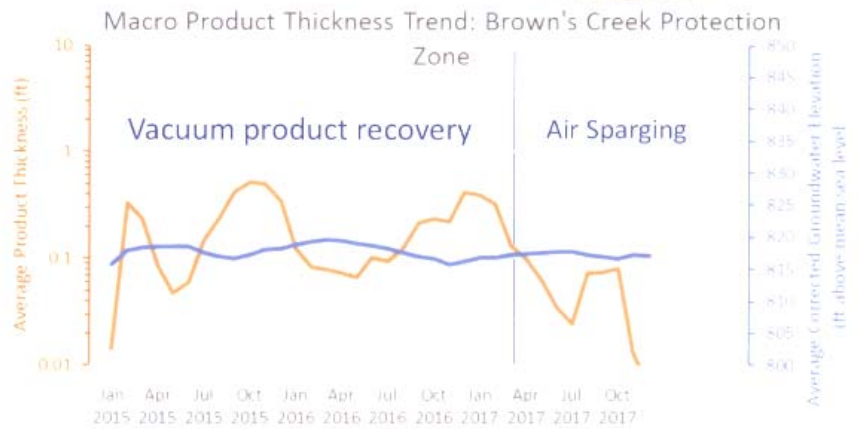
Brown's Creek Protection Zone

Vertical sparging curtain

Quantity: 27

Average depth: 44 ft

Screen length: 30 in

Design flow rate: 15 scfm each

- Started air sparging at 1 scfm on March 6, 2017
- Increased 1 scfm/week in March to 4 scfm
- Maintained 4 scfm through June
- Increased to 6 scfm July to October
- Increased 1 scfm/week in November to 10 scfm
- Flow rate in December 2017: 10 scfm each

Average reduction in product thickness: **95%**

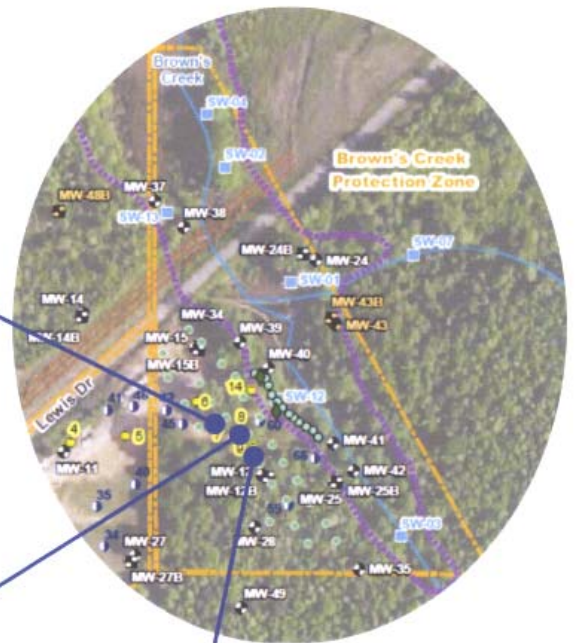
Brown's Creek Protection Zone Dissolved

99.7% average reduction in benzene

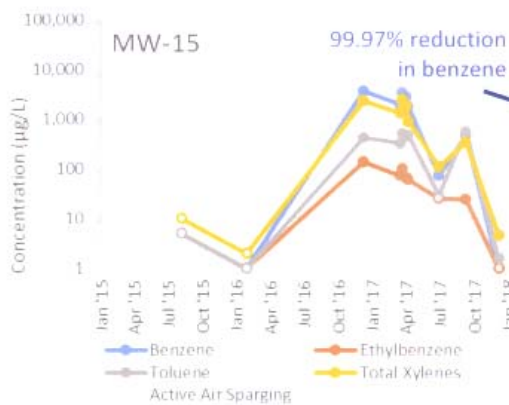
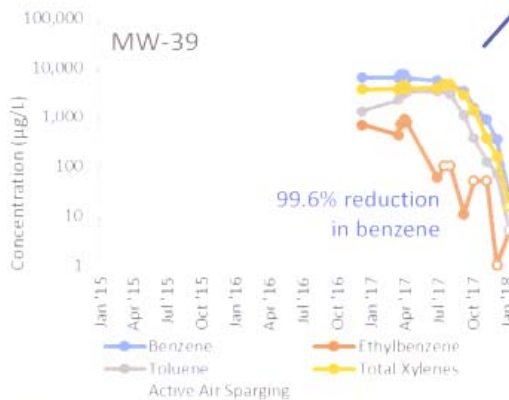
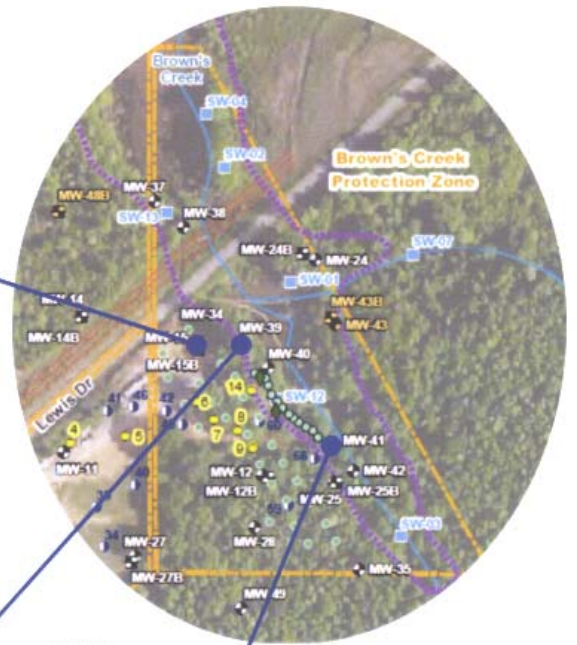
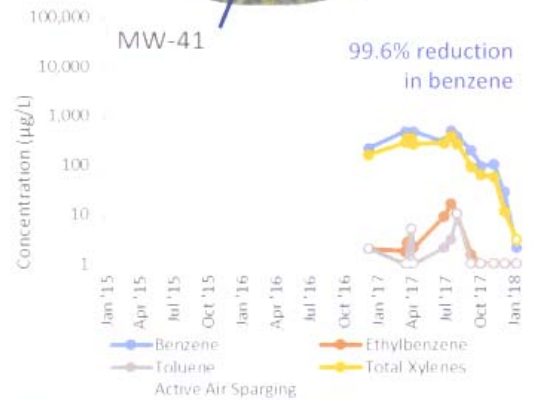
Note: Open circles denote that the compound was not detected; non-detects are plotted at the reporting limit

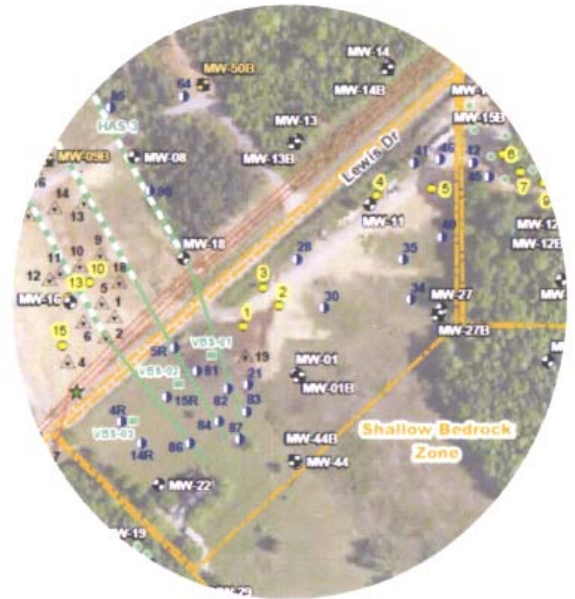
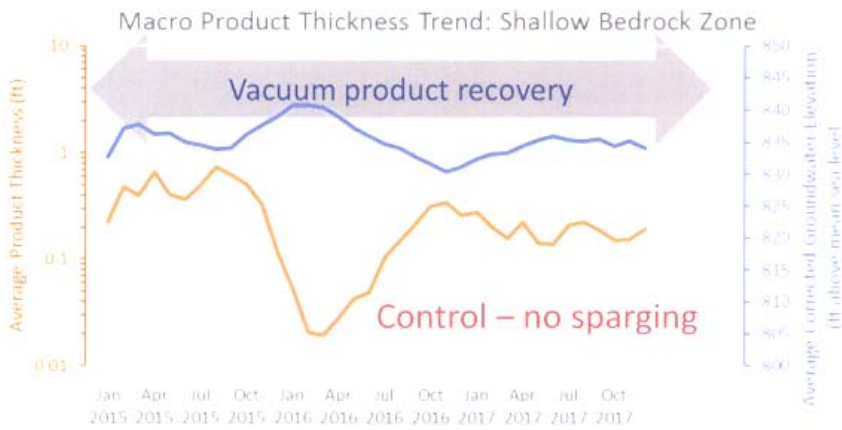
Shallow Bedrock Zone

Control: Weekly vacuum recovery; no sparging

Average reduction in product thickness: **-22%**

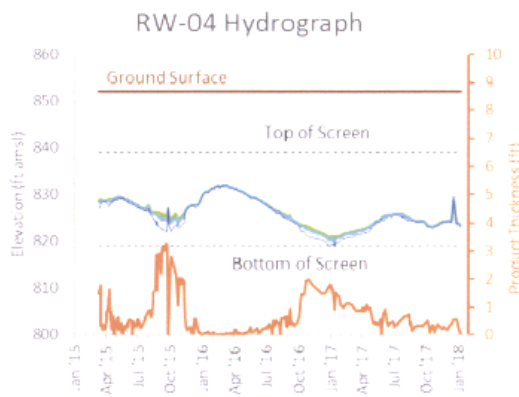
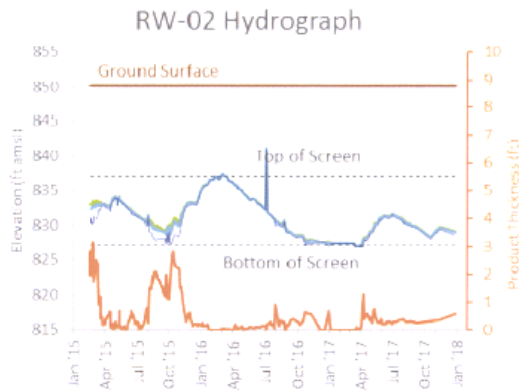
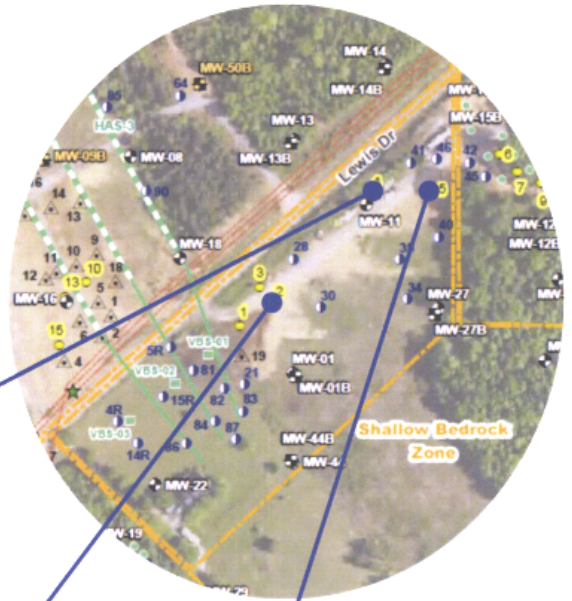
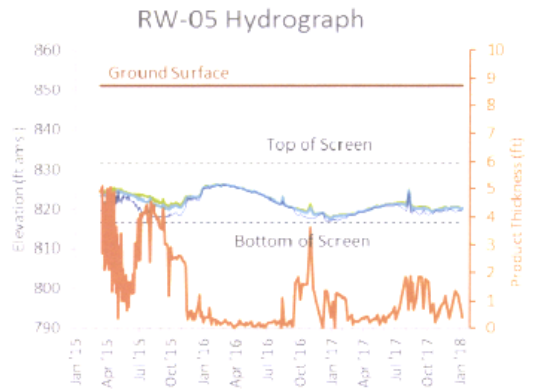
Challenge: Shallow Bedrock Zone LNAPL

- 25 wells still with LNAPL in Dec 2017
- Only 6 wells with >0.5 ft LNAPL
- Outside sparging influence
- Perform focused product recovery
 - Socks
 - Vac truck
 - AFVR?

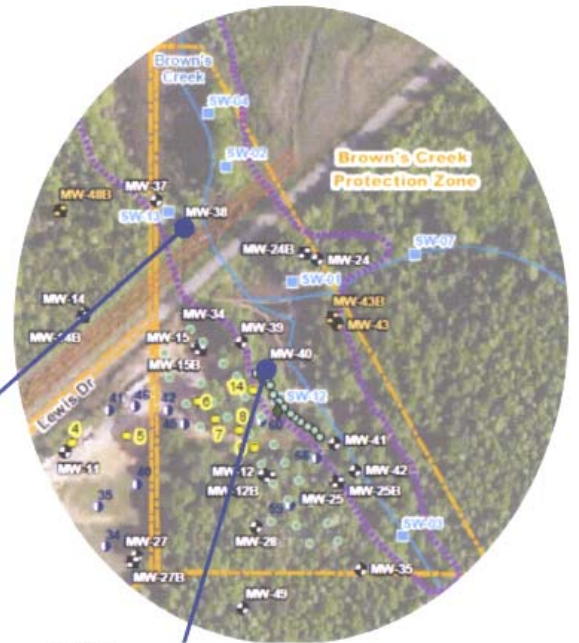
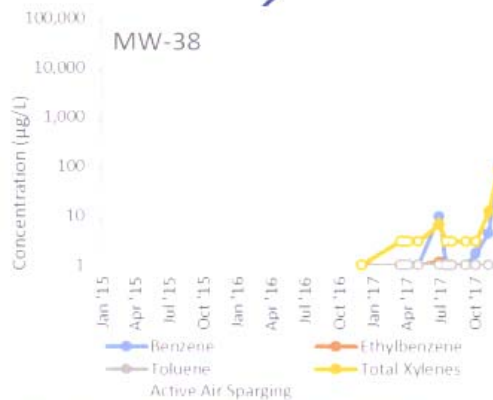
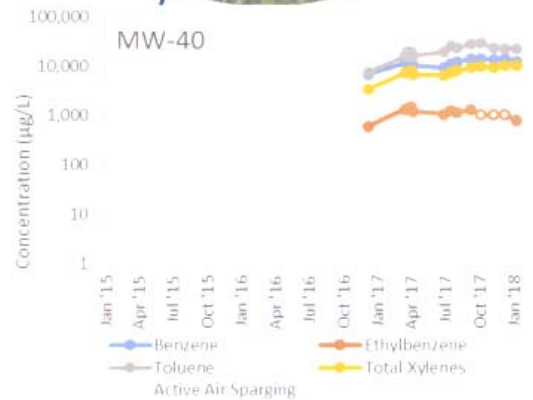
Challenge: Brown's Creek Protection Zone

- Optimize flow and pulsing sequencing
- Increase flows in vicinity of MW-40 from 10 scfm to design flow of 15 scfm; adjust pulsing or consider continuous
- Install two wells upgradient of MW-38 to evaluate source of impacts in MW-38

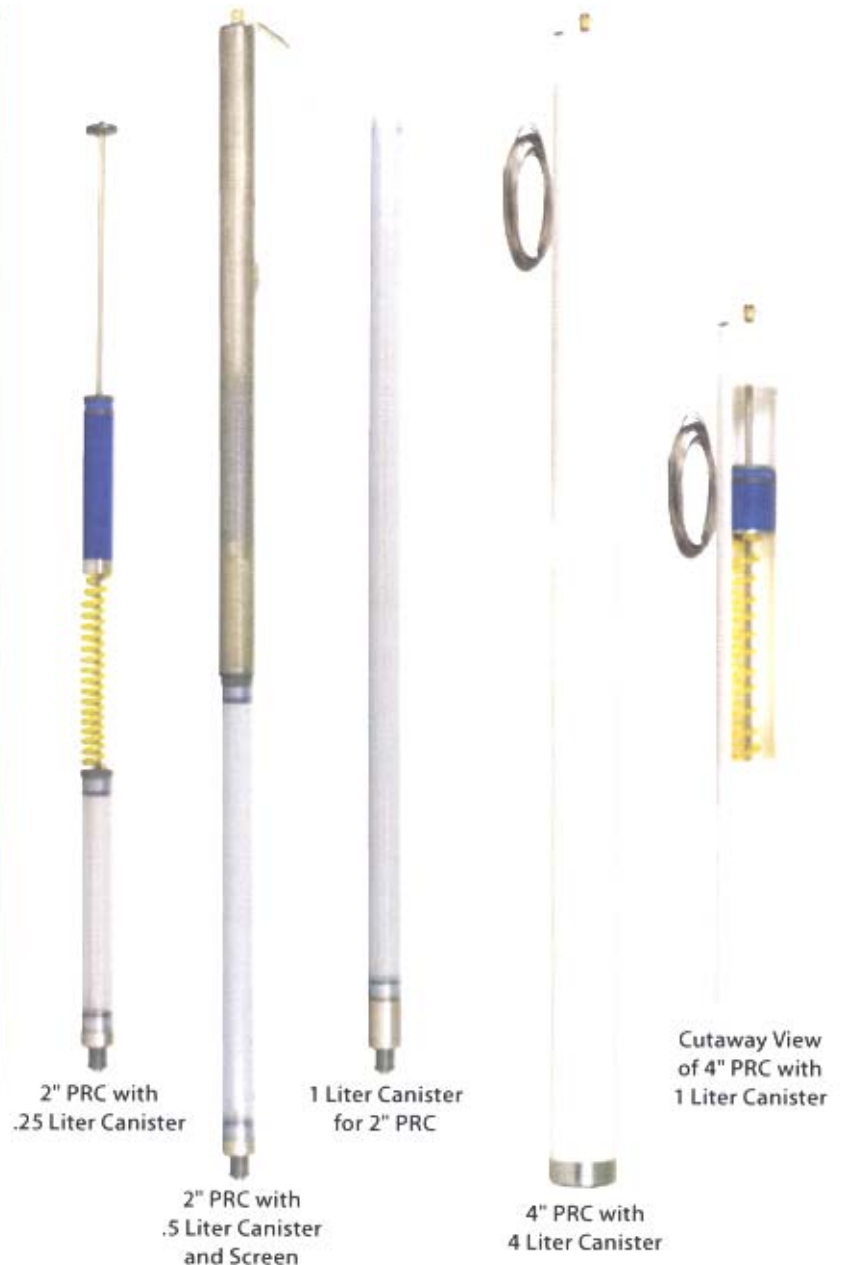
Geotech PRC Passive Skimmer

The Geotech PRC (Product Recovery Canister) is a passive skimmer with a floating intake that separates and recovers light hydrocarbons from groundwater. The Geotech PRC collects floating product down to a sheen then is emptied through a discharge valve at the bottom of the canister after being raised to the surface.

- Oleophilic/Hydrophobic filter buoy recovers product without taking in water
- Quick fill time – about 15 minutes with ample product
- Protected easy release drain valve
- Able to convert to active recovery systems

- 12" (30.5 cm) effective buoy travel
- 3 recovery capacities: .25, .5 and 1 liter
- Transparent recovery canister
- 2" (5 cm) or larger monitoring well applications
- Optional protective screen

- 16" (40.6 cm) effective buoy travel
- 3 recovery capacities: 1, 3 and 4 liter
- 4" (10 cm) or larger monitoring well applications
- Buoy protected in 0.020 (.5mm) slot PVC screen

1 Liter	3 Liter	4 Liter
Dimensions:	37.0" L x 3.5" OD (94cm x 9cm)	53.0" L x 3.5" OD (135cm x 9cm)	60.0" L x 3.5" OD (152cm x 9cm)
Empty Weight:	8 lbs. (3.7kg)	15 lbs. (6.8kg)	16 lbs. (8.2kg)
Full Weight:	9.5 lbs. (4.3kg)	19 lbs. (8.6kg)	25.5 lbs. (11.6kg)
Capacity:	.26 gal.	.8 gal.	1.06 gal.
Min. Water Required:	18.5" (47cm)	35.0" (89cm)	43.0" (109cm)
Materials (All):	Stainless steel, brass, and engineered plastics

.25 Liter	.5 Liter	1 Liter
Dimensions:	49.0" L x 1.75" OD (149cm x 4.4cm)	59.5" L x 1.75" OD (151cm x 4.4cm)	82.5" L x 1.75" OD (210cm x 4.4cm)
Empty Weight:	3.1 lbs. (1.4kg)	3.5 lbs. (1.6kg)	5.2 lbs. (2.4kg)
With Screen:	4.5 lbs. (2.0kg)	4.9 lbs. (2.2kg)	6.6 lbs. (3.0kg)
Full Weight:	3.5 lbs. (1.6kg)	4.3 lbs. (2.0kg)	6.7 lbs. (3.0kg)
With Screen:	4.9 lbs. (2.2kg)	5.7 lbs. (2.6kg)	8.1 lbs. (3.7kg)
Capacity:	.07 gal.	0.13 gal.	0.26 gal.
Min. Water Required:	29.0" (74cm)	39.5" (100cm)	62.0" (157cm)
Materials (All):	Stainless steel, brass, and engineered plastics
