HYDROGEOLOGIC ASSESSMENT REPORT: LUCK SALUDA

NEAR INTERSECTION OF DOUBLE BRIDGES ROAD
AND HEATHER LANE
SALUDA COUNTY, SOUTH CAROLINA

BLE Project Number J23-18886-01

Subject: **Hydrogeologic Assessment: Luck Saluda
Parcel Identification Number #174-00-00-006
Saluda County, South Carolina
BLE Project Number J23-18886-01**

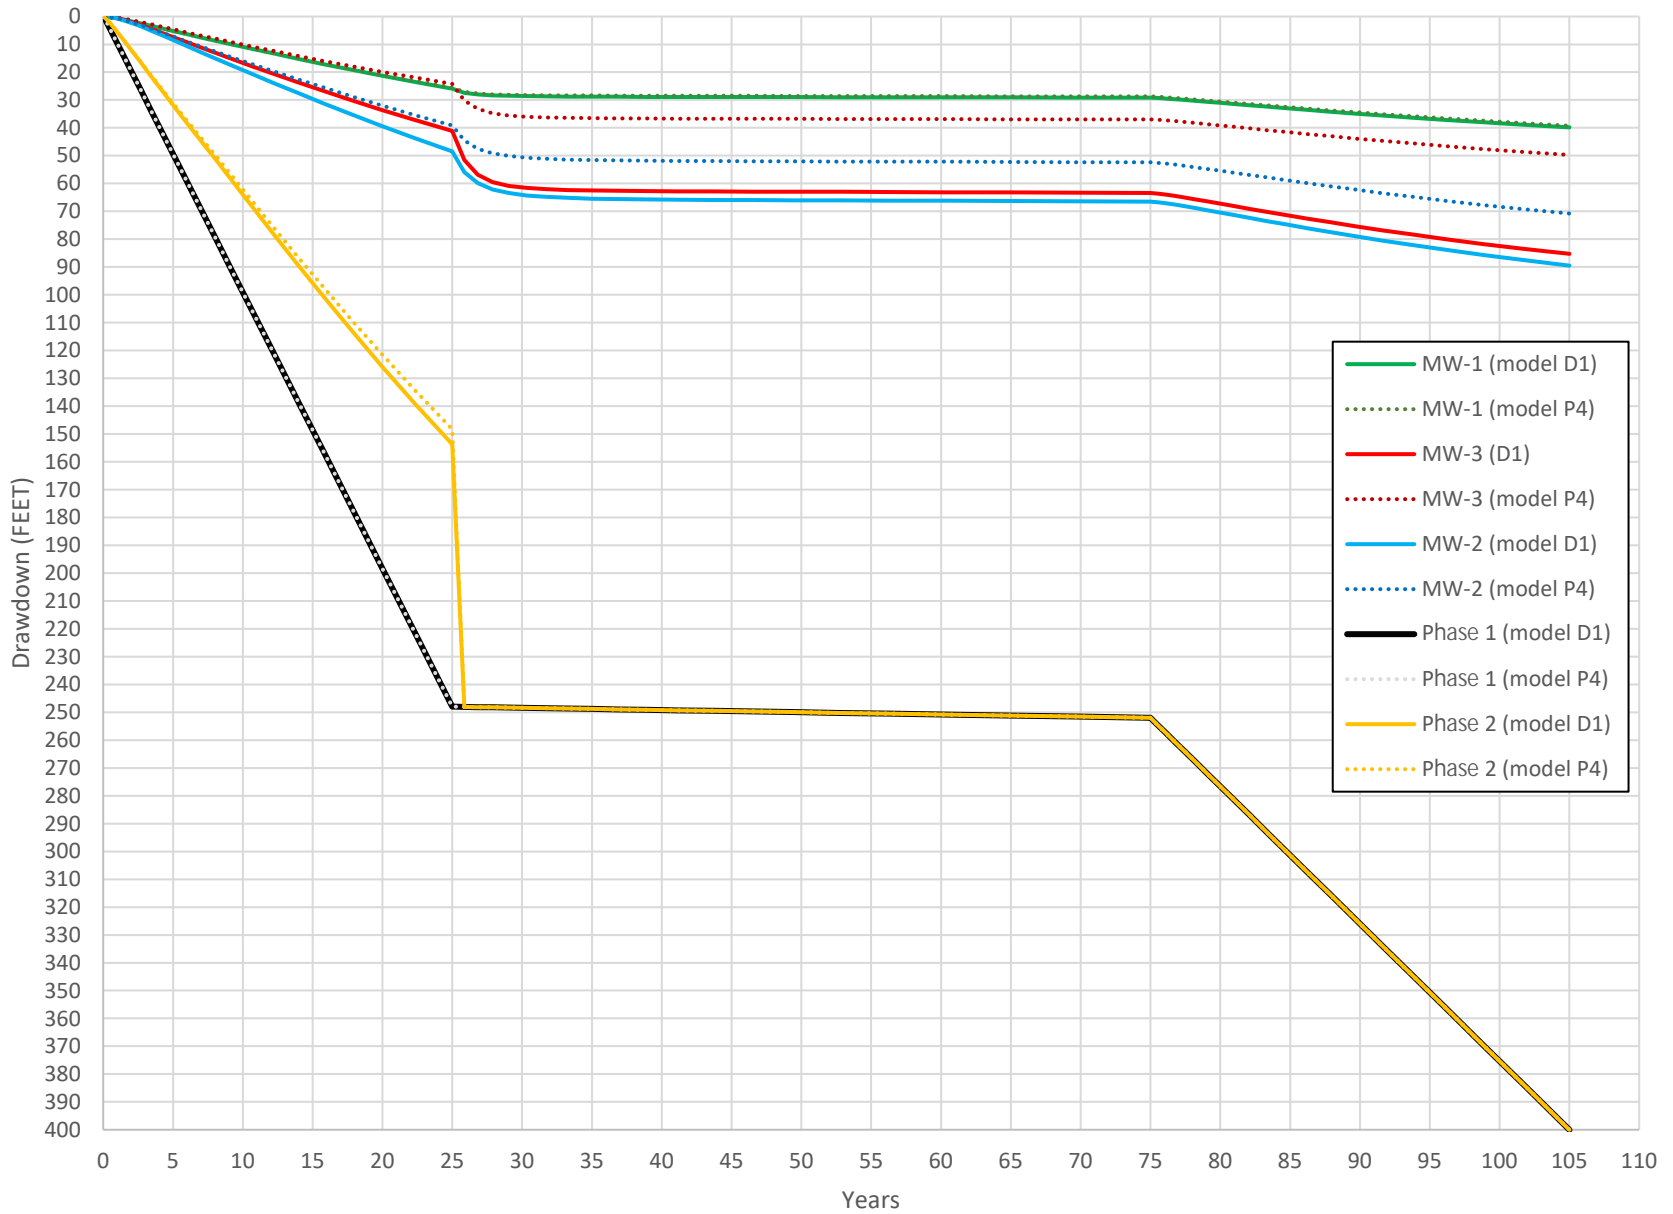
Saluda Models D1 and P4: Drawdown

**Drawdown over Time in Phase 1 Pit, Phase 2 Pit, and Observation Wells;
Dry Model (D1) (no re-infiltration of discharge water) and Pond 4 Infiltration Model (P4)**
