# **REMEDIAL INVESTIGATION WORK PLAN ADDENDUM**

## **FORMER BRAMLETTE MGP SITE**

### **JULY 2019**

**DUKE ENERGY CAROLINAS, LLC**

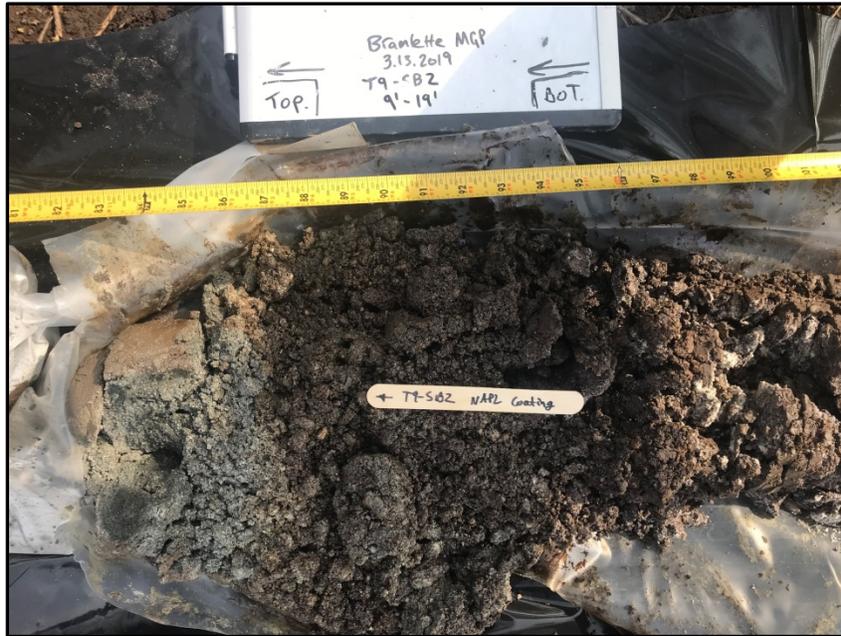
(1) NAPL (oil-like, carbureted water gas residuals [coal tar]) present within the coarse sands atop the saprolite unit

OLM and TLM are two distinct types of NAPL that have been observed at the Site OLM is generally limited in vertical extent to the coarse sand deposit that overlies saprolite. TLM occurs as thin lenses within clay deposits near historical drainage channels. Photographs of OLM (1) and TLM (2) are included below.

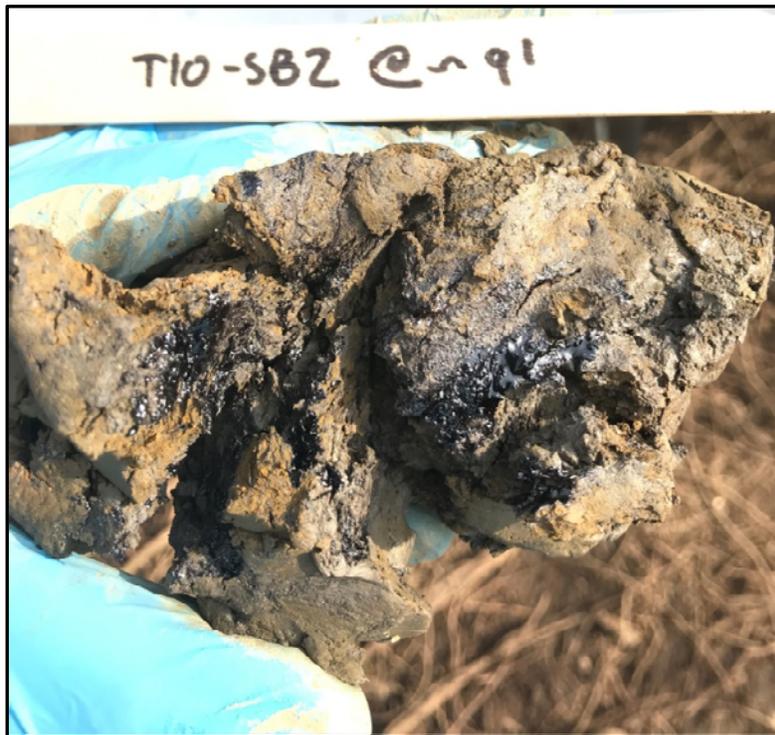
- (2) Shallow tar-like material (high viscosity) at the base of the landfill material and associated with relict/former historic land surface (coincident with former drainage traces)

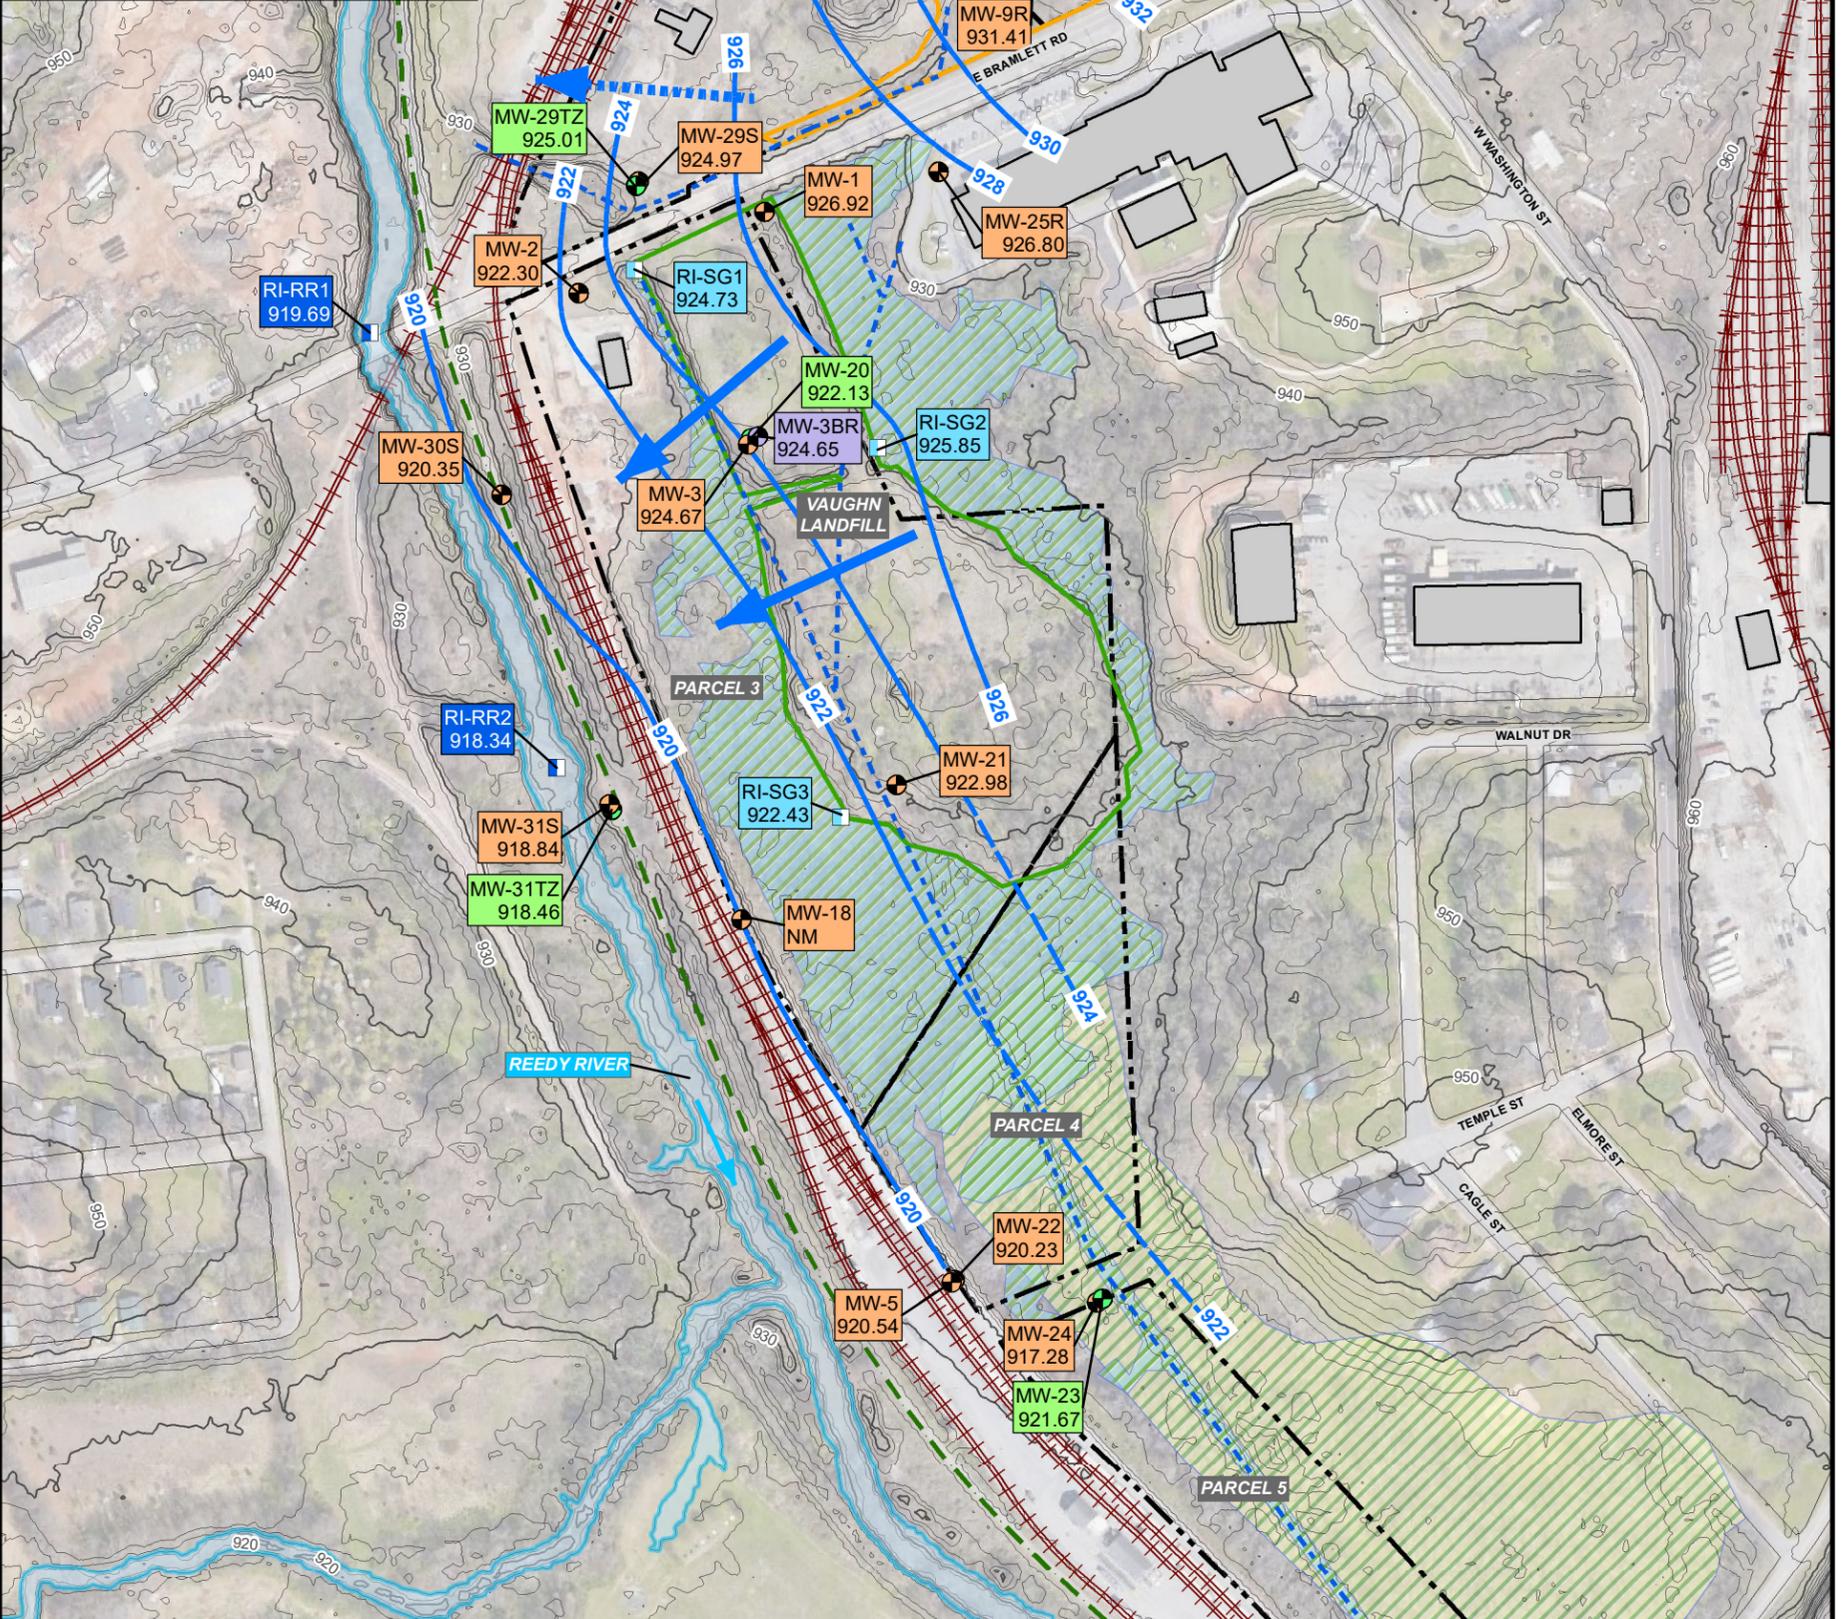
**FIGURE 3-2**  
**WATER LEVEL MAP (MAY 2019)**  
**FORMER BRAMLETTE MGP SITE**  
**EAST BRAMLETTE ROAD**  
**GREENVILLE, SOUTH CAROLINA**

- NOTES:**
- 1 WATER LEVELS USED FOR CONTOURING WERE COLLECTED ON MAY 2, 2019.
  - 2 ELEVATIONS ARE REFERENCED TO THE NORTH AMERICAN VERTICAL DATUM 88 (NAVD 88).

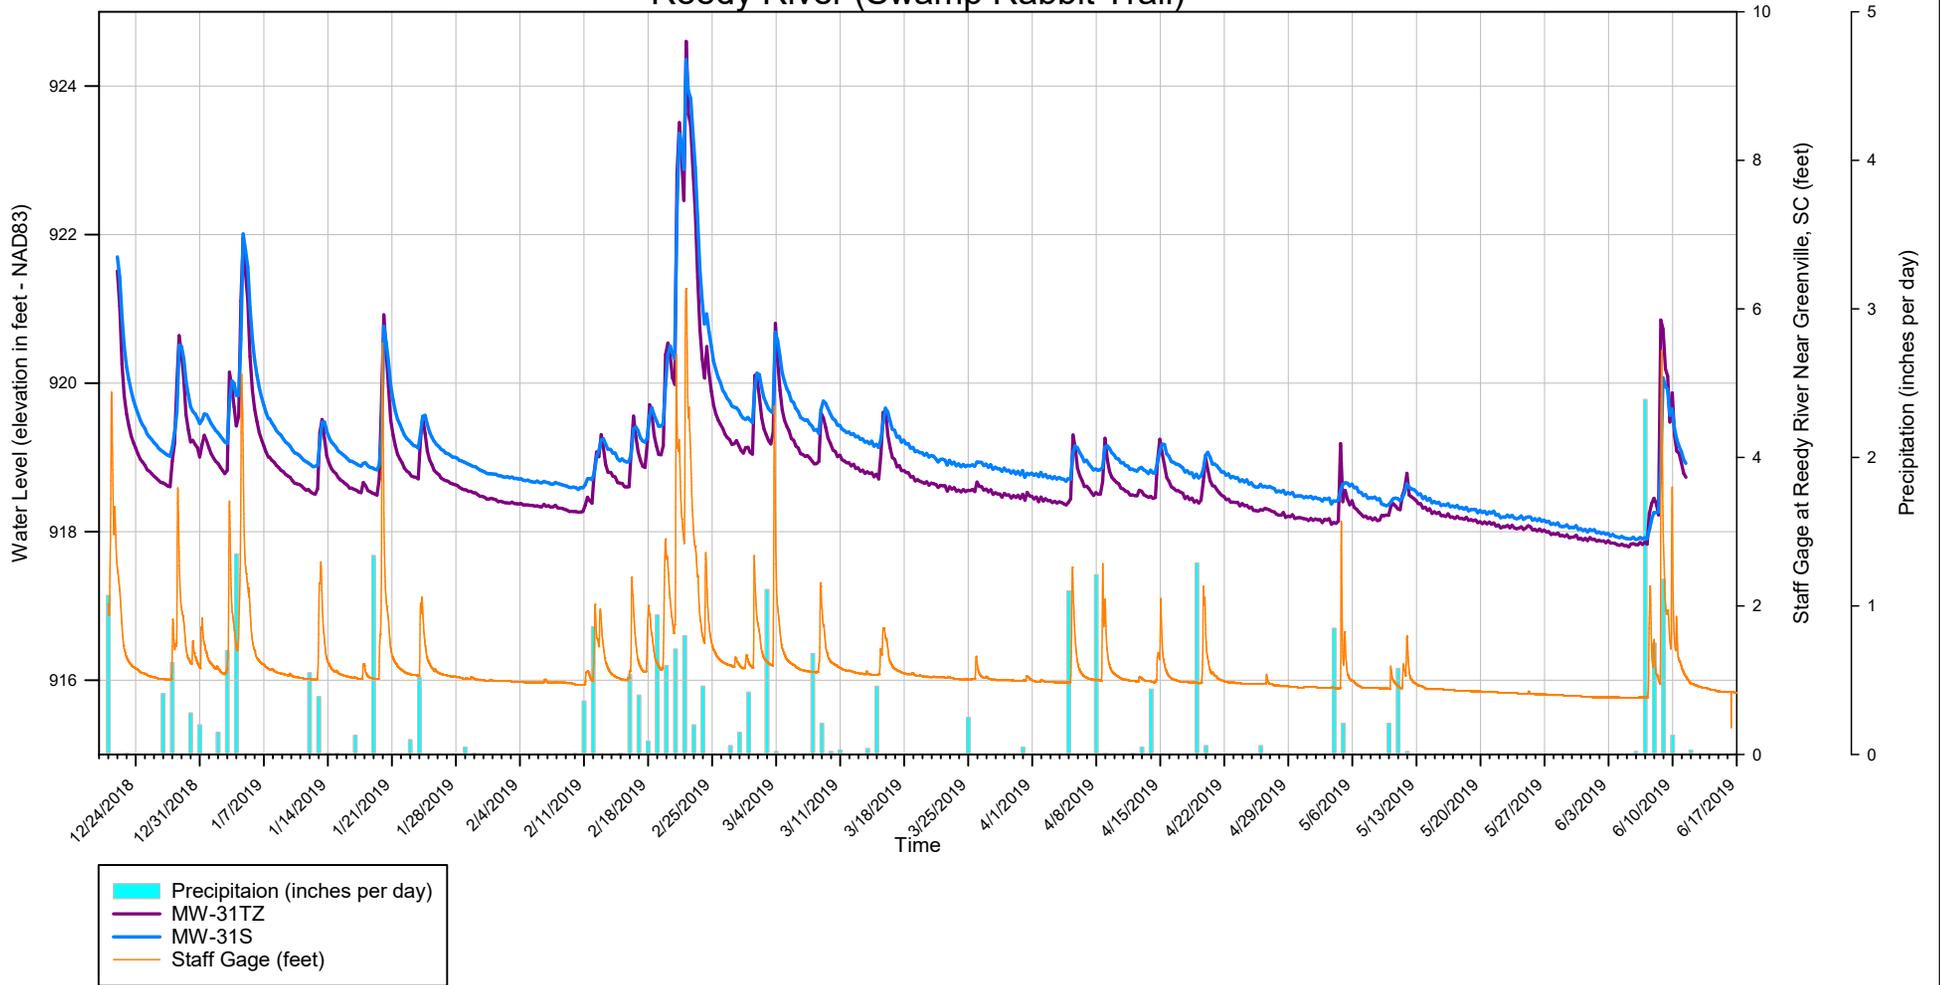
■ Precipitation (inches per day)  
— MW-31TZ  
— MW-31S  
— Staff Gage (feet)

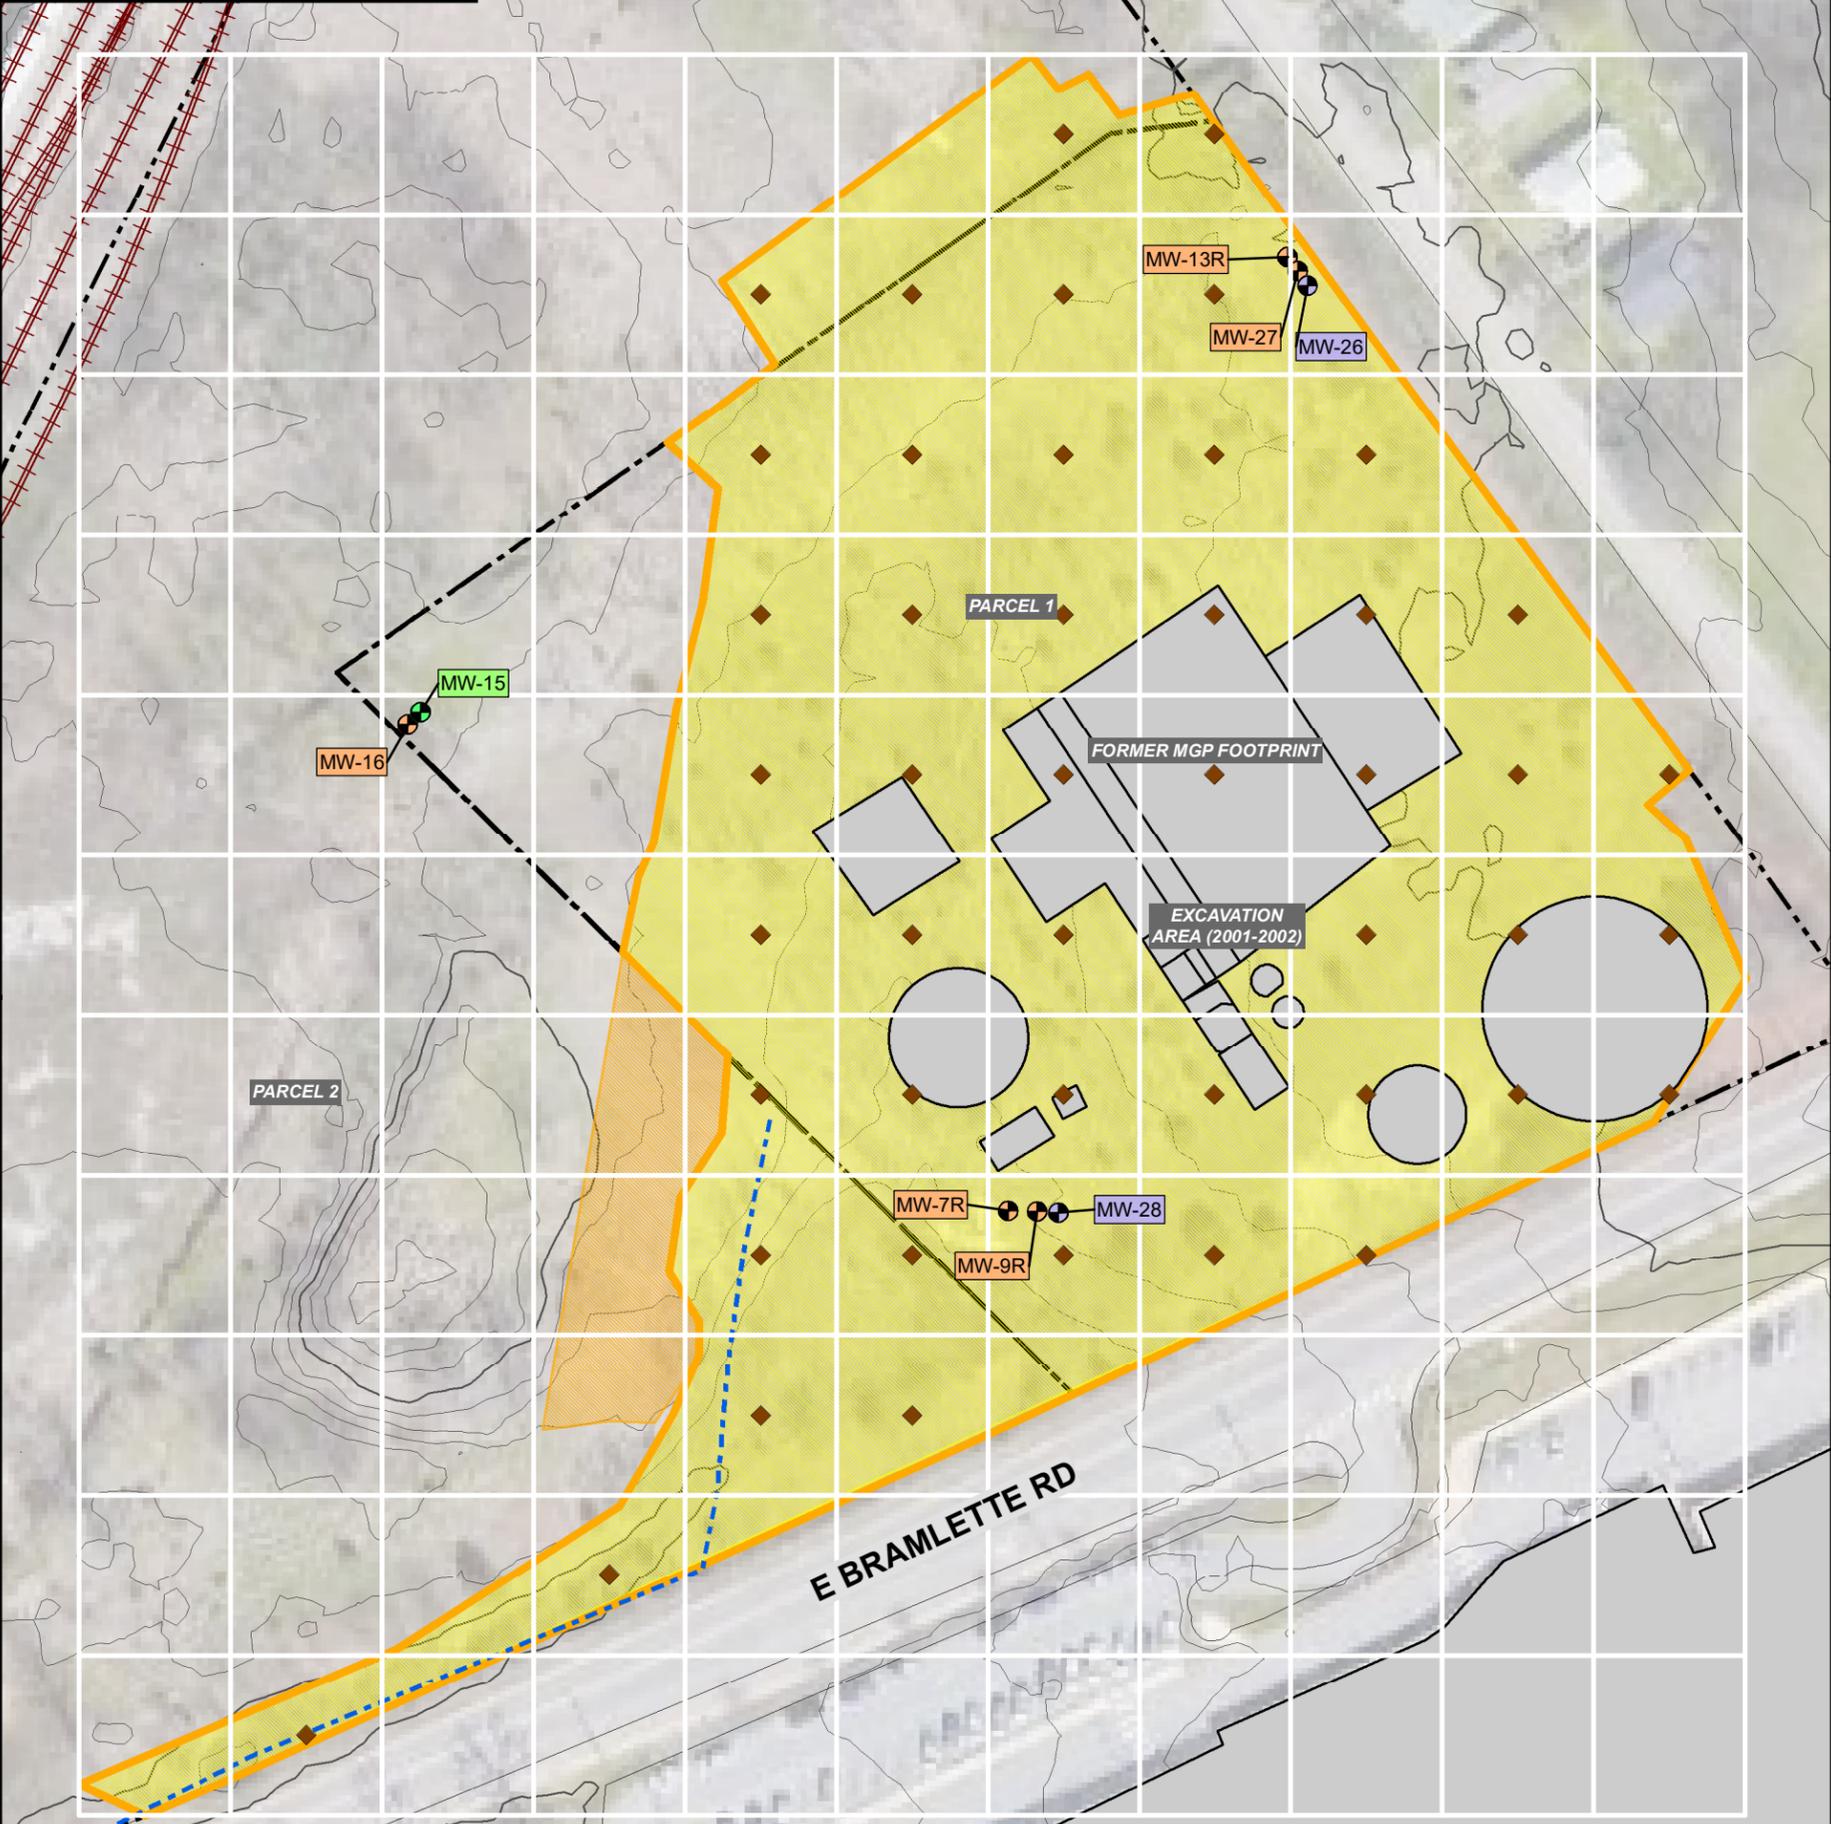
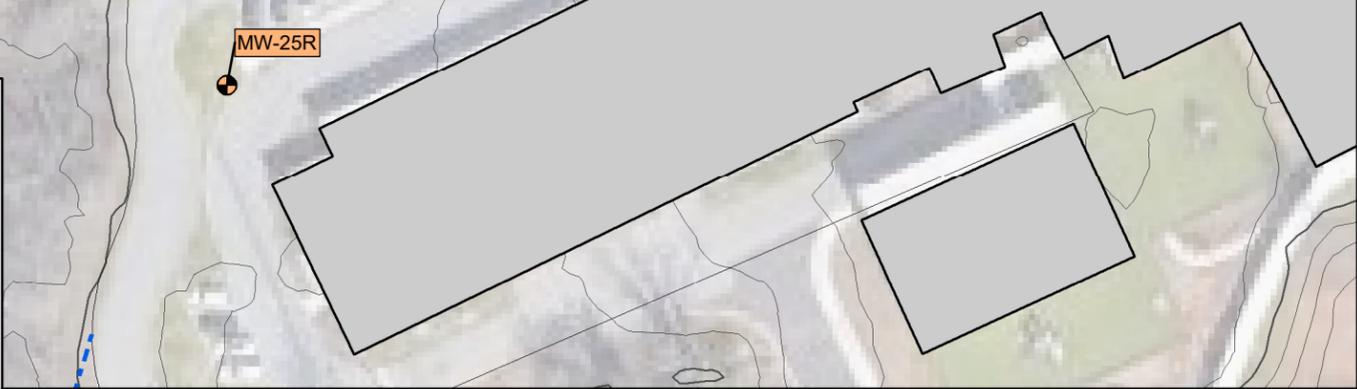
**FIGURE 4-1A**  
**PROPOSED WORK PLAN ADDENDUM SOURCE AREA**  
**VERIFICATION SOIL SAMPLING**  
**FORMER BRAMLETTE MGP SITE**  
**EAST BRAMLETTE ROAD**  
**GREENVILLE, SOUTH CAROLINA**

- ◆ PROPOSED SOIL BORINGS
- WELL IN SHALLOW ZONE
- WELL IN TRANSITION ZONE
- WELL IN BEDROCK ZONE
- AREA OF ADDITIONAL ENVIRONMENTAL MEDIA INVESTIGATIONS<sup>2</sup>
- AREA OF TEST PIT INVESTIGATION
- TOPOGRAPHIC CONTOUR (10' INTERVAL)
- TOPOGRAPHIC CONTOUR (2' INTERVAL)
- - - FORMER AND/OR CURRENT DRAINAGE DITCH (1964)
- ROAD
- RAILROAD
- BUILDING
- EXCAVATED AREA (2001-2002)
- PARCEL BOUNDARY

One objective of this work plan and the overall RI is to delineate the extent of NAPL impacts. As such, additional soil borings within Parcel 1 and to the east of Parcel 3 (Vaughn Landfill) are warranted. The soil cores will be visually inspected and logged for lithology and evidence of visible MGP-related impacts. Field screening will include headspace measurements using a PID in accordance with procedures described in Section 4.2 and the QAPP. Additional "step-out" borings may be necessary based upon the observed extent (if any) of NAPL impacts.
