# Watershed Plan for the Upper Broad Creek Watershed

Town of Hilton Head Island, SC

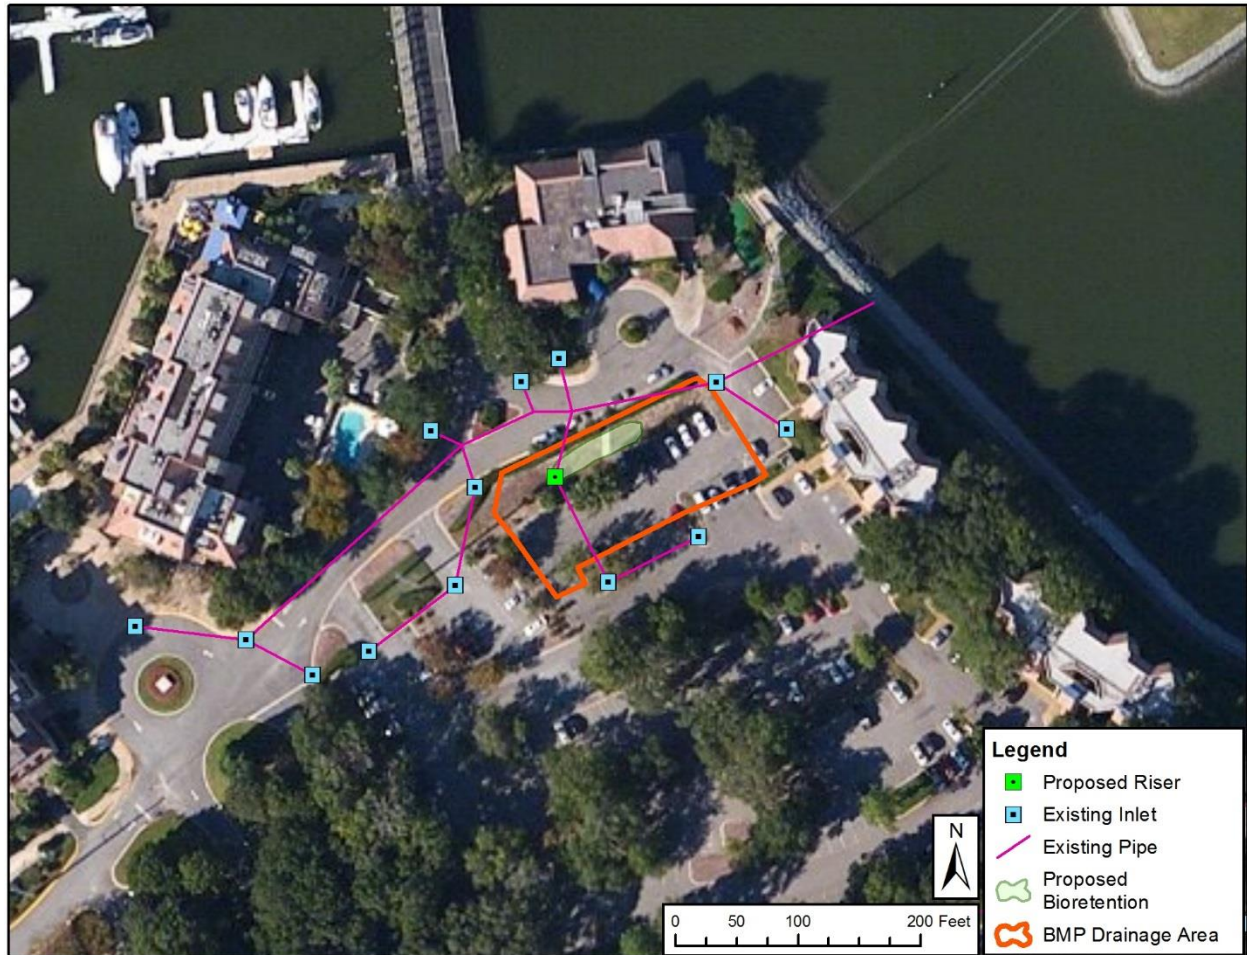
Proposed Design: Replace existing inlet with 1.5 foot high riser. Excavate and add media to create 0.03 ac bioretention cell in parking lot median. Replace pedestrian sidewalk with elevated walkway.

BMP drainage area limited by existing infrastructure which bypasses proposed bioretention area.

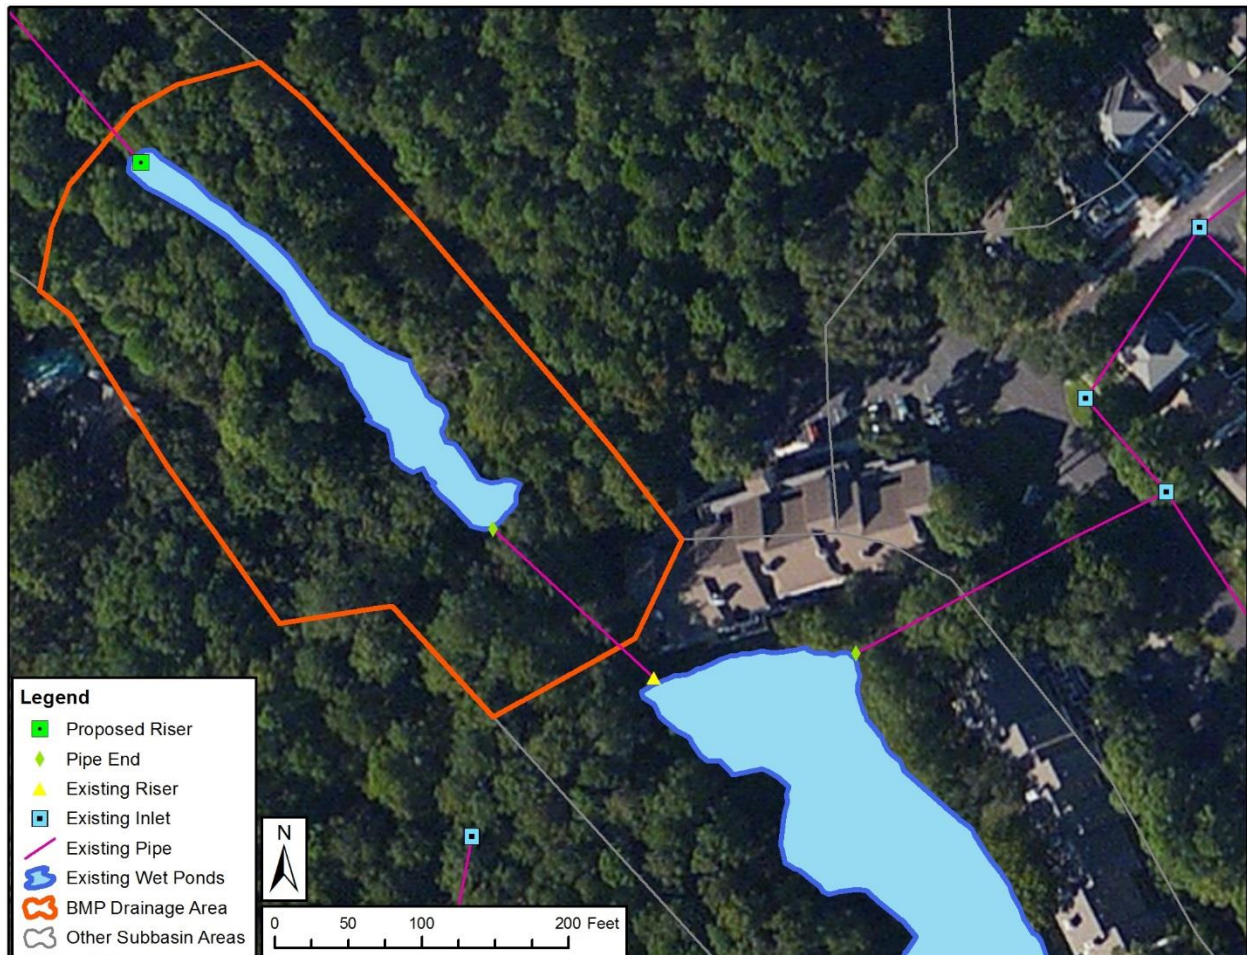
Proposed Design: Pond currently has a flashboard riser without boards to restrict flow. Riser will be replaced with a rectangular riser with a 4 inch orifice located at a stage of 1 foot.

This pond is on land owned by THHI. The large pond immediately upstream improves water quality to the extent that it limits the potential water quality impact of a retrofit to this pond (lower initial pollutant loads entering this pond makes further reductions more difficult).

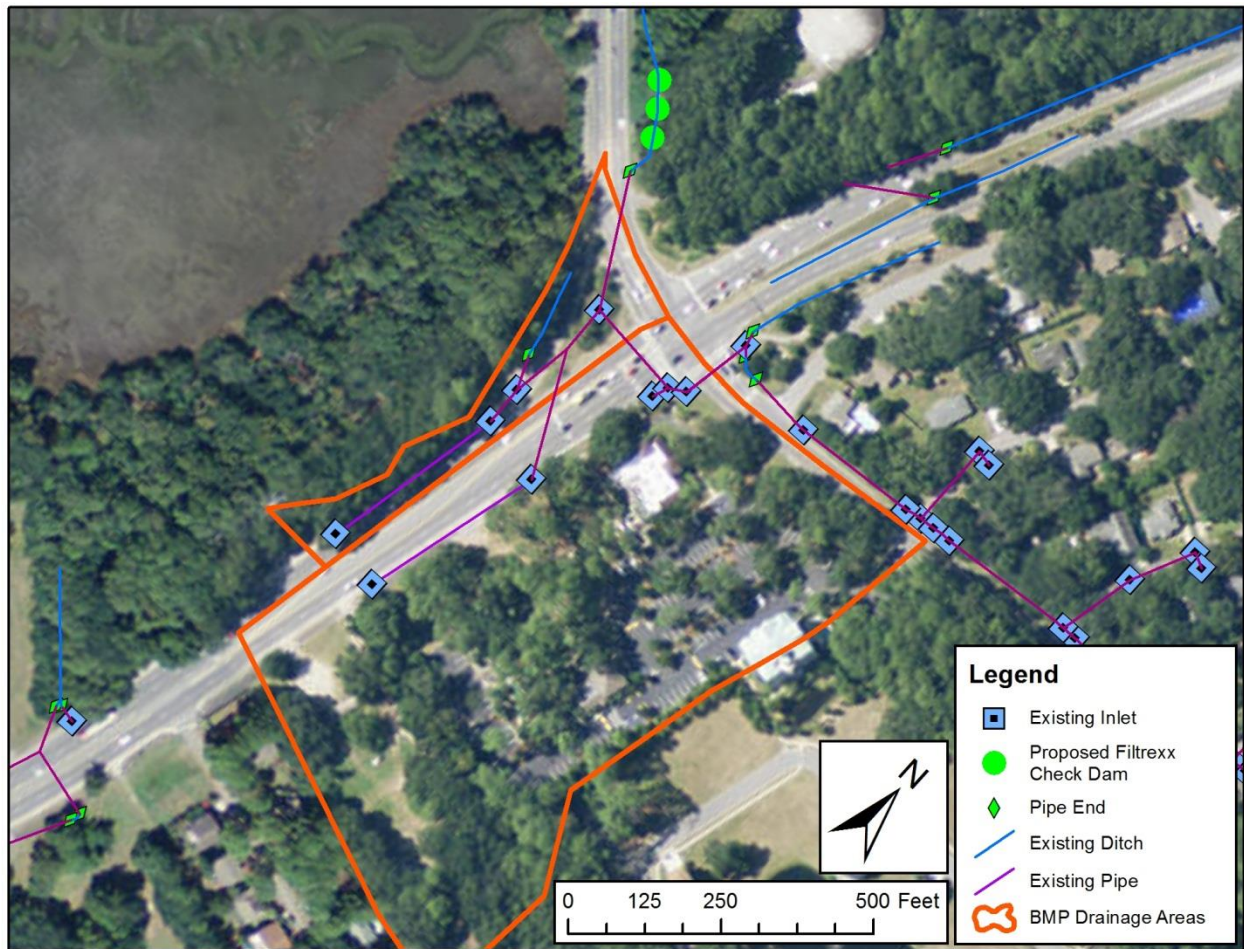
Life expectancy of Filtrexx check dams varies but averages 6 months. Unit costs were adjusted for the table below to simulate the cost of replacement for 15 years, similar to the lifespan of other BMPs in this analysis. Cost for each replacement is estimated to be \$3,000.

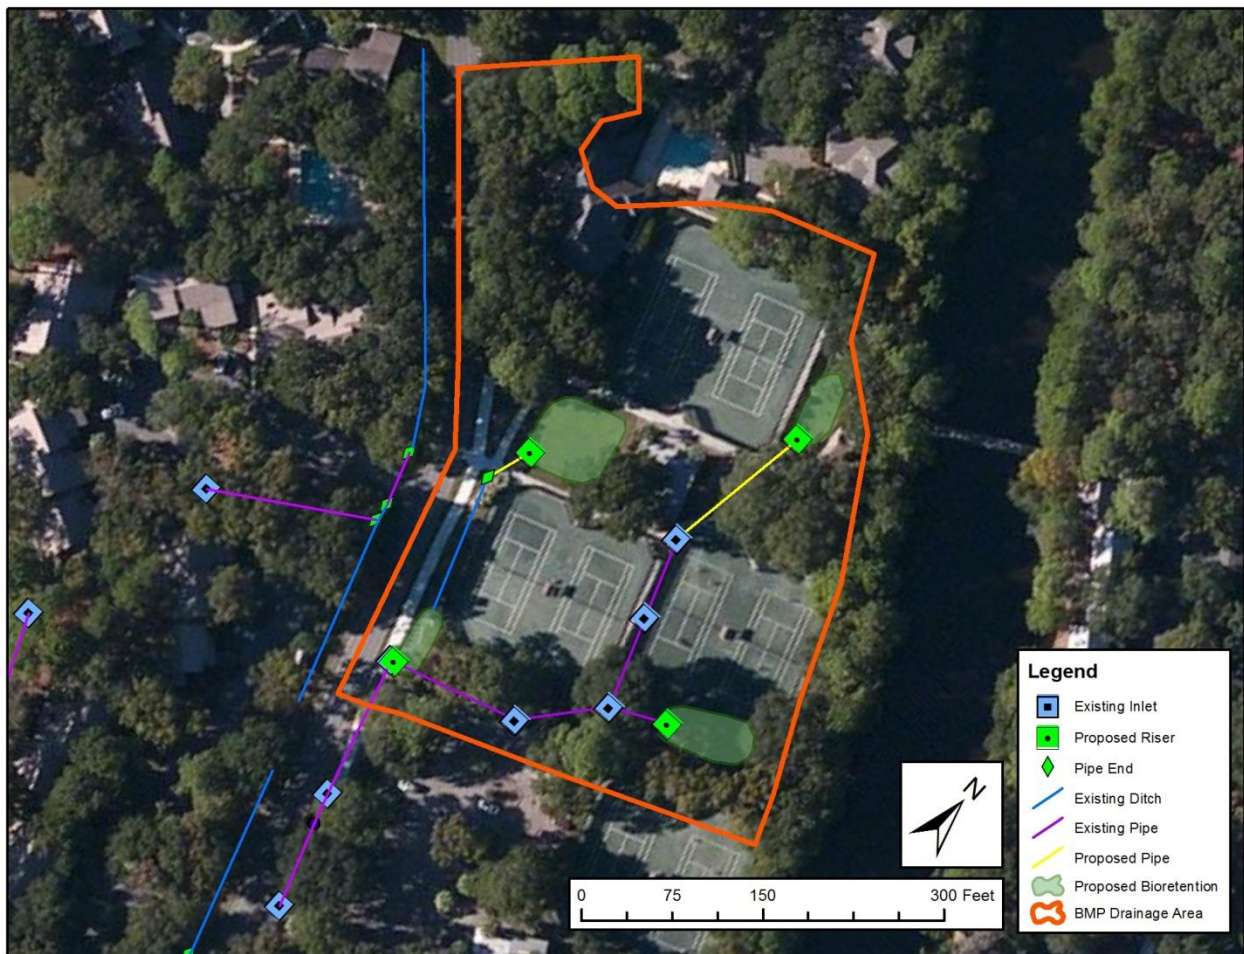
Bioretention cell locations and sizes are approximate. This is a conceptual estimate- there is no guarantee all the drainage area shown can be directed to BMPs without major changes to drainage structures.

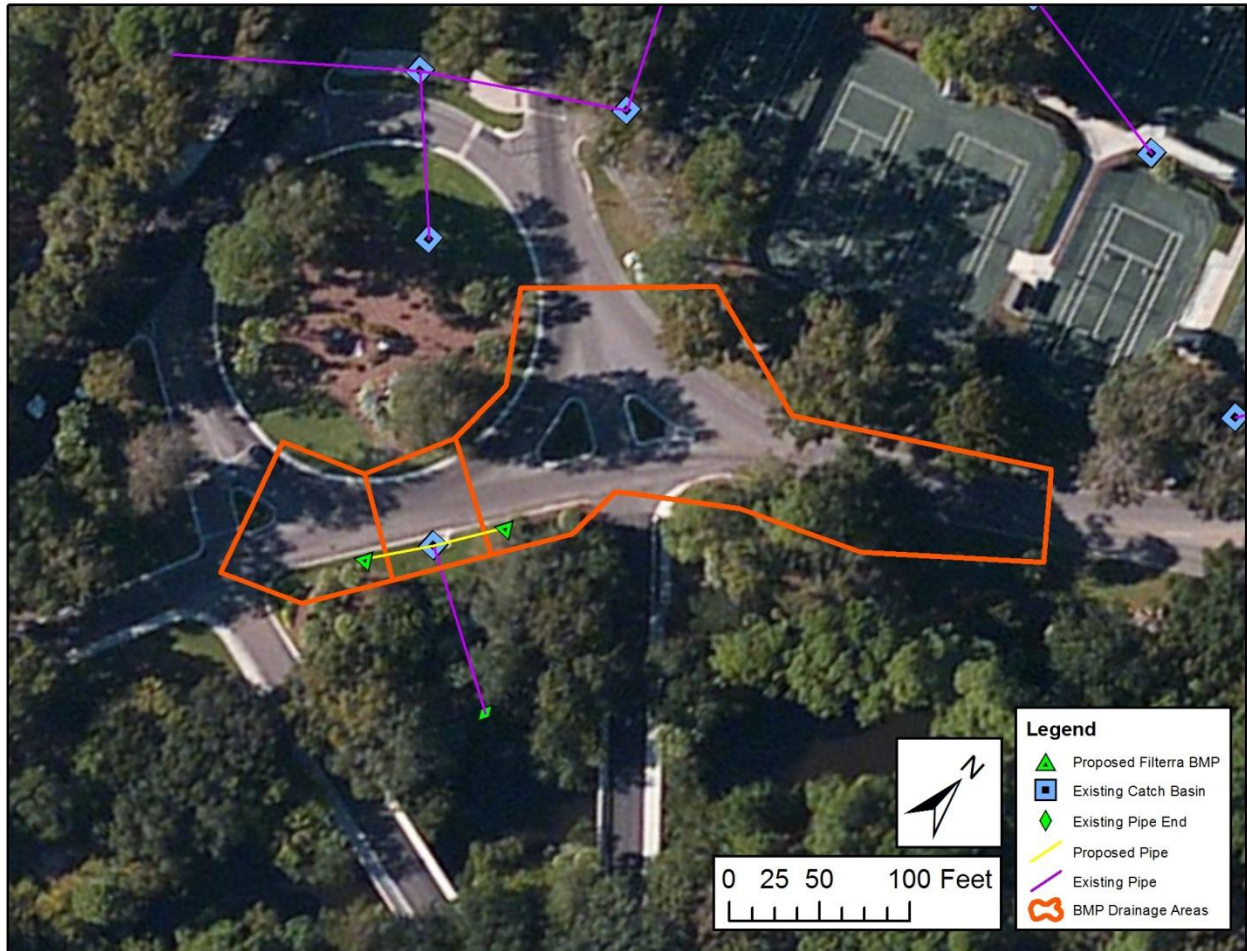
Plantings in Filterra units may be limited by line-of-sight restrictions.

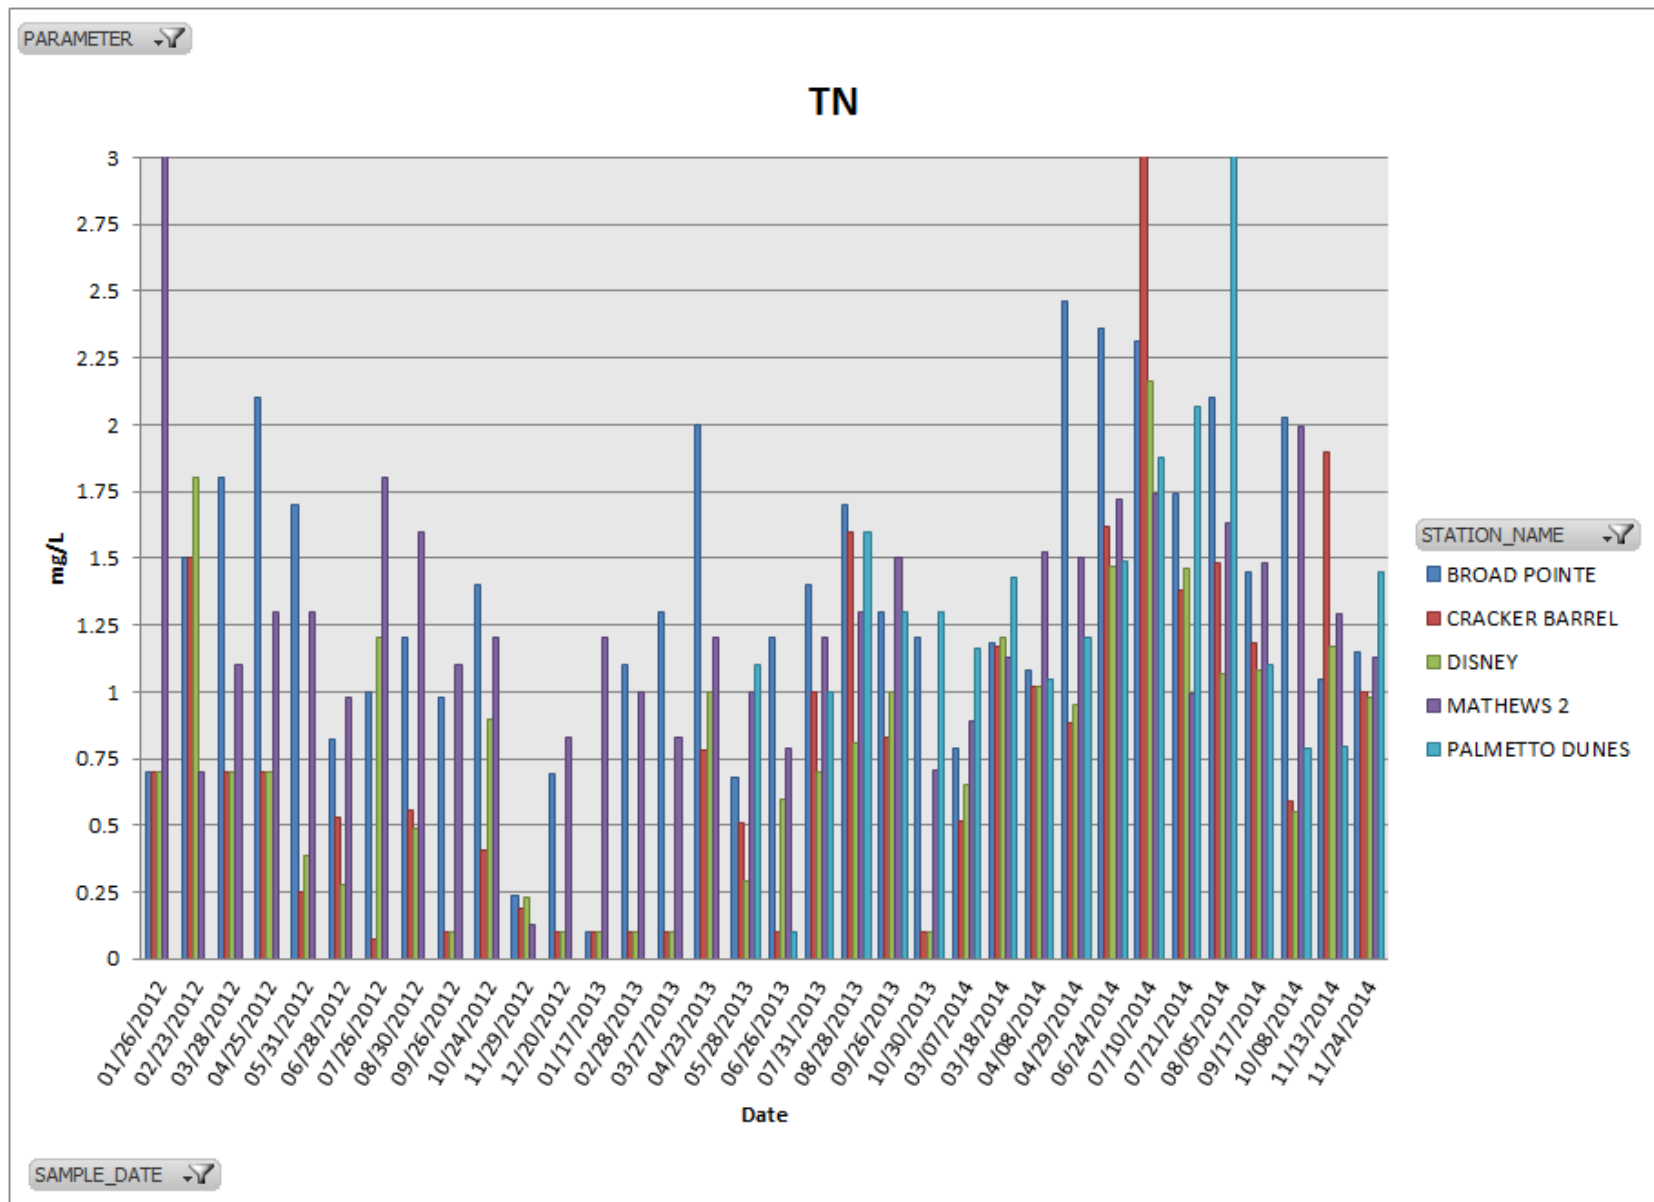
Figure 3: Total nitrogen levels at Town sampling locations.

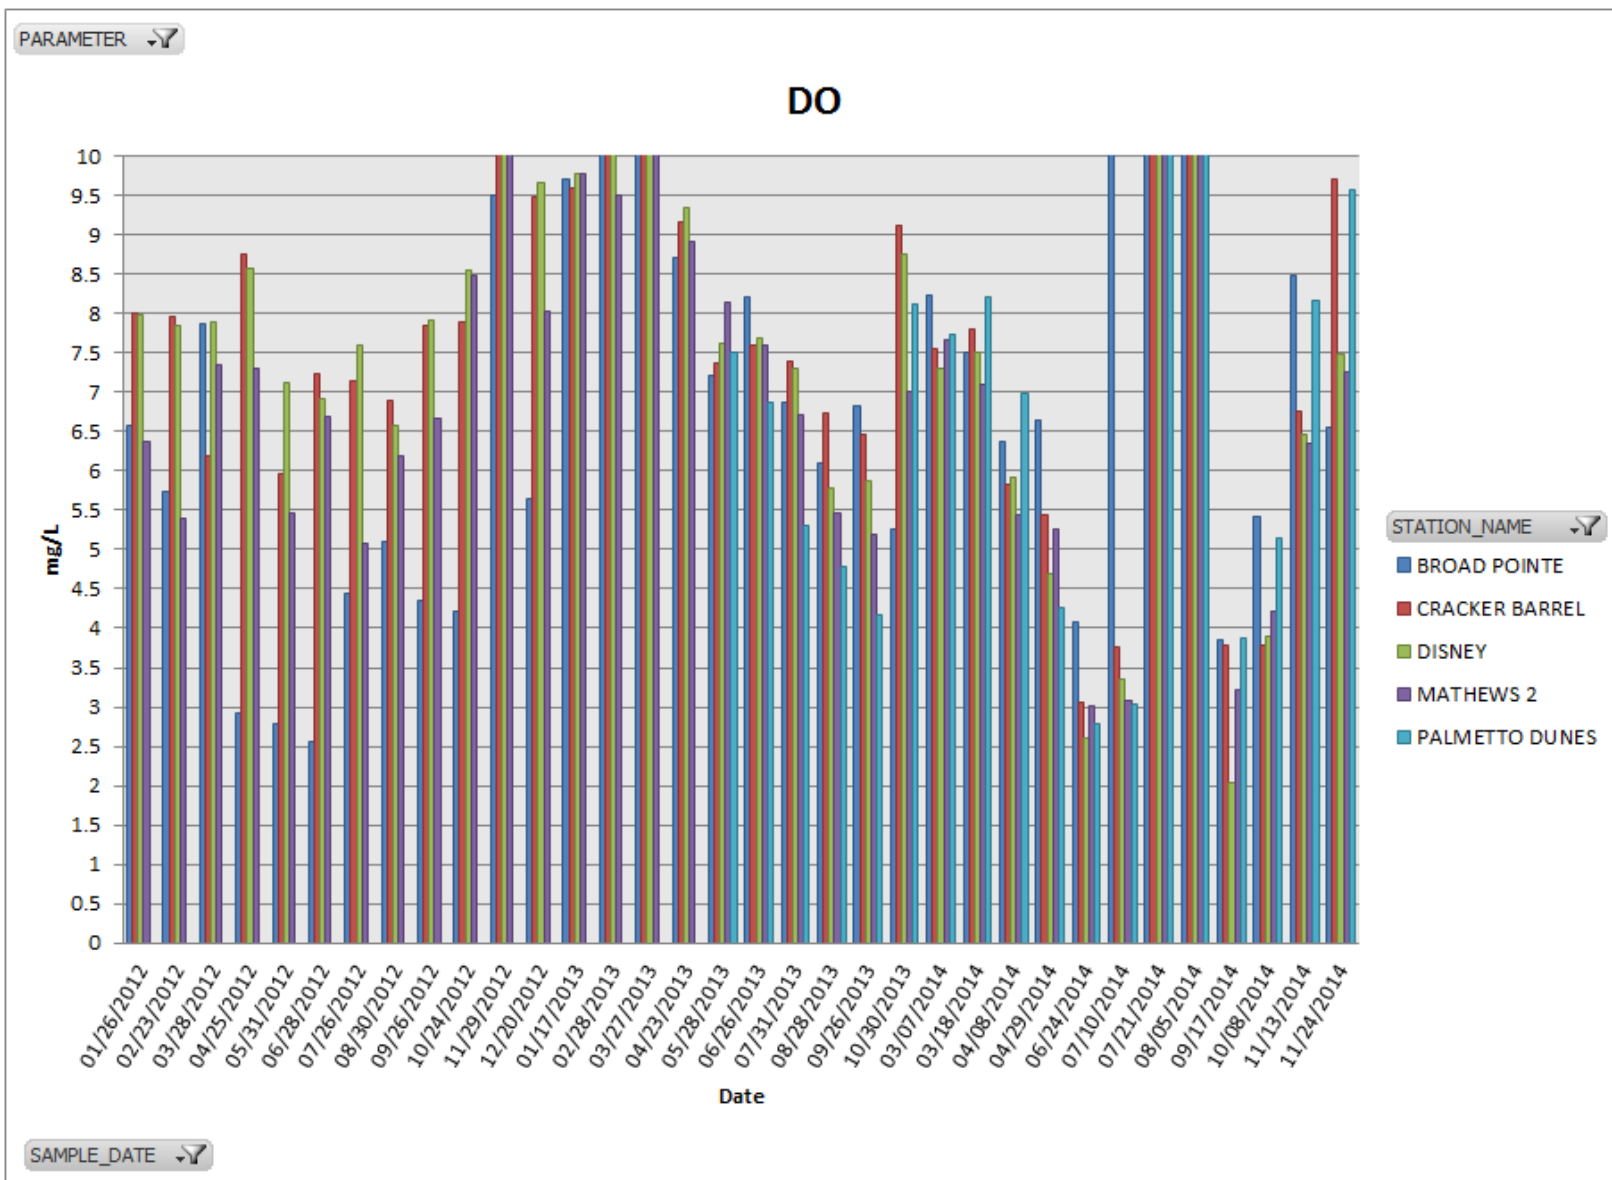
Figure 5: Dissolved oxygen levels at Town sampling locations.
