LAND-SURFACE COLLAPSE AND
GROUND-WATER PROBLEMS
IN THE JAMESTOWN AREA, BERKELEY COUNTY, SOUTH CAROLINA

B.C. Spigner
Hydrologist

South Carolina Water Resources Commission
Open-File Report No. [REDACTED] 2
July, 1978

South Carolina Water Resources Commission
Open-File Report No. 78-1
July, 1978

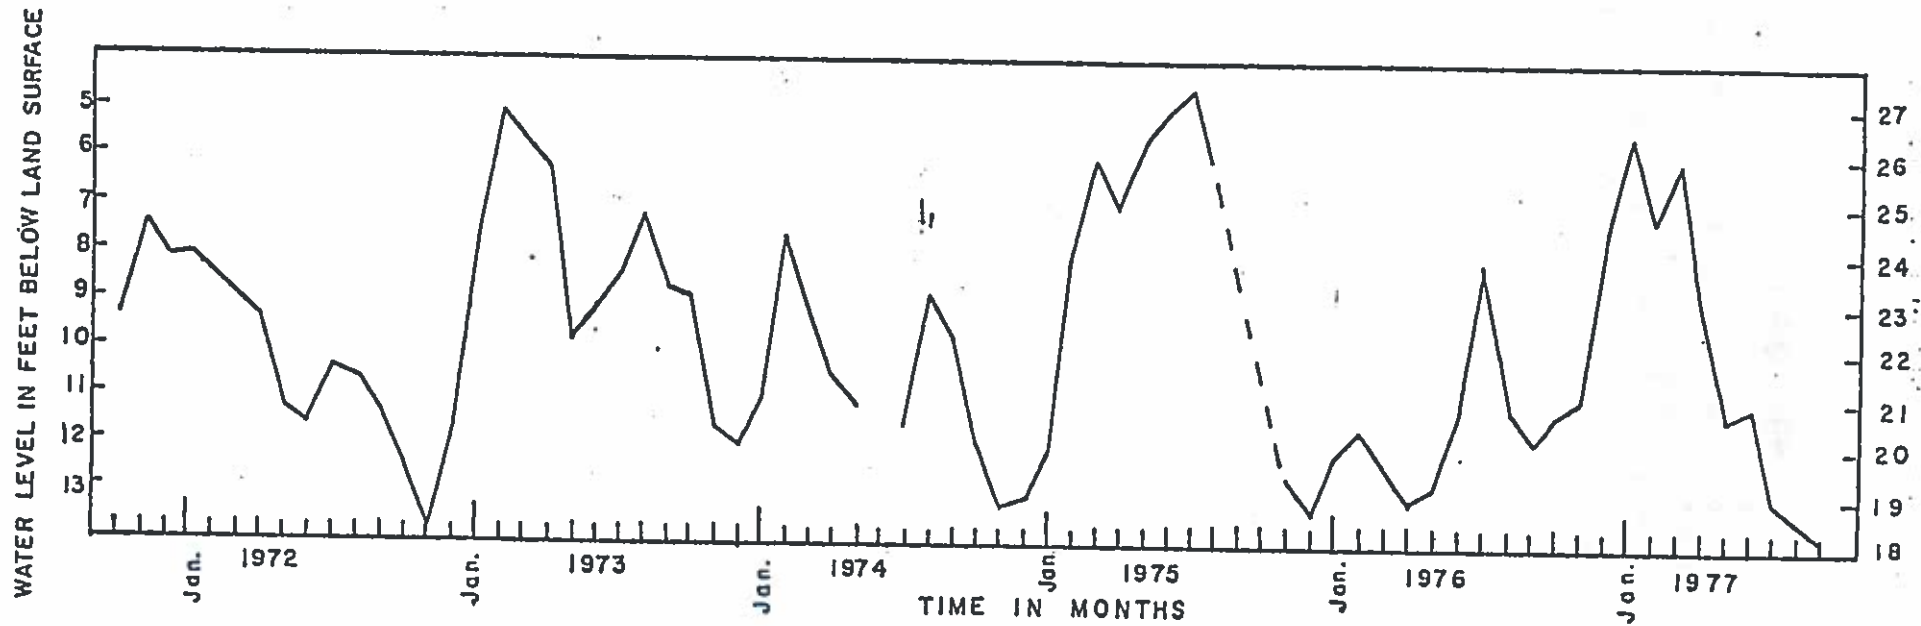
FIGURE 5 MEAN MONTHLY HYDROGRAPH OF OBSERVATION WELL BRK-53 AT JAMESTOWN, S. C.

Water levels in the Santee aquifer have been recorded in a U. S. Geological Survey observation well, Brk-53 (15X-L2), at Jamestown since October, 1971, and the monthly mean hydrograph of this well is shown in figure 5. This well is completed in the upper permeability zone of the Santee aquifer from 28-32 ft below lsd (land surface datum). Water levels in this well are unaffected by local pumpage; therefore, the hydrograph represents natural water-level fluctuations in the Santee aquifer. This hydrograph indicates that water levels respond to seasonal variations in rainfall. Water levels are normally lowest during the late Fall (October) and highest following winter rains. Water levels also respond to heavy rains during the Summer, primarily during July.

The normal fluctuation in the ground-water level in the Santee aquifer for the period October, 1971 to the present, recorded by U. S. Geological Survey observation well Brk 53 at Jamestown, has not been more than about 10 ft (fig. 5).
