Gills Creek Watershed: Assessment of Regulated Dams

February 15, 2016

PROJECT NAME: Gills Creek Watershed Assessment of Regulated Dams Report

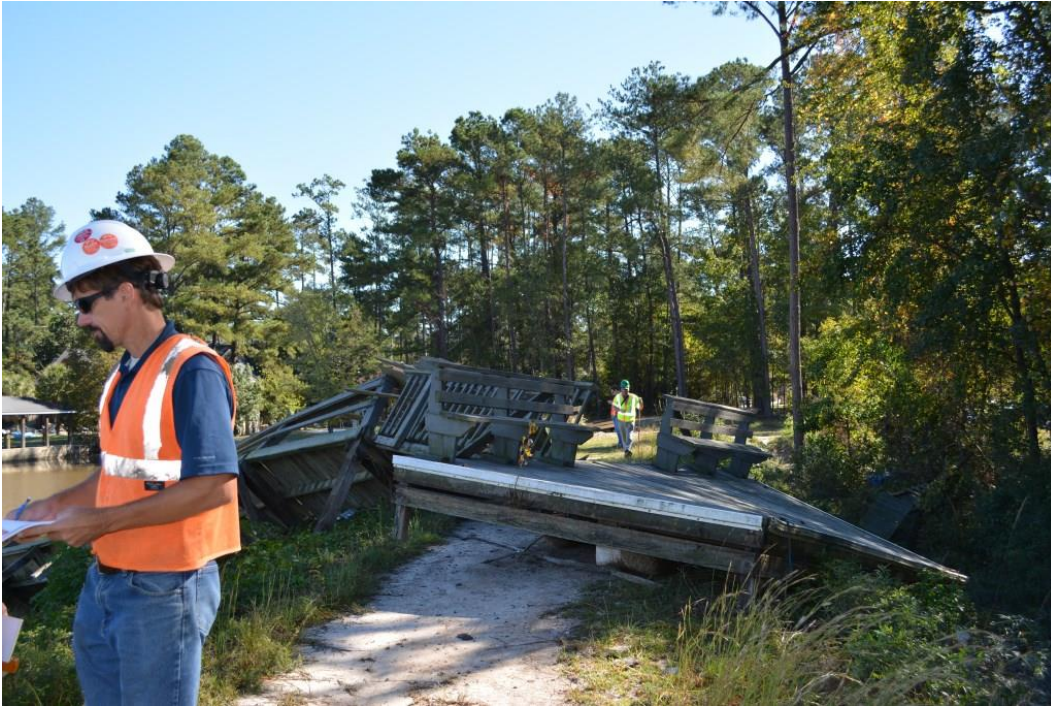
Photo 1: Dock remnants on left embankment crest

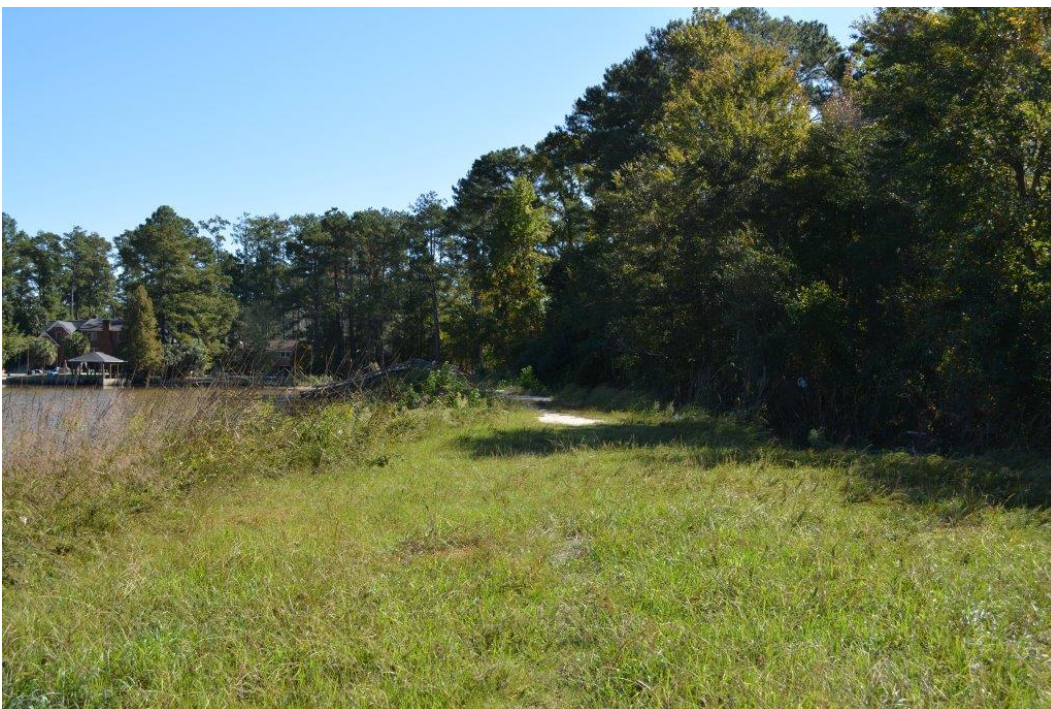
Photo 2: View of left embankment crest looking toward left abutment.

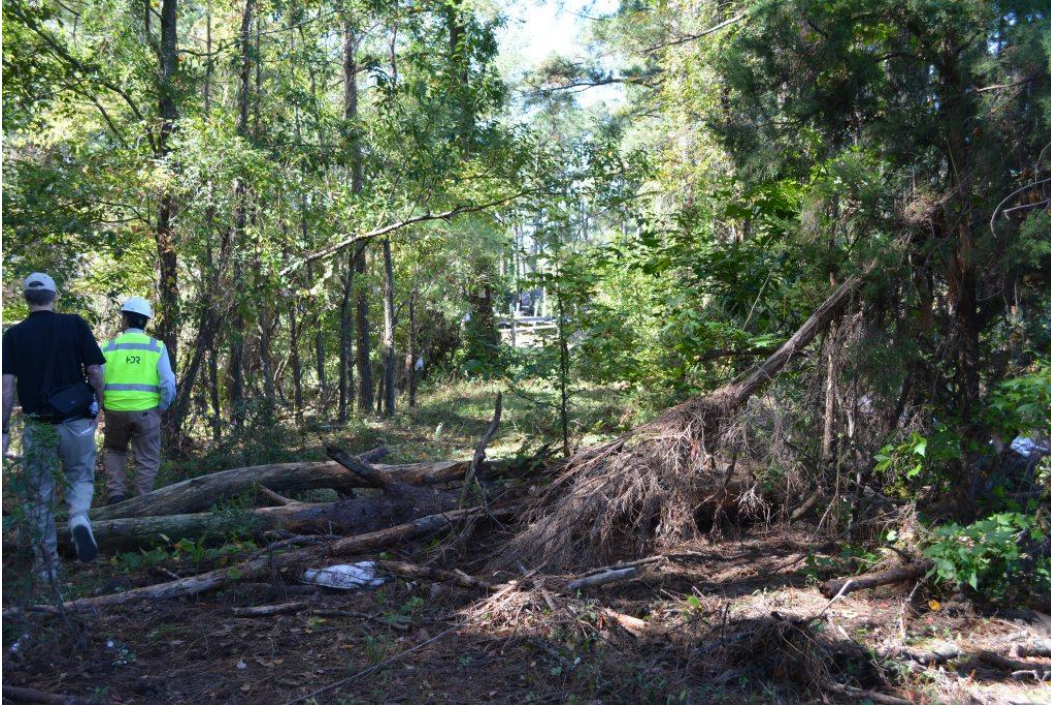
Photo 3: Right embankment crest looking toward right abutment showing tree growth on upstream and downstream slopes

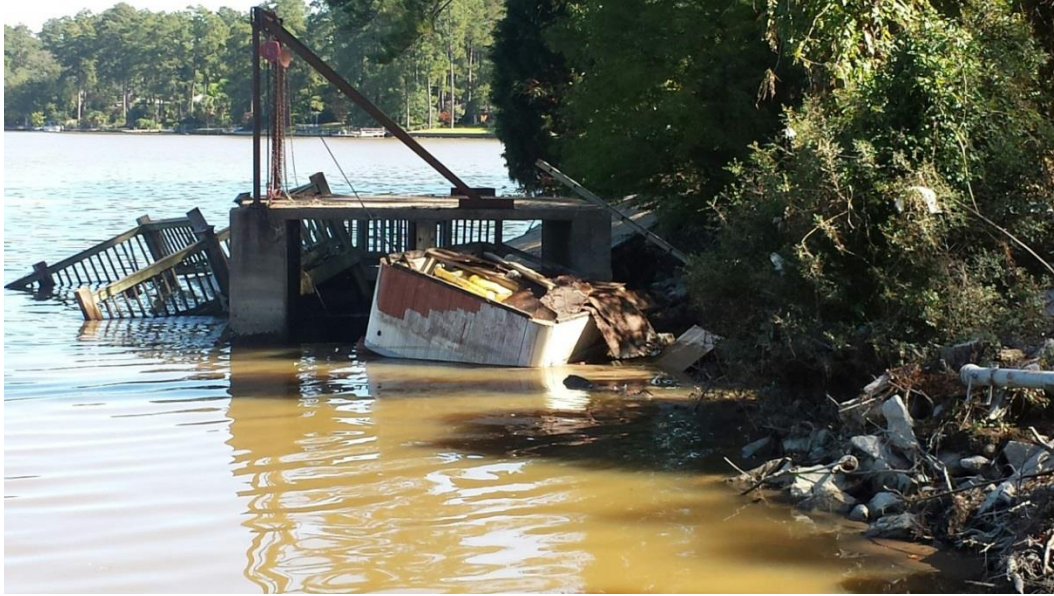
Photo 5: Concrete drop inlet at right abutment.

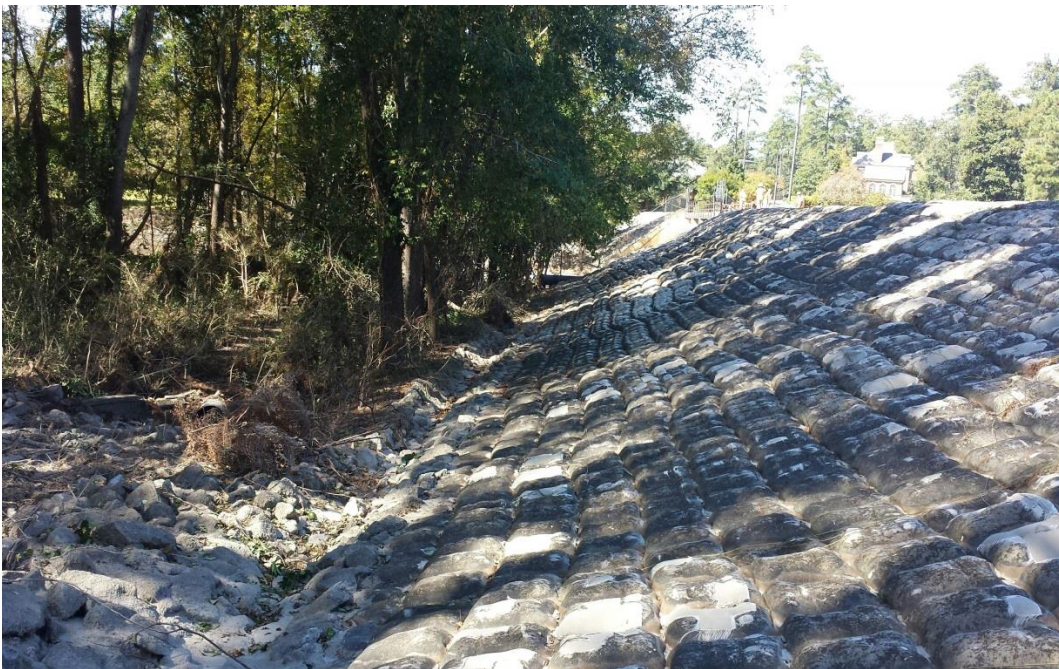
Photo 2: View along toe of the left embankment

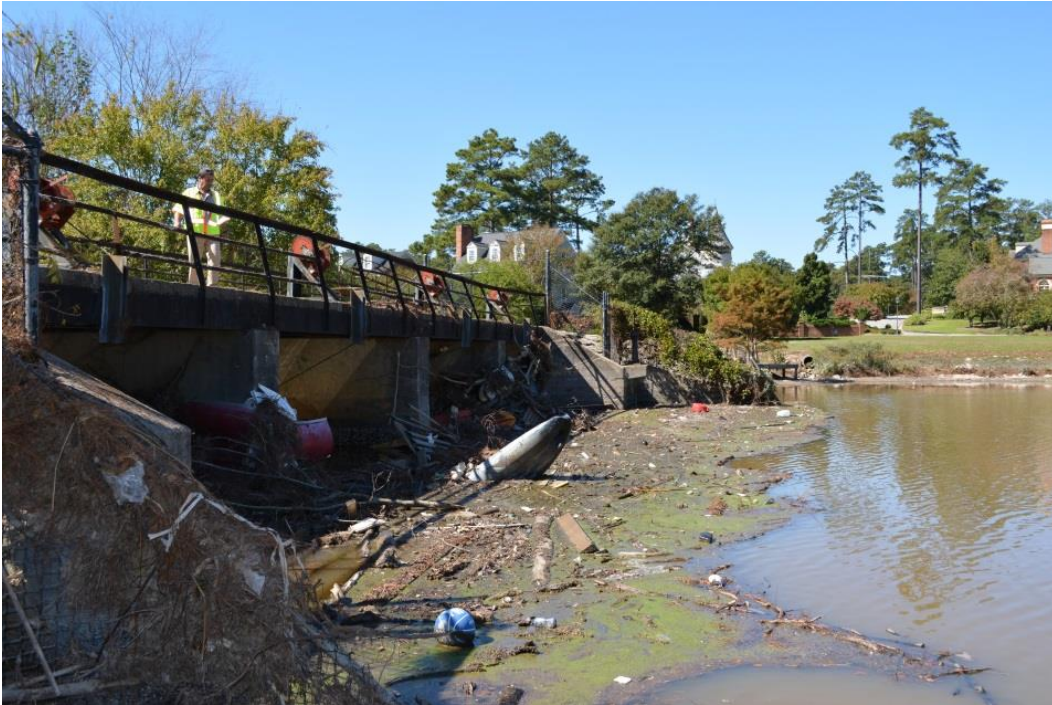
Photo 4: Upstream view of gated, concrete-buttress, overflow spillway

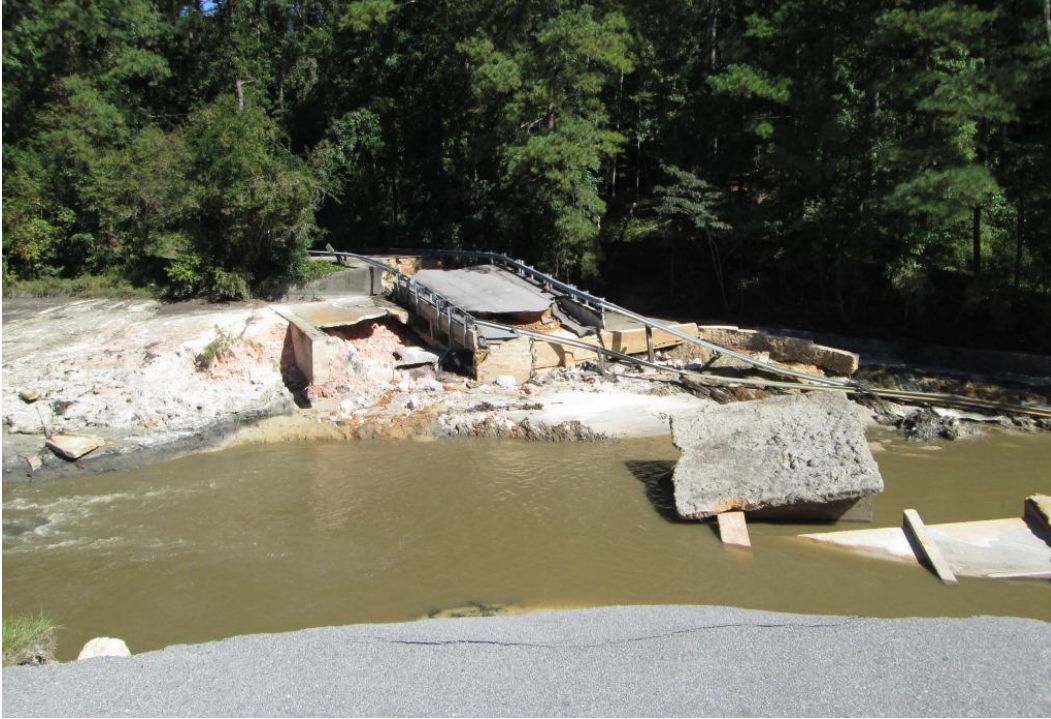
As shown in the photos, the entire embankment dam has been washed out, with remnants of a concrete retaining wall at the left abutment, remnants of the low level concrete box culvert in the middle of the stream, and a portion of the concrete channel of the auxiliary spillway at the right abutment.

Photo 1: View of dam breach and left abutment from right abutment.

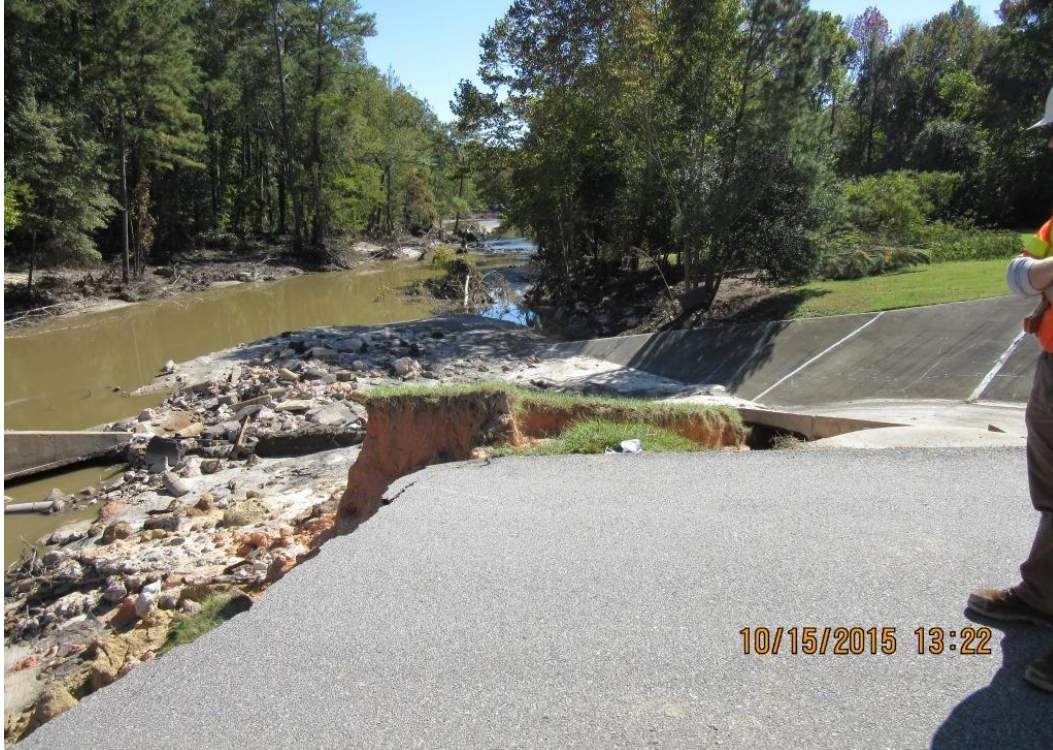
Photo 3: Downstream view of remnants of right concrete channel of the auxiliary spillway.

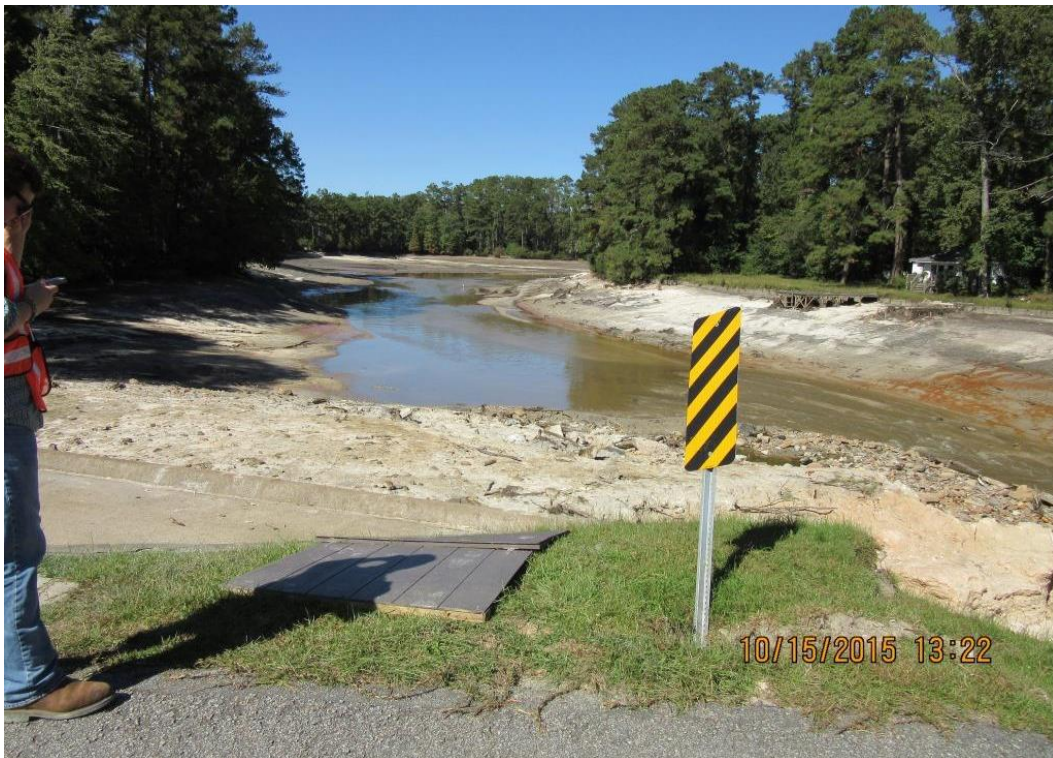
Photo 4: Upstream view; concrete approach slab of right auxiliary spillway is in the foreground

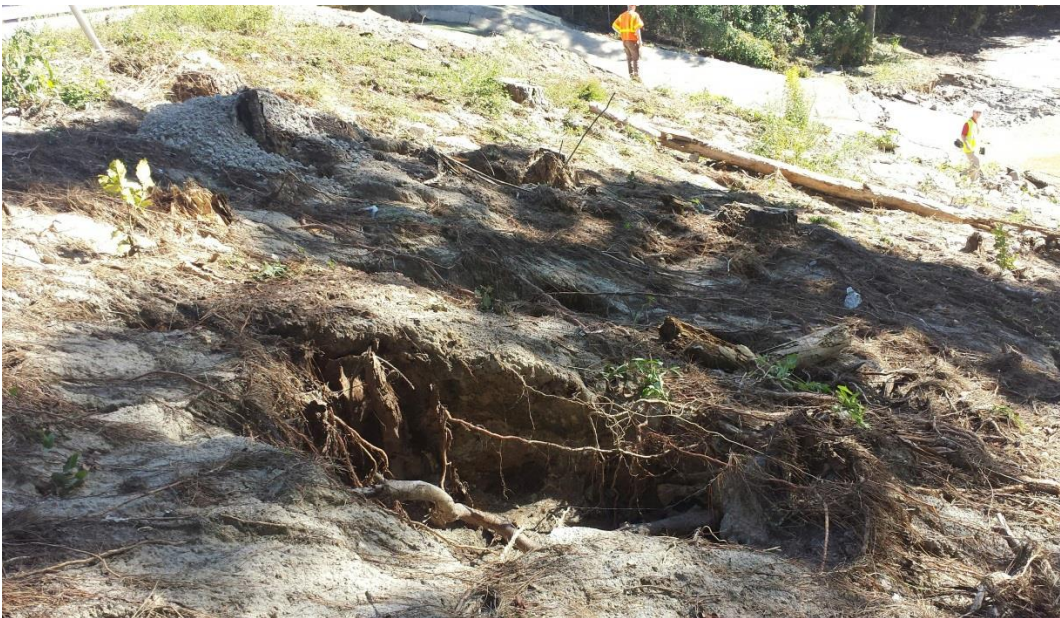
Photo 2: Erosion on downstream slope of the right embankment

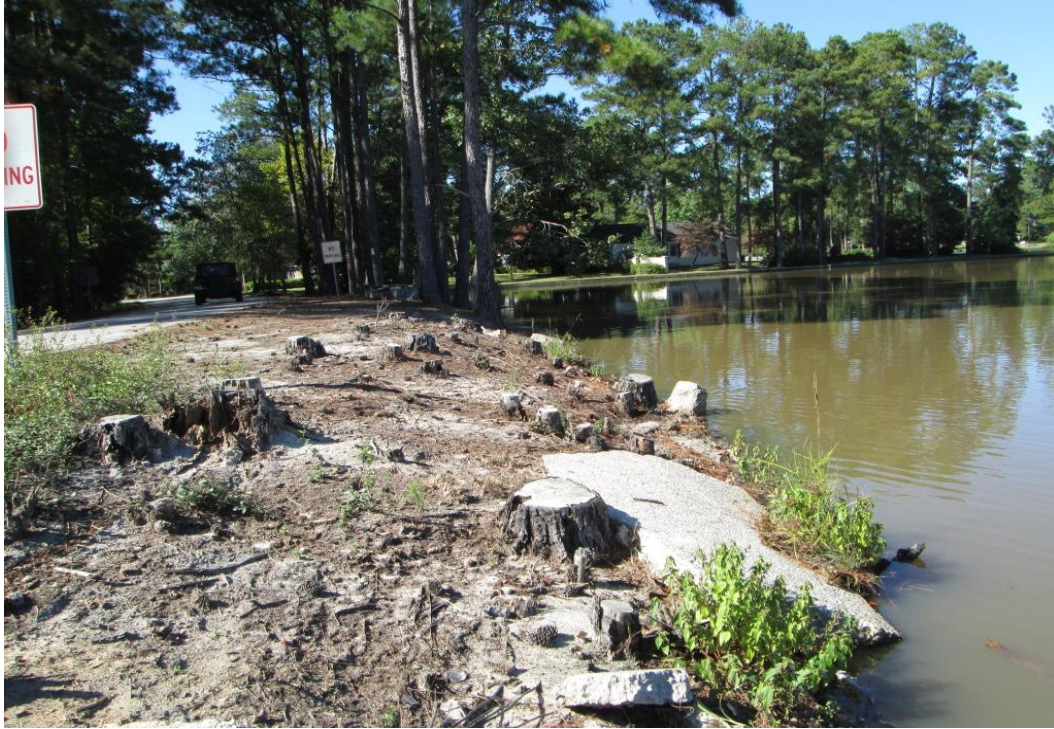
Photo 3: Upstream slope of right embankment with tree stumps and mature trees

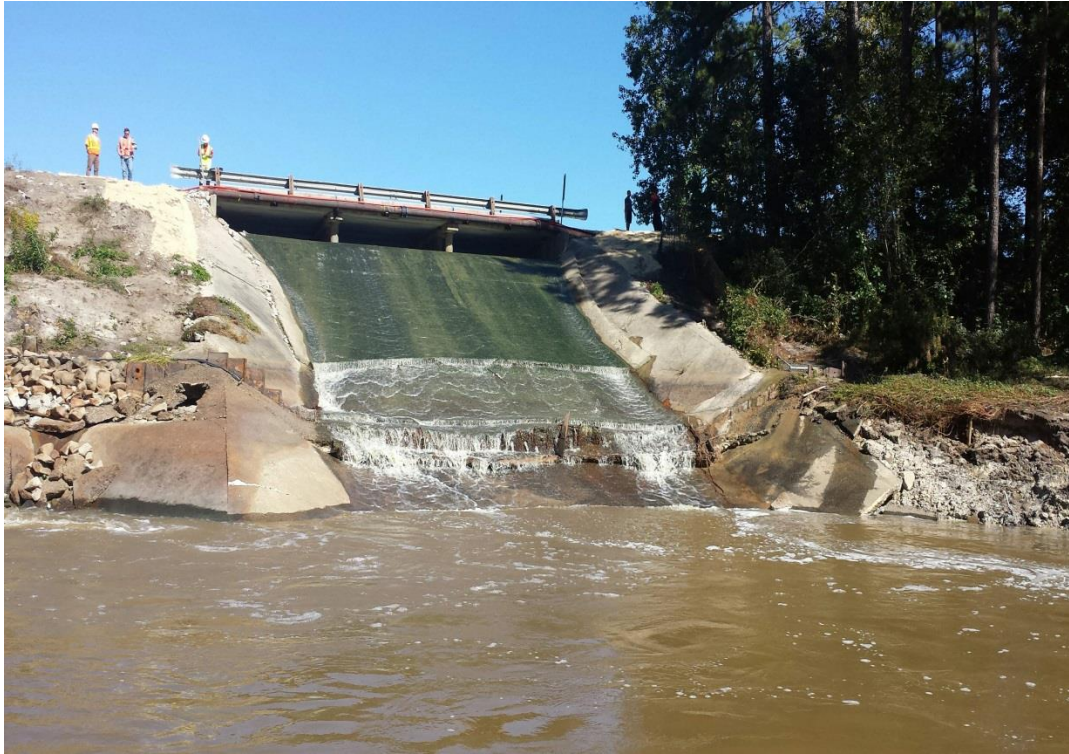
The auxiliary spillway is a concrete, uncontrolled, overflow spillway with a crest that is approximately 45 feet wide and about 5 feet below the bridge roadway surface (Photos 4 and 5). The auxiliary spillway generally appeared to be in fair condition, except for some areas of erosion and deterioration. Erosion and undermining with evidence of seepage was observed along each side of the concrete spillway as noted above (Photos 6 and 8). Significant cracks and voids in the spillway concrete were observed in the vicinity of the steel sheet-piling extending across the spillway surface near the toe (Photos 5 and 7).

Photo 5: View of auxiliary spillway; note erosion at toe of left embankment

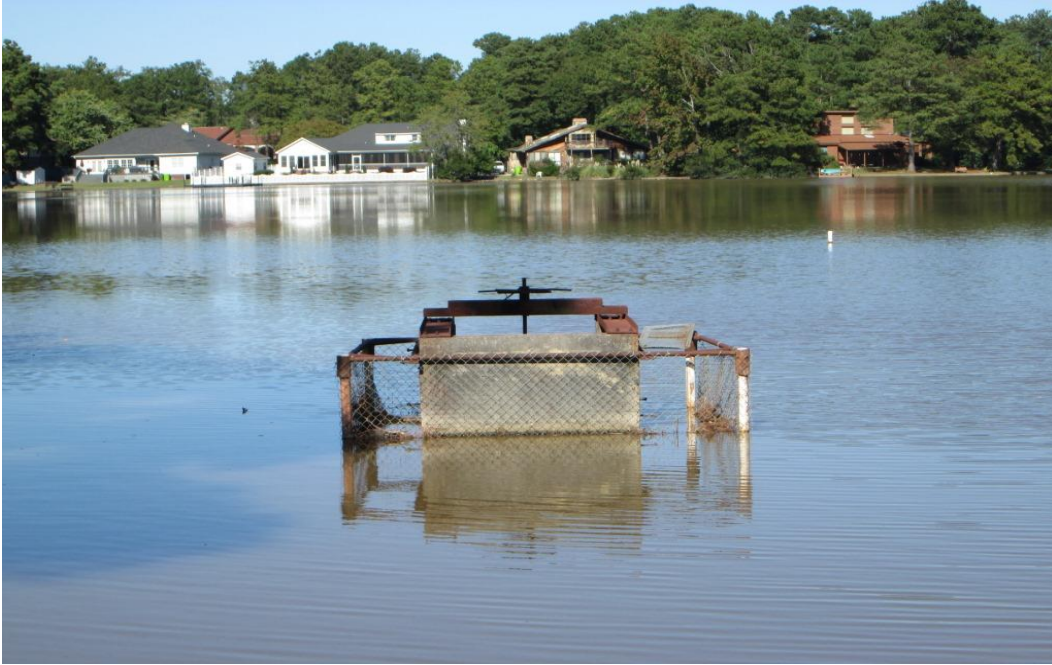
The service spillway is a low-level outlet (48-in. RCP) controlled by a concrete drop inlet located approximately 60 feet upstream of the dam. The inlet has a trash screen that appeared relatively free of debris (Photo 9). The outlet discharge is located to the right of the auxiliary spillway (Photo 10). Standing water with red coloration was observed at the headwall of the outlet structure, indicating potential seepage.

Photo 9: Service spillway drop inlet structure

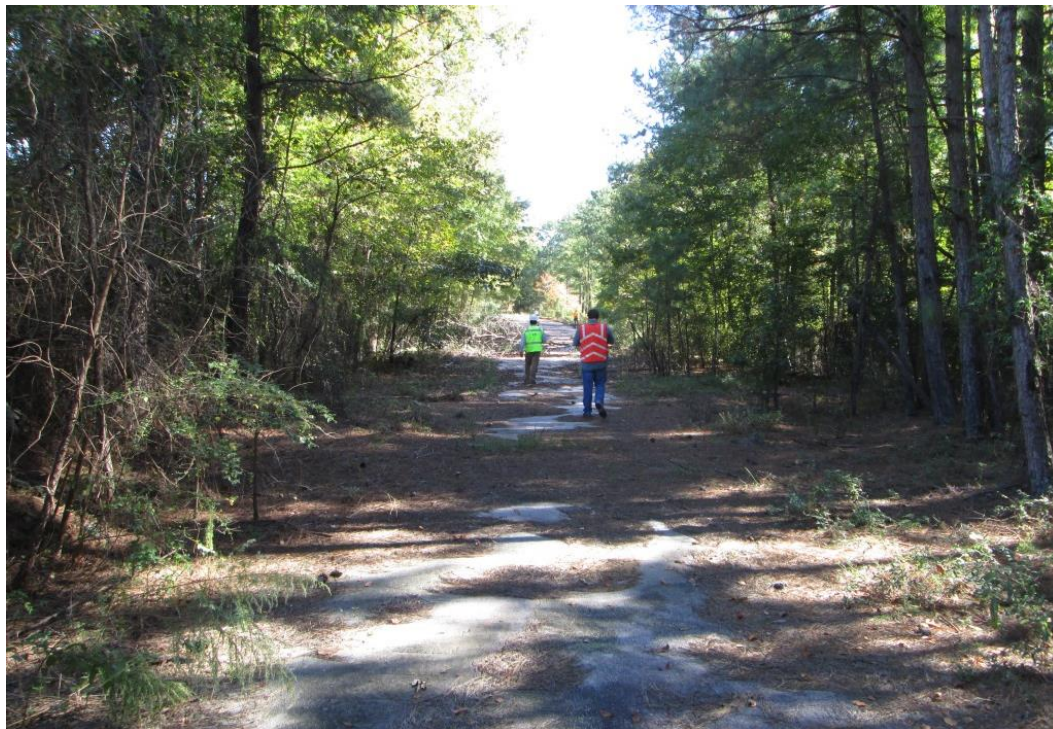
Photo 1: Crest of embankment dam looking toward the left abutment. Note mature trees and thick underbrush on embankment slopes.

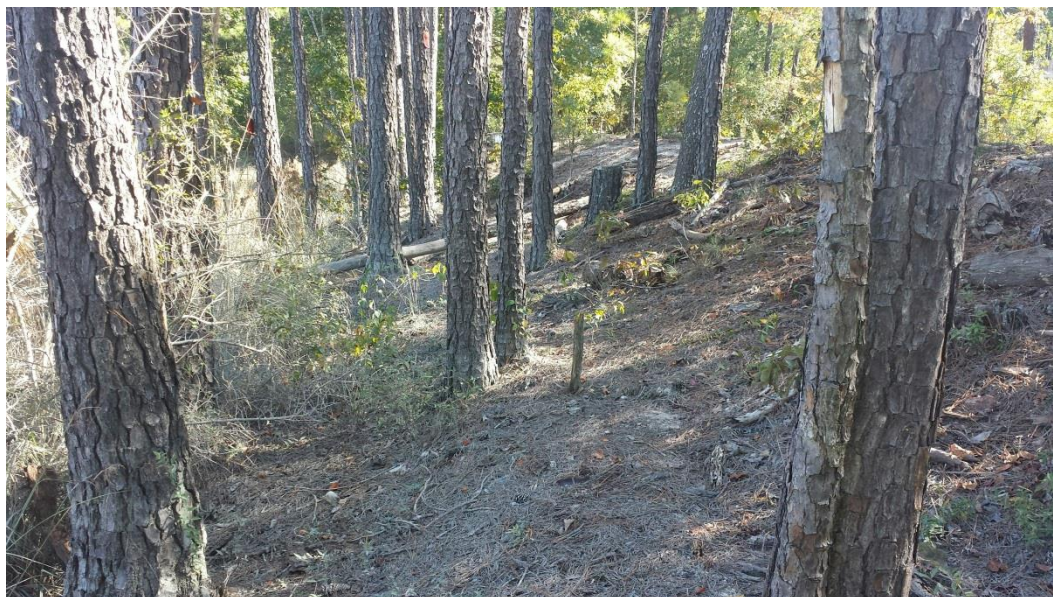
Photo 2: Tree growth on upstream embankment slope

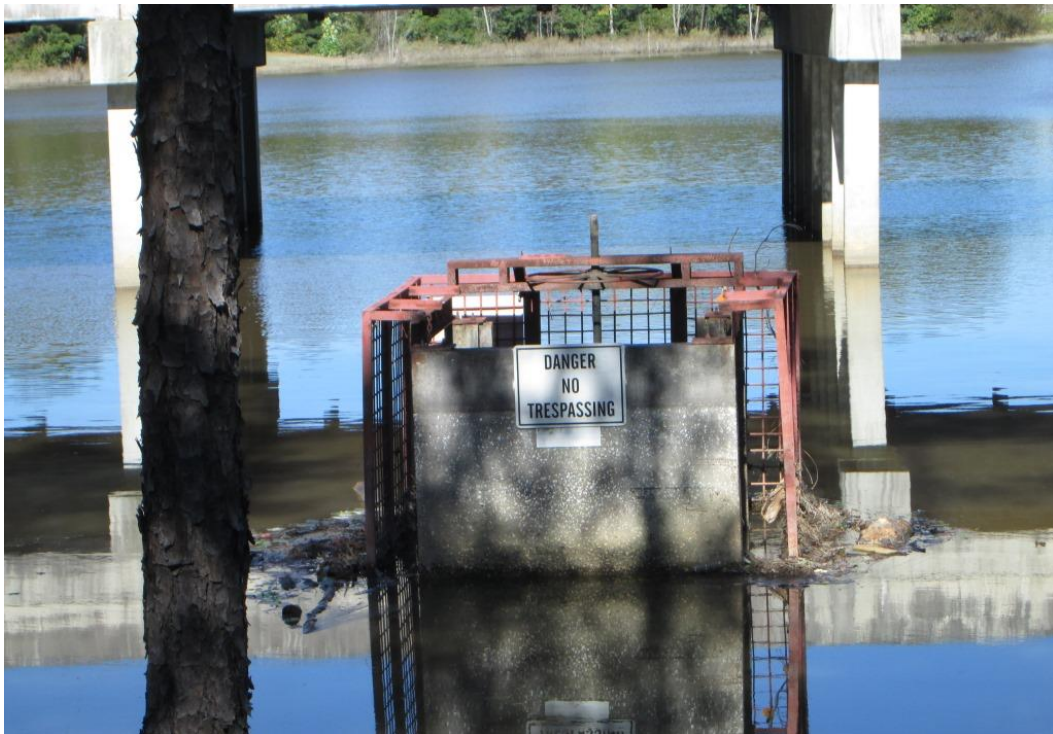
Photo 4: Service spillway drop inlet

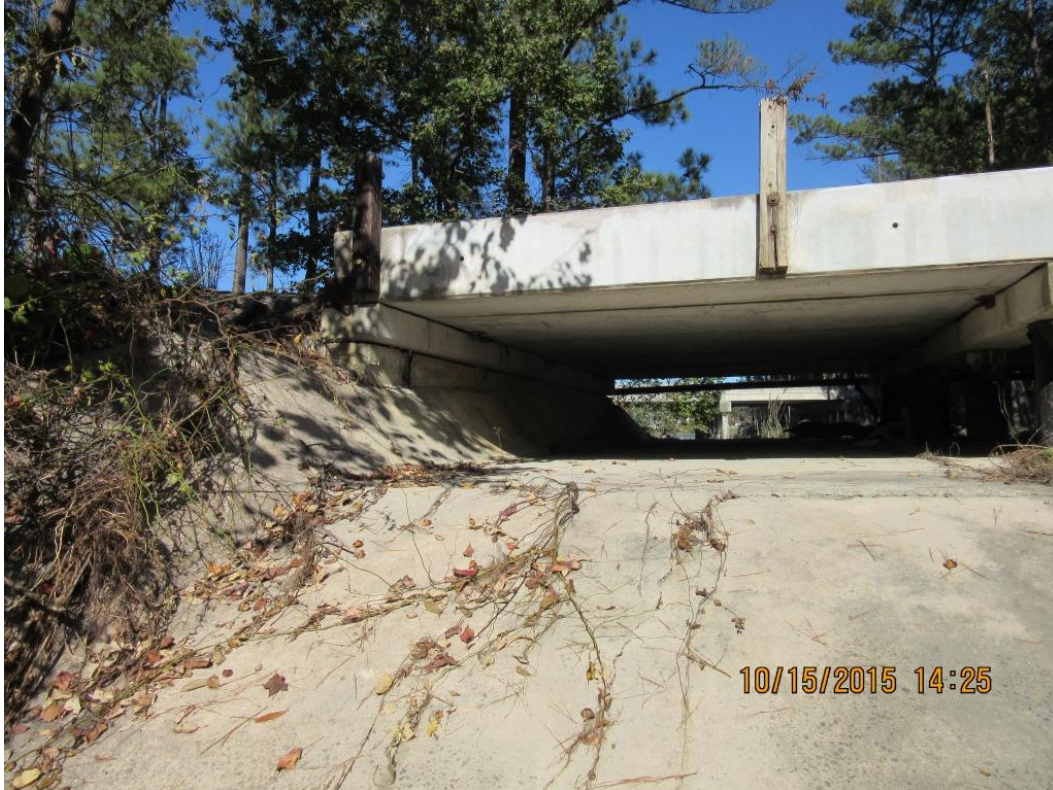
The auxiliary spillway is a concrete, uncontrolled, overflow structure (Photos 5 and 6). The crest length was measured to be 44 feet. The structure appeared to be in good condition with no areas of concrete deterioration. Minor wood debris had accumulated on the spillway. Erosion was noted at all four corners of the auxiliary spillway abutments at the crest (Photo 7). The approach channel to the auxiliary spillway was vegetated but free of accumulated debris (Photo 8).

Photo 5: Auxiliary spillway viewed from the downstream side

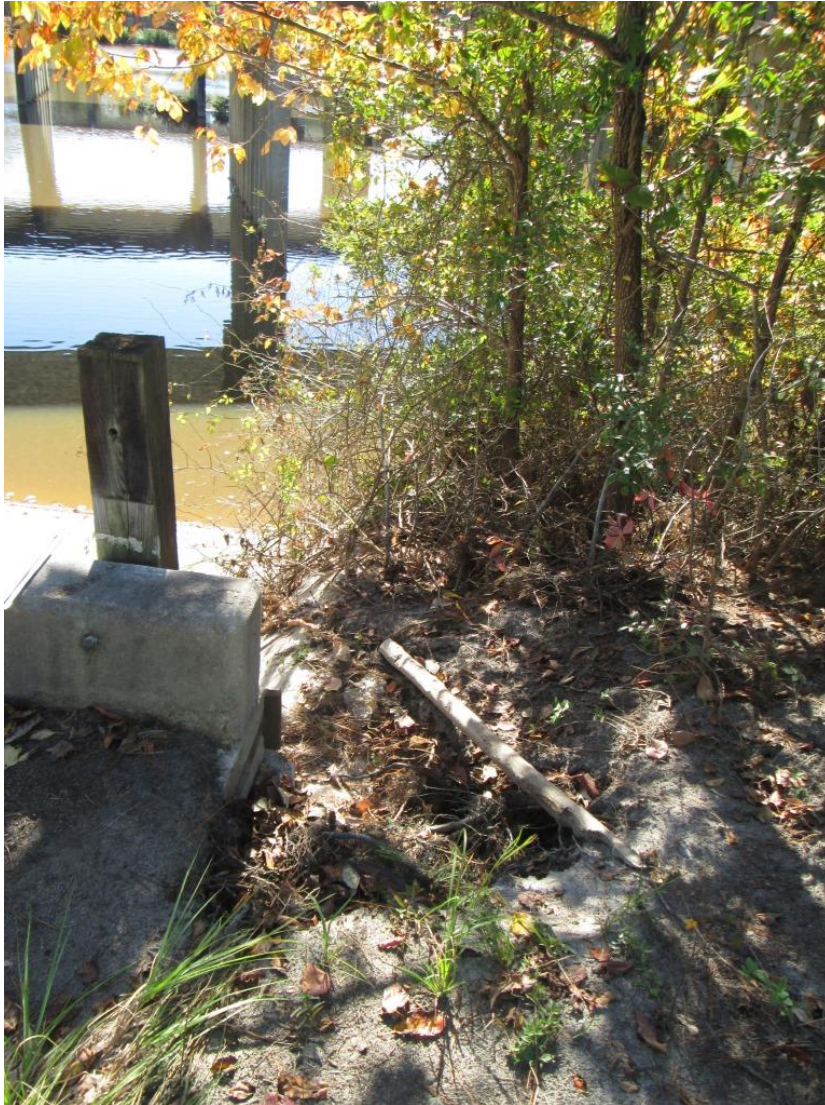
Photo 7: Erosion at auxiliary spillway/bridge right abutment

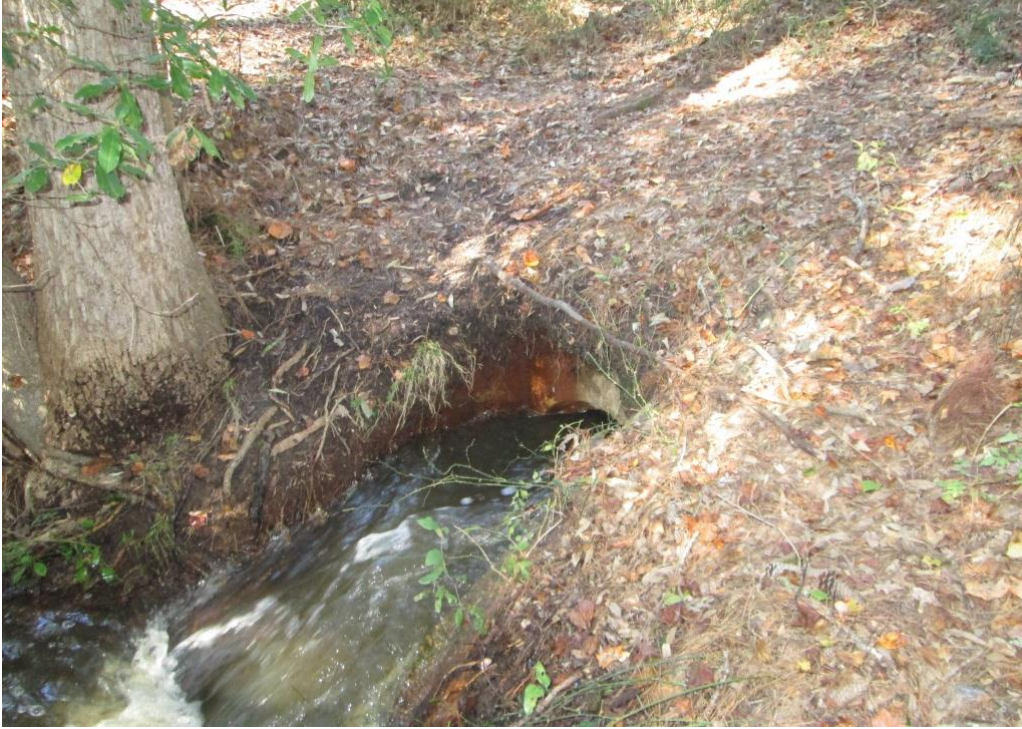
The service spillway intake is a 24-inch-RCP, low-level outlet, noted on drawings on file as “drawdown pipe”. Drawings indicate the inlet to the low-level pipe is near the base of the embankment and is controlled by a slide gate operated by a long-stem hand operator. The outlet of the low-level pipe discharges into the stream just downstream of the lower auxiliary spillway. The outlet of the low-level pipe appeared to be in good condition (Photo 3).

Photo 3: Service spillway outlet works

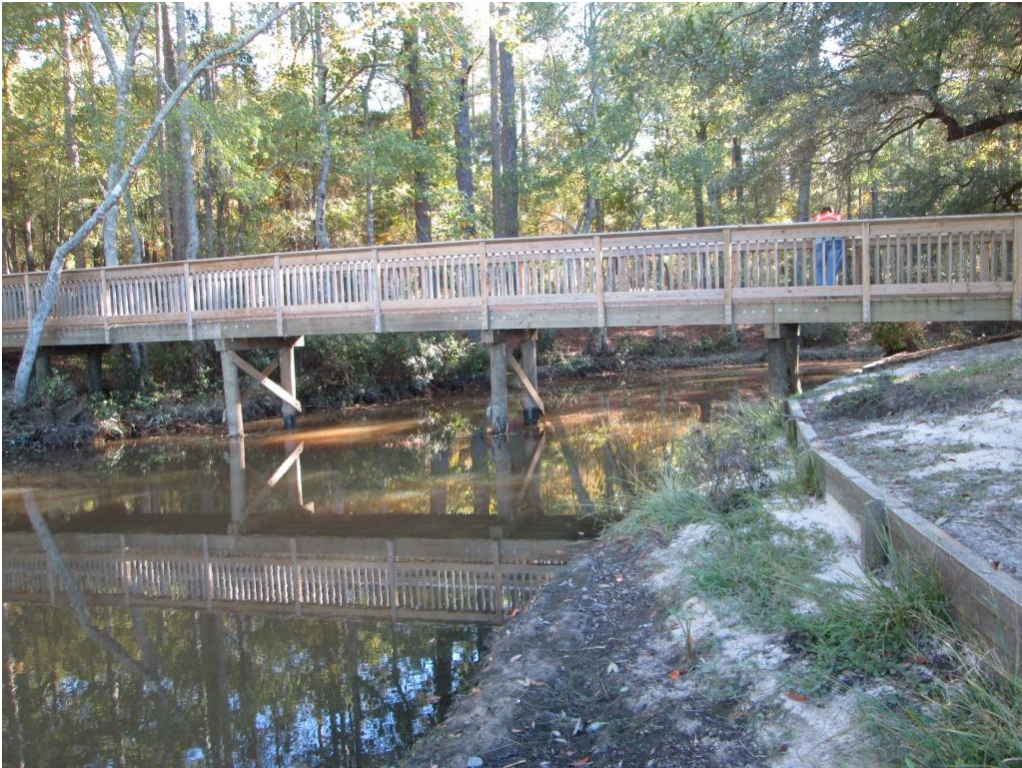
Photo 4: Approach channel to auxiliary spillway

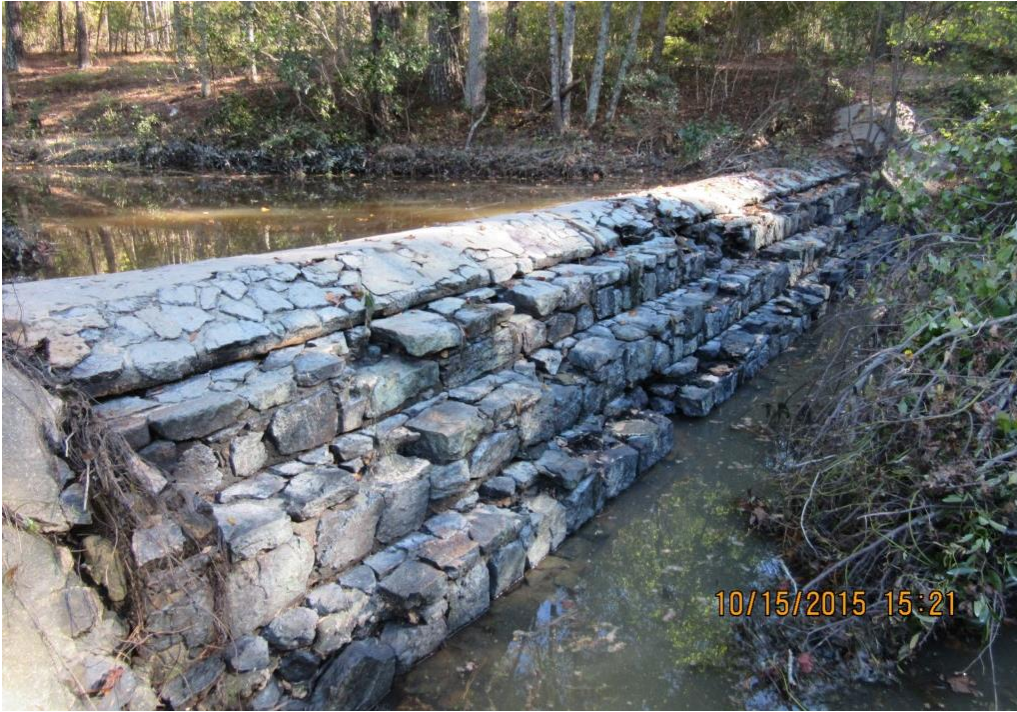
Both masonry stone dams are generally in fair condition with missing and loose stones (Photo 5). The concrete overlay of the upper stone dam crest is moderately deteriorated; the concrete crest of the lower dam appeared to be in good condition (Photo 6). No significant erosion was visible at the toe of either dam. There was no indication of displacement of the dams, however the concrete abutments of the stone dams exhibited cracks (Photos 7 and 9), which could be caused by hydraulic loading under flood conditions and/or movement of supporting foundation soil, or woody growth (Photo 8). The abutments may be susceptible to further deterioration under future flood conditions.

Photo 5: Auxiliary spillway upper masonry dam

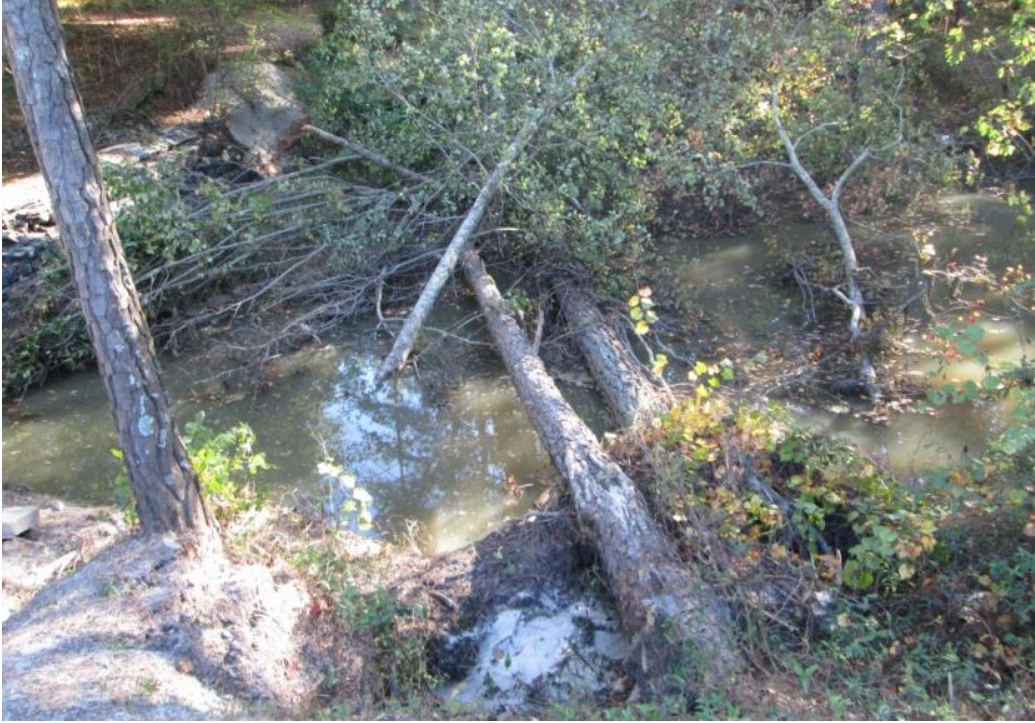
Minor erosion of earth at the abutments and along stream banks indicates the stone dams were overtopped during the flood event. The right earthen embankment slope forms the stream bank between the stone dams. This slope is steep and supported by wood timber and concrete walls. Moderate erosion and sloughs of the earth slope was observed (Photo 10). Some of the sloughs/voids in the slope appear to be from felled trees (leaves still green) observed in the area between the two stone dams.

Photo 11: Felled trees in auxiliary spillway between upper and lower masonry stone dams

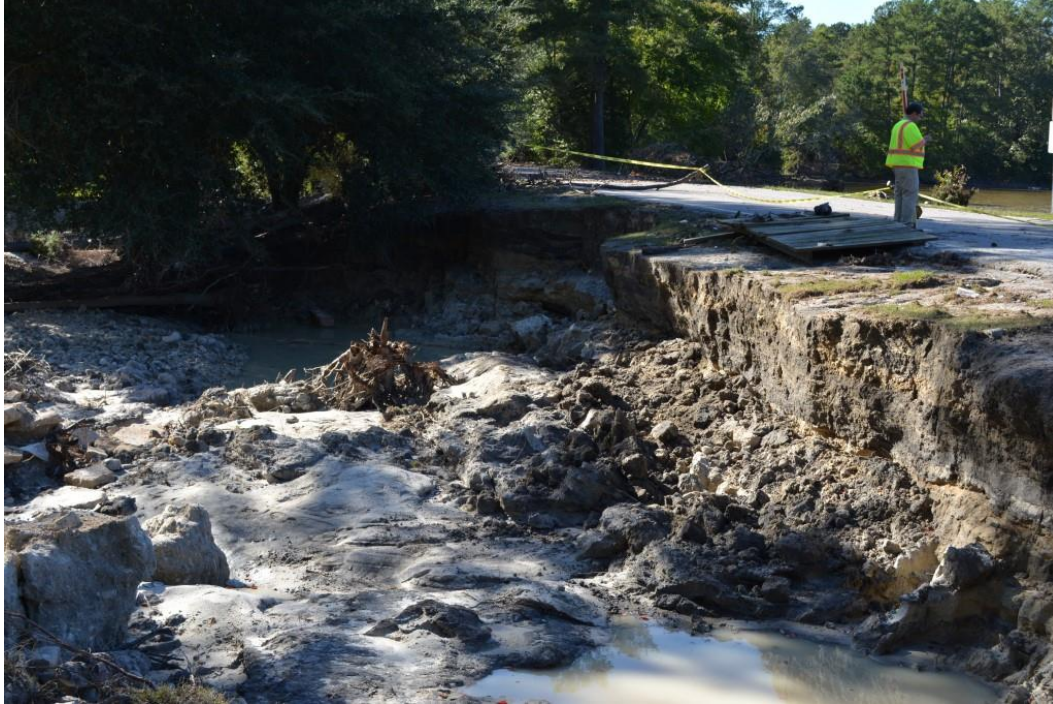
Photo 1: Erosion and headcutting of downstream slope of embankment dam

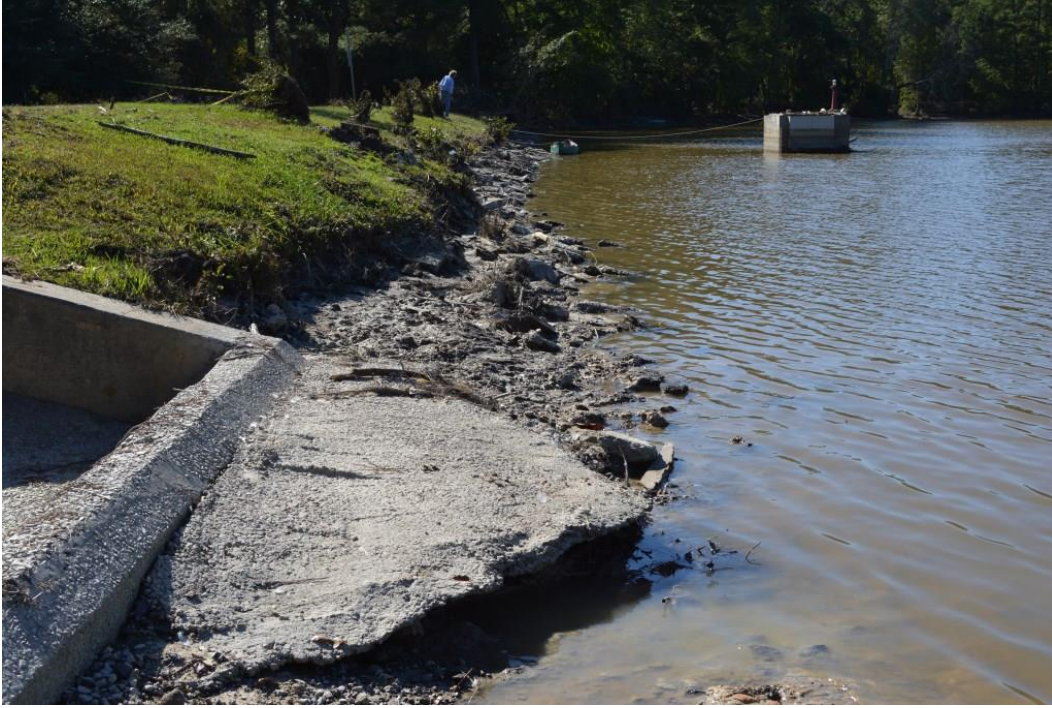
Photo 3: View of upstream embankment slope from auxiliary spillway

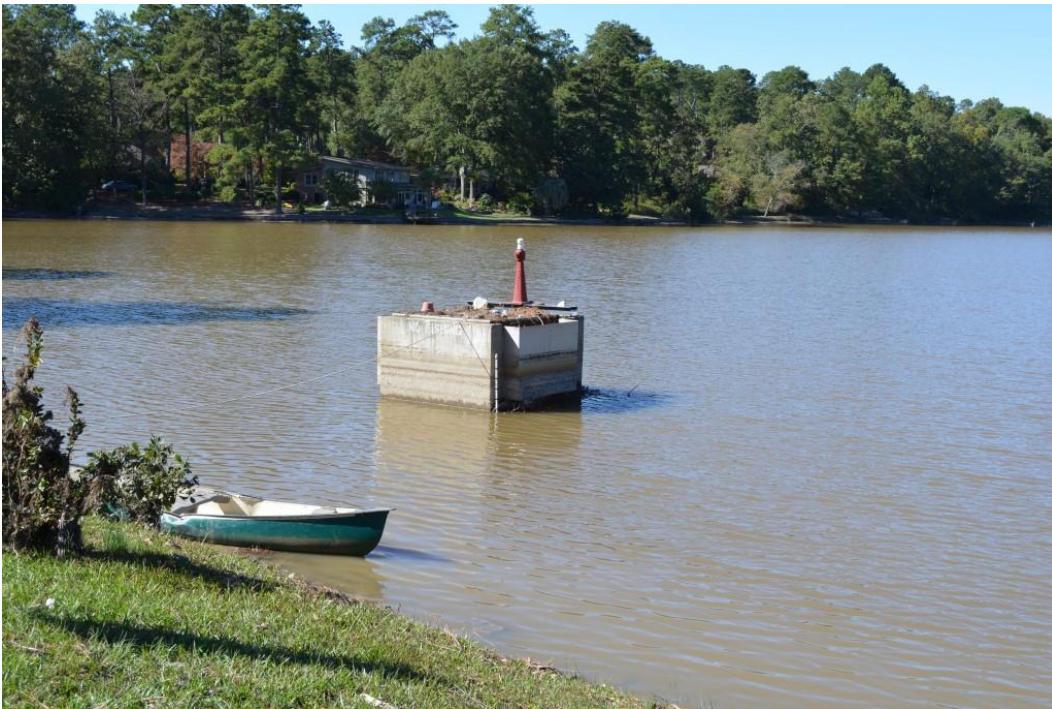
Photo 6: Service spillway drop inlet

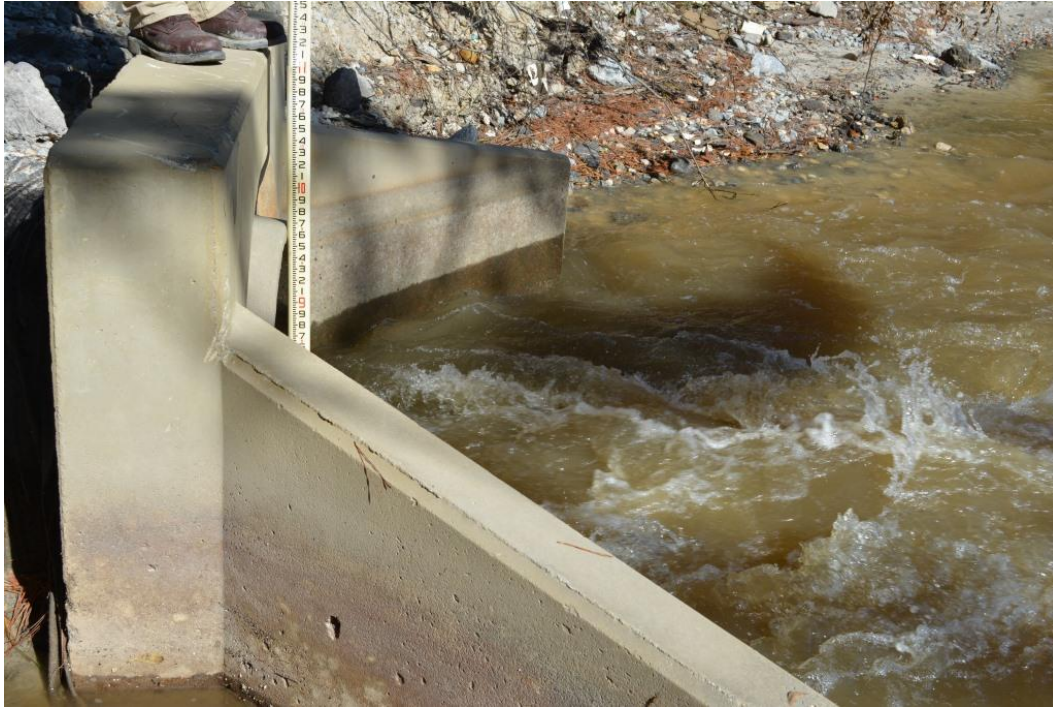
Photo 7: Service spillway outlet structure

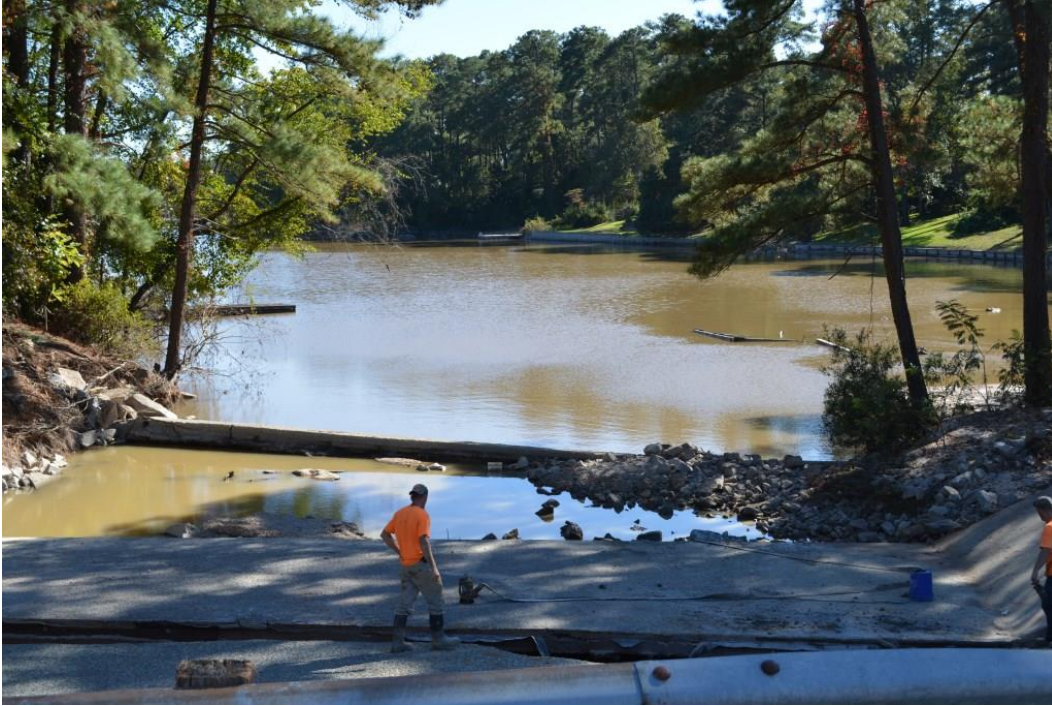
Photo 9: Downstream view from bridge over auxiliary spillway

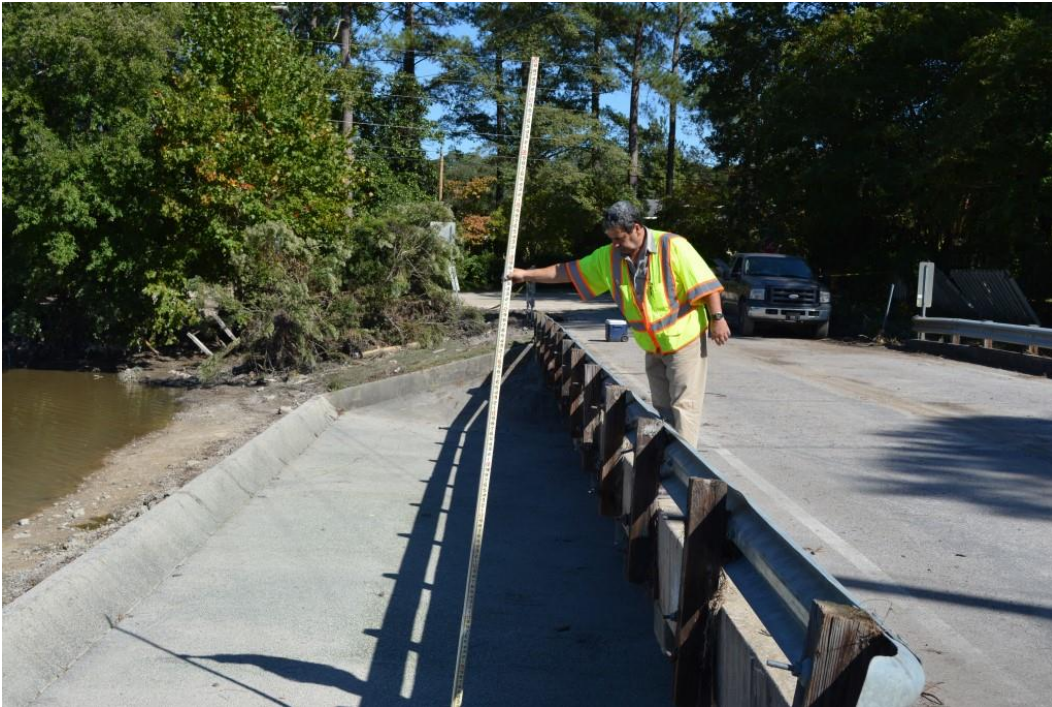
Photo 10: View of auxiliary spillway upstream of bridge

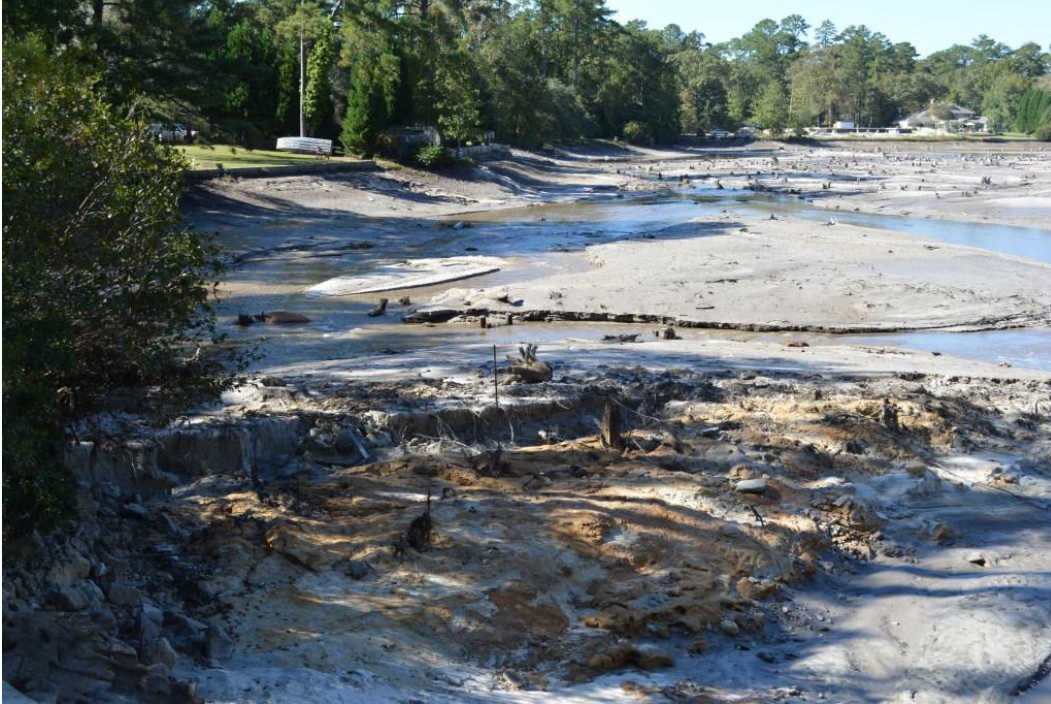
Photo 1: View upstream from the auxiliary spillway
