Gills Creek Watershed: Assessment of Regulated Dams

February 15, 2016

PROJECT NAME: Gills Creek Watershed Assessment of Regulated Dams Report

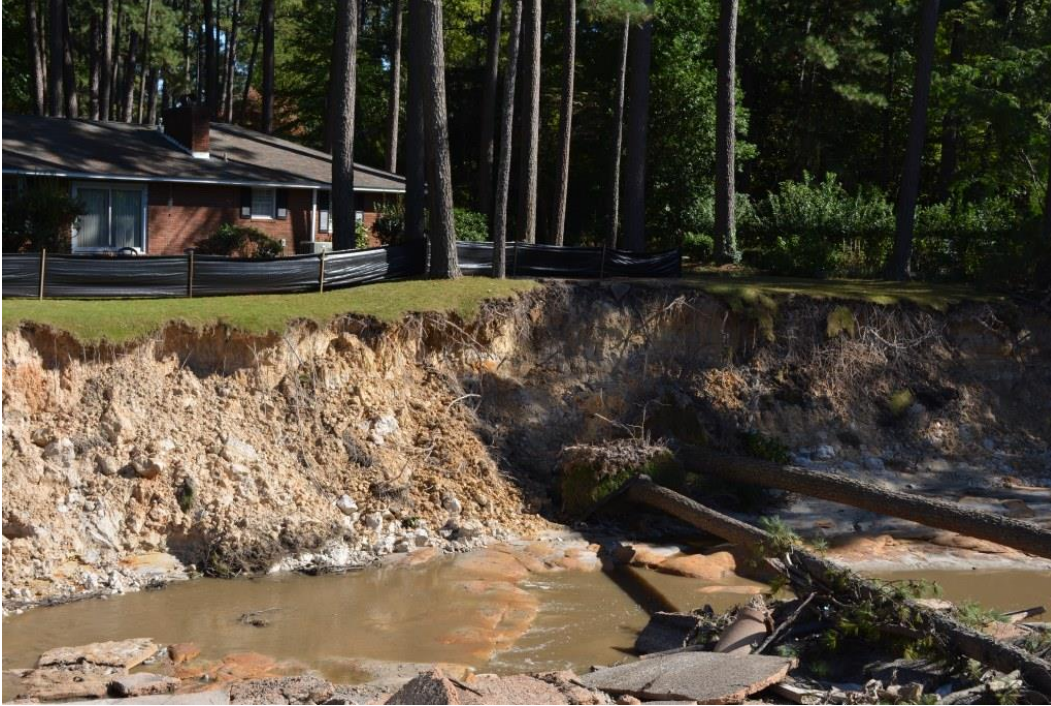
Photo 5: Erosion along the left side of the auxiliary spillway, looking downstream from the bridge

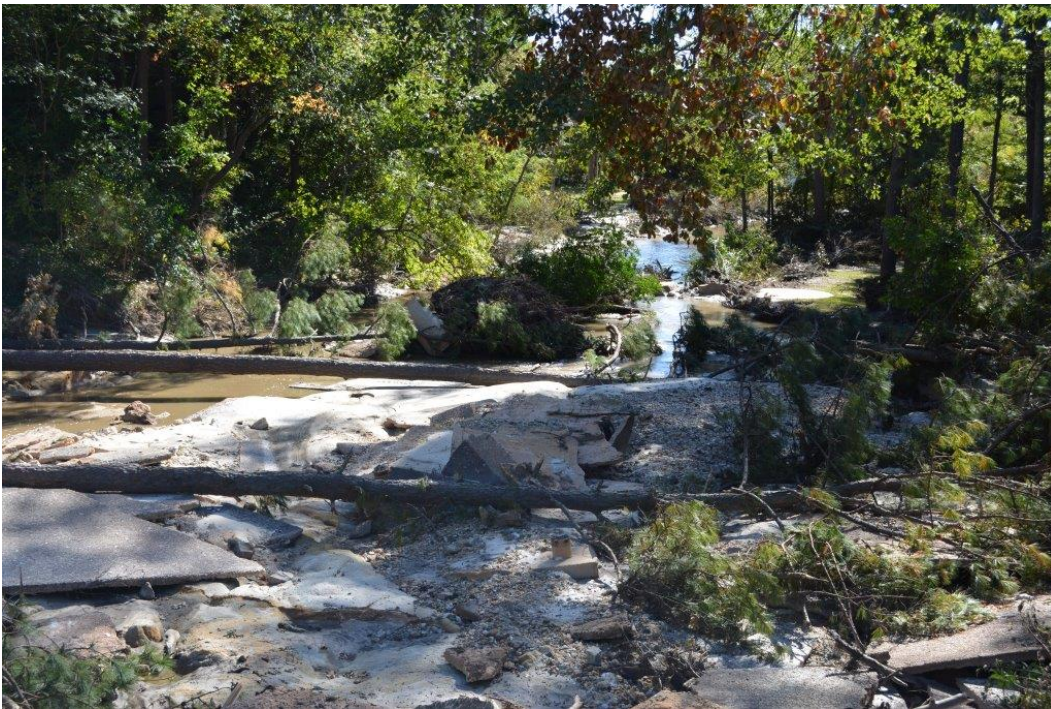
The auxiliary spillway was completely washed out from the flood. Photo 6 shows portions of the concrete spillway in the channel downstream of the bridge.

Photo 6: View of the auxiliary spillway looking downstream of bridge; concrete debris is seen in the foreground

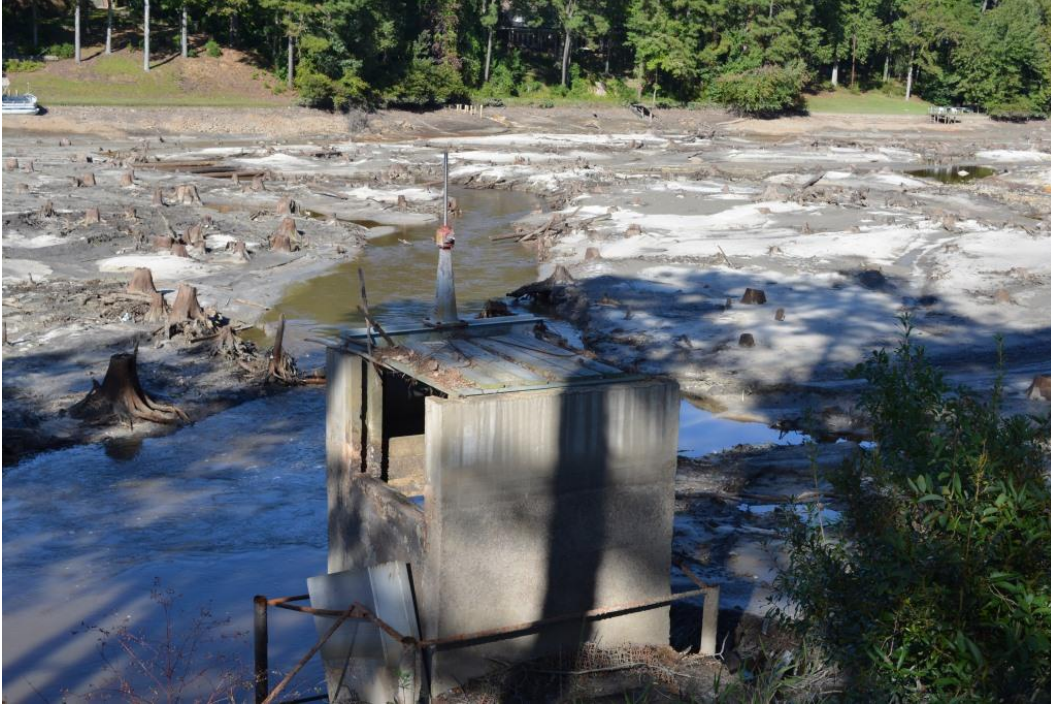
Photo 1: Service spillway drop inlet structure

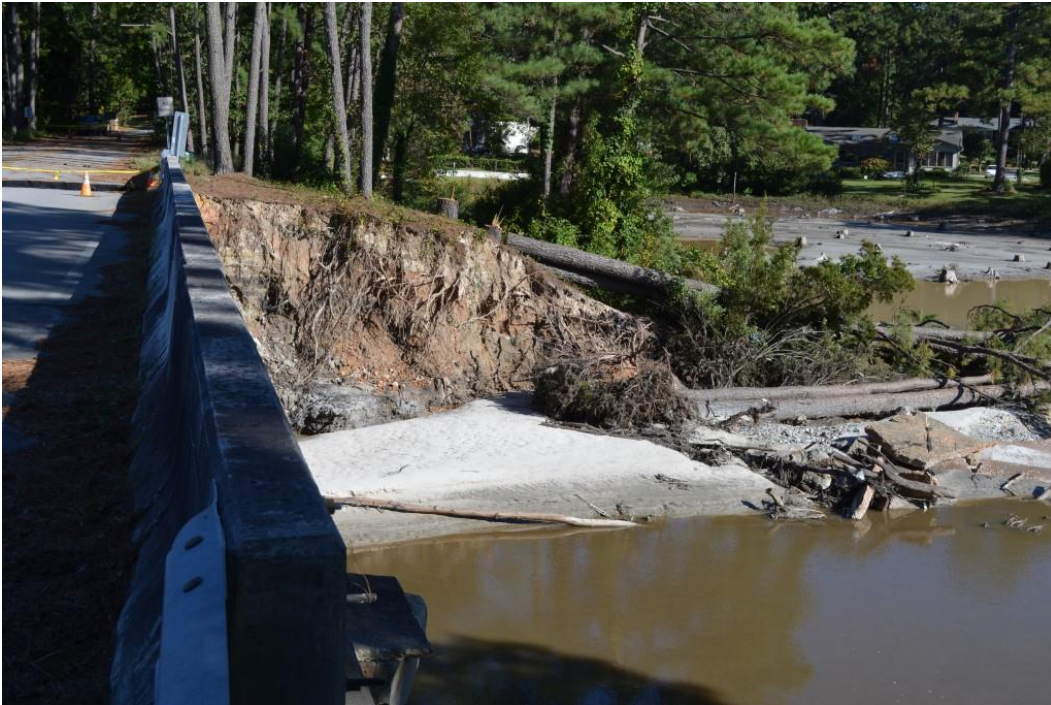
Photo 2: View of eroded embankment at left abutment of the auxiliary spillway looking downstream

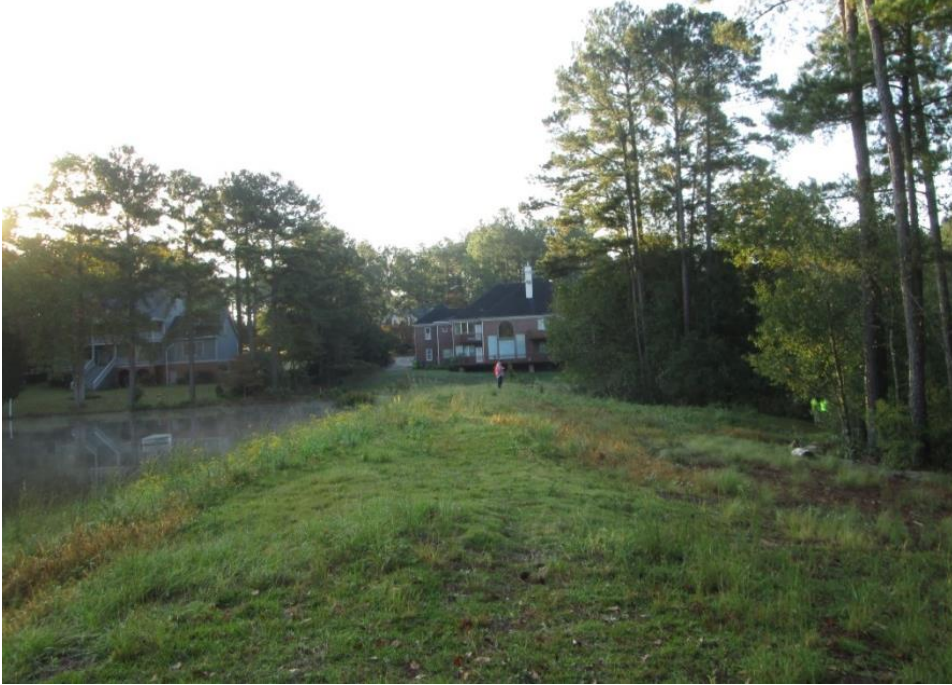
Photo 1: Embankment crest viewed from right abutment. Grass cover on upstream slope; trees and underbrush on downstream slope and toe.

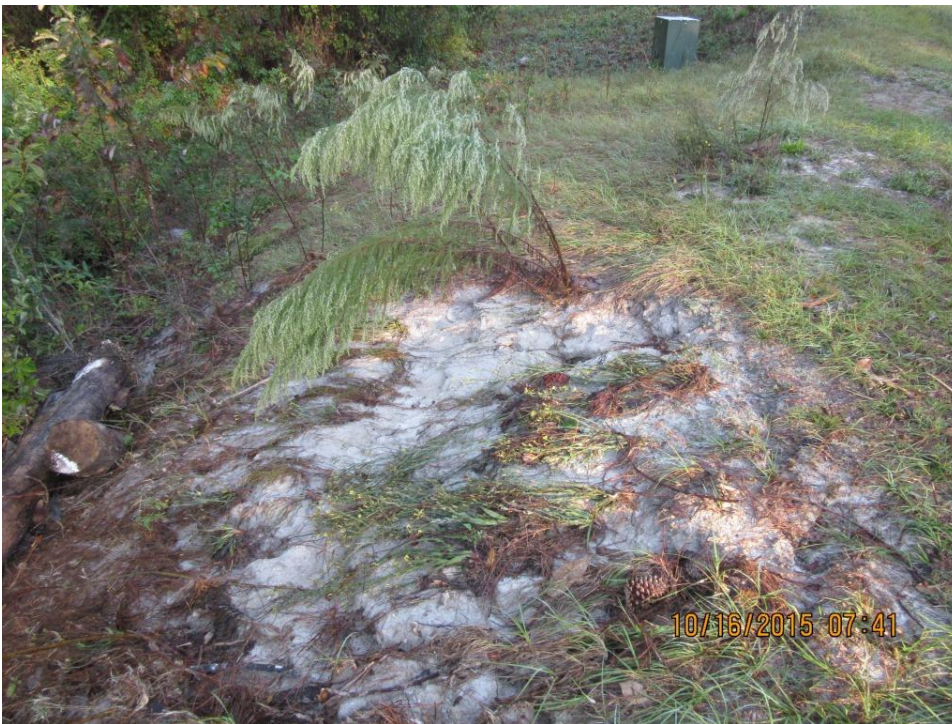
The overall condition of the embankment appears good, with no significant erosion, sloughs, or depressions observed. There were no visible indications that the embankment crest was overtopped during the flood event. Minor surficial erosion of the embankment slope adjacent to the auxiliary spillway was observed, apparently from flow through the auxiliary spillway (Photo 2). A moderate depression of about 1-to-2-feet deep was observed at the toe of the dam along the alignment service spillway outlet pipe; this area has been used as a fire pit (Photo 3).

Photo 2: Minor erosion of the left downstream embankment.

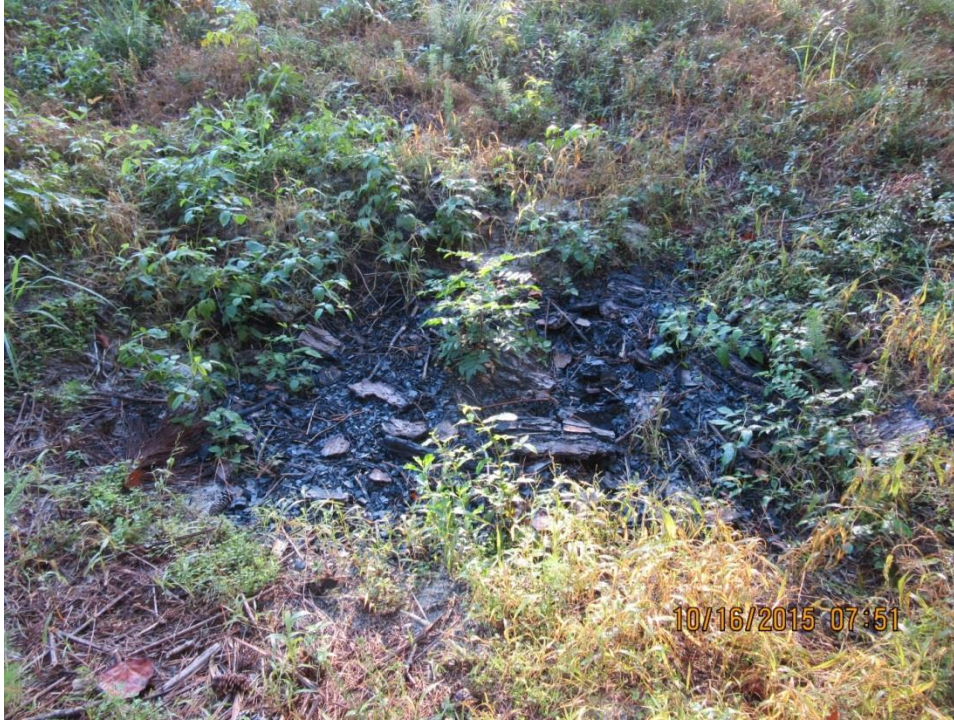
Photo 3: Depression at toe of embankment

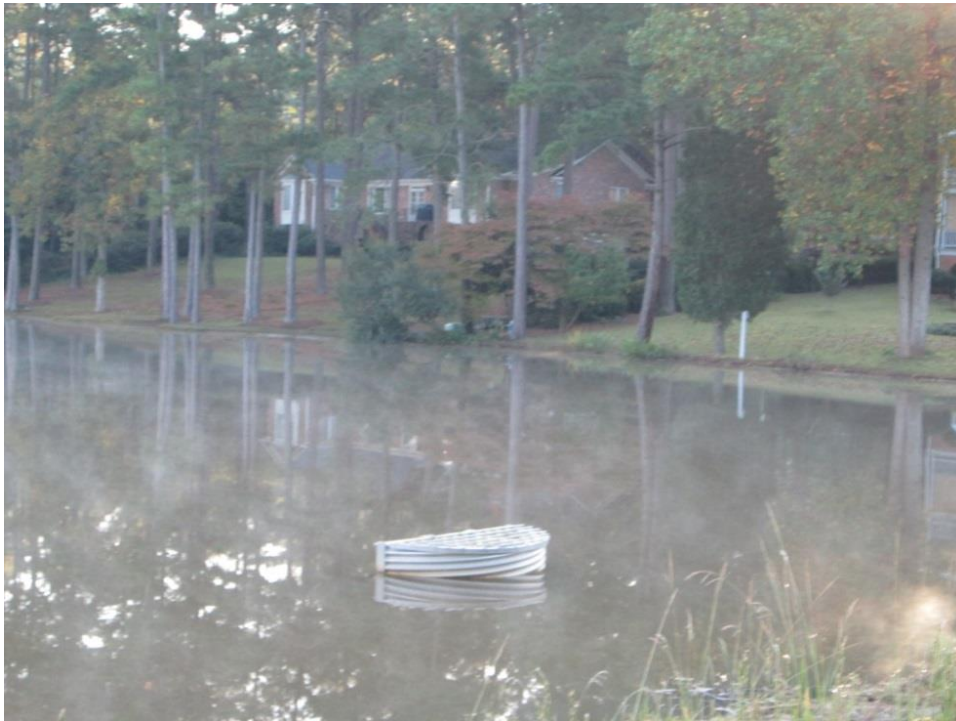
The service spillway consists of a low-level pipe (48-inch CMP) with a drop-inlet intake with trash screen located approximately 30 feet upstream of the embankment to the left center of the dam (Photo 6). There was no debris accumulation at the drop inlet. Discharge from the outlet pipe into the stream was observed (Photo 7). The service spillway facilities appeared to be in good condition.

Photo 6: Service spillway inlet works.

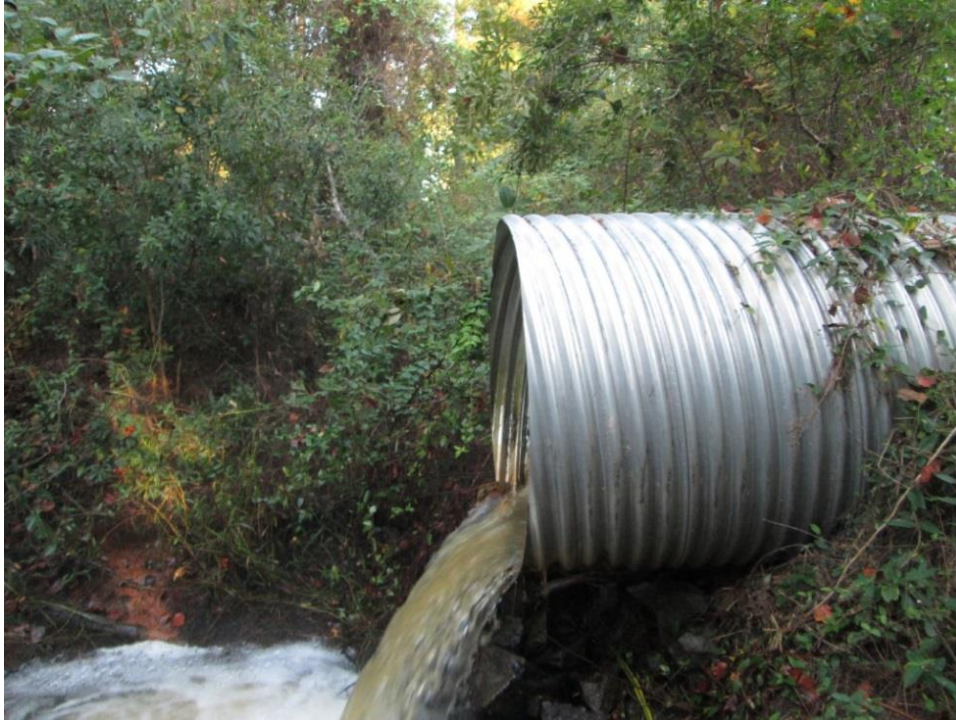
Photo 7: Service spillway outlet pipe

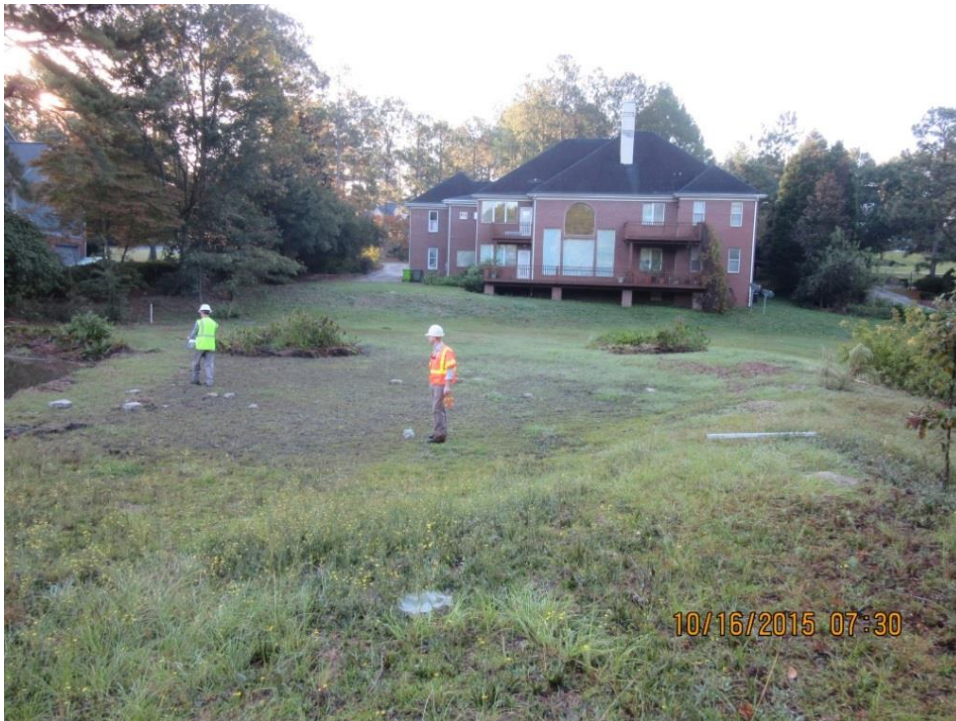
The auxiliary spillway is an earthen-grassed, uncontrolled, overflow channel located at the left abutment. It has a crest length of approximately 80 feet and conveys flow about 200 feet to the stream. Overtopping of the spillway during the flood event to a depth of 1 to 2 feet was evident. The spillway appeared to generally be in good condition (Photo 8) with some minor surficial erosion. Water was observed to be emerging at a location on the downstream slope of the auxiliary spillway about 100 feet downstream from the pond, approximately 5 feet below pond level (Photo 9). This seepage appears to be indication of piping of subsurface red clay material through the auxiliary spillway. A significant erosion channel was developed in the downstream area of the auxiliary spillway which exposed what appears to be a stormwater main (Photo 10).

Photo 8: Auxiliary spillway, viewed from embankment crest toward left abutment

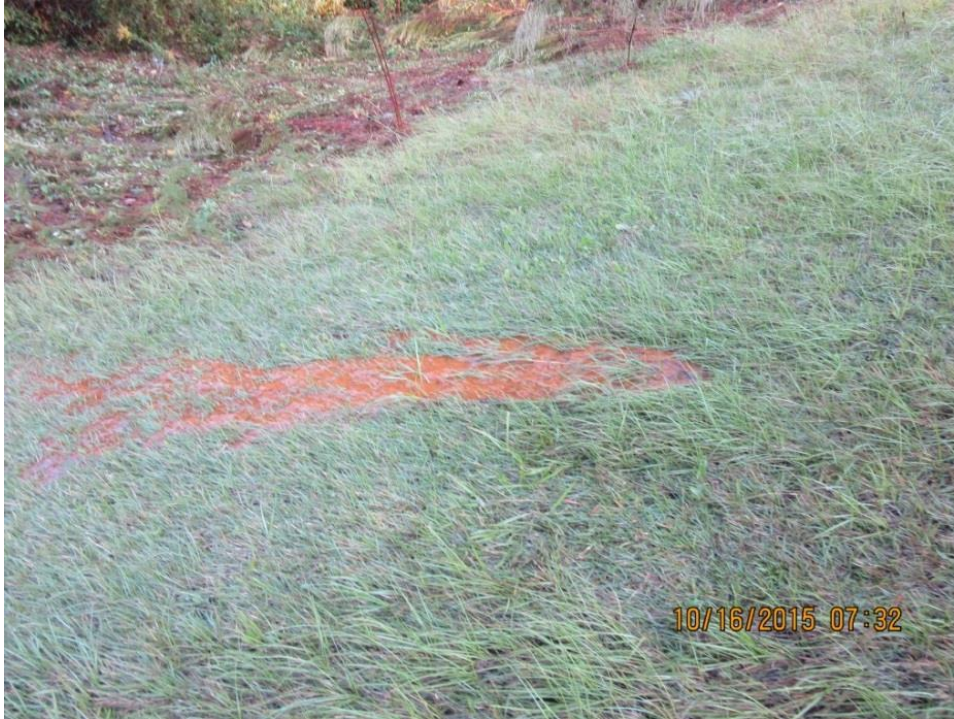
Photo 9: Seepage at downstream end of auxiliary spillway

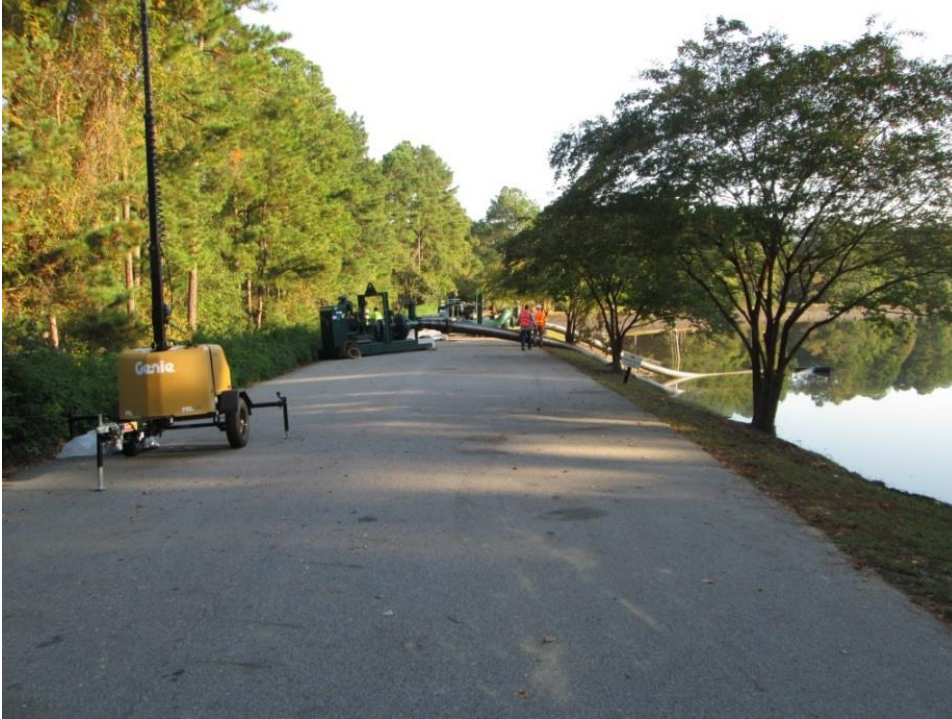
The earthen embankment dam crest is approximately 30 feet wide with a secondary road along the crest (Photo 1). The dam was overtopped by an estimated 2 to 4 feet of water. The embankment generally exhibited minor surficial erosion and several areas of significant erosion. Overtopping resulted in failure of the downstream slope of the embankment along the alignment of the service spillway low-level outlet pipe that undercut the roadway (Photo 3). The length of the slope failure (left to right) was measured to be about 70 feet. No seepage was observed from the failed slope area.

Photo 1: Embankment dam crest viewed from the left abutment.

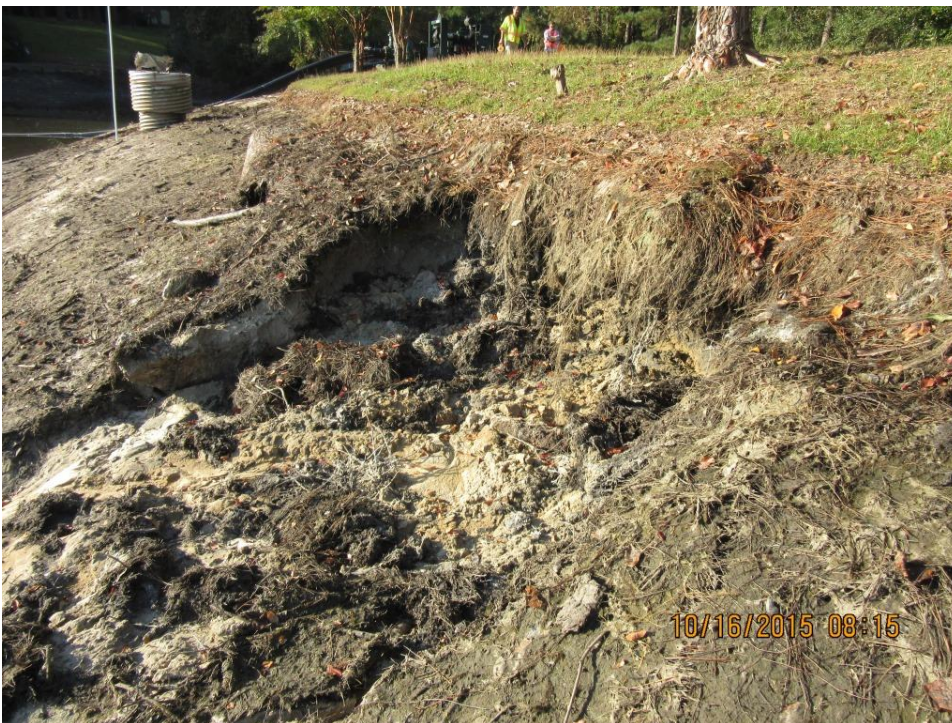
The upstream slope had two areas of moderate sloughs (Photo 2). A few *crepe myrtle* trees were growing on the upstream slope, and there were mature trees and underbrush on the lower portion of the downstream slope and toe. Riprap was observed on the upper portion of the upstream slope near the right abutment (Photo 4). The earthen embankment has an upstream slope of approximately 2H:1V and a downstream slope of approximately 2H:1V.

Photo 2: Upstream embankment slope slough

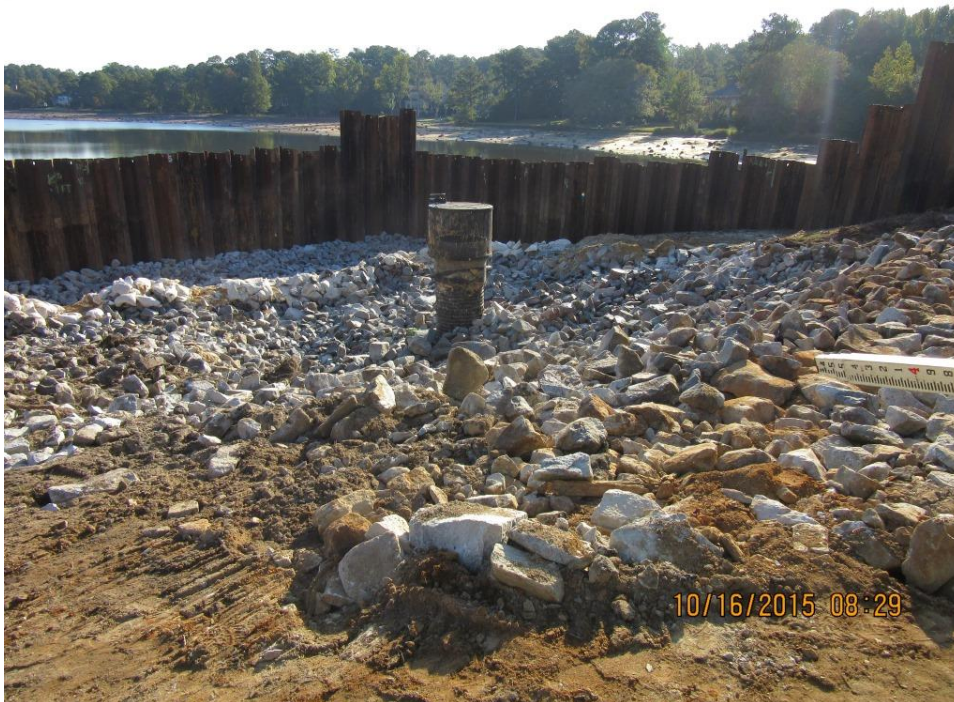
The service spillway consists of a drop-inlet riser and a low-level discharge pipe. A new 36-inch steel riser equipped with a trash screen was installed in 2010 (Photo 4). The low-level inlet pipe was sealed off during installation of the new riser. The apparent aluminum 30-inch, low-level discharge pipe outlets at the toe of the embankment (Photo 8).

Photo 4: Rock fill placed in sinkhole area of upstream embankment slope; service spillway riser is in the foreground

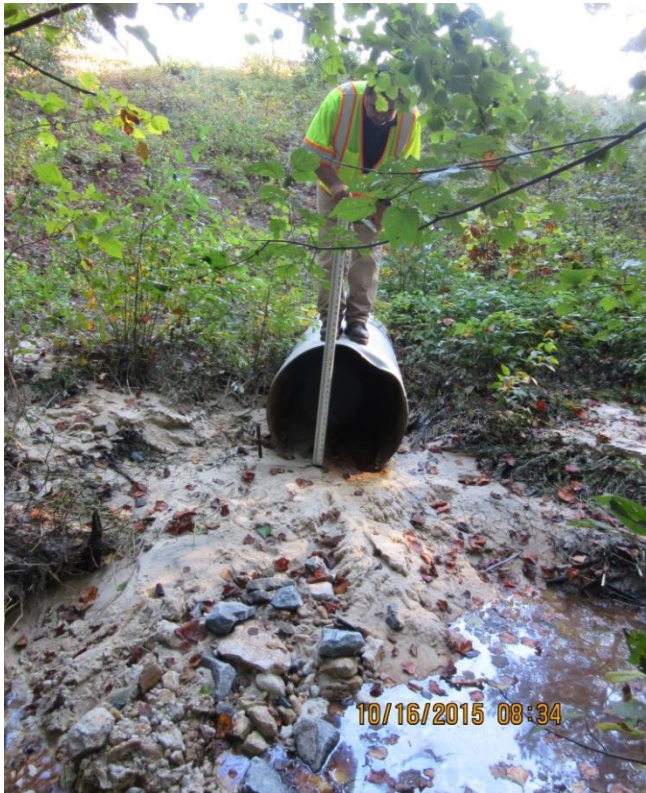
Photo 8: Service spillway outlet pipe

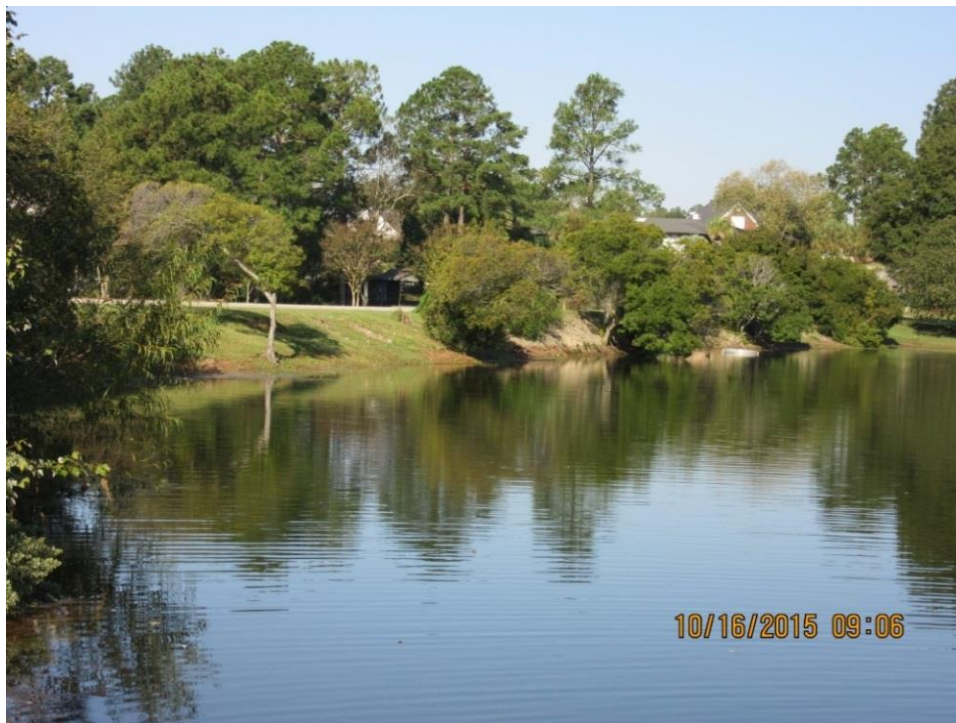
Photo 1: Embankment dam viewed from left abutment

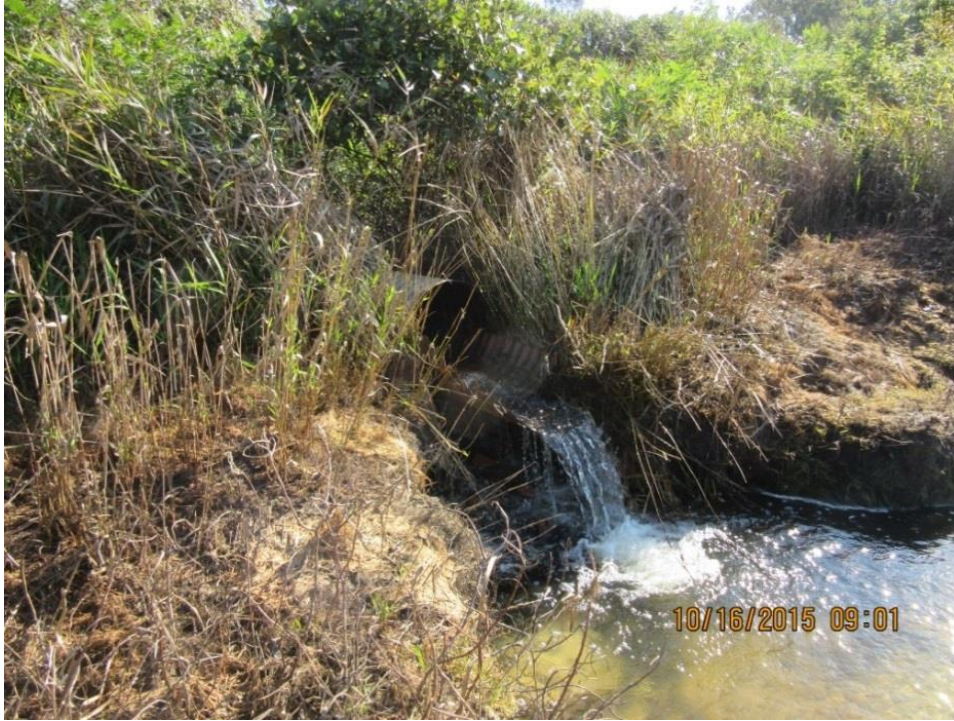
The service spillway is a low-level, 30-inch CMP pipe with drop inlet equipped with a trash screen. The inlet (Photo 4) and outlet pipe (Photo 5) appeared to be in good condition. No debris was observed on the inlet trash screen.

Photo 5: Service spillway outlet pipe. Note minor erosion around the pipe.

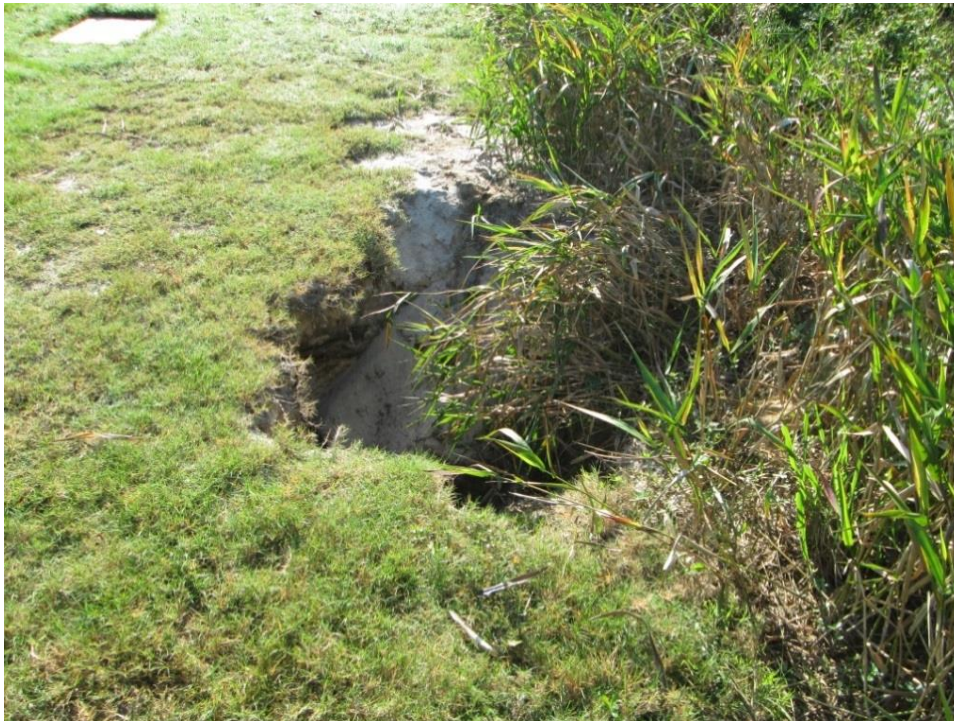
Photo 6: Erosion on downstream slope of embankment, approximately 30 feet upstream of the service spillway outlet

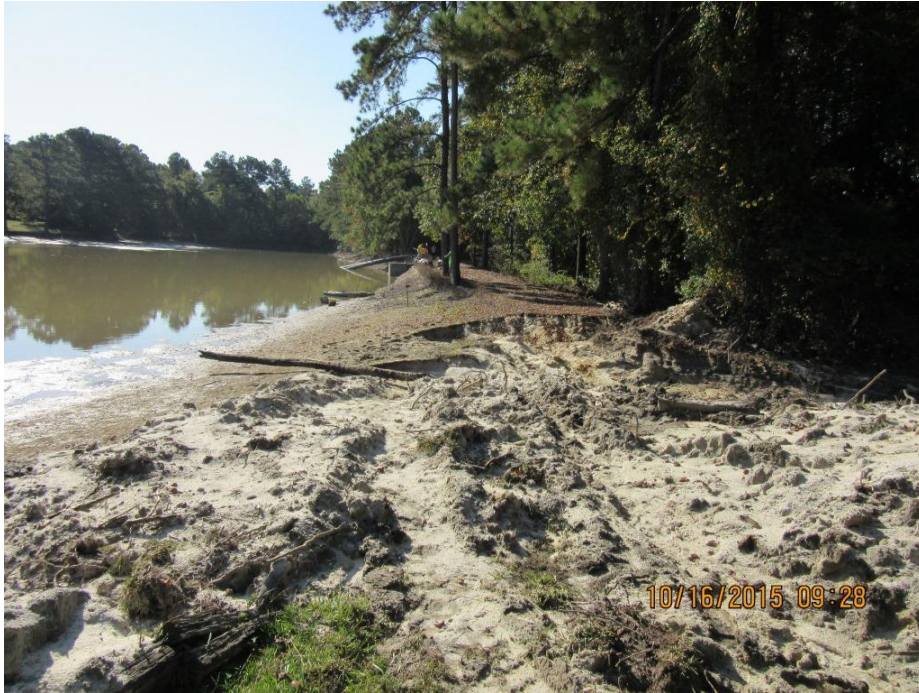
Photo 3: View of approach to the emergency channel that was excavated at the right abutment during the flood to convey water downstream

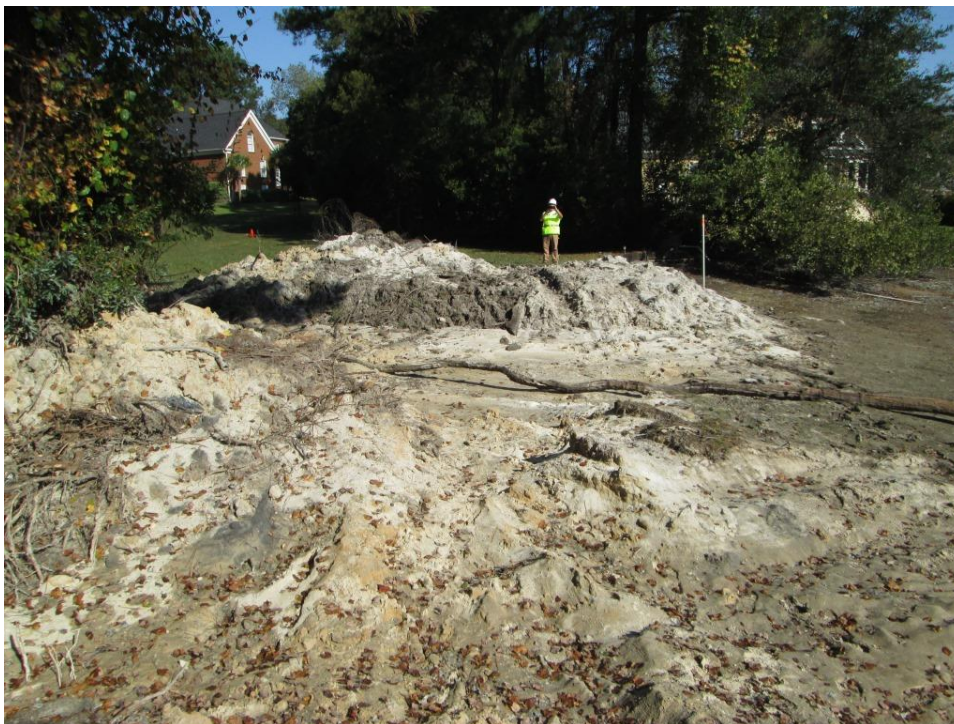
Photo 4: Temporary channel viewed from the embankment

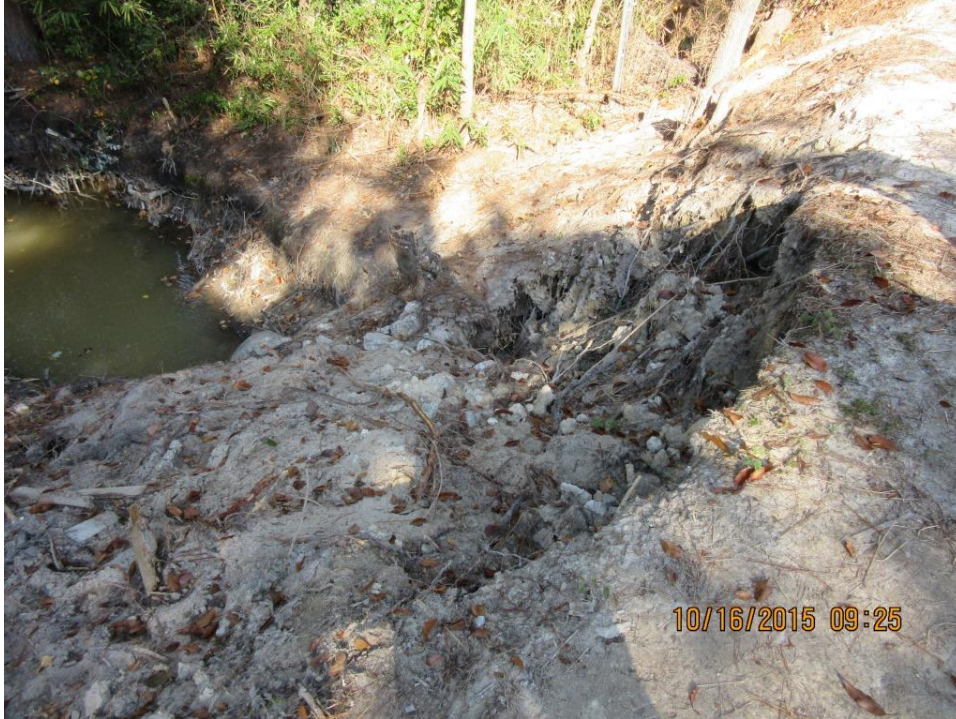
Photo 5: Slough of downstream slope viewed from embankment crest

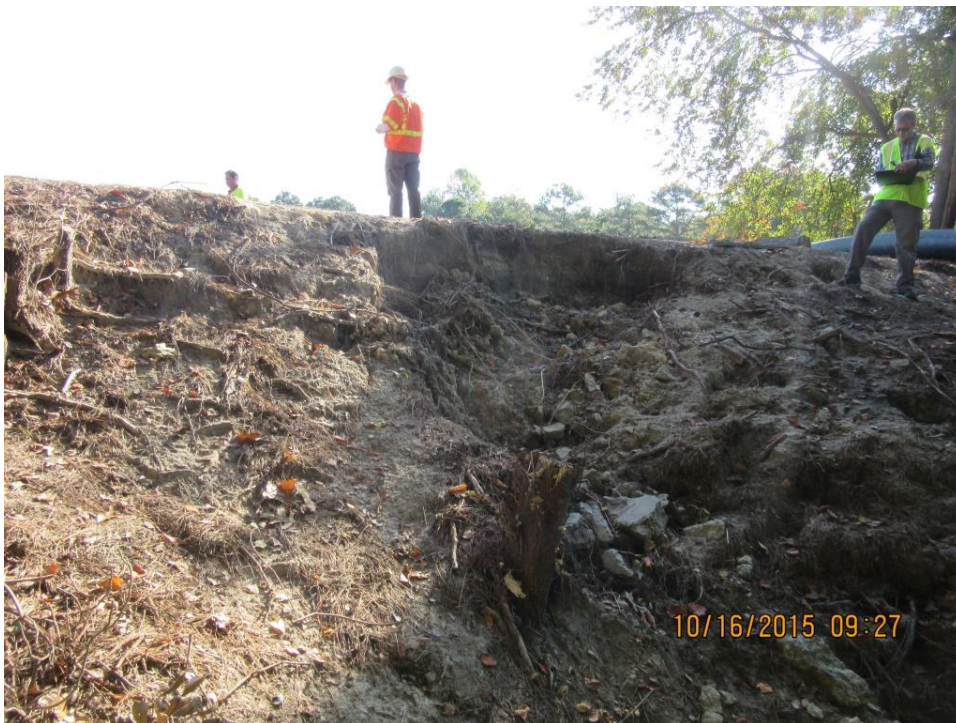
Photo 6: View of slough of embankment from downstream

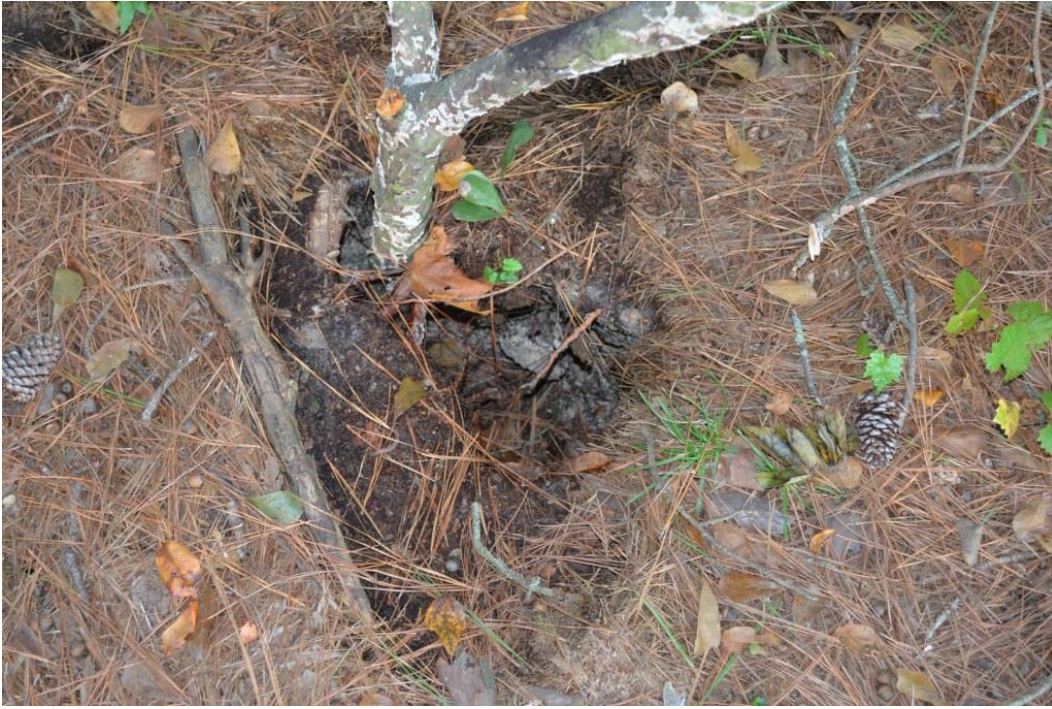
The only observed sign of distress in the embankment is a 8-inch-diameter and 1.0-foot-deep depression on the crest that is in line with what appears to be an irrigation line that runs from upstream of the dam, through the dam approximately 5 feet below the crest, and to a pump set on the downstream face of the dam that is connected to PVC pipe that leads away from the pump. Photo 4 shows the depression, and Photo 5 shows the view from the depression to the pump.

Photo 4: Depression on embankment crest

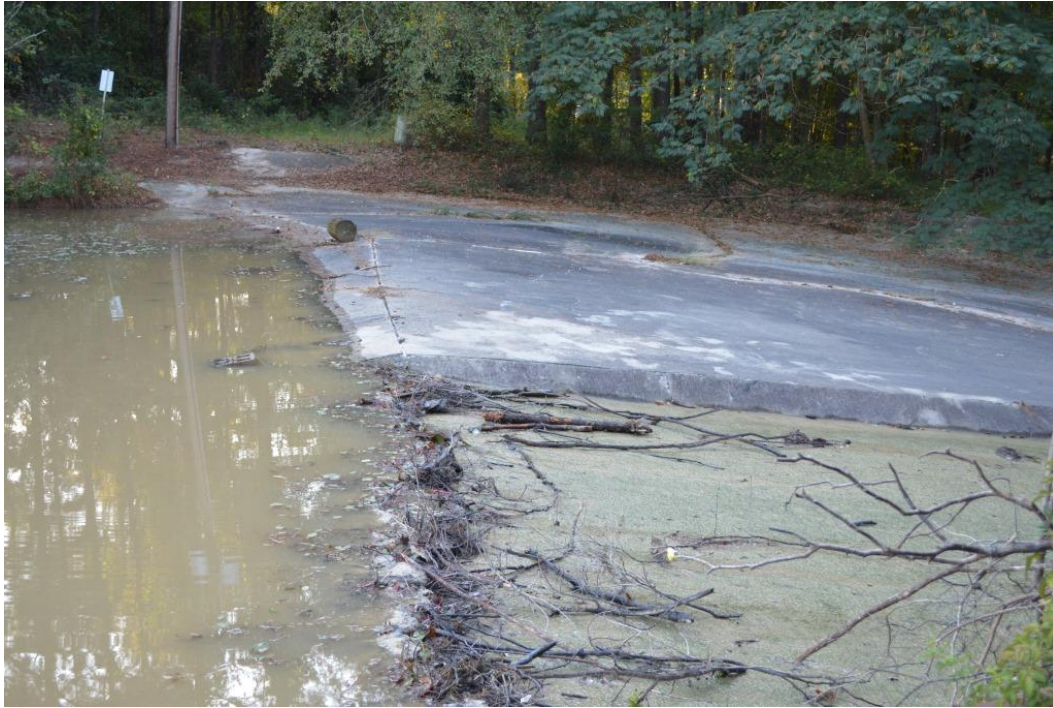
The auxiliary spillway is a concrete-lined overflow channel, approximately 80 feet wide, that extends from the left extent of the embankment to the left abutment. The spillway has two sections with one section nearest the left abutment approximately 8 inches higher in elevation than the interior section. Photo 9 shows the auxiliary spillway. The debris in the lower section has resulted in the elevation of the reservoir being elevated. The consistent placement of the debris may be the work of beavers. At the downstream end of the auxiliary spillway there is significant erosion and structural damage where water is conveyed under the road in two 48-inch and two 24-inch culverts. Photos 10 and 11 show the damage to the end of the spillway next to the road.

Photo 9: Auxiliary spillway with debris

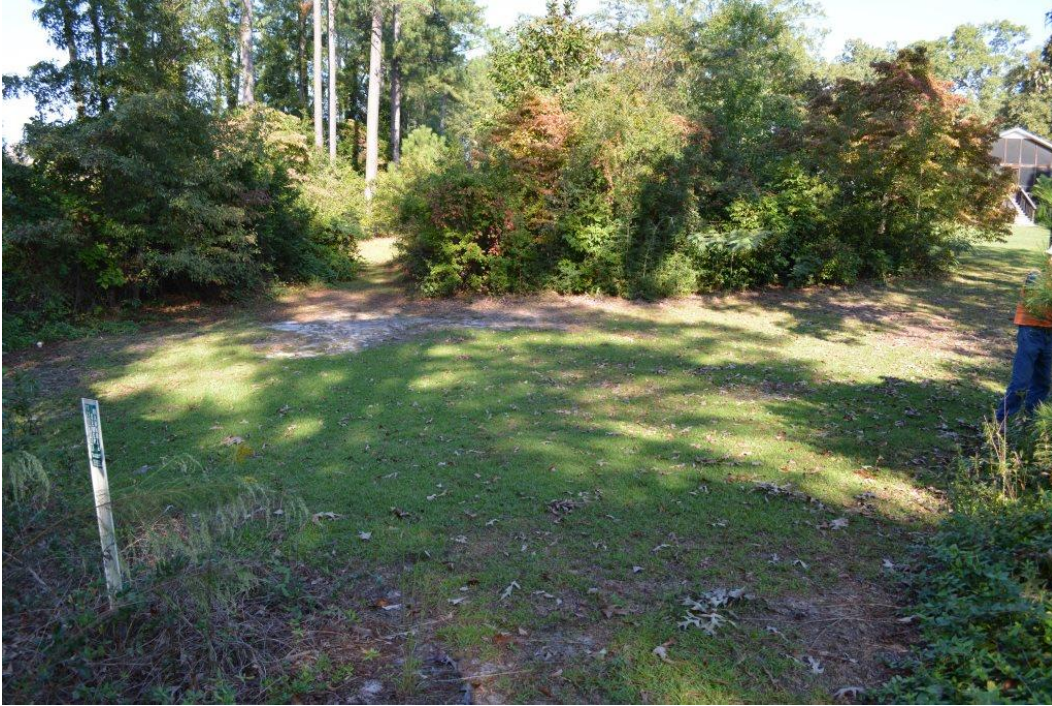
The auxiliary spillway is an earthen grass-lined uncontrolled overflow channel that is approximately 1.5 to 2 feet lower in elevation than the crest (Photo 5). The auxiliary spillway is located in a residence's back yard. The auxiliary spillway did not show any evidence of overflow such as vegetation bent in the downstream direction or debris in the spillway and is in good condition.

Photo 5: Auxiliary spillway at right abutment

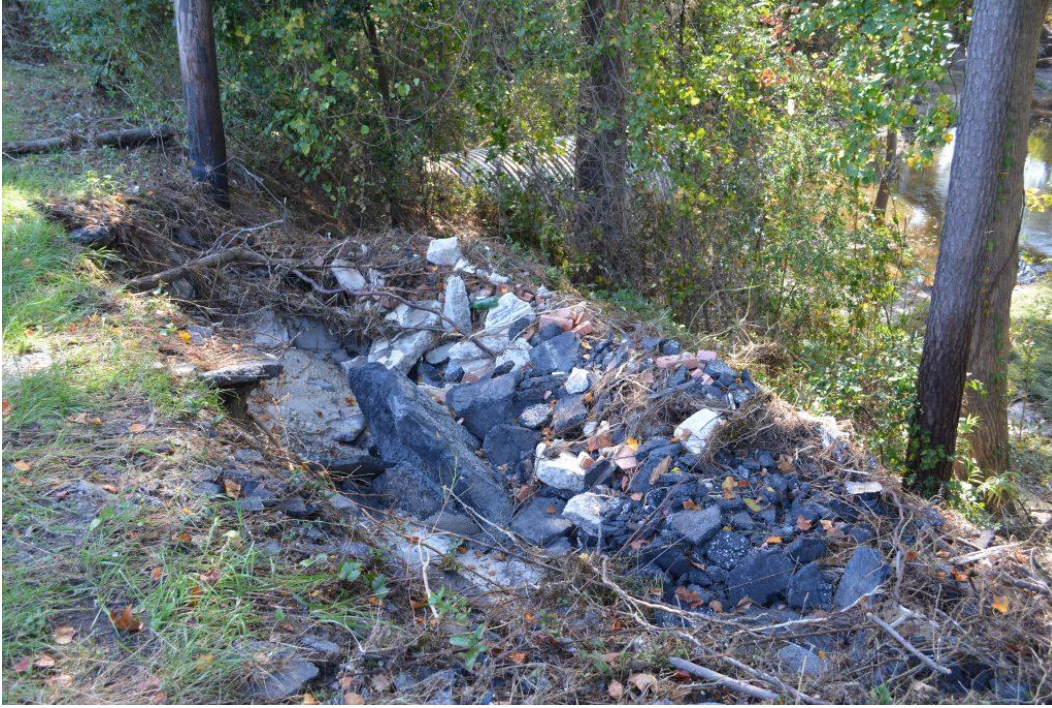
Photo 3: Downstream embankment slope erosion

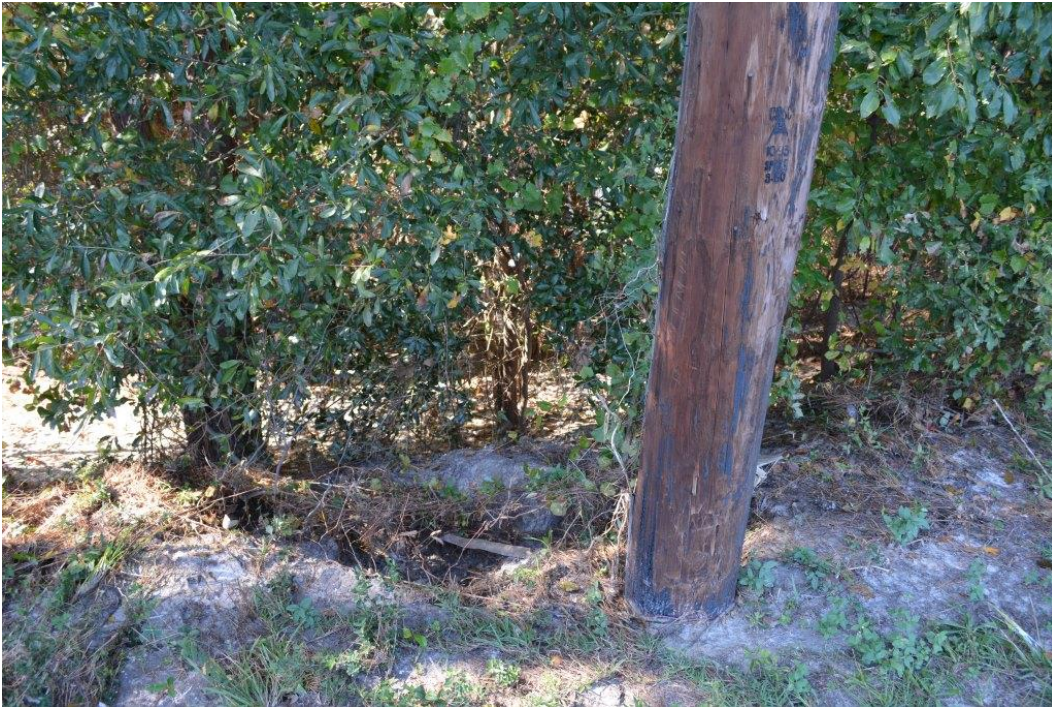
Photo 4: Slough and debris on downstream slope

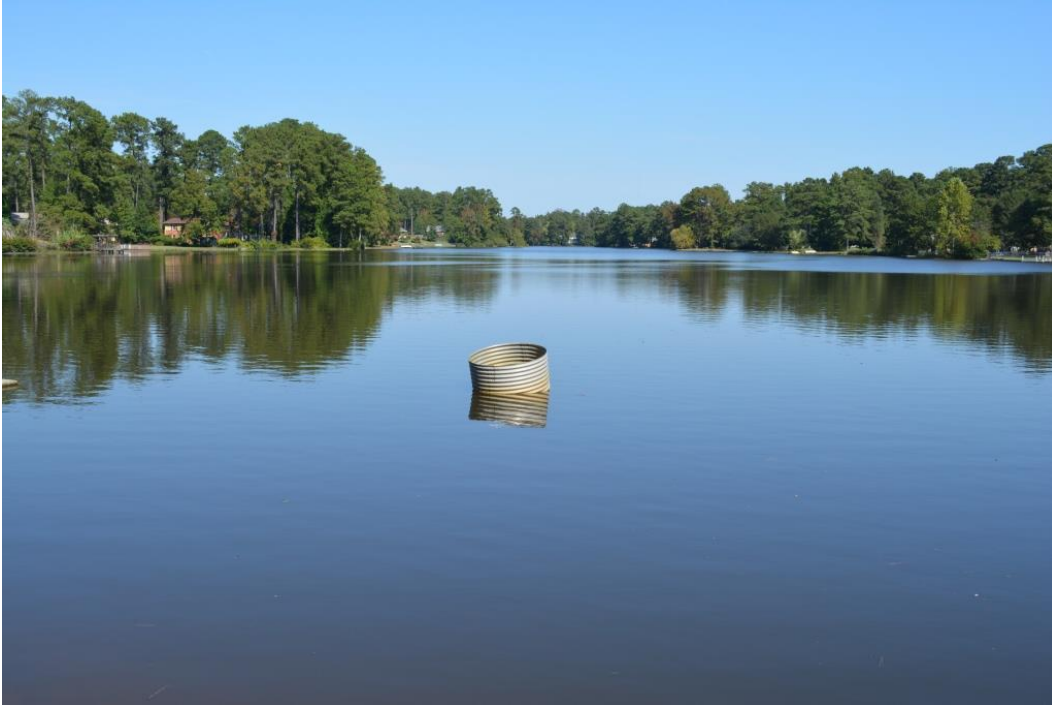
Photo 5: Service spillway intake

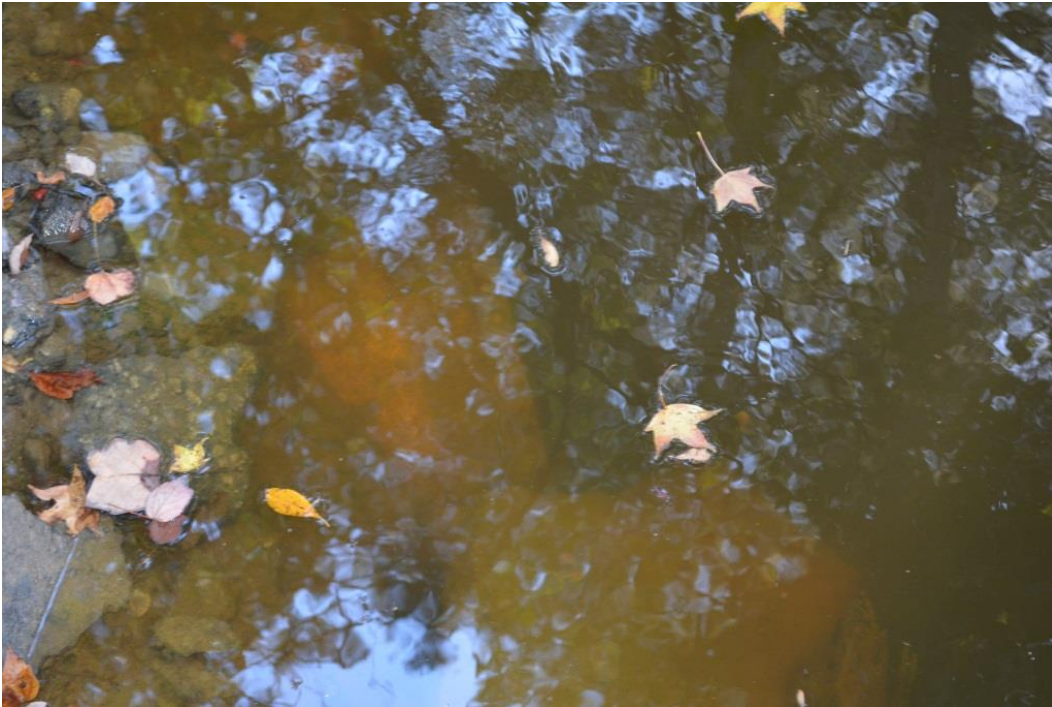
Photo 6: Service spillway outlet shown under water
