Gills Creek Watershed: Assessment of Regulated Dams

February 15, 2016

PROJECT NAME: Gills Creek Watershed Assessment of Regulated Dams Report

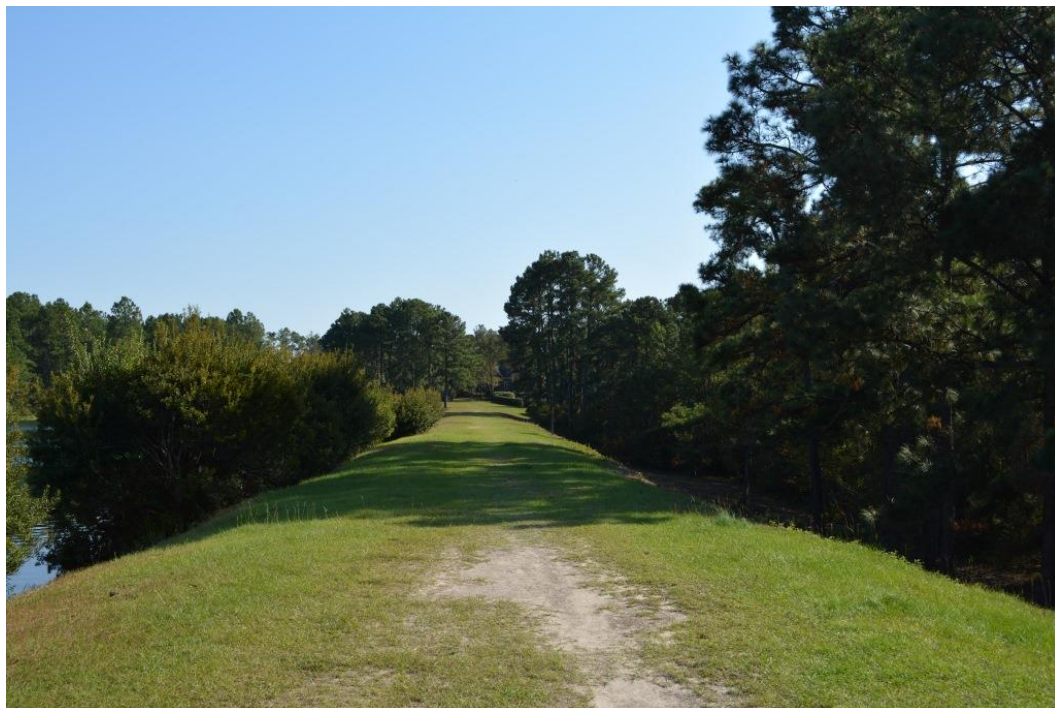
The embankment has an approximately 20-foot-wide crest, an upstream slope that varies from 3H:1V to 2H:1V, and a downstream slope of 2.5H:1V to 3H:1V. The upstream slope is in good condition having full grass cover with the growth of large bushes at the waterline. The crest has grass cover over 80 percent and shows no signs of settlement or erosion. Photo 1 presents a view of the upstream slope and crest from the right abutment. The downstream slope is in fair condition, but has sparse vegetative cover and areas of significant erosion. Photos 2 and 3 show the condition of the downstream slope and examples of erosion. Based on conditions such as absence of debris or vegetation pushed in a downstream direction, it is apparent that the dam did not experience overtopping during the flood event.

Photo 1: Embankment crest viewed from right abutment

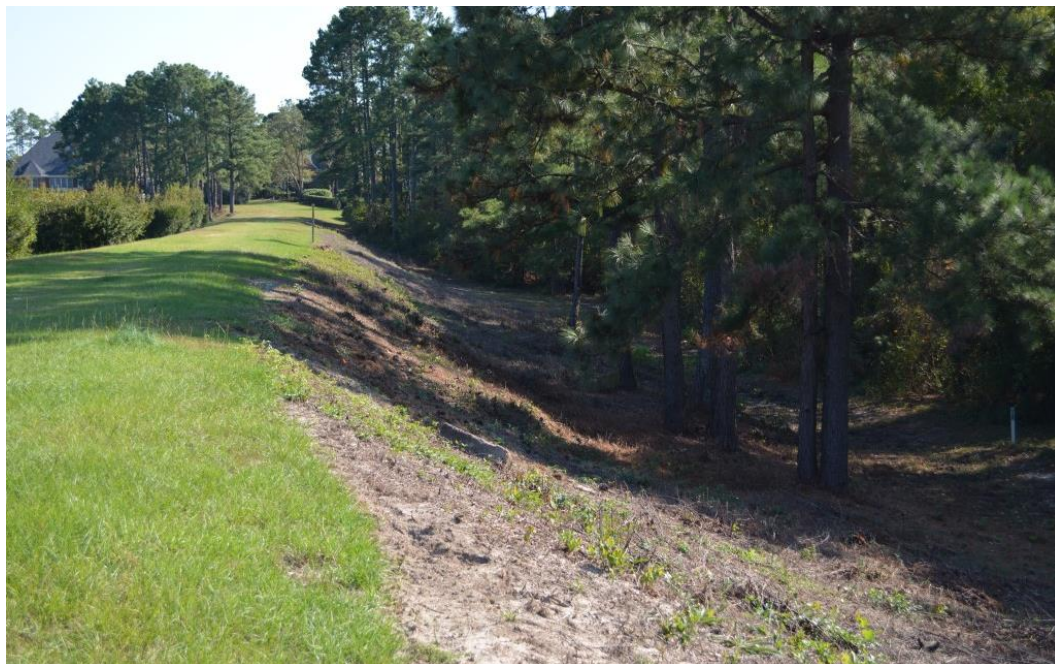
Wet areas were observed along the toe of the embankment dam between approximately 200 feet left of the right abutment to 500 feet left of the right abutment. The seepage was minimal, with no notable flow. Several pine trees are located at the toe of the dam.

Photo 2: Downstream slope of embankment

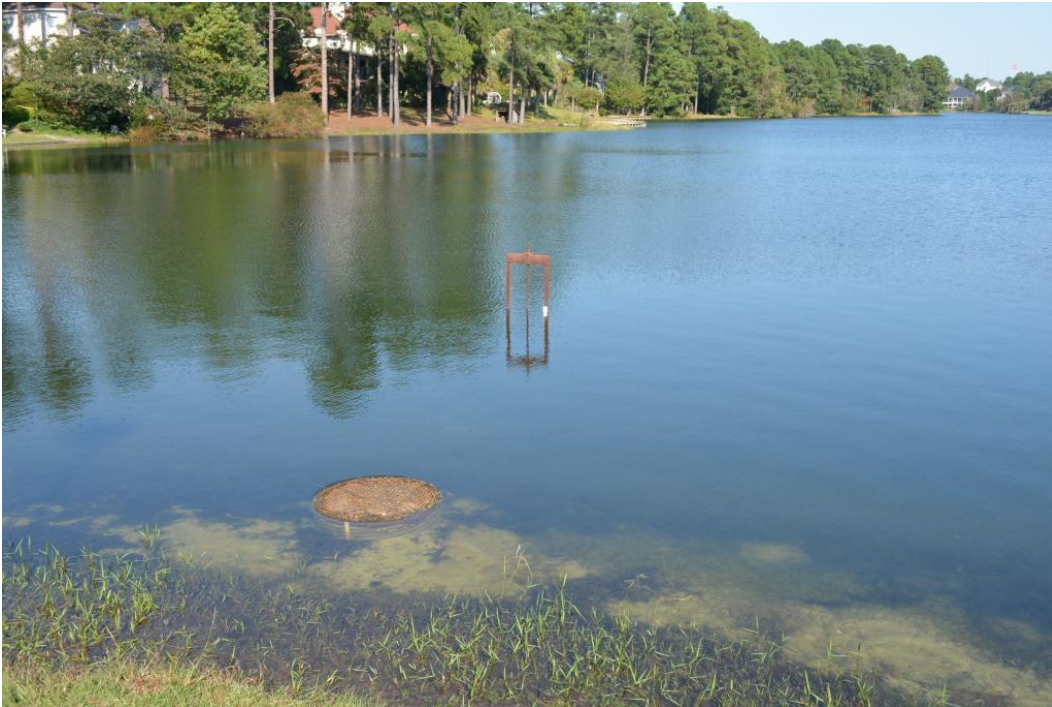
The service spillway is comprised of a drop inlet located approximately 20 feet upstream of the dam. The inlet was observed to be corrugated-steel pipe (approximate 36 inch diameter) with a trash screen cover (Photo 4). Moderate debris including pine needles and twigs were observed on the trash screen. A concrete pipe extends from the spillway inlet to a storm drain catch basin located downstream at the groin of the dam and right abutment. A concrete drain pipe extends

Photo 4: Service spillway intake and control

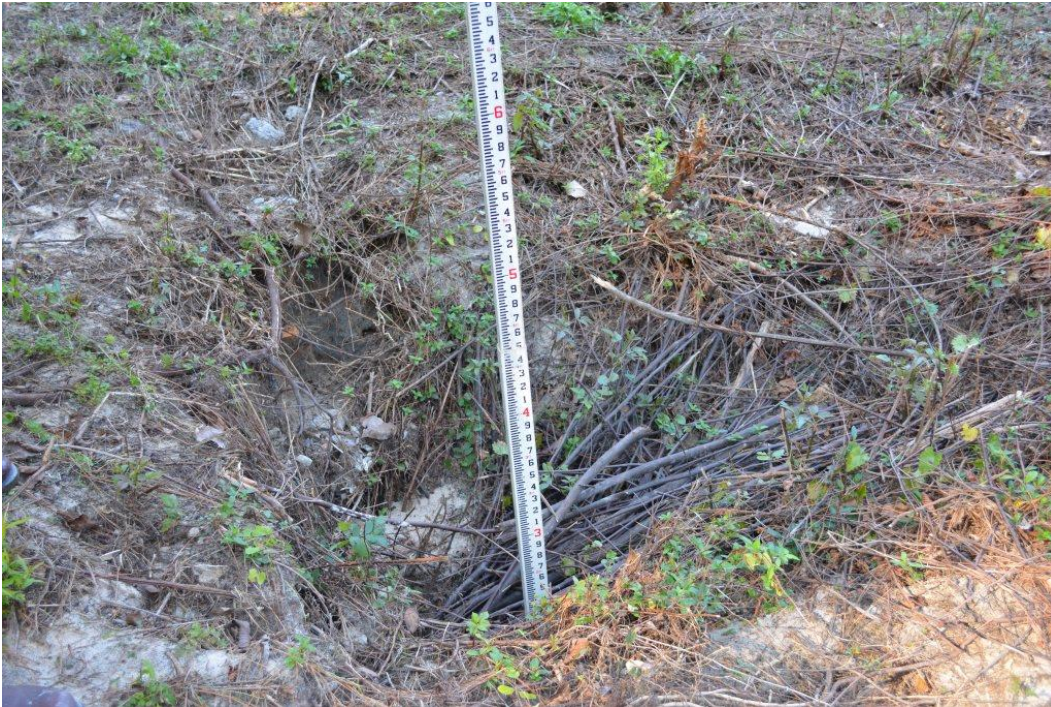
from the catch basin along the toe of the dam to another catch basin (Type 9) located approximately 400 feet left of the right abutment. A 24-inch CMP drain pipe extends approximately 100 feet downstream from the Type 9 catch basin to the outfall discharge to the receiving drainage-way (Photo 7). A hole approximately 2.5 feet deep was observed adjacent to the catch basin, just downstream from a wet area observed at the toe of the dam (Photo 5). This void appears to have developed from loss of soil material associated with potential leakage from the pipe near the connection with the catch basin and/or seepage through the embankment. A depression/void was also observed above the approximate alignment of the drain pipe approximately 50 feet right of the Type 9 catch basin toward the right abutment (Photo 6).

Photo 6: Depression at embankment toe along alignment of the service spillway outlet pipe

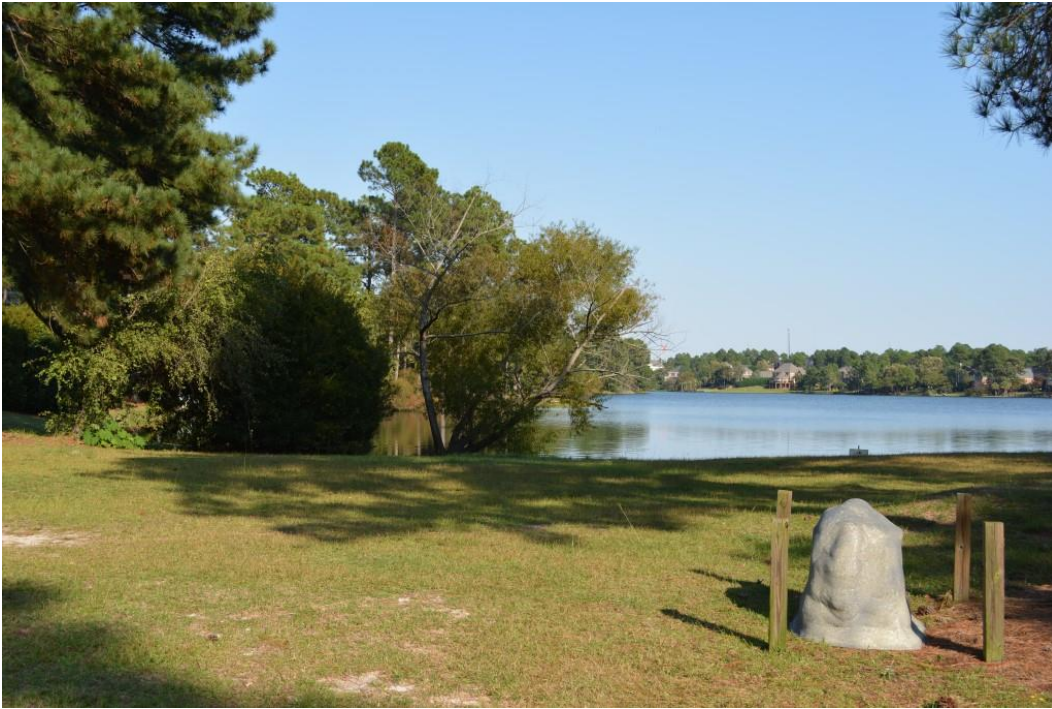
The auxiliary spillway is located on the right abutment of the dam. The spillway is approximately 50 feet wide and is a grass-lined earthen overflow spillway with a 1.5-foot-high training berm on the left of the spillway. Photo 8 shows the auxiliary spillway from downstream of the spillway crest looking upstream into the reservoir. The spillway did not show evidence of flow.

Photo 8: View of auxiliary spillway looking upstream

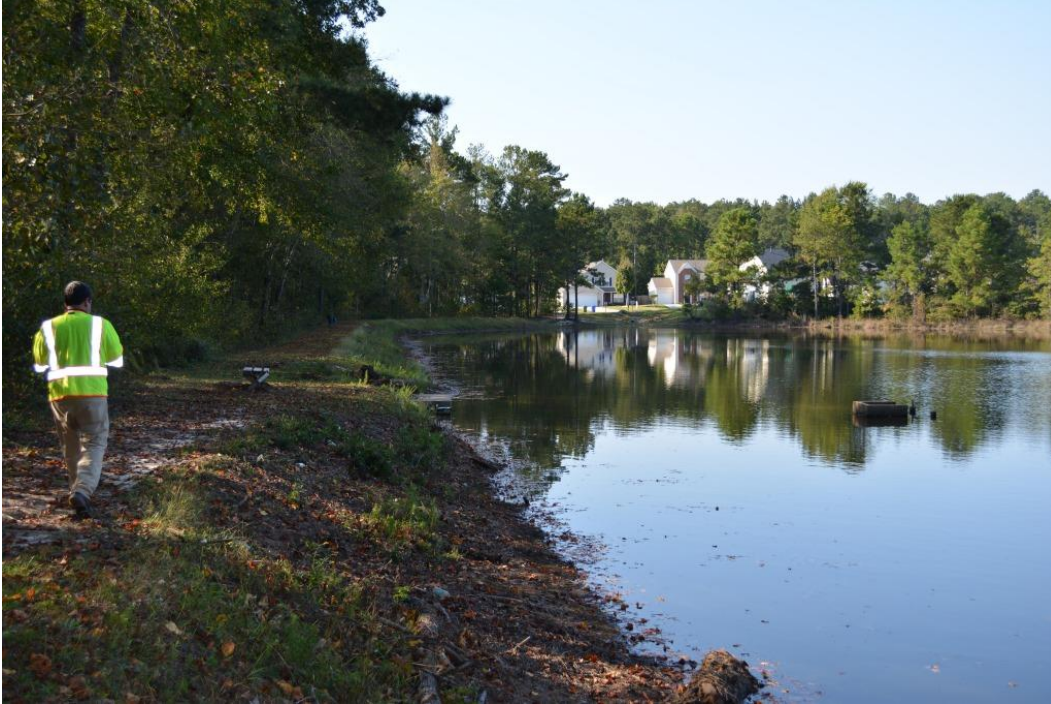
The embankment has an approximately 10-foot-wide crest, upstream slope that varies from 3H:1V to 2H:1V (Photo 1); and downstream slope of 2.5H:1V to 2H:1V. The crest of the dam is not level as indicated by visual evidence that some areas of the crest were overtopped during the flood event by approximately 3 to 4 inches, including the area at the service spillway. The upstream slope appears to be in good condition having moderate grass cover. The crest has grass cover over approximately 60 percent of the surface. Photo 1 presents a view of the upstream slope and crest from the left abutment. The downstream slope has significant tree growth as well as forest undergrowth including vines, ivy, and weeds. The downstream face is generally in good condition; however, a scoured area was observed near the service spillway where the dam experienced overtopping. Photo 2 shows the downstream portion of the crest and tree growth on the downstream slope. Photos 3 and 4 show the limited areas of significant erosion on the downstream slope, and debris accumulation from overtopping.

Photo 1: Deer Lake embankment dam crest and upstream slope

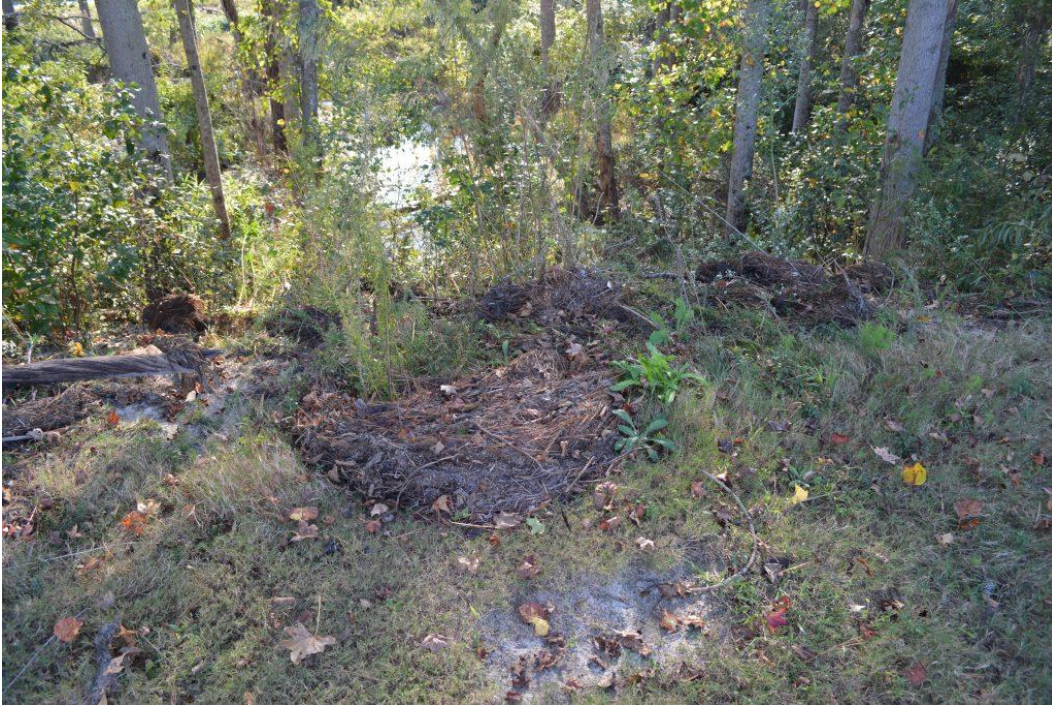
Photo 3: Debris accumulation on downstream embankment slope due to overtopping

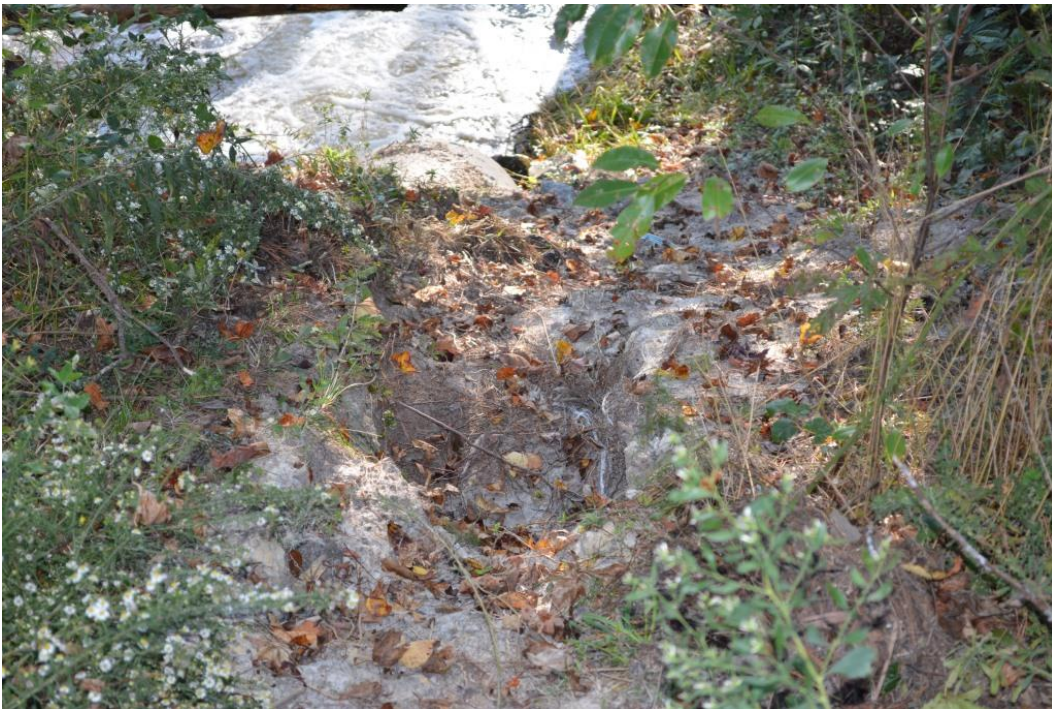
Photo 4: Scour on downstream embankment slope

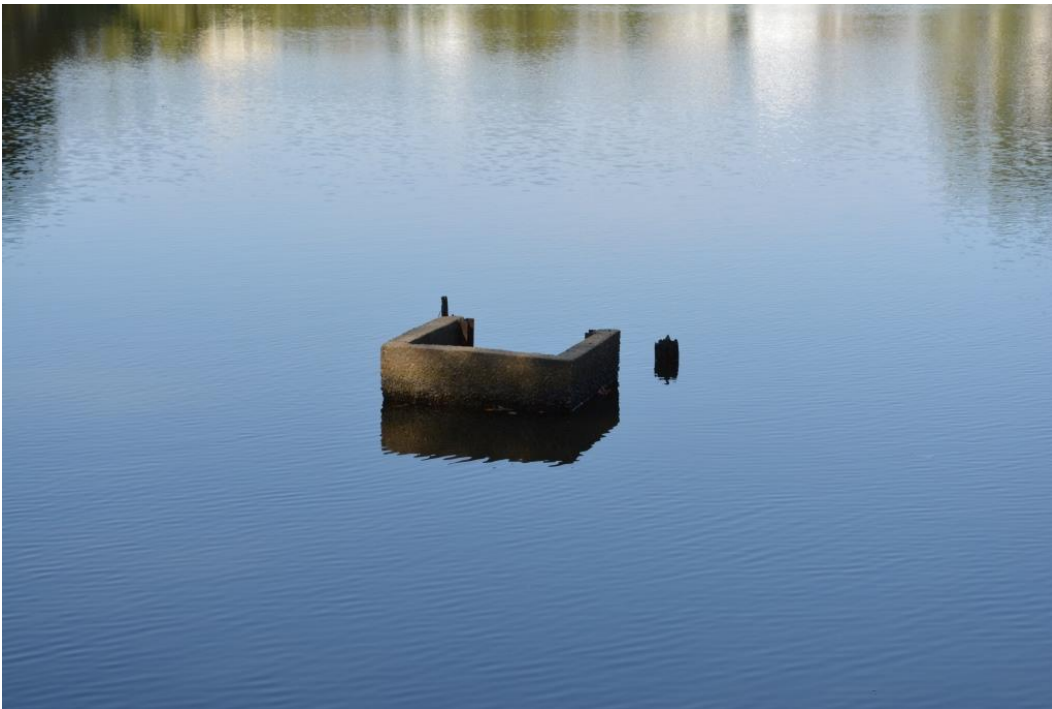
A second concrete box-inlet structure with an open, upstream-face, inlet structure was observed approximately 60 feet upstream of the dam (Photo 6). There was no flow into this inlet, and operational condition of this intake is unknown; it may be an active secondary inlet to the service spillway or an abandoned intake. Photo 7 shows discharge from the low-level outlet pipe.

Photo 6: Intake structure (possibly abandoned)

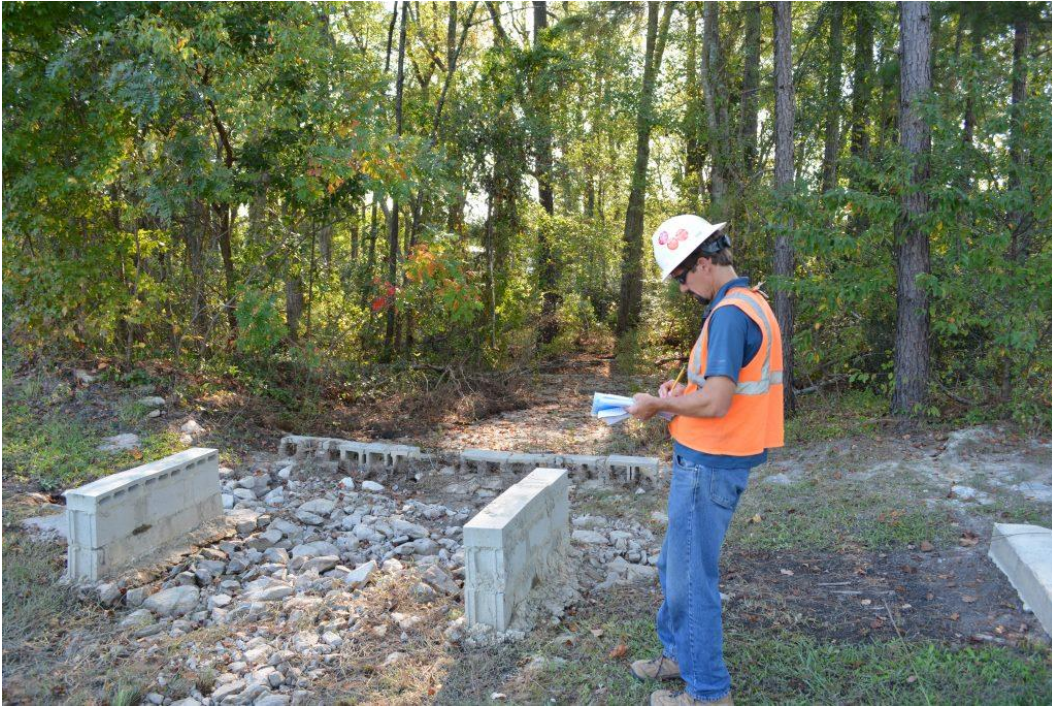
The auxiliary spillway is located at the right abutment. The spillway is an earthen, rock-lined, 20-foot-wide, overflow spillway that is approximately 2.5 to 3.0 feet below the crest of the dam. The auxiliary spillway channel is free of debris, except for debris from a wooden bridge deposited approximately 70 feet downstream; this debris would not result in impairment of spillway capacity.

Photo 8: Auxiliary spillway view looking downstream

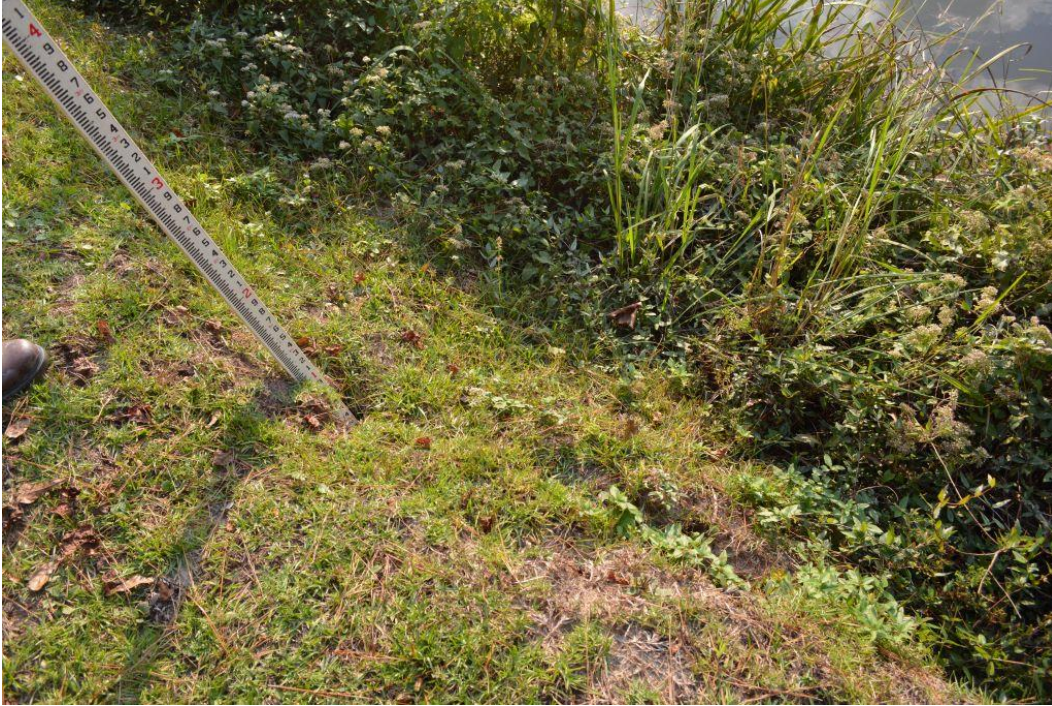
Photo 3: Slough on upstream face

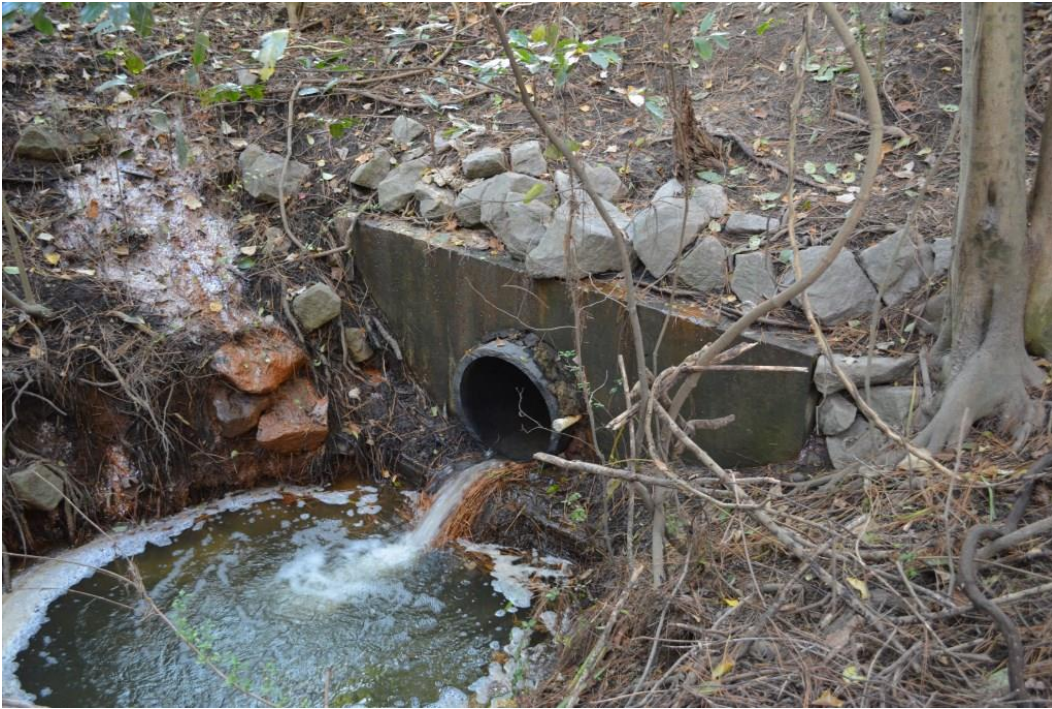
Photo 6: Service spillway outlet pipe and seepage

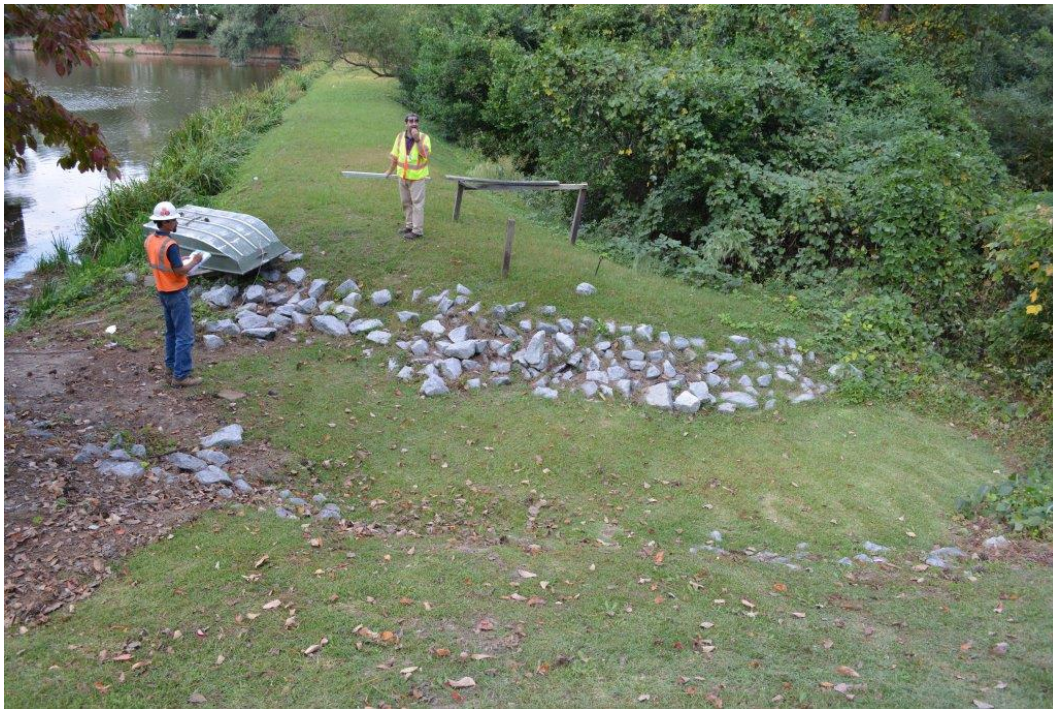
The auxiliary spillway is located at the right abutment. The spillway is an earthen-bottom spillway with rock-lined slopes and is approximately 10 to 12 feet wide. The auxiliary spillway did not exhibit signs of surficial erosion and is free of debris.

Photo 8: Commons Pond auxiliary spillway viewed from right abutment

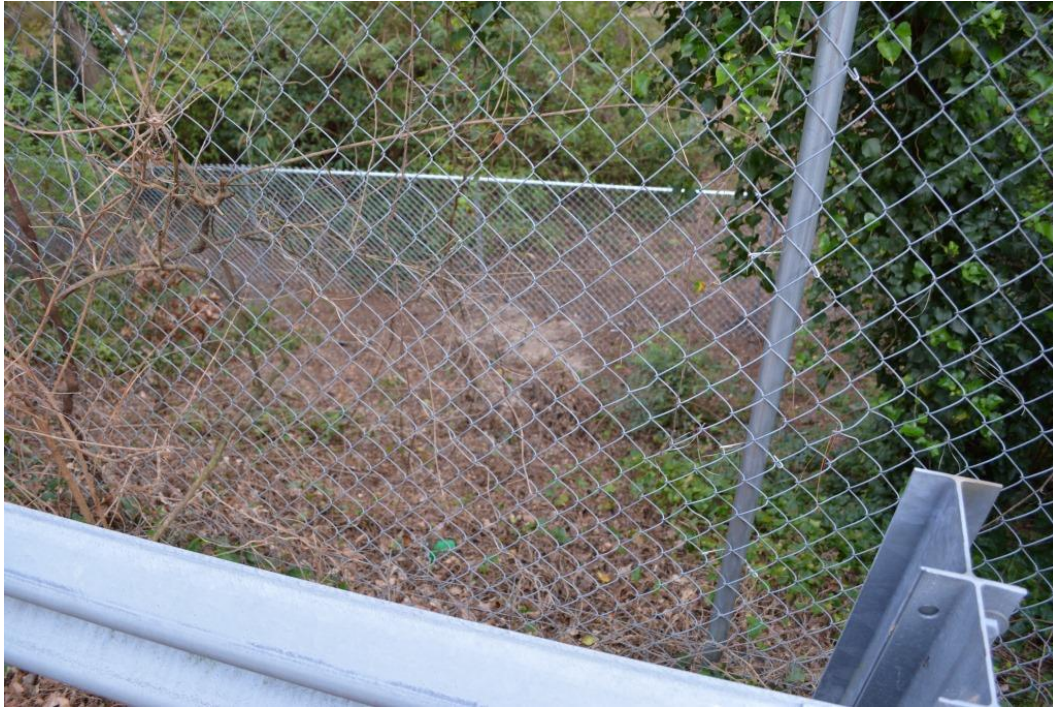
Photo 3: View of embankment downstream slope from crest
