Subject: Inspection of CONESTEE LAKE DAM, D2876, Greenville County, Significant Hazard Class

CONESTEE LAKE DAM : D2876

Dams Preliminary Inspection Form

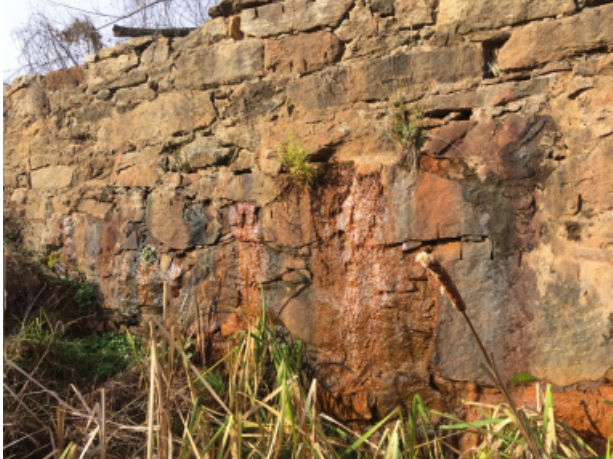
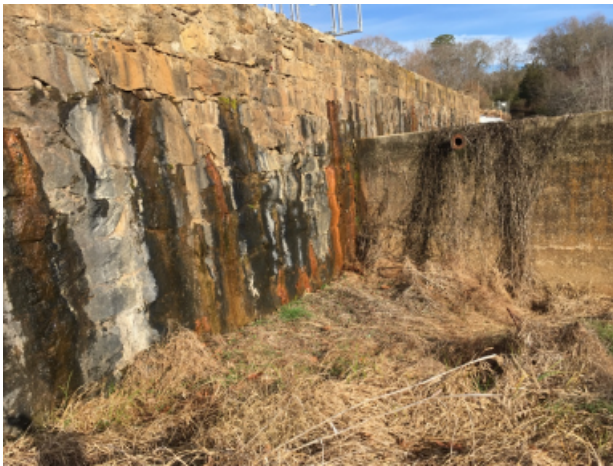
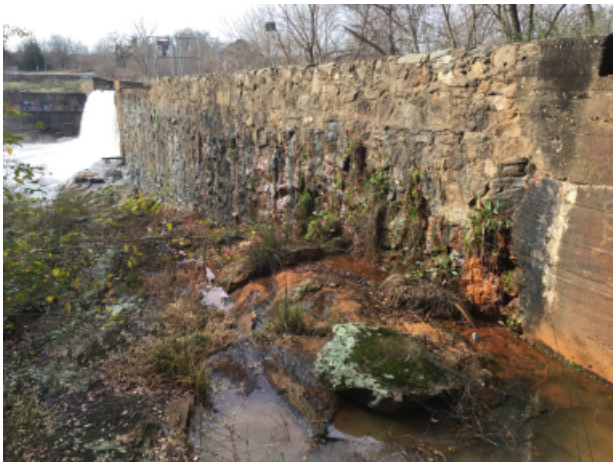
Concrete/Masonry Dams: Downstream Face

- The previous SCDHEC inspections on December 18, 2014, December 1, 2016 and the inspection on December 11, 2019, noted numerous active seeps and deterioration of the masonry joints throughout the downstream face on the both the left and right side. A recent engineering study was submitted to the Department on April 19, 2019 by Kleinschmidt and the report noted "Numerous active seeps were observed along the entire length of the downstream face of the dam. Most of these seeps appear to be transporting fine sediment (silt and clay) resulting in an ochre coloration to the seeps and the accumulated materials where the seeps flow across the bedrock at the base of the dam. These accumulated translocated materials have been analyzed and documented to contain high concentrations of heavy metals previously detailed in this report." Due to the movement of fine sediments containing hazardous constituents, a repair plan should be developed to address and control the seepage through the dam.
