SOUTH CAROLINA
WATER RESOURCES COMMISSION
GEOLOGY - HYDROLOGY DIVISION

INVESTIGATION
OF GROUND - WATER PROBLEMS NEAR
THE VULCAN MATERIALS MARBLE QUARRY
CHEROKEE COUNTY, SOUTH CAROLINA

May 1988

Open-File Report No. 19

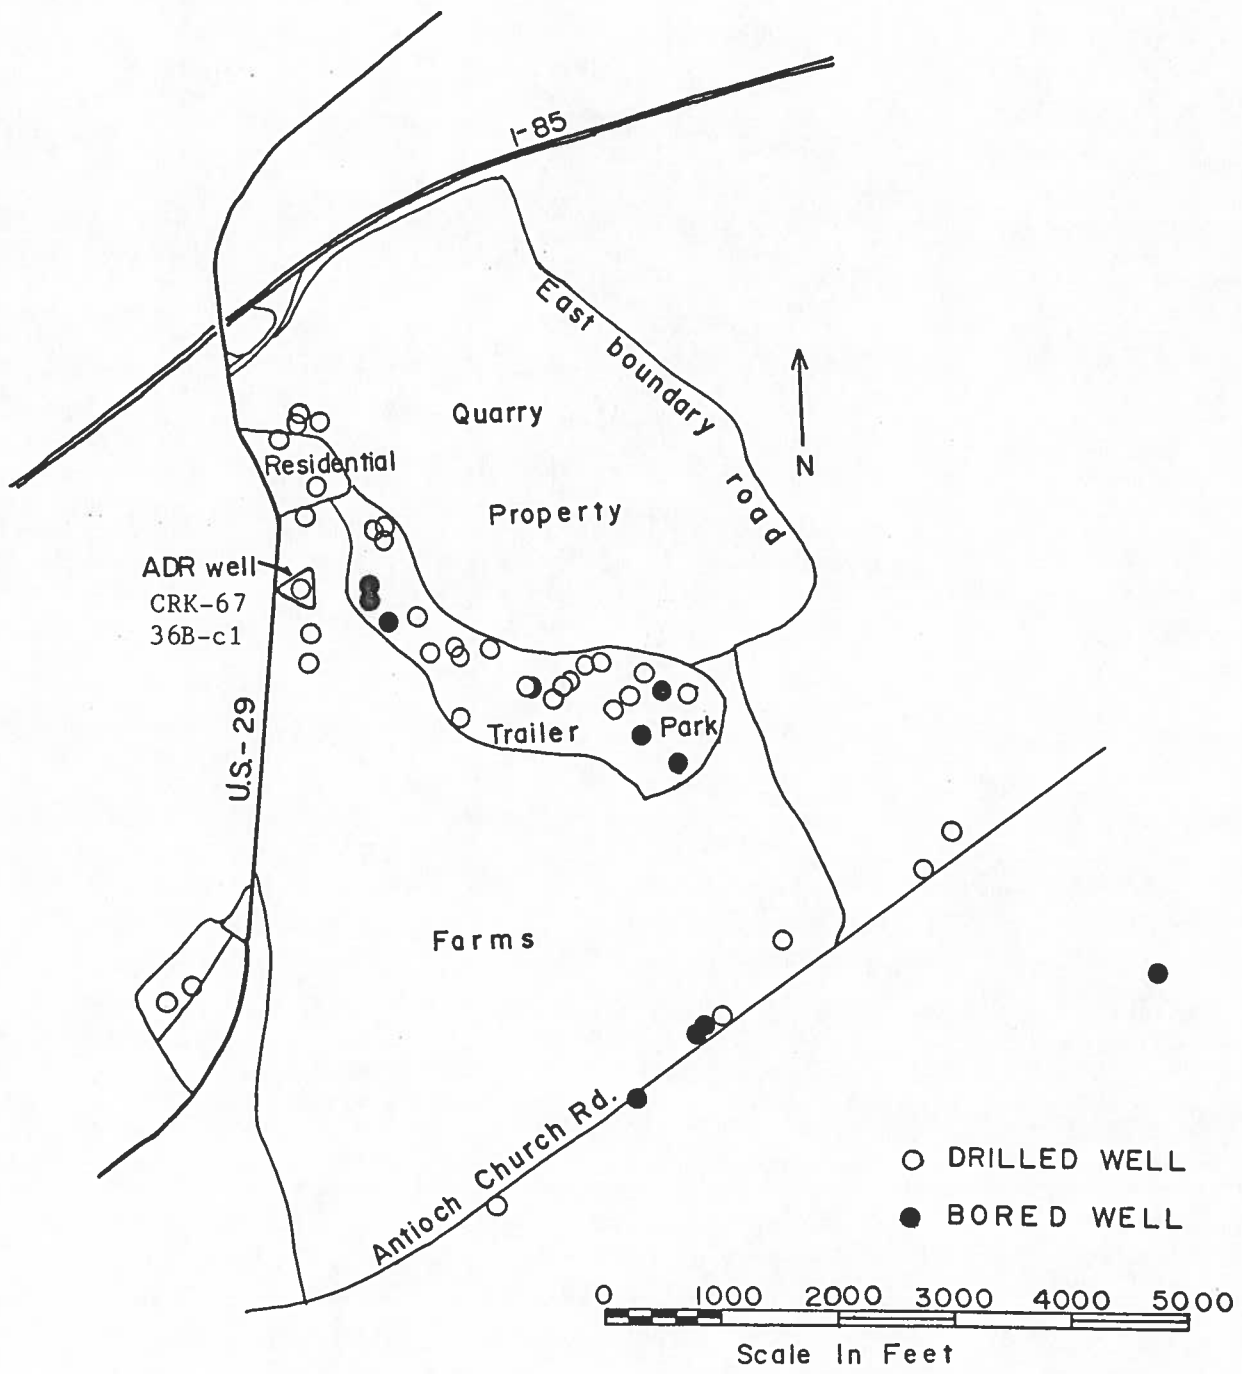
Figure 10. Location of ground water Automatic Data Recorder (ADR) well.

Since March 1986 an automatic data recorder (ADR) has been continuously recording water levels in the vicinity of the Vulcan Materials quarry (Figure 10). Initially two ADR's were employed but one malfunctioned and was removed. Data was plotted to disclose predominant trends and cycles. Along with these water levels, blasting times were also marked to study the impact of blasting on local water level changes.

The well chosen for this study is located a half-mile west of the center of the quarry pit and is a 6-inch well that is 405 feet deep with 66 feet of galvanized casing (well # CRK-67/36B-c1). The ADR was installed March 12, 1986, and records the water level every 6 minutes.
