SC DEPARTMENT of
**ENVIRONMENTAL
SERVICES**

Subject: Inspection of UPPER SUNNY HILL POND DAM, D2523, Kershaw County, High Hazard Class

UPPER SUNNY HILL POND DAM : D2523

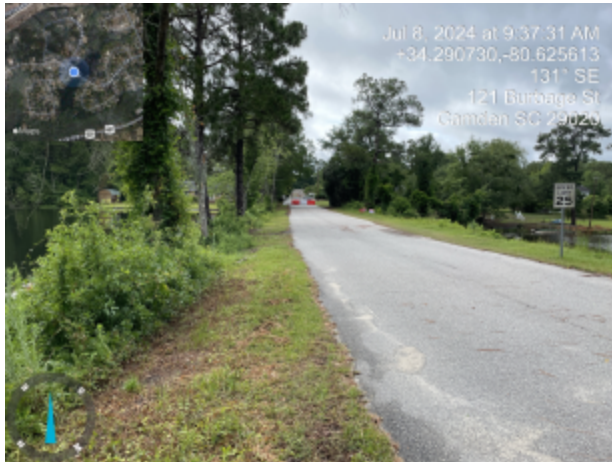
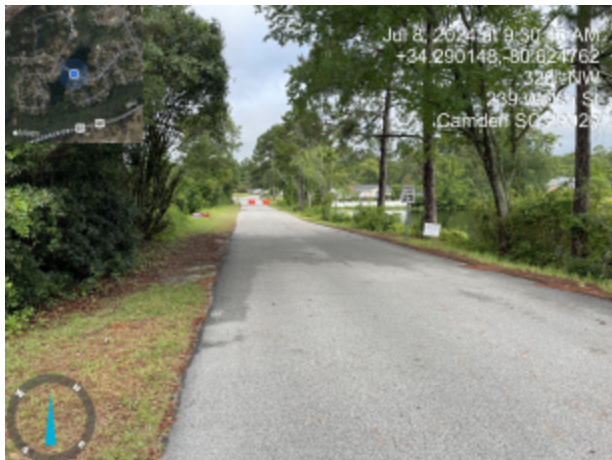
1. Grass Cover	Monitor
Paved Sunnyhill Drive on the crest of the dam. Shoulders of the crest are mostly grassed, some bare areas or areas with pinestraw coverage observed.	
2. Deleterious Vegetation	No Deficiency
3. Trees	No Deficiency
4. Animal Activity	No Deficiency
5. Surface Cracking	Monitor
Longitudinal cracking of the pavement observed near the sinkhole.	
6. Horizontal Alignment	No Deficiency

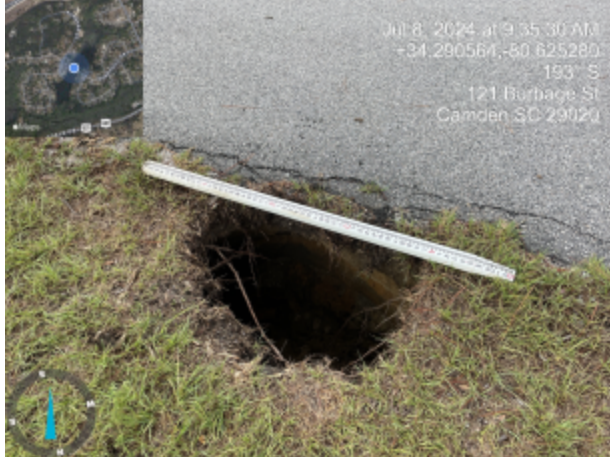
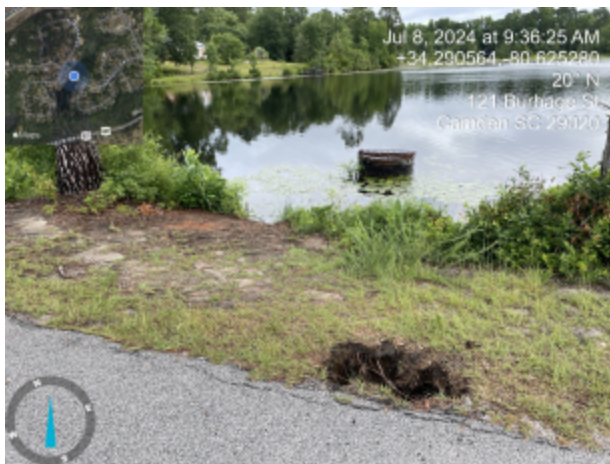
Embankment: Crest

Needs Permitted
Repair(s)

Engage a Professional Engineer to evaluate the stability of the crest around the sinkhole and develop a permit application for repairs and stabilization of the embankment.

Monitor for worsening cracking along the pavement.

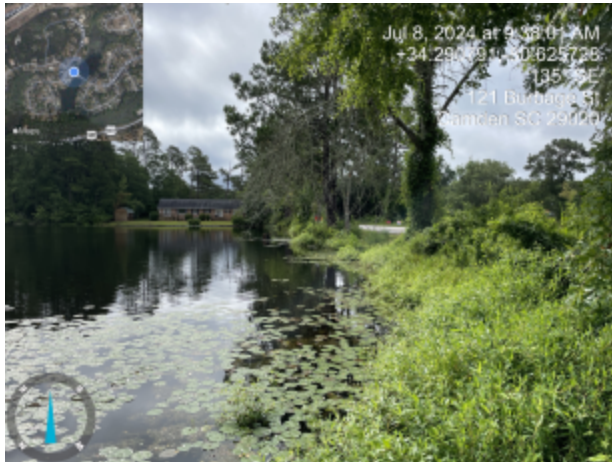
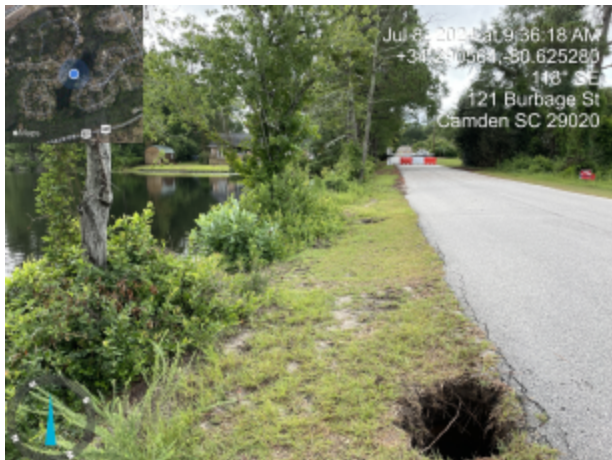
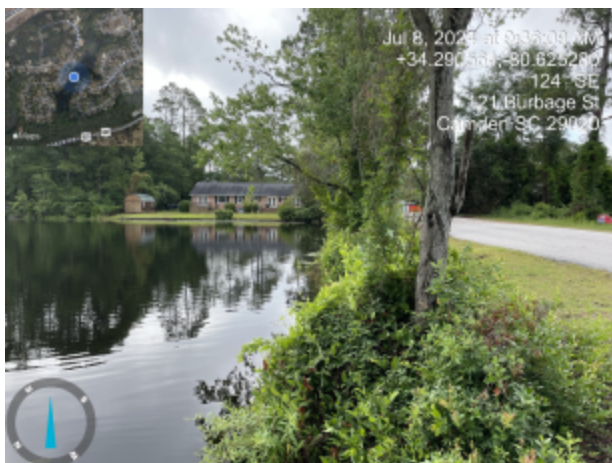
Dense brush and woody vegetation less than 4 inches in diameter observed along the upstream slope, mainly along the water line.

Numerous trees greater than 4 inches in diameter observed, including dead trees and decaying stumps.

Numerous voids/subsided areas observed within the upstream slope. Depths vary, but all are greater than 12 inches in depth. Standing water was observed within one of the voids. Some of the voids appear to have formed around tree roots.

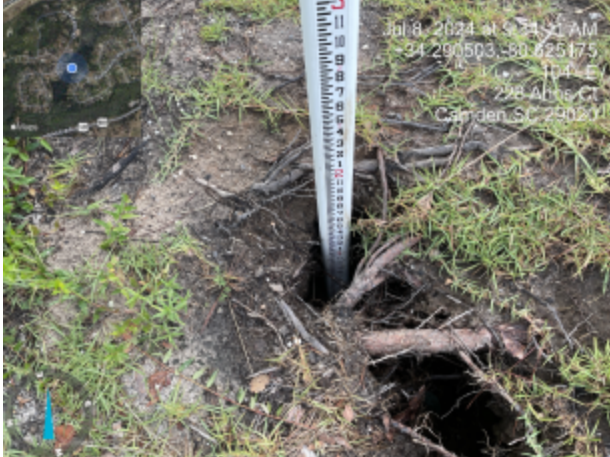
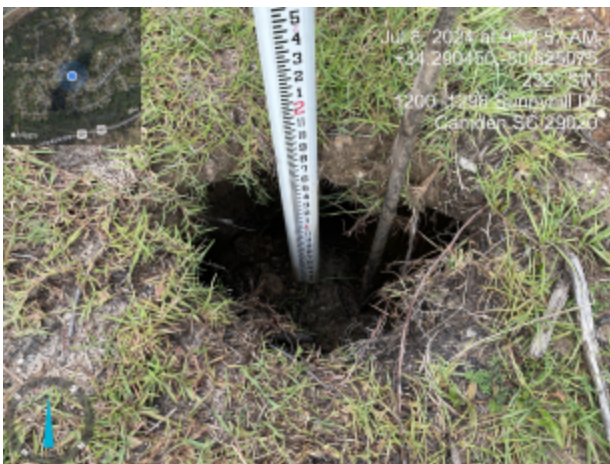
Embankment: Upstream Slope

Minor scarping observed on the upstream slope near the right side of the dam. Less than 12 inches.

Regular Monitoring
 Necessary, Needs
 Maintenance, Needs
 Permitted Repair(s)

Engage a Professional Engineer to evaluate the condition and stability of the upstream slope, especially around areas with voids. Engineer should develop a permit application for repairs and stabilization of the upstream slope.

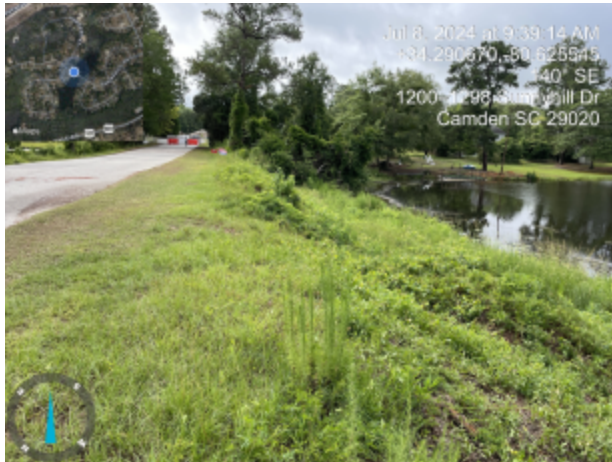
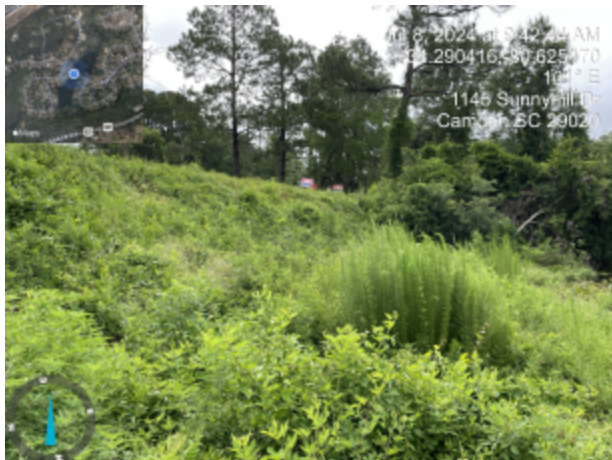
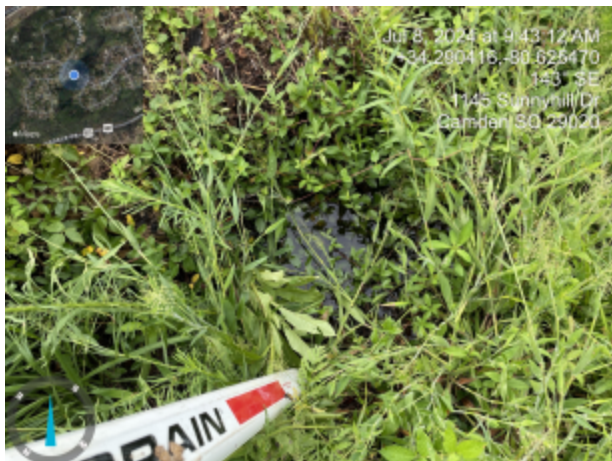
Decaying tree stumps observed.

Dense brush and woody vegetation observed in the groins of the downstream slope.

Multiple voids observed within the downstream slope, potentially around tree roots and stumps. Depths greater than 2 feet observed in some areas.

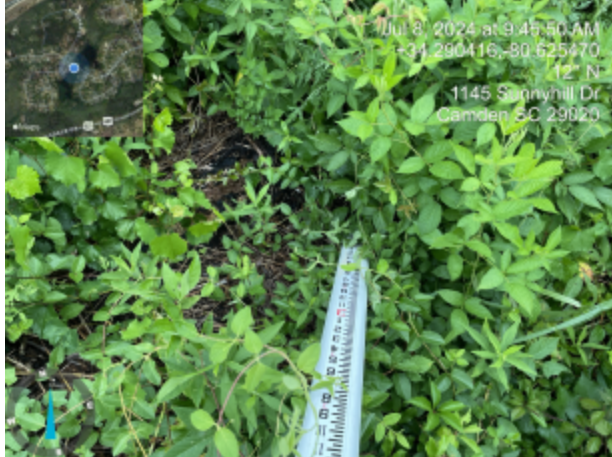
Puddles observed along the downstream slope, potentially due to recent rainfall.

15. Other:	
16. Embankment: Downstream Slope Condition	Regular Monitoring Necessary, Needs Maintenance, Needs Permitted Repair(s), Condition Prevented Full Inspection
<div style="border: 1px solid black; padding: 5px;"> <p>Violation Determined: 7/8/2024</p> <p>DAMMAINTREP</p> <p>Engage a Professional Engineer to evaluate the stability and condition of the downstream slope, especially around decaying tree stumps. Engineer should develop a permit application for repairs of the voids and eroded sections of the downstream slope.</p> <p>Engage a Professional Engineer to evaluate the area of the downstream slope experiencing scarping and to develop a permit application for slope repair and stabilization.</p> <p>Manage/remove brush and woody vegetation less than 4 inches in diameter to allow for full inspection of the downstream slope.</p> <p>Develop grass coverage or other form of erosion protection following deleterious vegetation removal.</p> </div>

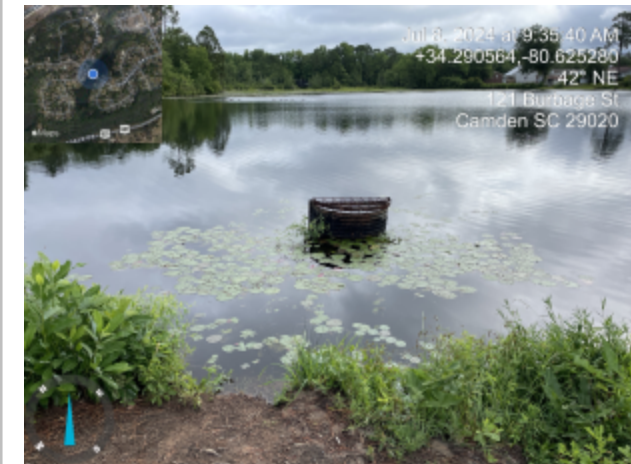
8. Spillway: Inlet Structure Condition Regular Monitoring Necessary
