Subject: **Inspection of LAKE CONESTEE DAM, D2876, Greenville County,
Significant Hazard Class**

CONESTEE LAKE DAM : D2876

Dams Preliminary Inspection Form

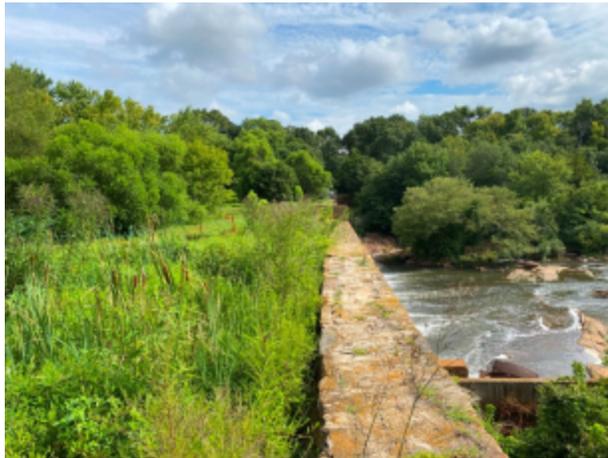
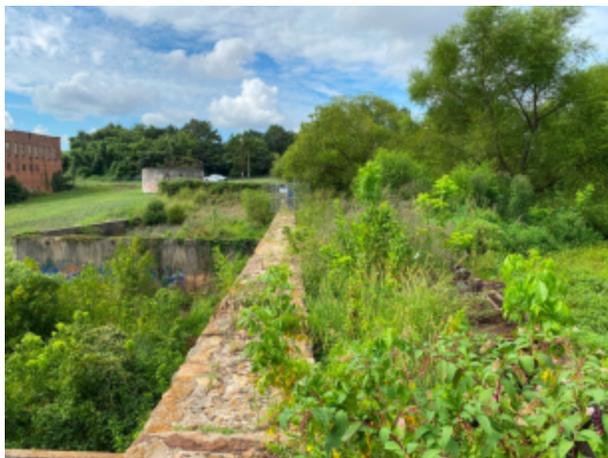
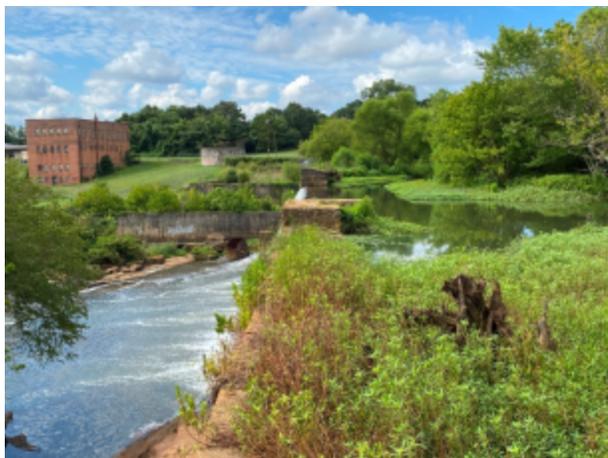
7. Concrete/Masonry Dams: Upstream Face Condition

Regular Monitoring
Necessary, Condition
Prevented Full
Inspection

**Violation Determined: 8/19/2022
DAMMAINTREP**
