# SPRING LAKE DAM : D3539

## Dams Preliminary Inspection Form

Start Date: 09/28/2018

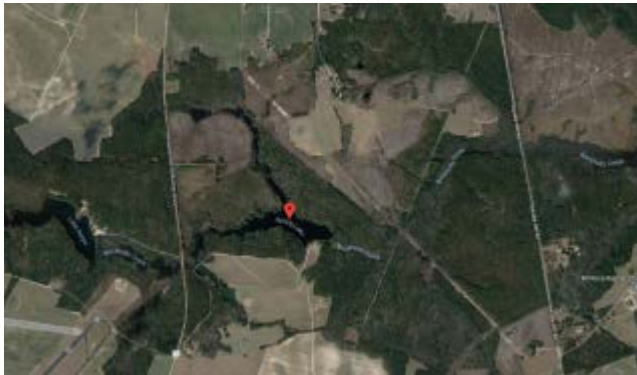
Photo Taken: 10/5/2018 3:13:21 PM

Society Hill Road (1.15 mi) and Plumfield Road (2.5 mi) downstream.  
Evidence of overtopping of Society Hill Road was noted in the ArcGIS Collector check that was conducted a few days after Hurricane Florence.
