January 29, 2018

RE: Inspection of BOWATERS CAROLINA DAM 6 (DHEC ID # D3657)  
York County

# BOWATERS CAROLINA DAM 6 (D3657)

## Dams Preliminary Inspection Form

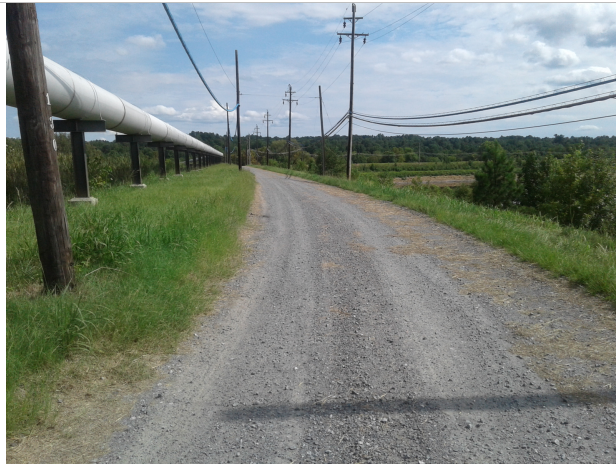
Photo Taken: 8/30/2017 4:05:50 PM

Freeboard: N/A (no water, dry post-processing sludge basin)

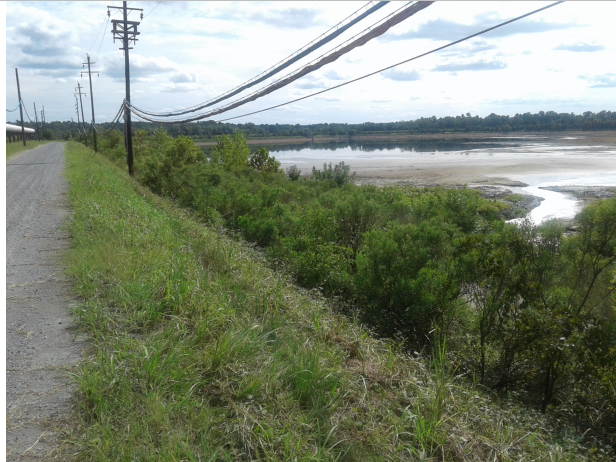
Photo Taken: 8/30/2017 3:58:11 PM

Slope: 2H:1V

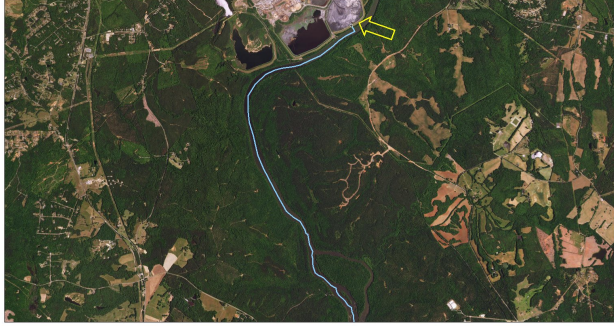
<p style="font-size: small; margin-top: 5px;">August 20, 2017</p> </div> <div style="width: 50%; padding-left: 10px;"> <p>Photo Taken: 9/4/2017 1:03:07 PM</p> </div> </div>		
2. Inundation Map	<input type="button" value="No"/>	
3. Structures/Developments	<input type="button" value="No"/>	
4. Roads/Railways	<input type="button" value="No"/>	
5. Utilities	<input type="button" value="No"/>	
6. Consider For Reclass?	<input type="button" value="No"/>	
7. Additional Comments (Refer to item number if applicable)		
<b>Inspection Summary</b>	<b>Answer</b>	<b>Violation</b>
1. Overall Condition (*Per National Inventory of Dams Definition)		
Fair
