RE: Reinspection of Lake Elizabeth Dam D-0024, Classification C1, Richland County

The Lake Elizabeth Dam was inspected on December 4<sup>th</sup>, 2012 under the provisions of South Carolina Dams and Reservoirs Safety Act.

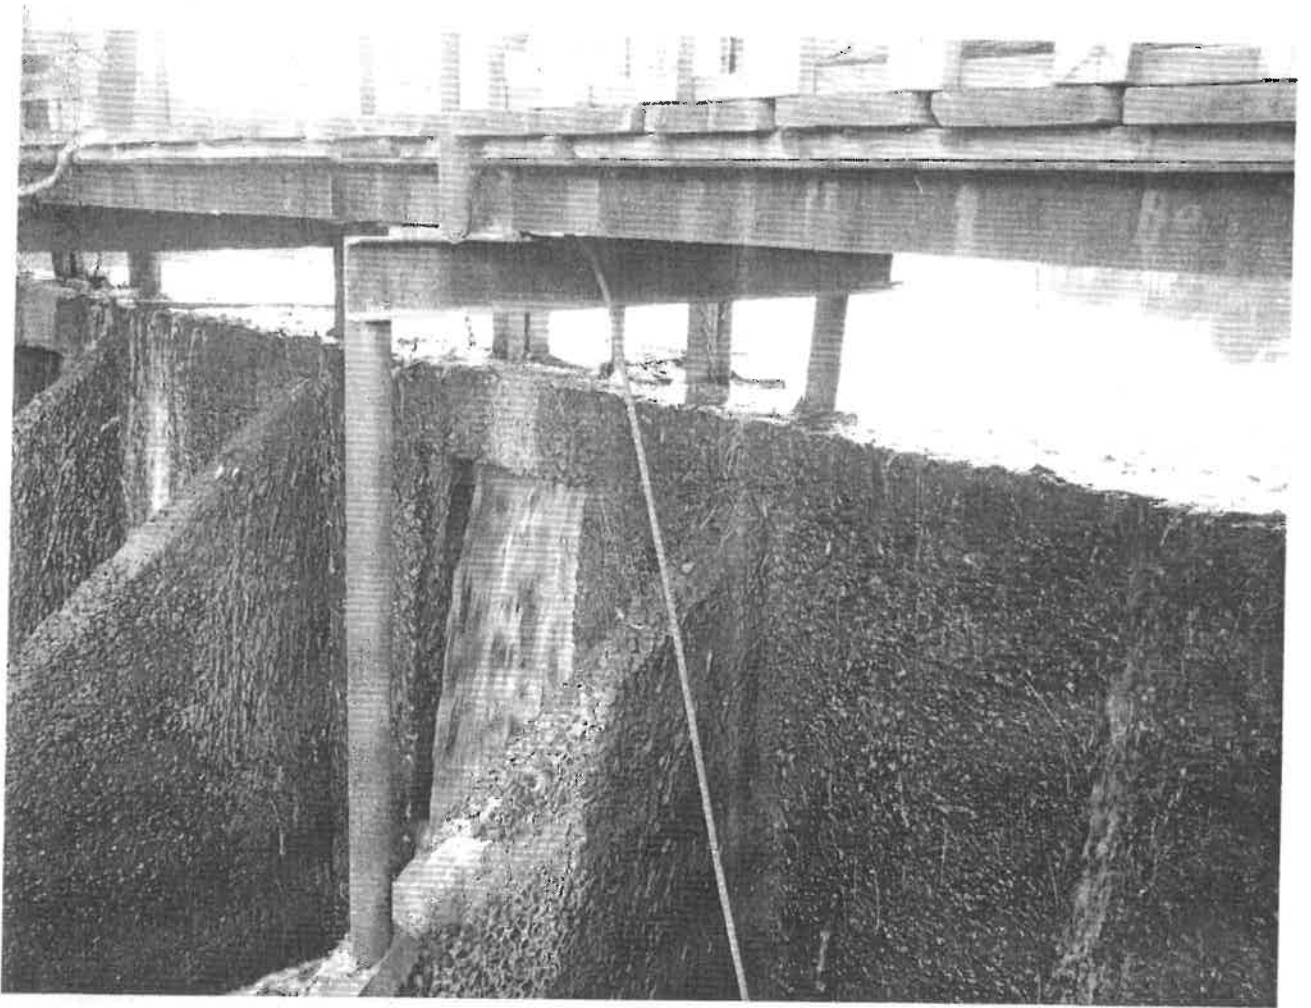
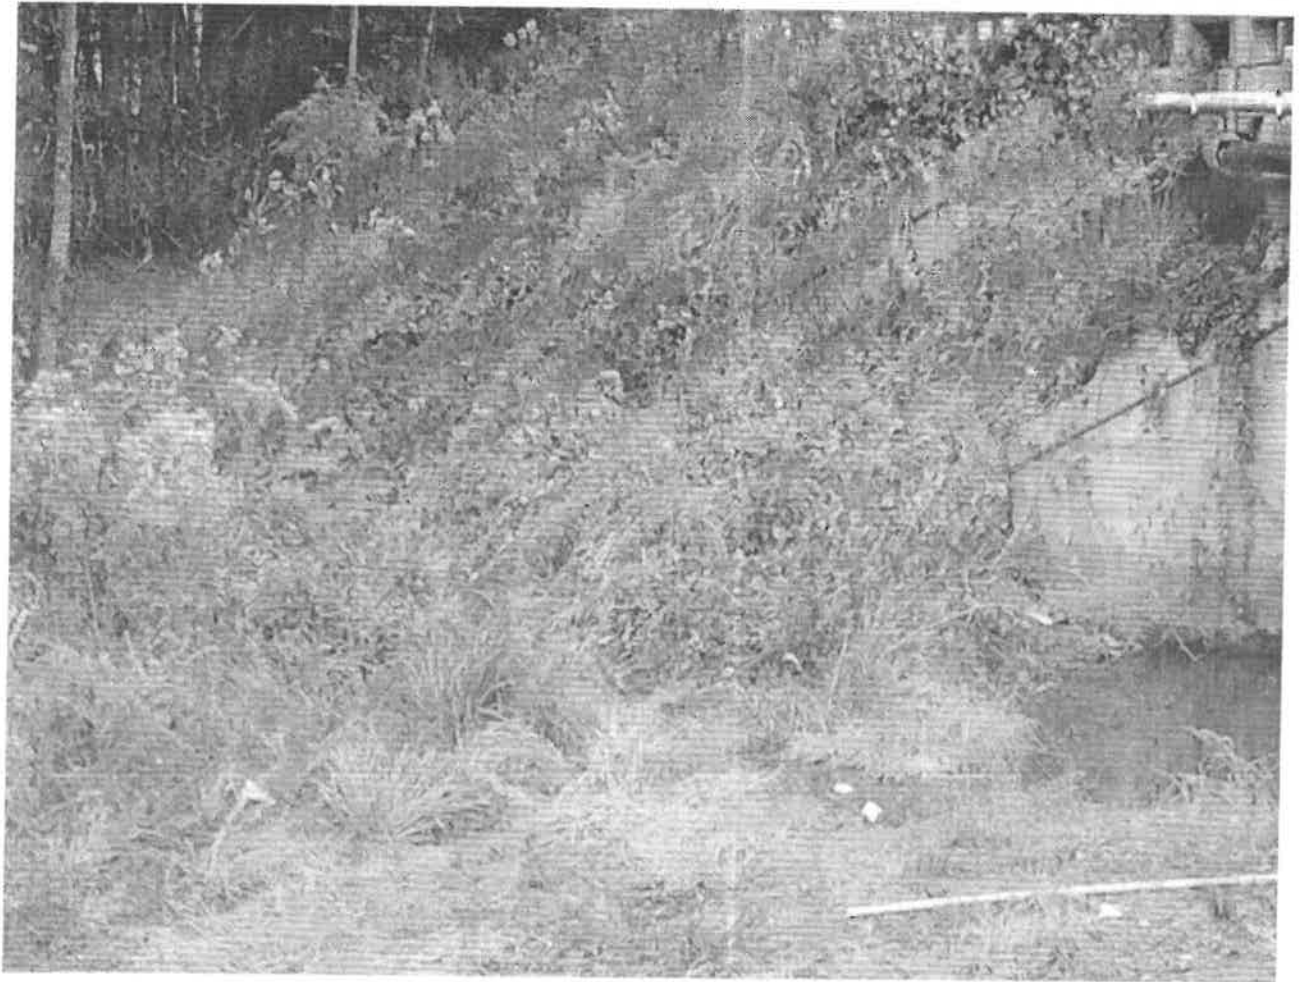
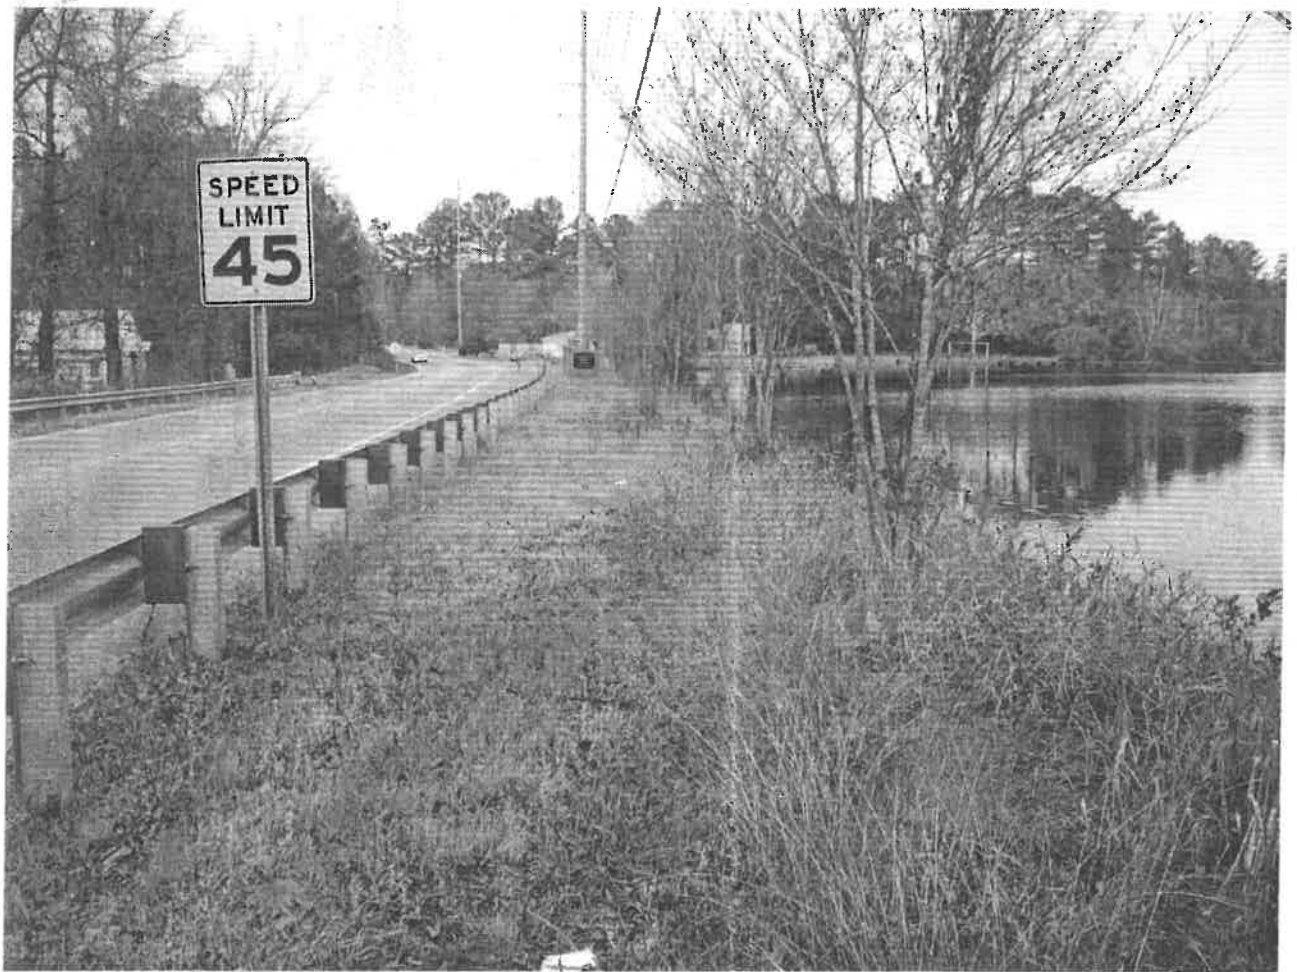
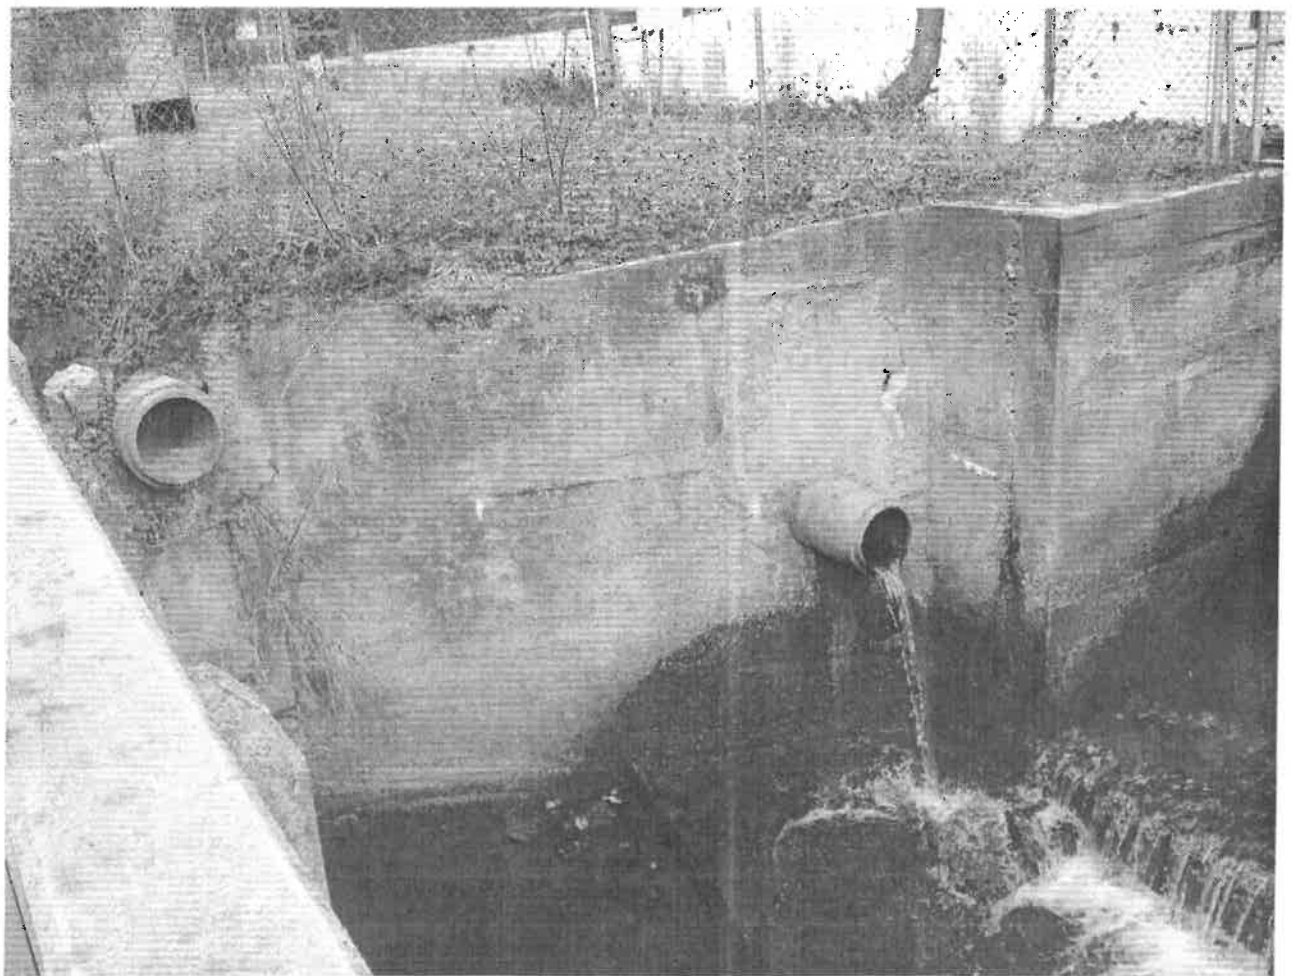
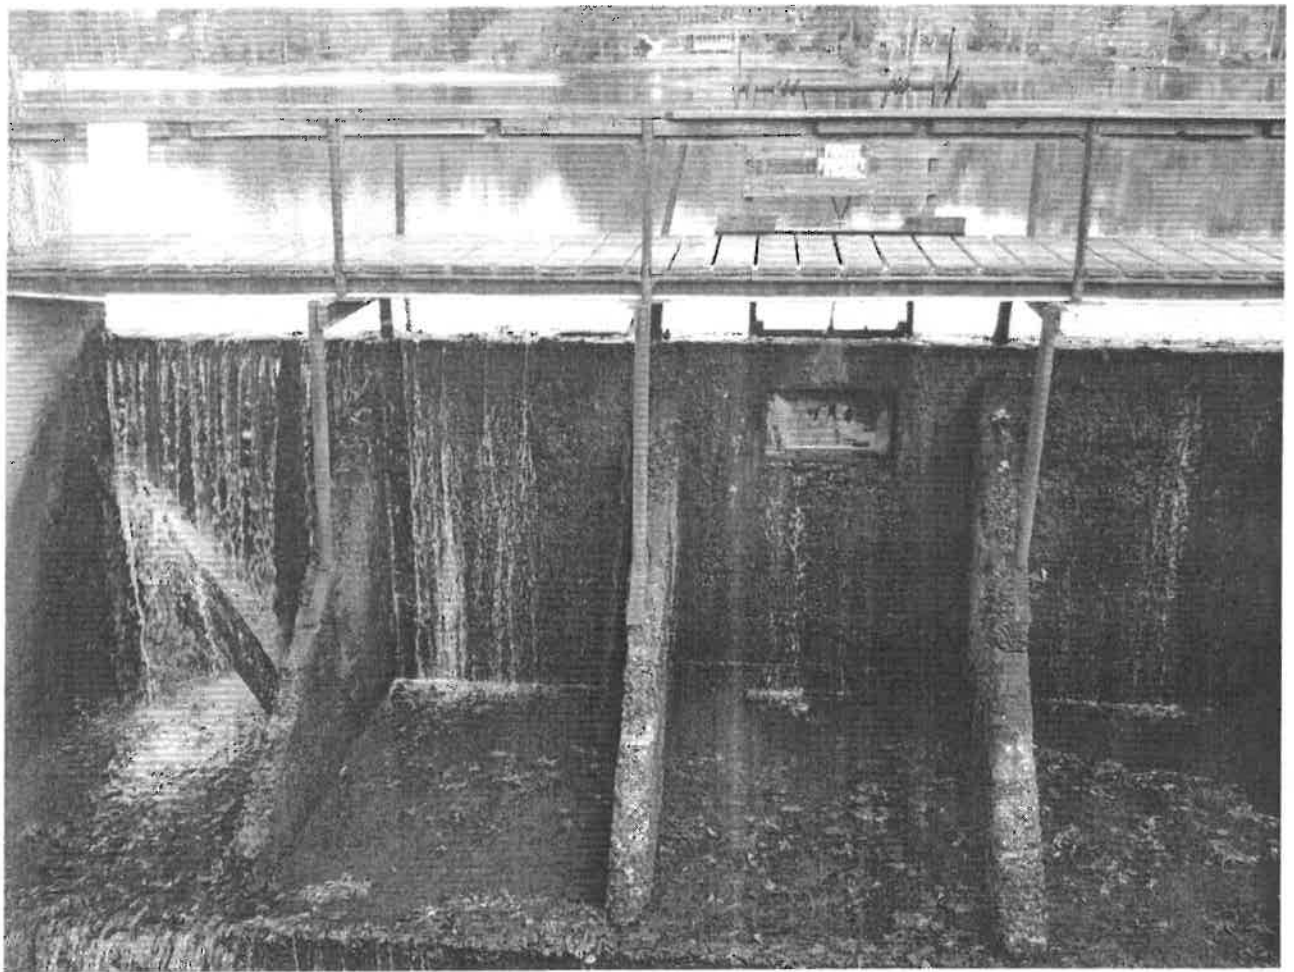
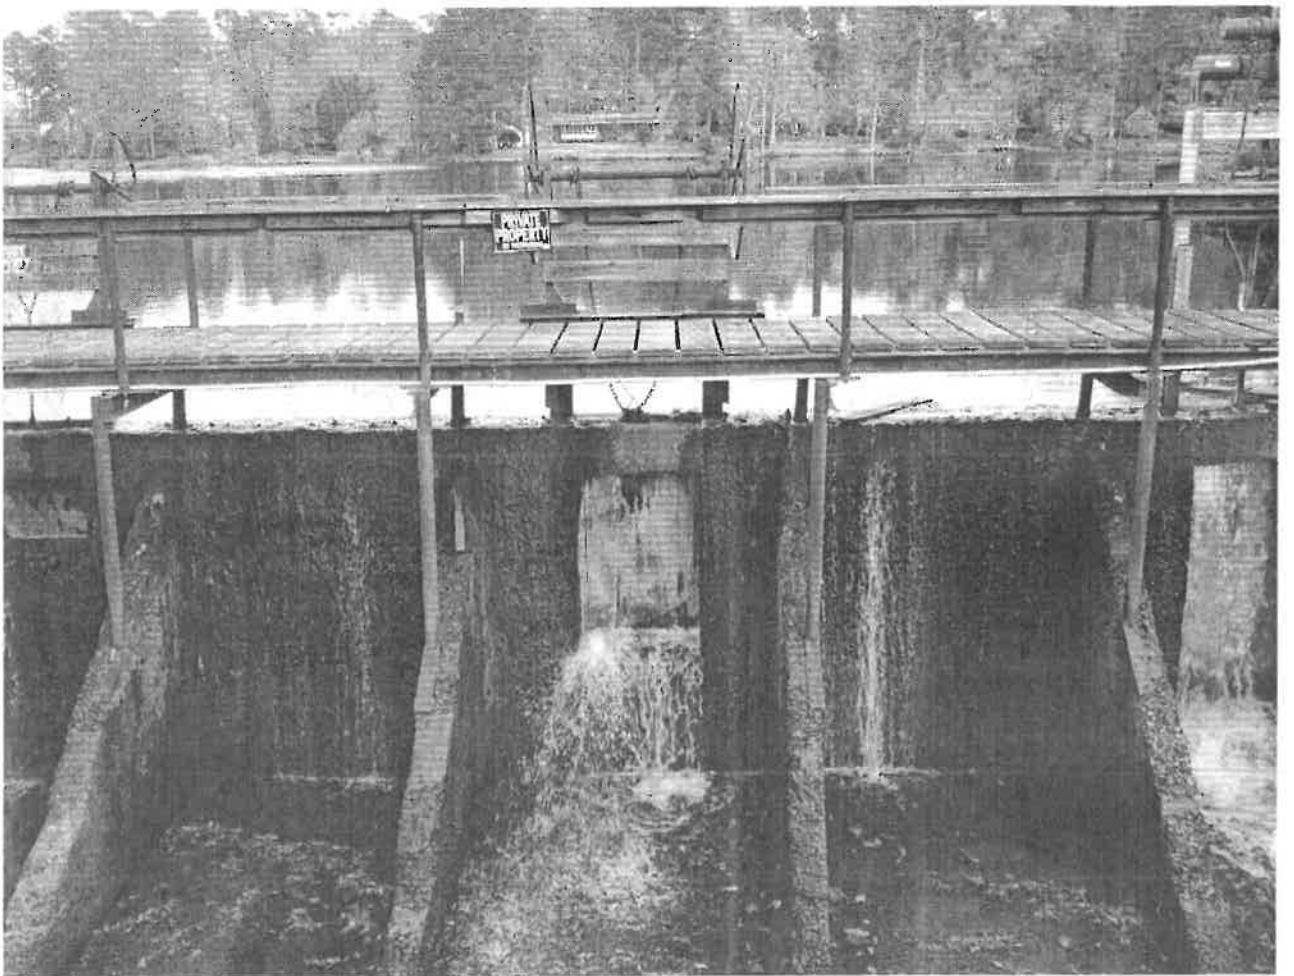
During this inspection, I noticed trees, weeds, two small sinkholes and a small crack on the upstream side of the dam (see photo's enclosed). The holes and crack are near the Lake Elizabeth Estates Sign and should be filled, compacted and monitored for changes. The crack should also be monitored and if the holes or cracks show any signs of getting worse, an engineer should be retained to evaluate them.

- i. Vegetation (grass, trees weeds)? grass, weeds, trees
- ii. Animal activity observed? \_\_\_\_\_
- iii. Any obvious alterations or repairs made? \_\_\_\_\_
- iv. Erosion observed on upstream slope? \_\_\_\_\_
- v. Settlement or cracks visible in slope? Some holes - See pictures  
Small crack on north side - See picture

Small Crack should be monitored
