Subject: Request for Modification of Product Recovery Activities
Plantation Pipe Line Company
Lewis Drive Remediation Site
Belton, South Carolina
Site ID #18693, "Kinder Morgan Belton Pipeline Release"

On behalf of Plantation Pipe Line Company (Plantation), Jacobs has prepared this correspondence to request a modification to the product recovery activities currently conducted at the Lewis Drive Site in Belton, Anderson County, South Carolina (Site ID #18693).

Table 1. Product Skimmer Recovery Results
Table 2. Groundwater Elevation and Product Thickness Data
Figure 1. Site Features with Measurable Product.
Attachment A – Product Thickness Trends

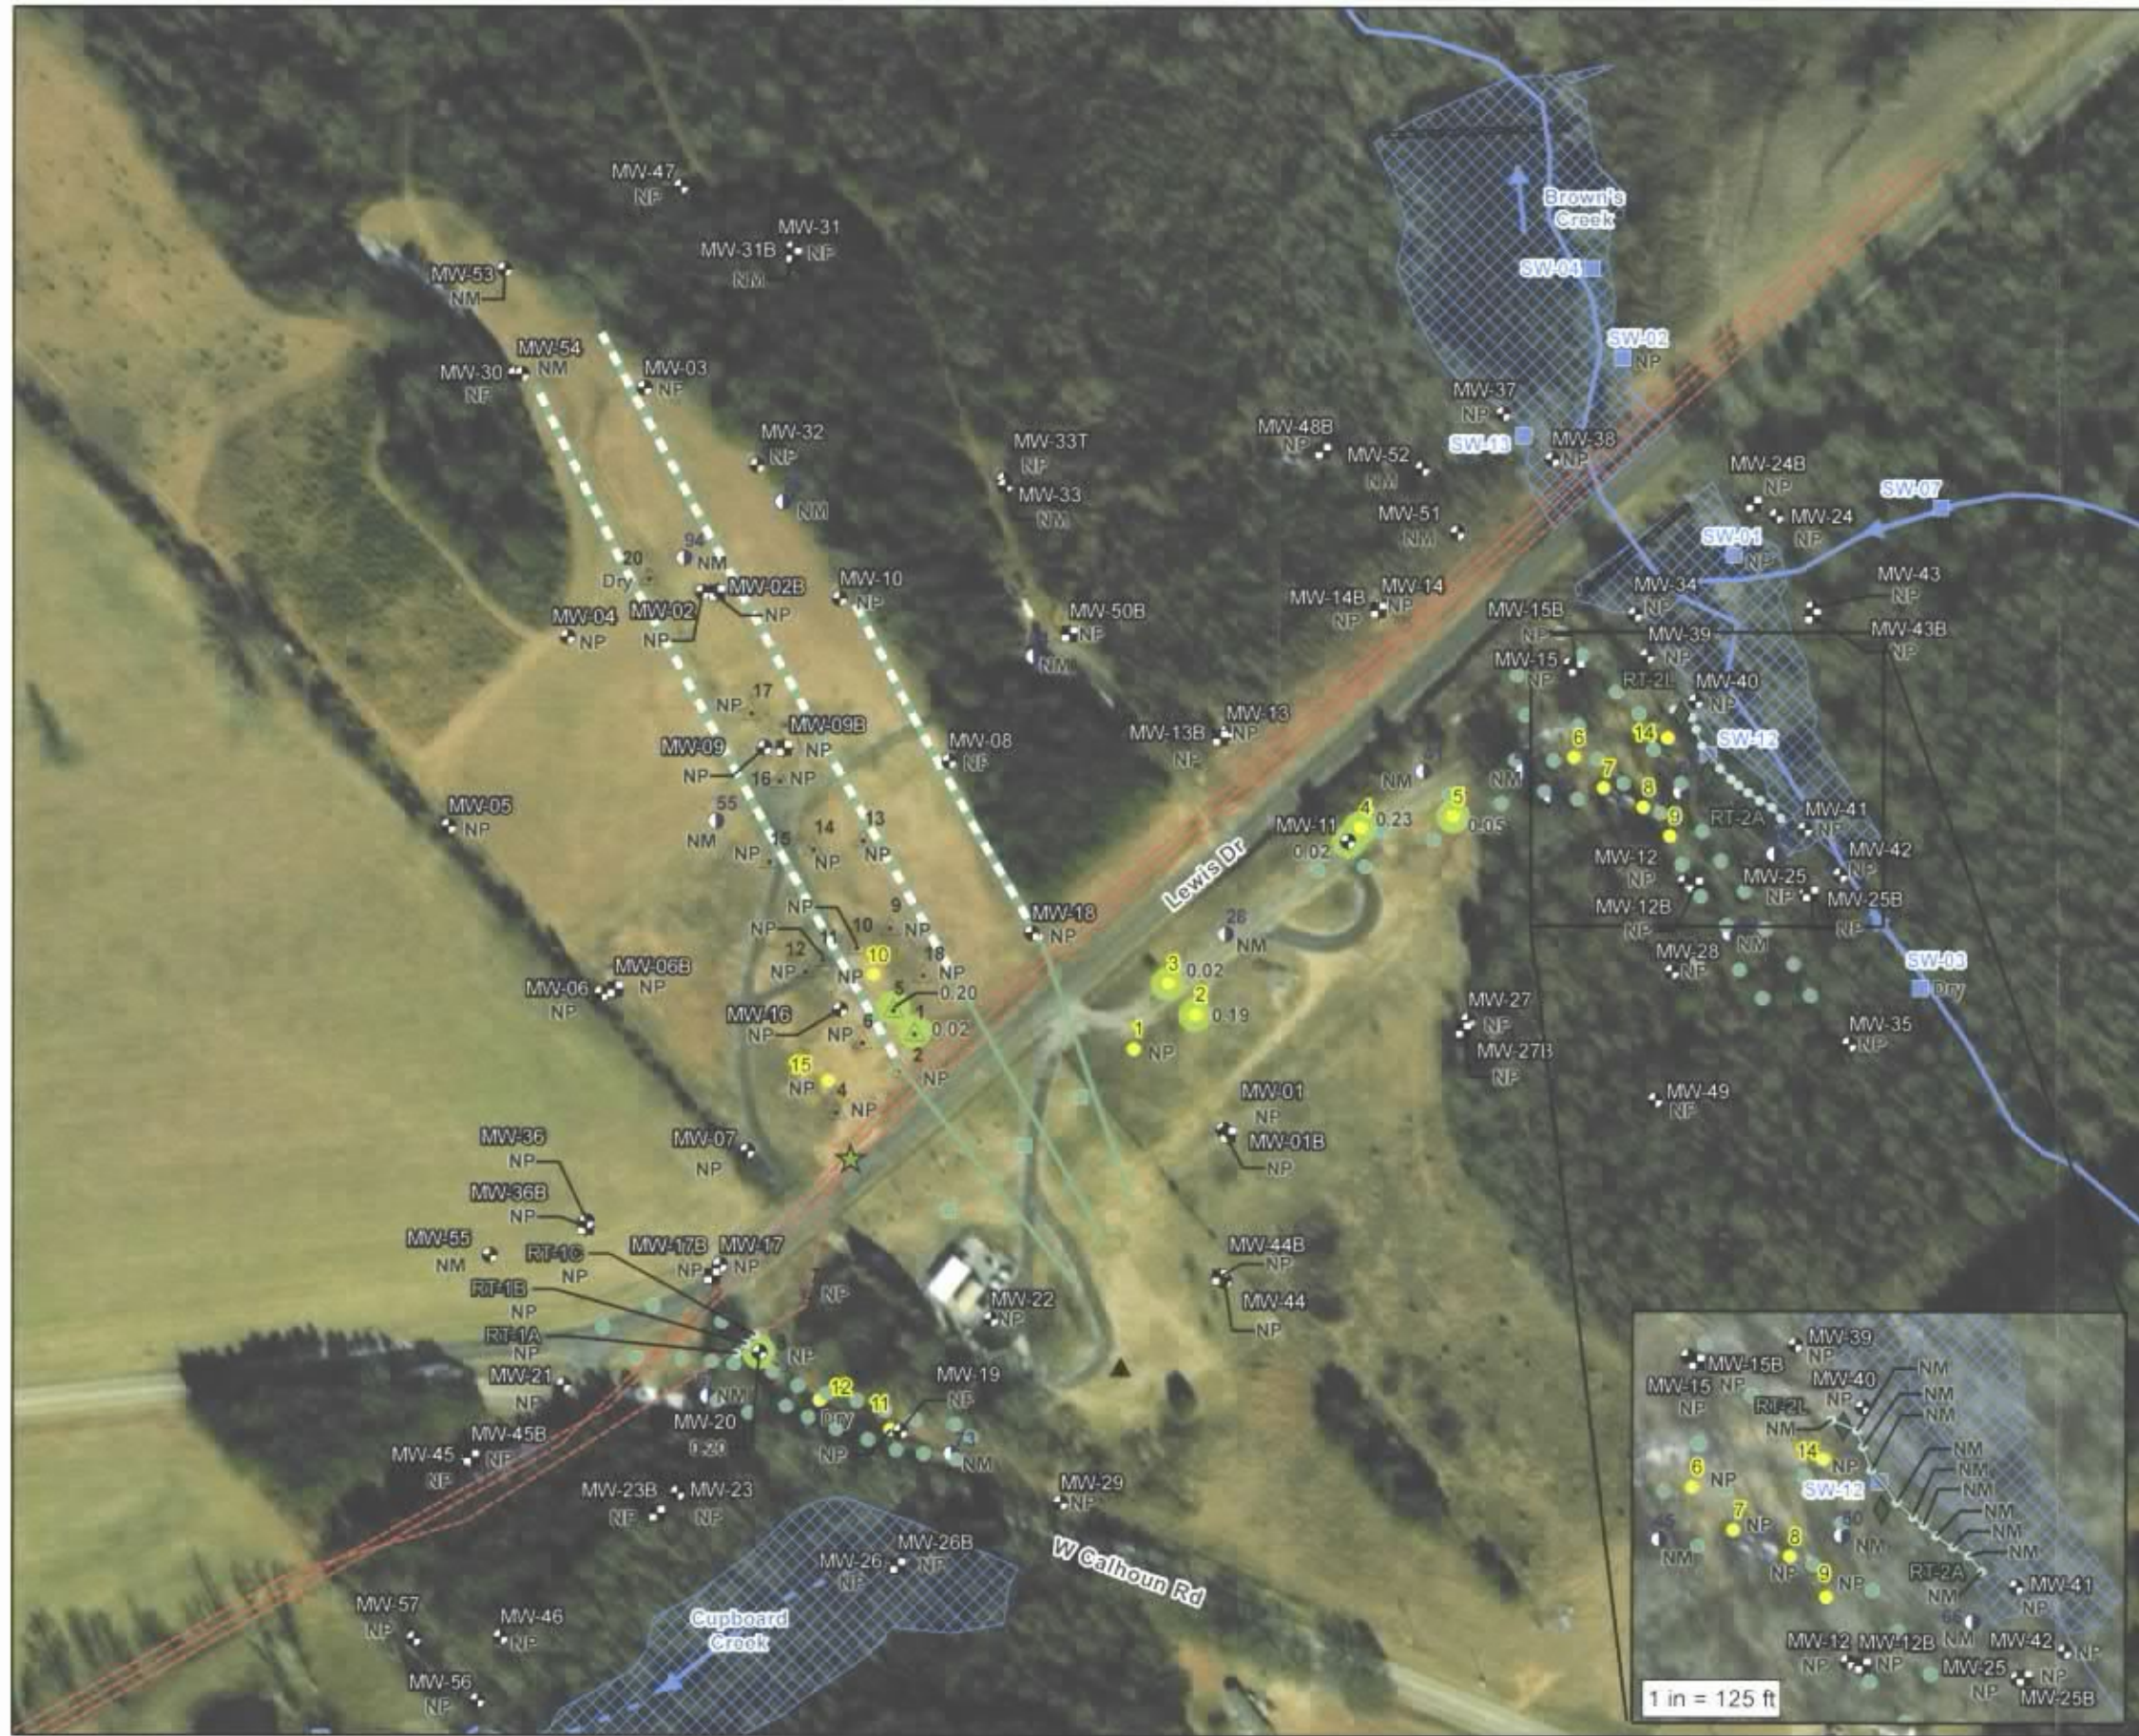
0.02 Product thickness in feet as of 9/16/2019
 NP No product detected
 NM Not measured

Figure 1. Site Features with Measurable Product
 Lewis Drive Remediation Site
 Belton, South Carolina
 Site ID #18693 "Kinder Morgan Belton Pipeline Release"
