CAP - Addendum Revision No. 2

Corrective Action Plan Addendum  
Lewis Drive Remediation Site  
Belton, South Carolina  
Site ID Number 18693  
("Kinder Morgan Belton Pipeline Release")

March 1, 2017 and revised October 12, 2017

**Corrective Action Plan Addendum Revision 2  
Lewis Drive Remediation Site  
Belton, South Carolina  
Site ID Number 18693  
("Kinder Morgan Belton Pipeline Release")**

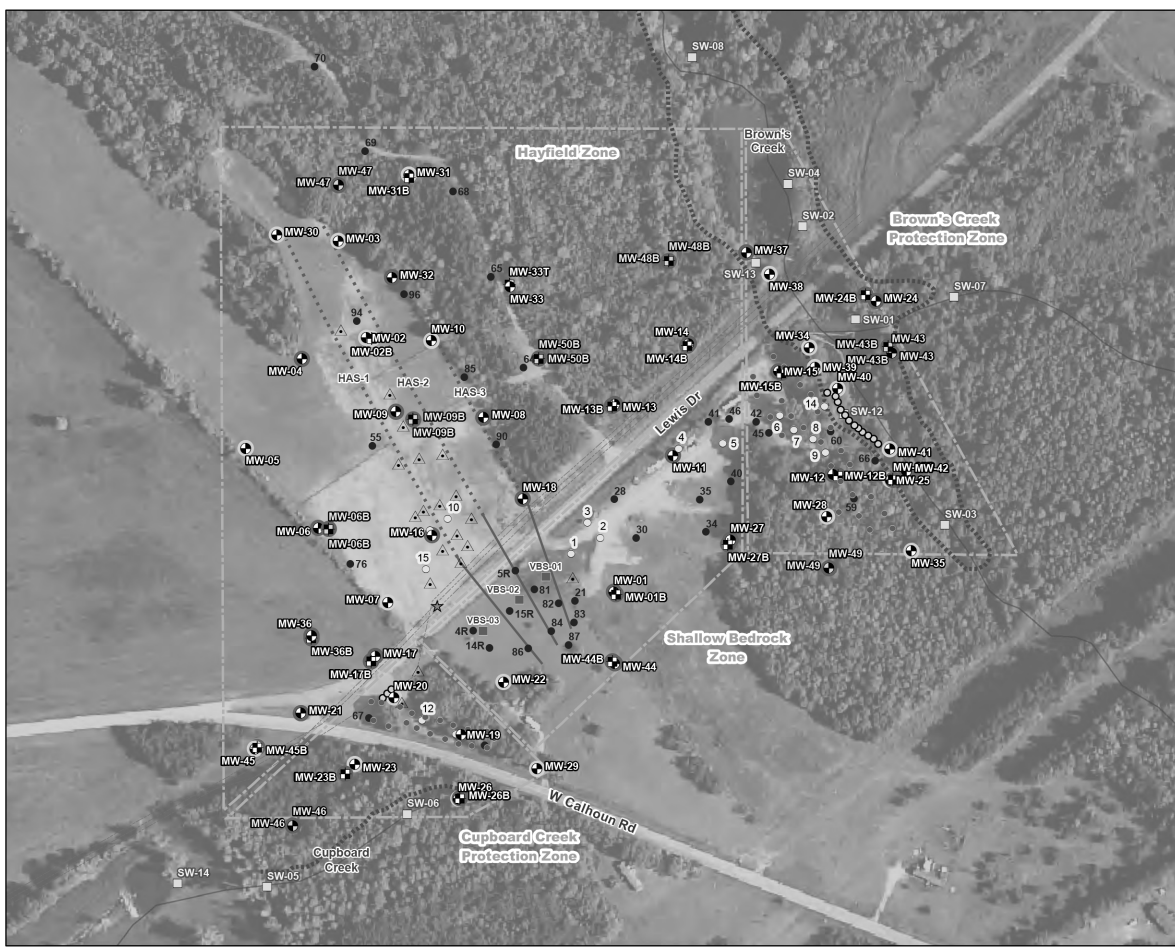
- LEGEND**
- ★ Release Point
  - ⊕ Residuum Monitoring Well
  - ⊕ Bedrock Monitoring Well
  - ⊕ Proposed Shallow Monitoring Well
  - ⊕ Proposed Bedrock Monitoring Well
  - Piezometer
  - △ Recovery Sump
  - Recovery Trench Point
  - Recovery Well (4" diameter)
  - Surface Water Sampling Location
  - Well to be sampled quarterly for Year 1
  - Well to be sampled monthly for Year 1
  - Pipeline
  - Horizontal Air Sparging Well Riser
  - ⋯ Horizontal Air Sparging Well Screen
  - ~ Stream (NHD)
  - ⋯ Inspection Route for Sheen or Distressed Vegetation
  - Remediation Zone

Surface water samples will be collected weekly during startup, monthly for the first 6 months of operations, and quarterly for the following year of operations from each of the 17 locations indicated on Figure 2. As needed, any recommended alterations to the monitoring frequency after the first year will be proposed to SCDHEC and will be summarized in the Annual Report. Since the purpose of the remedial action and the related sampling is to monitor the performance of the measures being implemented, the diffusion aerators in Brown’s Creek will not be shut off prior to sampling. Samples will be analyzed for BTEX and naphthalene using EPA Method 8260B. Samples will be collected in accordance with the QAPP Revision 3 (CH2M, 2017e) and EPA Region 4 protocol.

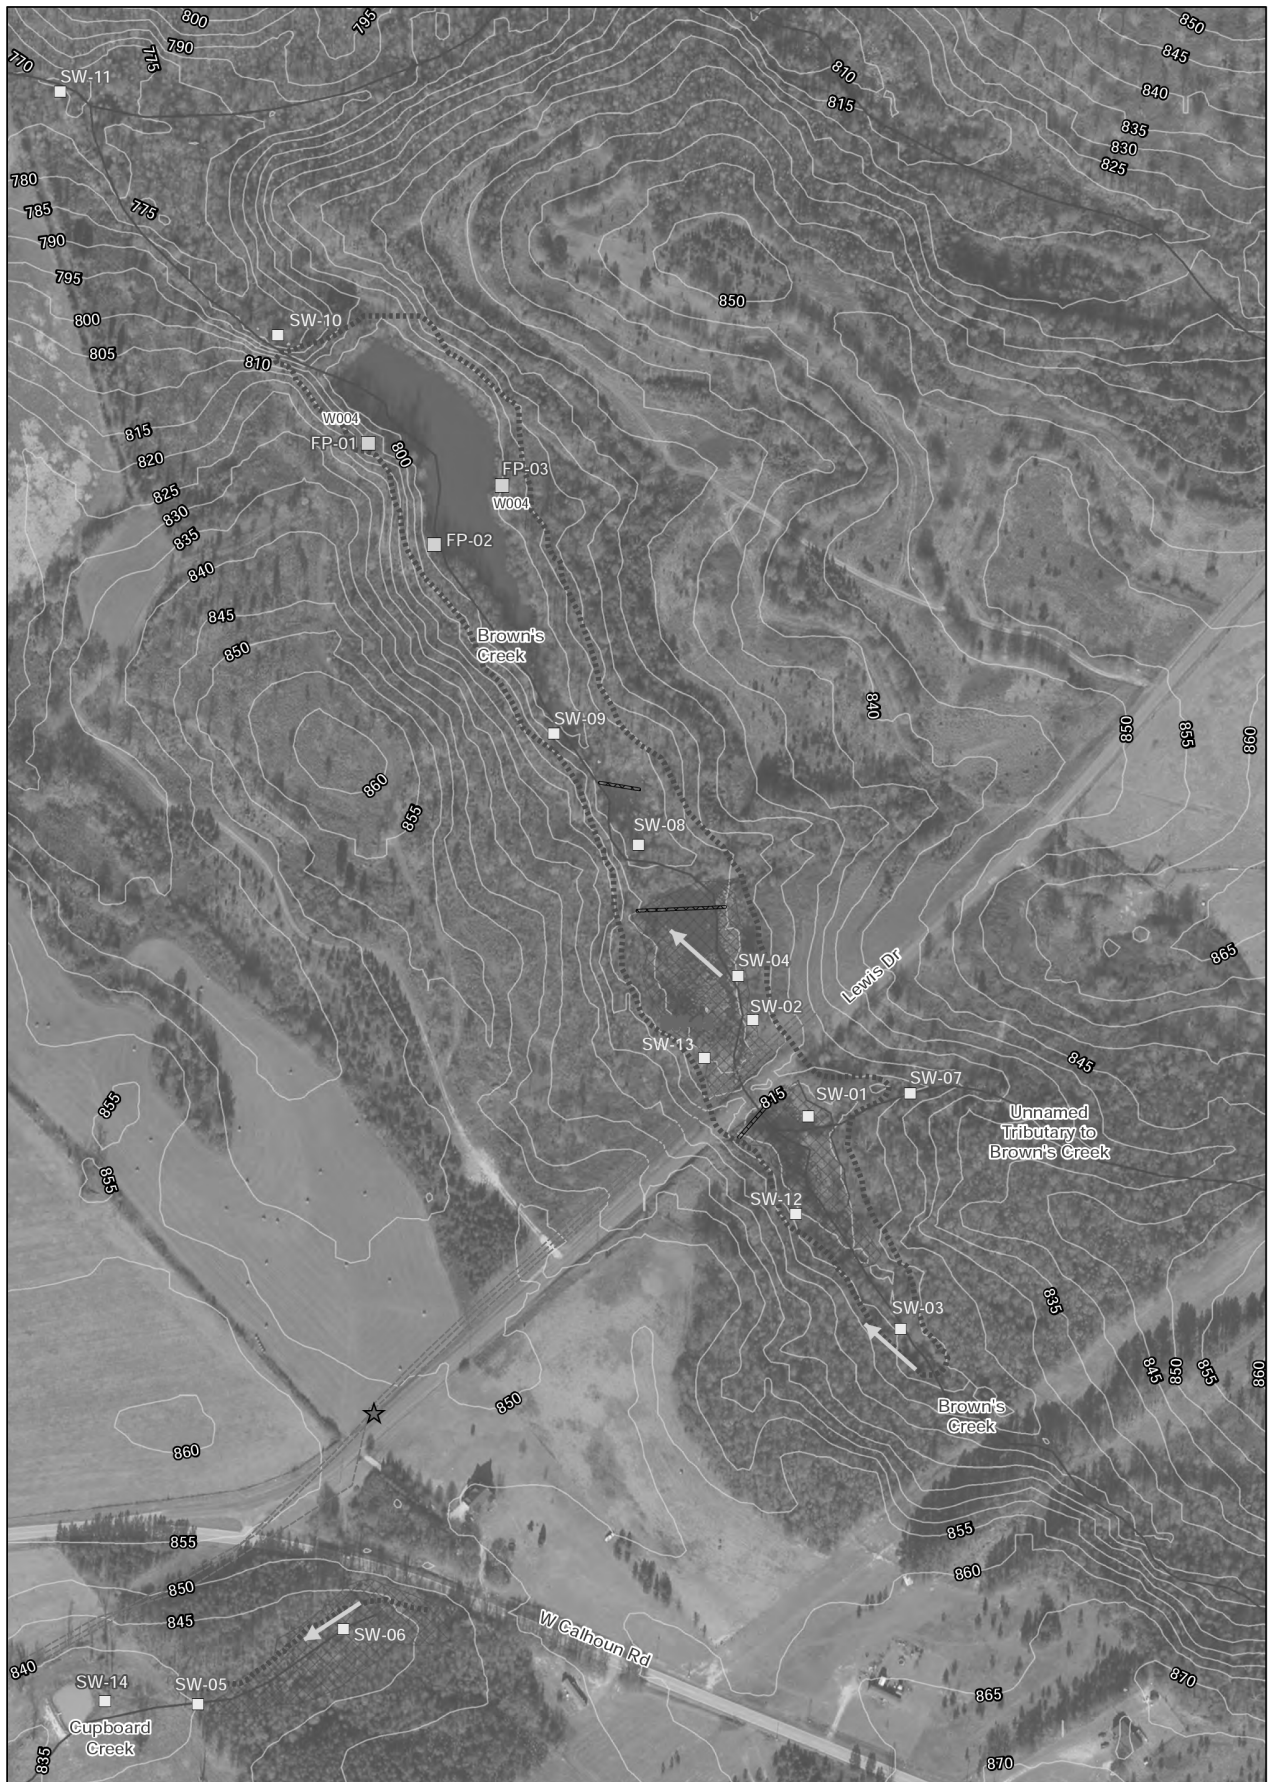
- ★ Release Point
- Surface Water Sampling Location
- ▣ Fish Pond Surface Water Sampling Location
- Pipeline
- Inspection Route for Sheen or Distressed Vegetation
- Flow Direction of Creek
- ~ Topographic Contour (5-foot Interval)
- ~ National Hydrography Dataset Stream
- ⊕ Delineated Wetland
- ⊗ Beaver Dam

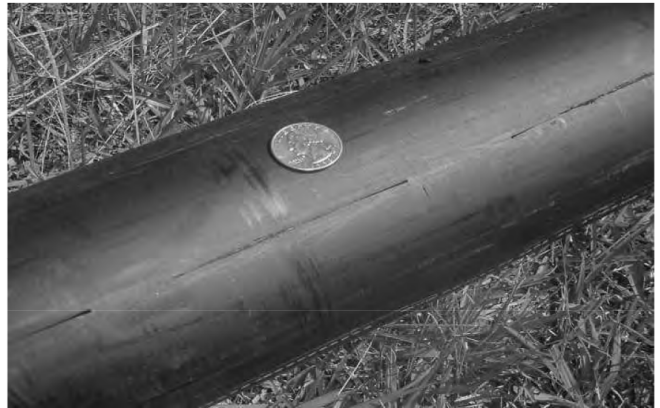
Open area must be designed for site specific conditions, or non uniform flow will result.

**Typical Air Sparge “Screen” (Slotted Pipe):**  
*4” HDPE Pipe, 400 ft Long Slotted Section  
0.020 Inch Wide Slots, <0.5% Open Area*

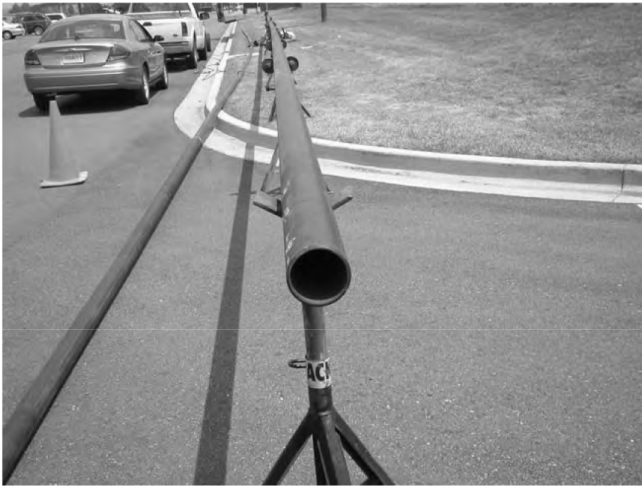
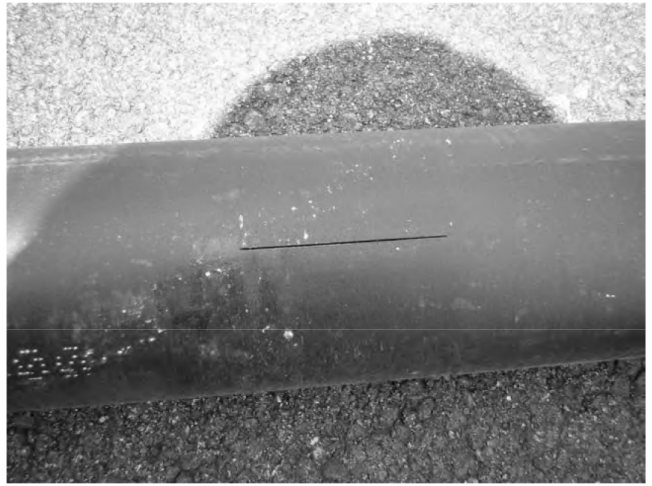
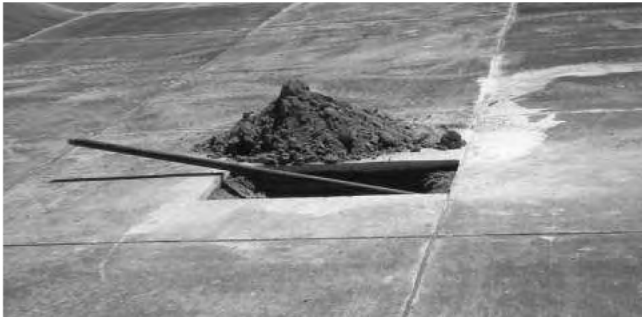
## Case Study 1 – Well Screen

Three-inch diameter steel screen (0.020" inch slot) and casing for the HDD sparge wells.

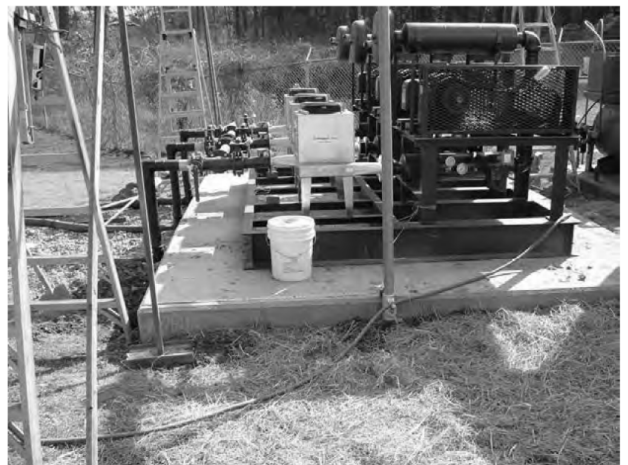
Blower Skid

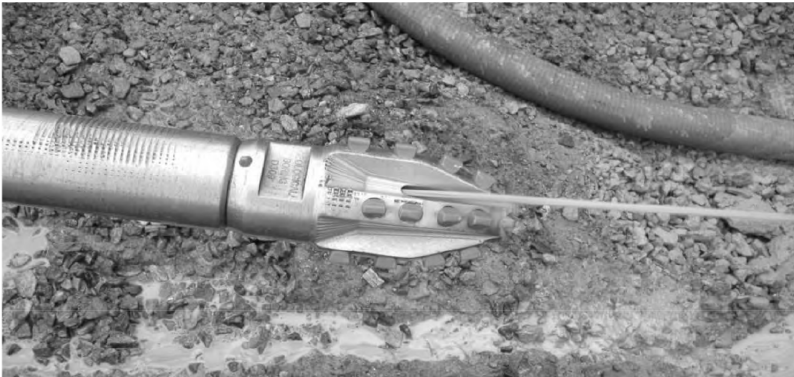
**“All Soils” Spade Bit and  
Mud Jet**

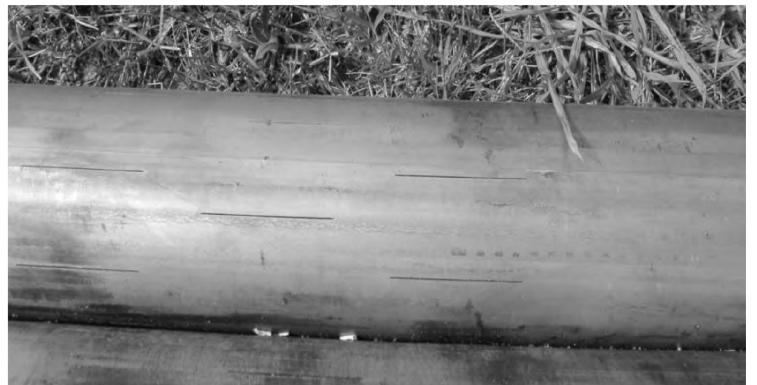
**Longitudinally Slotted  
304 SS Pipe**

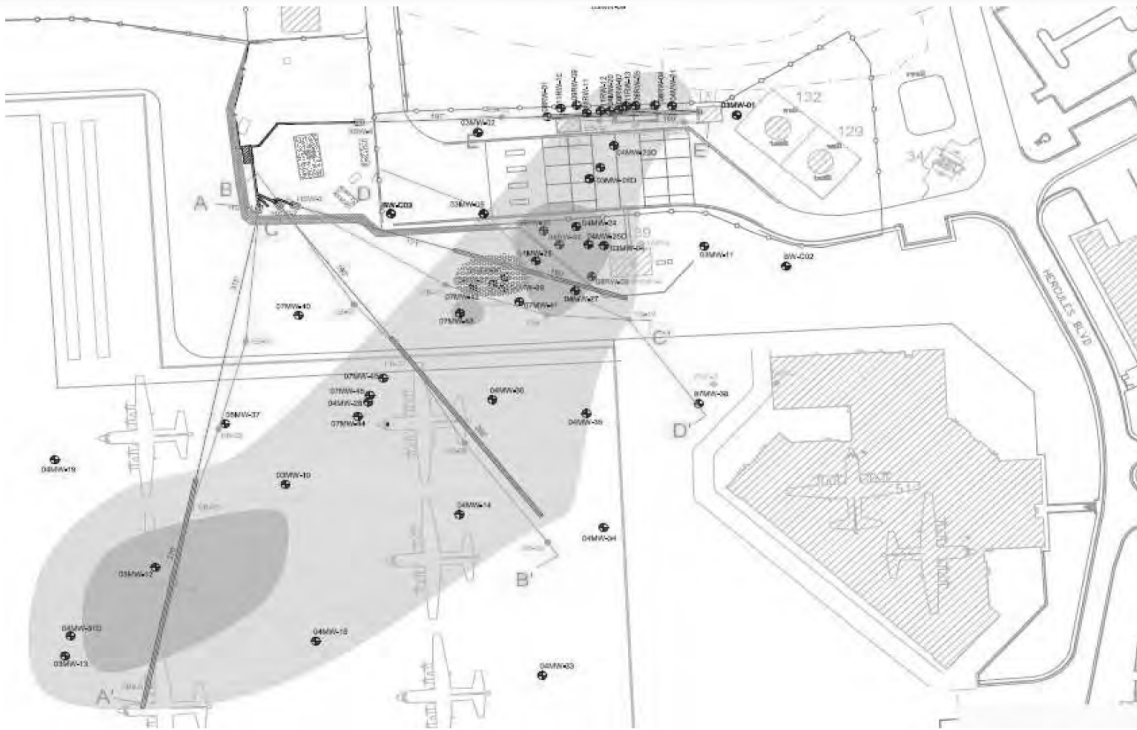
Petroleum Plume. Four Blind End HDPE Sparge Wells, Each ~ 350-600'

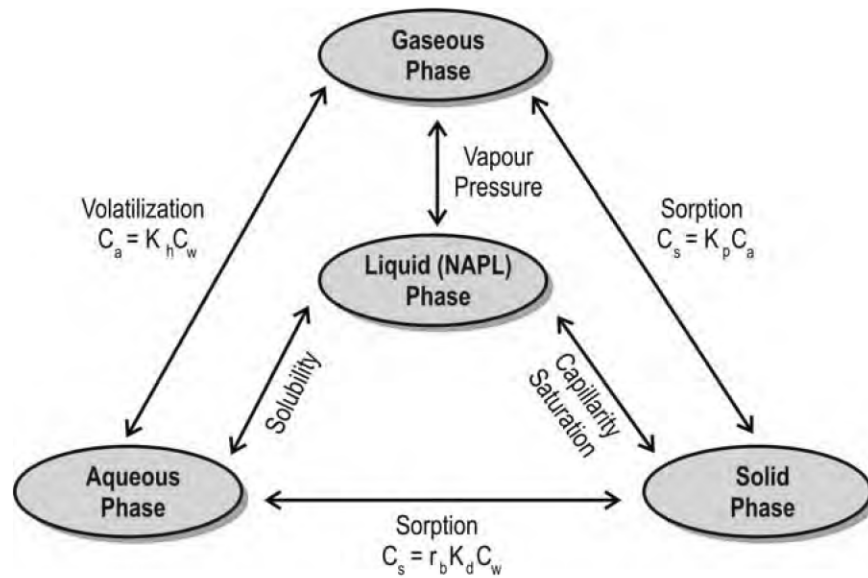
Partitioning of VOCs where:

$C_a$ ,  $C_w$ , and  $C_s$  = concentration of VOC component in air, water and solid;  
 $K_H$  = Henry's constant;  
 $K_p$  = partition coefficient;  
 $K_d$  = distribution coefficient;  
and  $r_b$  = soil bulk density (USACE, 1995)

Partitioning relations can be used to estimate contaminant mass removal rates as a function of time. Raoult's Law, Henry's Law and soil vapour partitioning relations can be used to evaluate partitioning from NAPL, water and soil respectively. Changes in contaminant composition and contaminant retardation also affect estimation of future mass removal rates. As air travel towards an extraction well-screen, contaminants sorb and desorb, volatilise and dissolve, in response to changing soil conditions and contaminant concentrations. Retardation typically describes sorption/desorption processes, however the same equilibrium concepts apply to partitioning from dissolved and NAPL phases. The equilibrium balance between contaminant phases is summarised as follows:

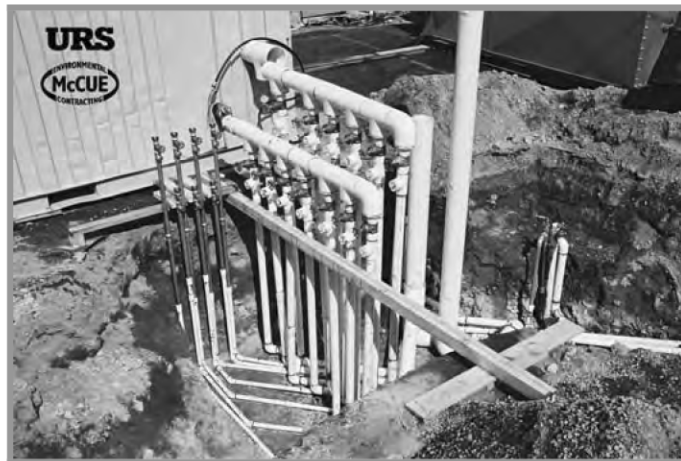
**Photograph 1: AS & SVE manifolds under construction.**

The well network on site was interconnected with 4 and 6-inch diameter buried header lines. These header lines connected to AS and SVE manifolds erected within the fenced compound surrounding the equipment shed. Dedicated AS and SVE lines running to wells on the highway were plumbed together to form the manifolds.

The AS manifolds and AS header line connected at an automated valve and to a 150 cfm sparge compressor. Similarly, the SVE manifolds and SVE header connected at a second automated valve and to a 500 cfm SVE blower and a 500 cfm thermal catalytic oxidizer unit. All system wells, including nested AS wells, nested SVE wells and discrete SVE wells, were designed to be controlled in groups via the automated valves, or individually at the manifolds or at the wellheads by manually turning well-dedicated valves. System wells/wellheads north of the highway remained accessible via 24-inch gasketed, bolt down steel road boxes, while those beneath and south of the highway were buried following connection to the pipeworks.

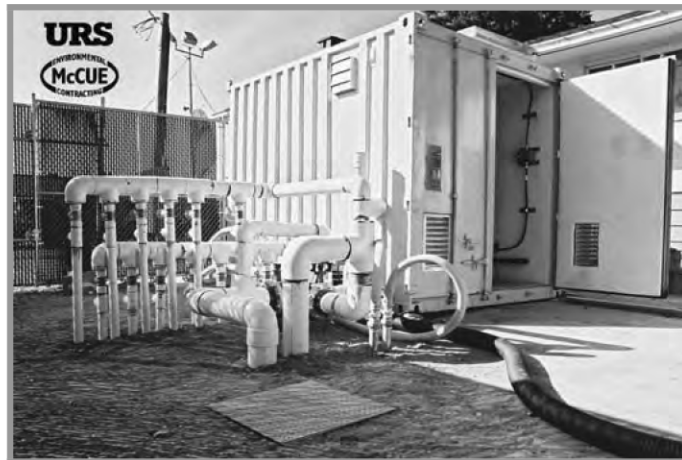
**Photograph 2: Compound including equipment enclosure, SVE manifold, automated valve and piping, header connections and well roadbox.**

- PVC pipe is not rated for compressed air conveyance. As a safety precaution, URS elected to have aboveground (and near surface) sections and the AS manifold constructed of galvanized steel, while wellhead connections and associated buried pipeworks were constructed of Schedule 40 PVC.
- Installing AS and SVE wells as nested pairs saved considerable time and cost during drilling.
- The manifolds permitted system performance monitoring and operation control of wells situated on the highway from a single location within a safe and secure area.

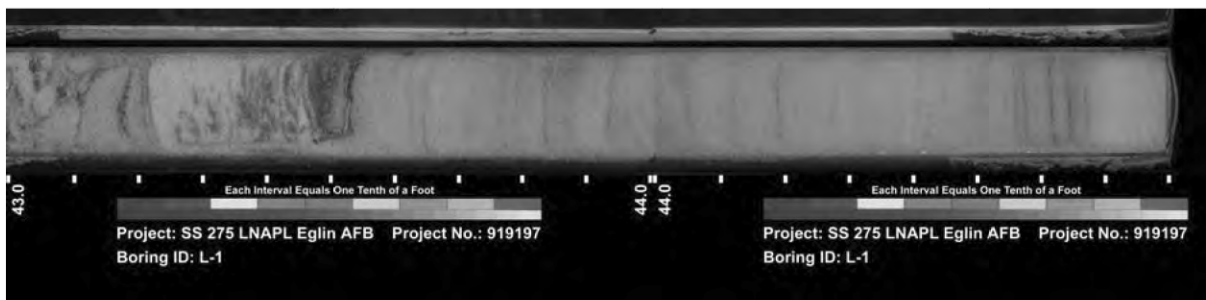
Figure 2  
Digital Photograph of Intact Soil Core Segment

The LNAPL saturations observed at the site were low. They ranged from less than 0.05-percent (non-detect) up to 11-percent by pore volume. The average smear zone saturations at each of the two borings were 0.7 and 0.8-percent by pore volume. In order to account for

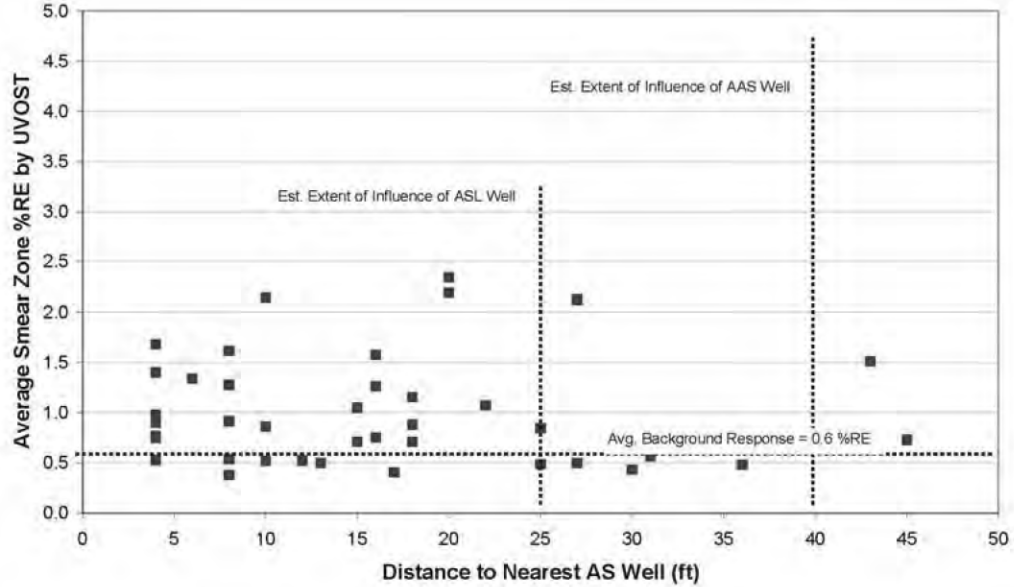
Figure 5  
Correlation of UVOST™ Response with Distance to Nearest air sparging Well

consistent trend in response observed with distance from the air sparging wells. No depletion is observed near and no accumulation is observed at the 25-foot extent of influence of the ASL wells.

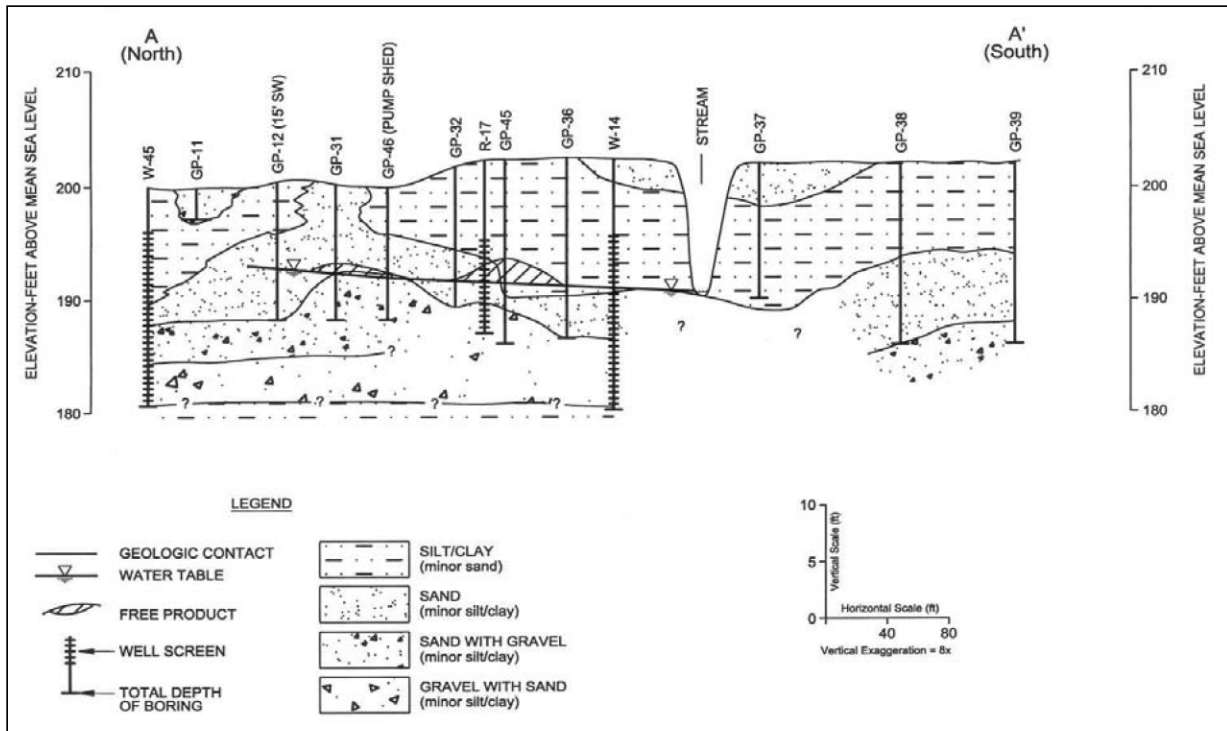
**FIGURE 1. Generalized cross section.**

highly transmissive coarse gravel and sand (Figure 1). The sand and gravel zone averages 10 feet thickness and overlies a sandy-silty-clay semi-confining layer of the Eutaw Aquifer, which occurs at approximately 20 ft bgs. The shallow impacted water table at SS-26 occurs within the sand and gravel zone at 5 to 15 ft bgs, depending on location relative to the tank berms. The average hydraulic conductivity of the Surficial Aquifer is  $4.4 \times 10^{-3}$  cm/sec.

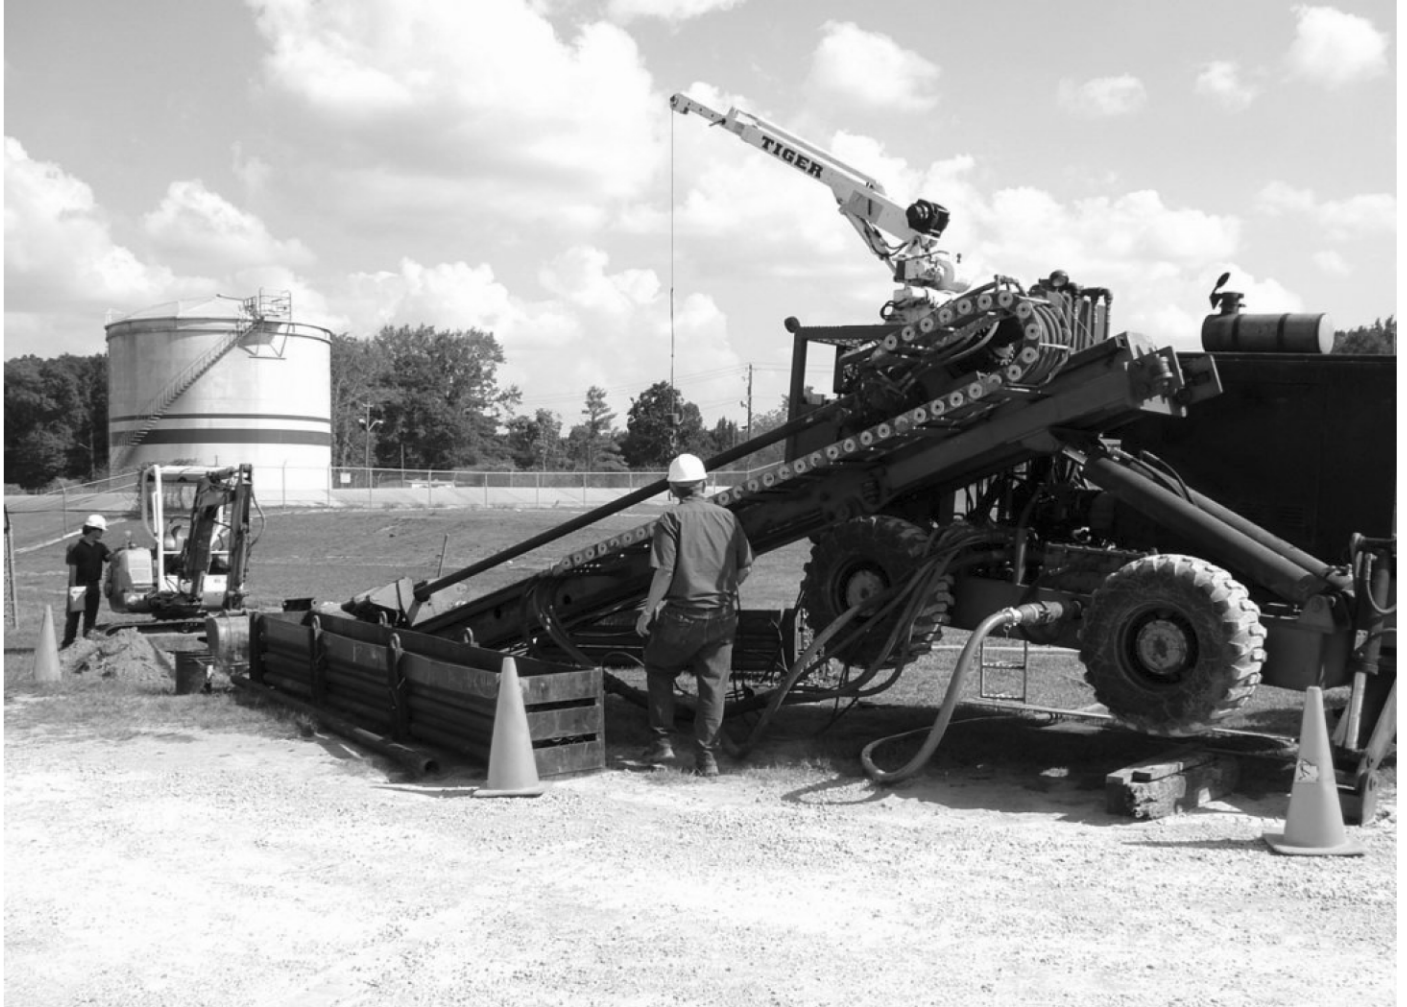
**FIGURE 5. HDD well installation (Tank No. 3 in background) at Site SS-26.**

Use of positive displacement blowers was originally considered appropriate for this application, because of the relatively low hydrostatic head (approximately 10 feet of water). As previously indicated, corrosion of the well slots caused wellhead pressures to increase, from approximately 11 psi to over 14 psi, which is the practical limit of the blowers. Exhaust gas temperatures also exceeded 320°F during the summer months, and most of the air flow had to be vented to the atmosphere to prevent overload conditions. In hindsight, use of a rotary screw compressor would have offered greater operational flexibility.

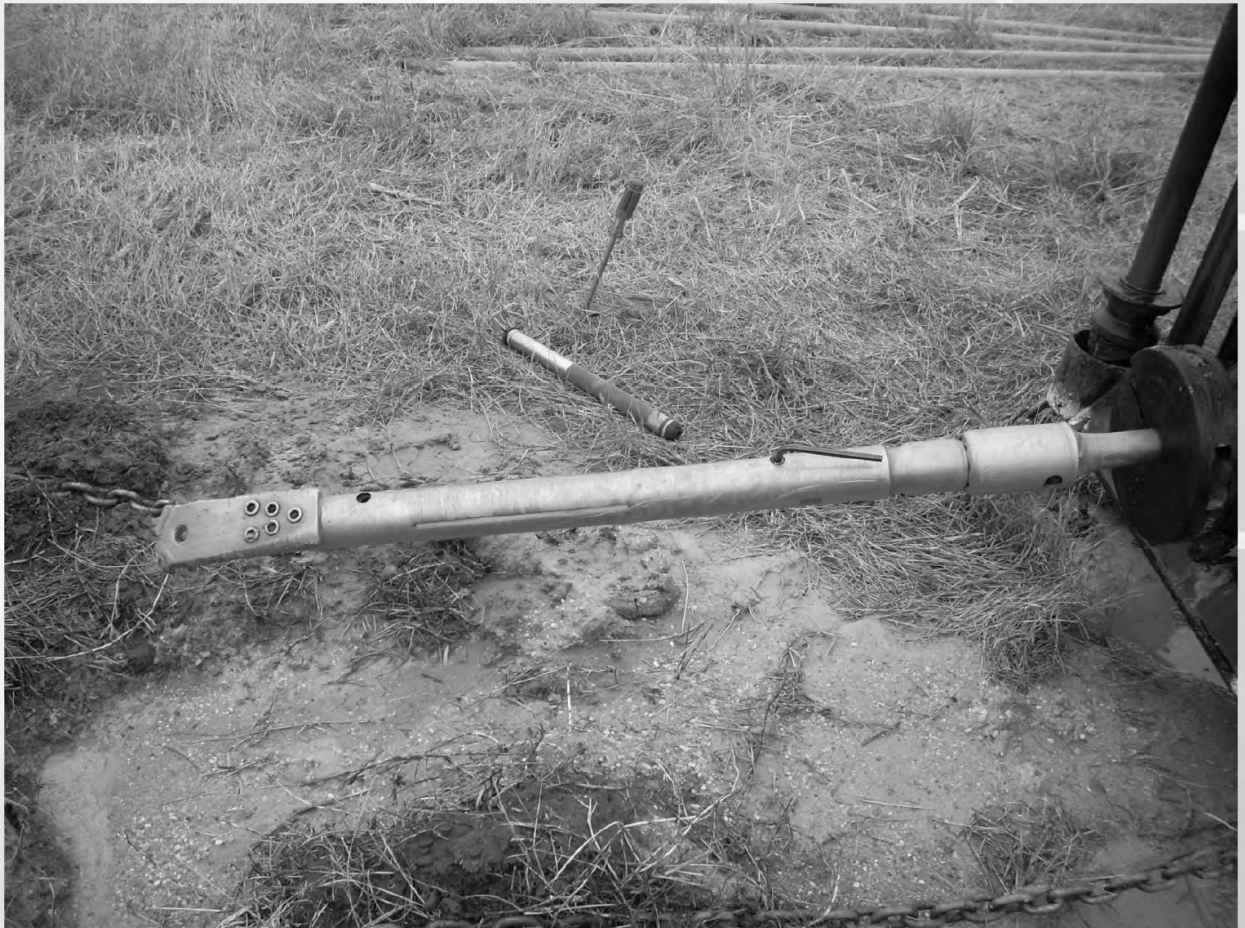
# Walkover Device

- Walkover
  - Use earth's electromagnetic field
  - Battery powered sonde (transmitter): 80 ft depth
- Wireline
  - Create an artificial EM field
  - Sonde with wireline and coil: 200 ft depth
  - ◆ Pro: Cost      Con: Interference
- Gyro Steering Tool (GST)
  - ◆ Cruise missile guidance technology: No depth limit
  - ◆ Pro: No interference    Con: Cost

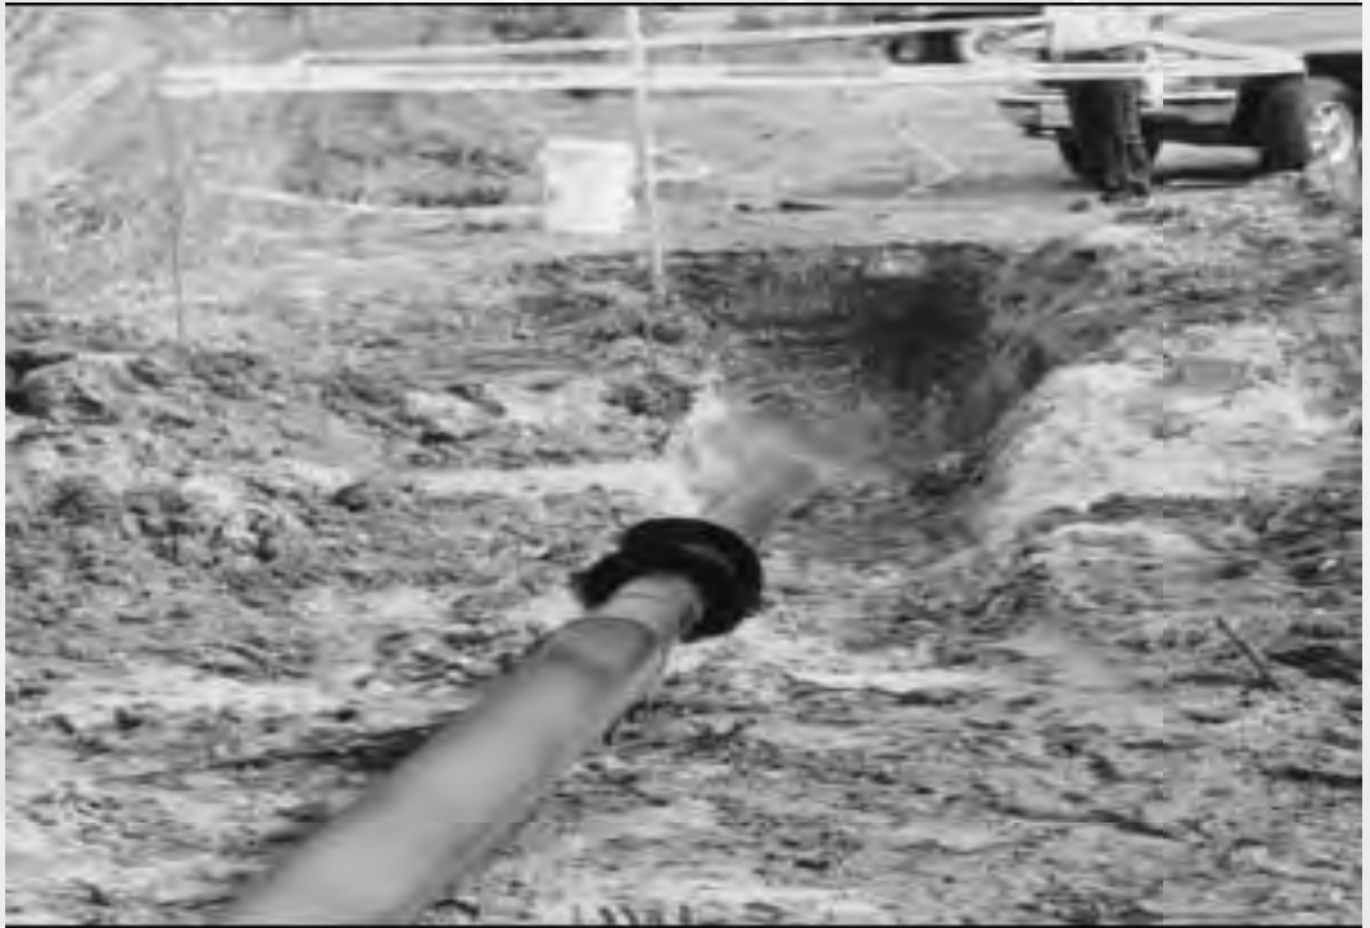
# Well Seal

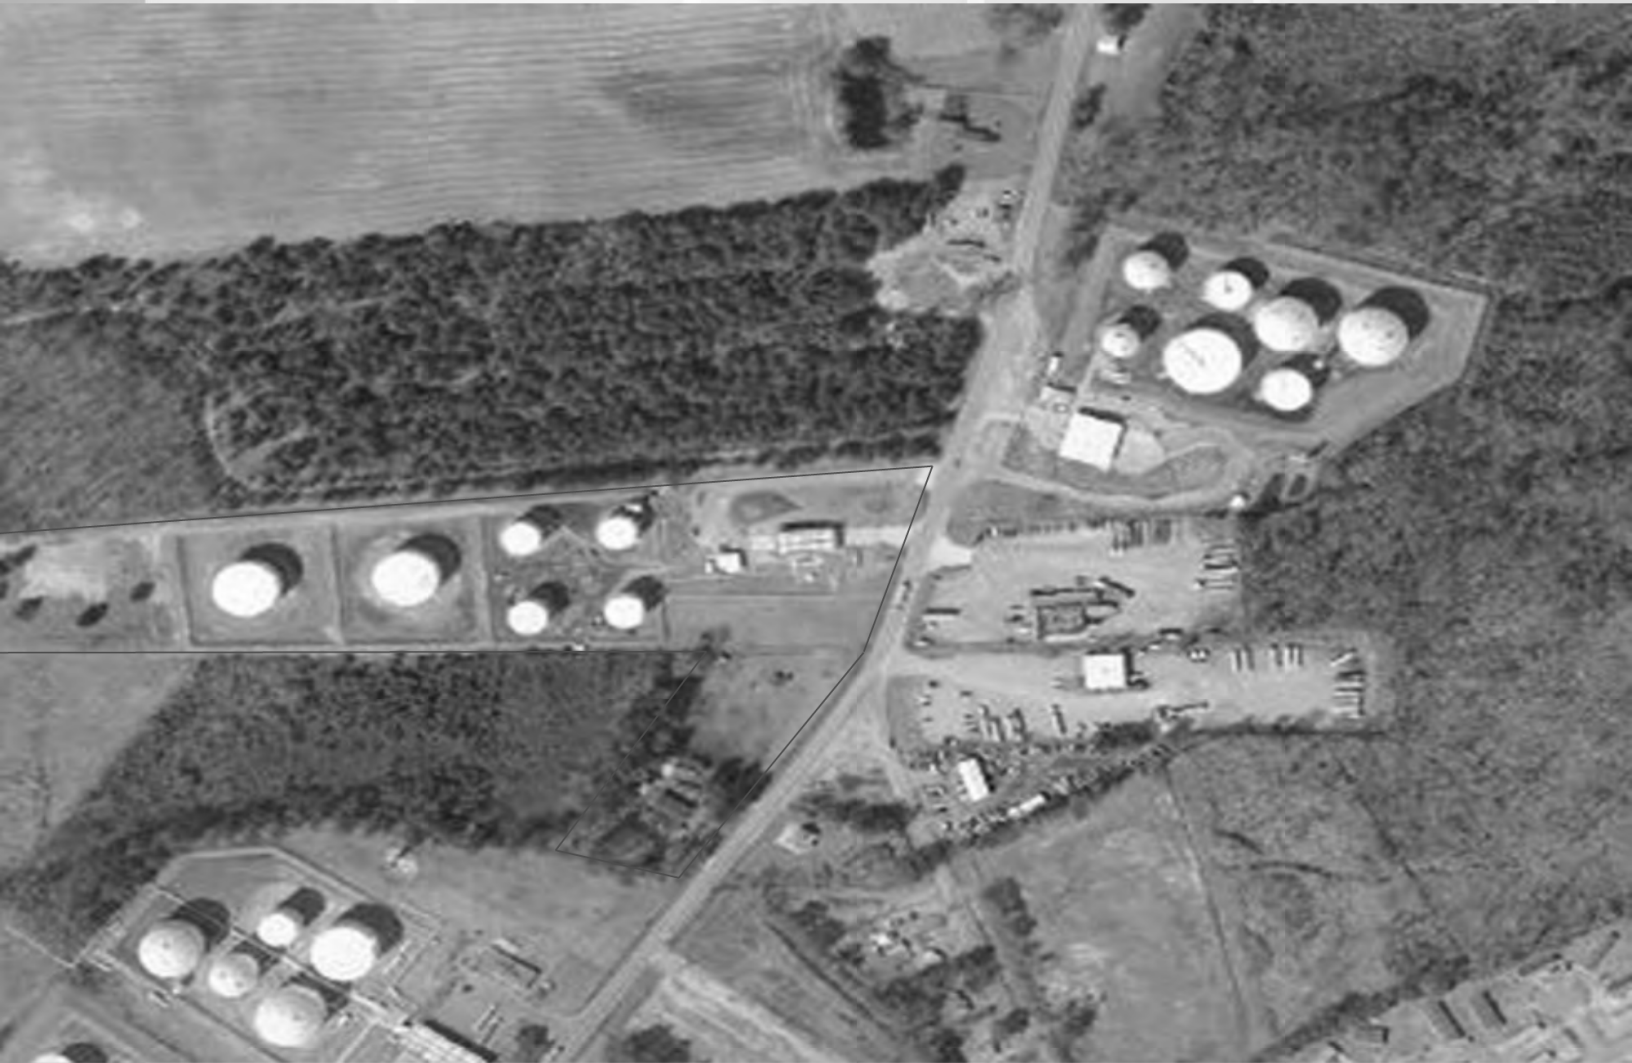
# Selma Terminal - Site Layout

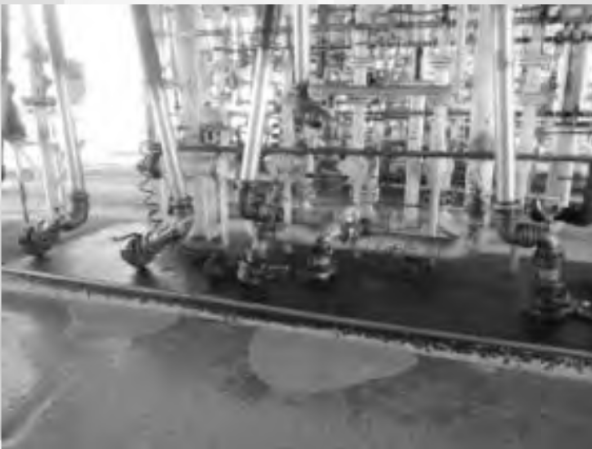
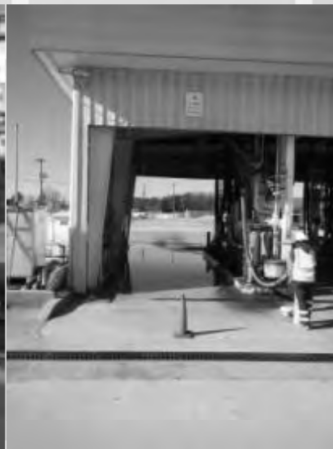
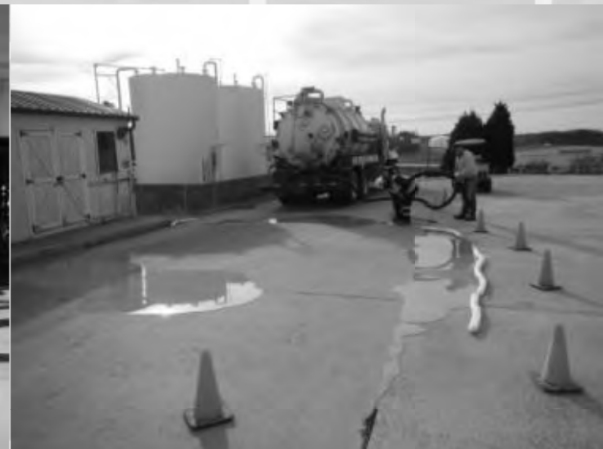
## KMST GN2 – Lessons Learned

- Frac-outs in the loading rack 80 ft away and 50 ft below grade
- Check for secondary pathways, UST/OWS
- Require a Frac-out plan
- Understand drilling parameters

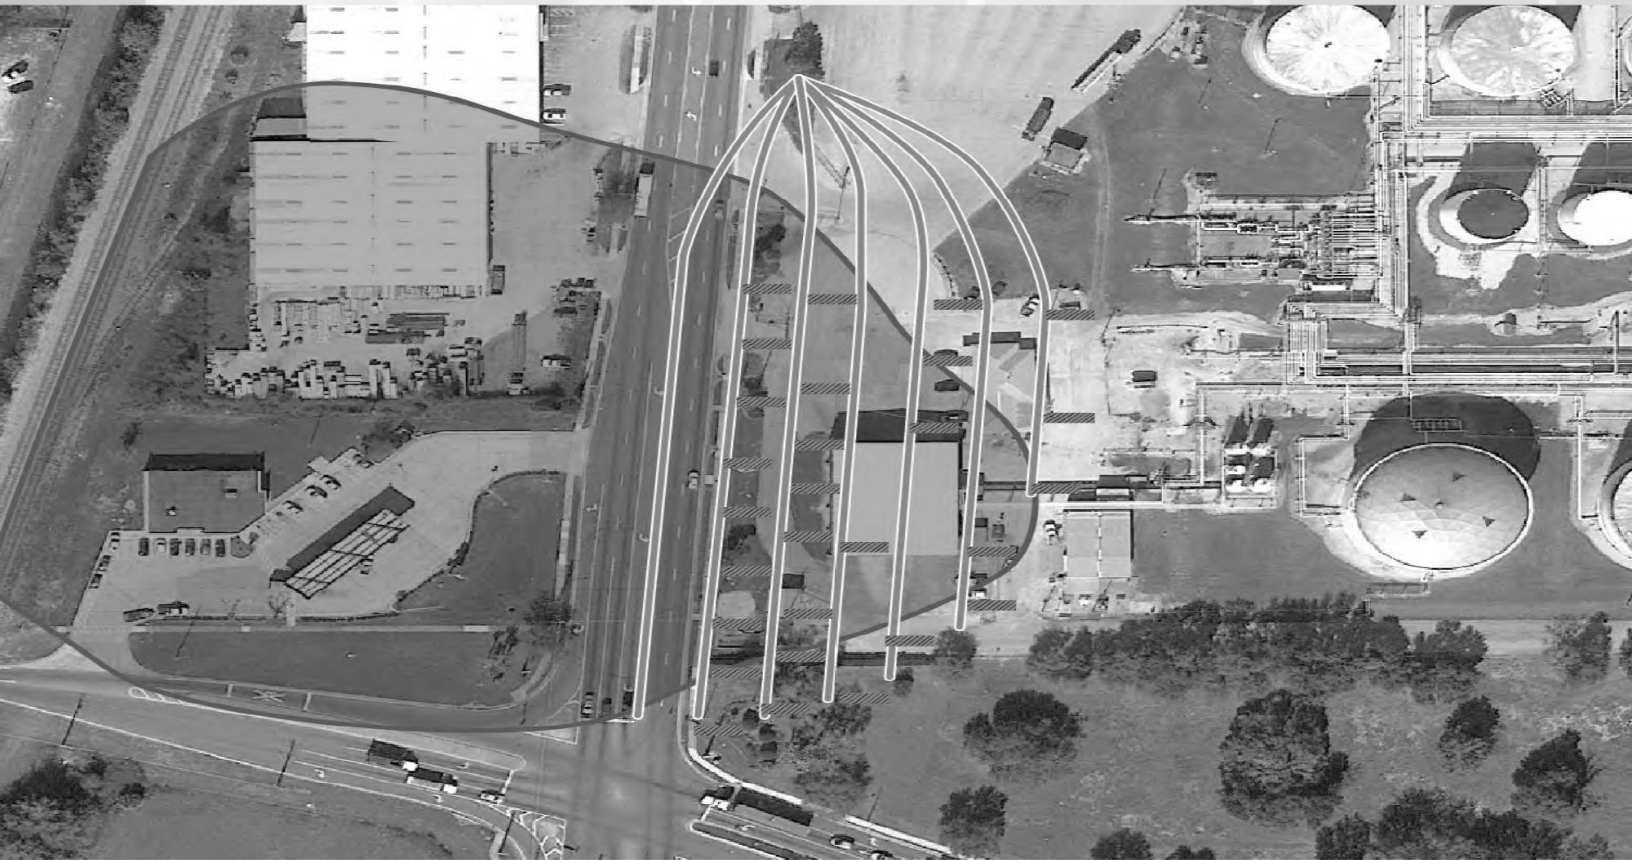
- ◆ 7 air sparge wells to 35 ft depth
- ◆ 3" HDPE blind bores

- Lost communication with drill head under power substation
- Change from walkover to wireline with coil (\$350K)
- Used bentonite based mud for first time

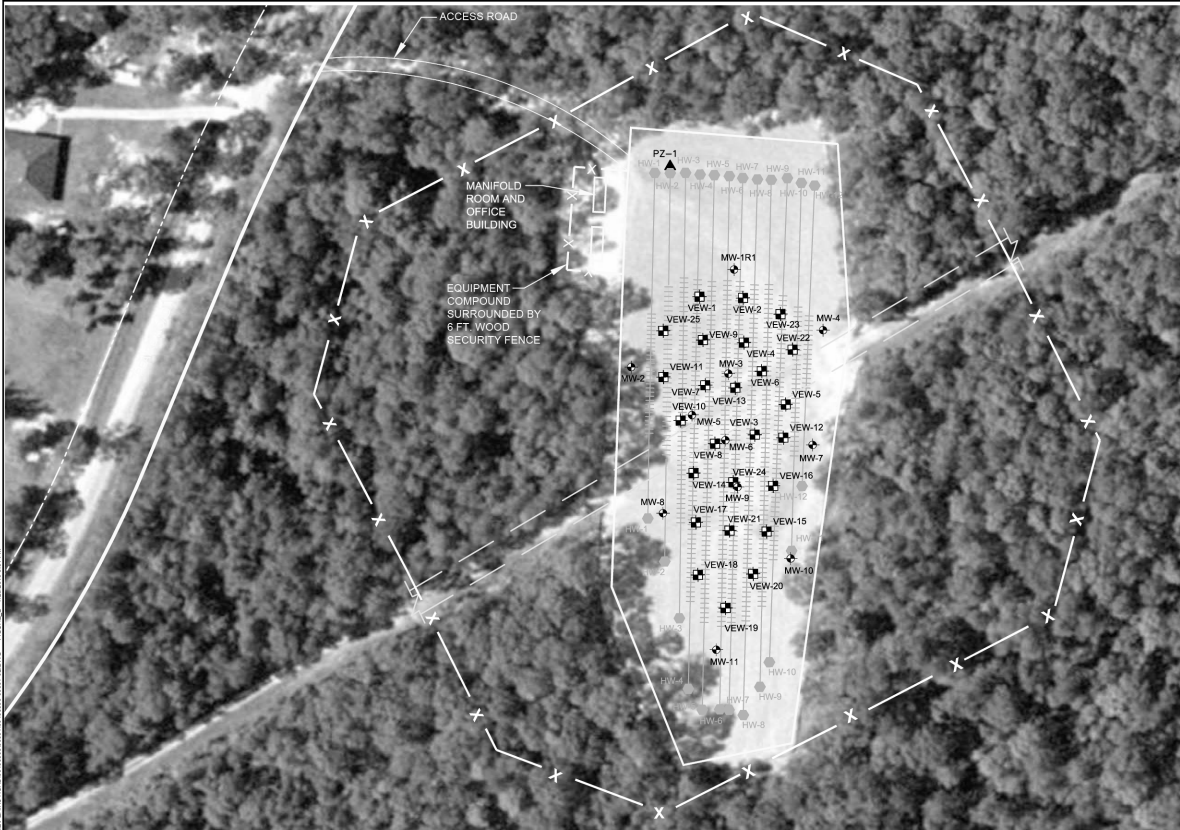
1

- MONITOR WELLS
- HORIZONTAL AIR SPARGE WELLS
- VAPOR EXTRACTION WELLS
- PIEZOMETER
- SCREENED INTERVAL

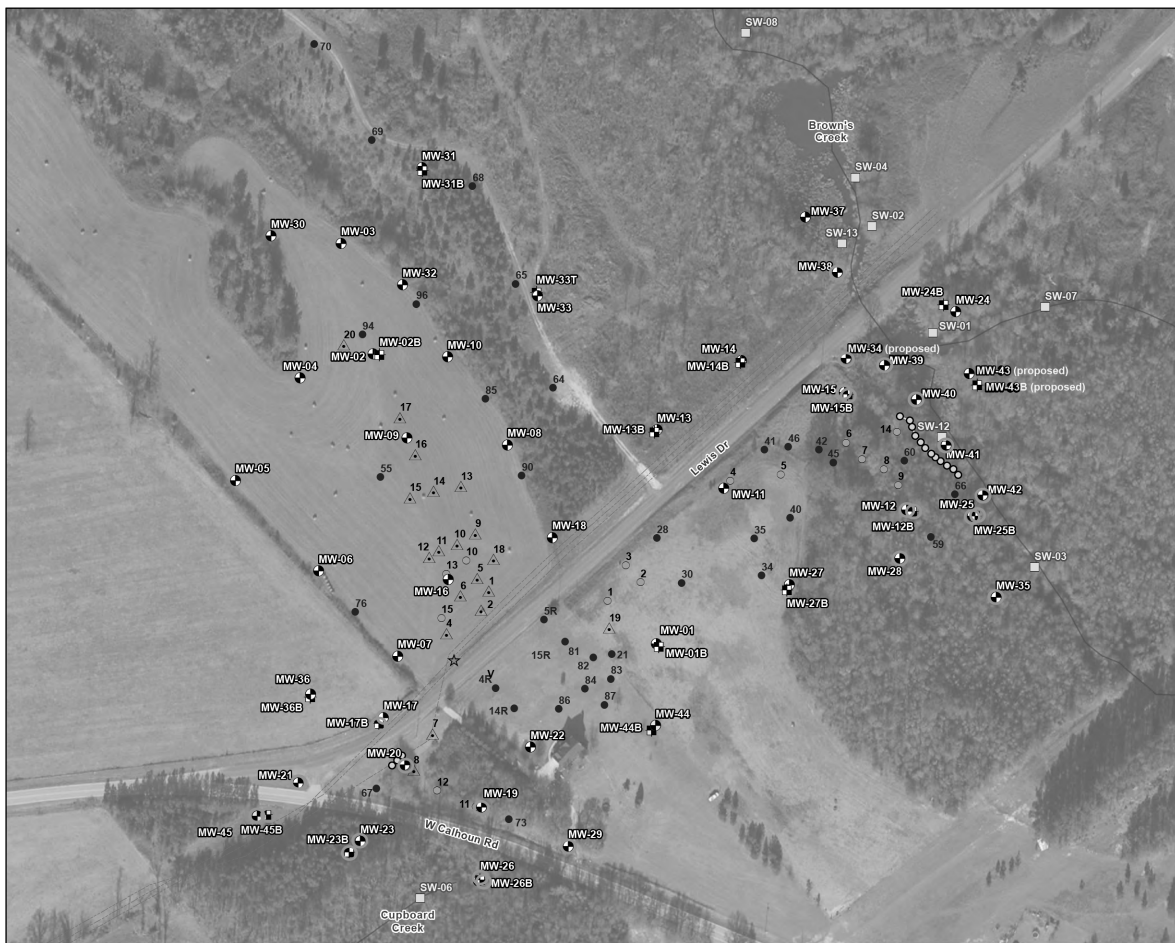
Figure

- LEGEND**
- ★ Release Point
  - New Shallow Monitoring Well (not yet surveyed)
  - New Bedrock Monitoring Well (not yet surveyed)
  - ⊕ Residuum Monitoring Well
  - ⊖ Bedrock Monitoring Well
  - Piezometer ("R" indicates Replacement)
  - △ Recovery Sump
  - Recovery Trench Point
  - Recovery Well (4" diameter)
  - Surface Water Sampling Location
  - Monitoring Wells to be sampled weekly during startup
  - Pipeline
  - Recovery Trench
  - Stream (NHD)
  - Horizontal Air Sparging Well Riser (not yet surveyed)
  - Horizontal Air Sparging Well Screen (not yet surveyed)

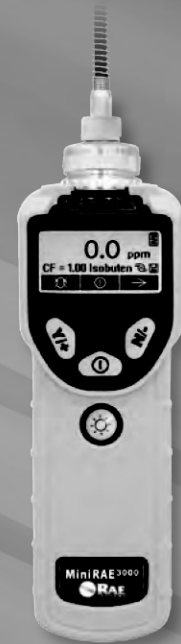
# MiniRAE 3000

Portable Handheld VOC Monitor

The MiniRAE 3000 is a comprehensive handheld VOC (Volatile Organic Compound) monitor that uses a third-generation patented PID technology to accurately measure more ionizable chemicals than any other device on the market. It provides full-range measurement from 0 to 15,000 ppm of VOCs.

The MiniRAE 3000 has a built-in wireless modem that allows real-time data connectivity with the ProRAE Guardian command center located up to 2 miles (3 km) away through a Bluetooth connection to a RAELink 3\* portable modem or optionally via Mesh Network.

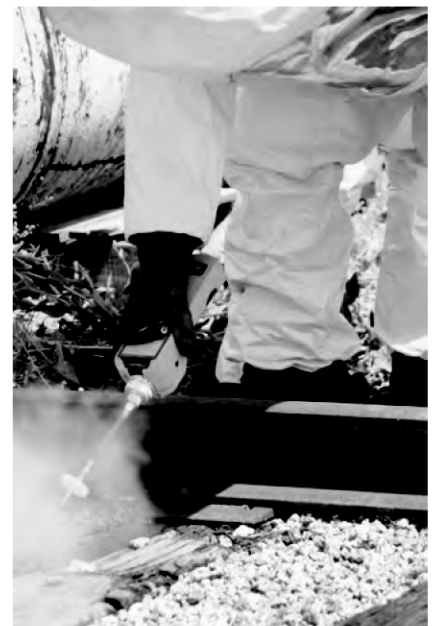
Workers can quickly measure VOCs and wirelessly transmit data via Bluetooth or optional Mesh radio.
