CAP - Addendum Revision No. 2

Corrective Action Plan Addendum  
Lewis Drive Remediation Site  
Belton, South Carolina  
Site ID Number 18693  
("Kinder Morgan Belton Pipeline Release")

March 1, 2017 and revised October 12, 2017

**Corrective Action Plan Addendum Revision 2  
Lewis Drive Remediation Site  
Belton, South Carolina  
Site ID Number 18693  
("Kinder Morgan Belton Pipeline Release")**

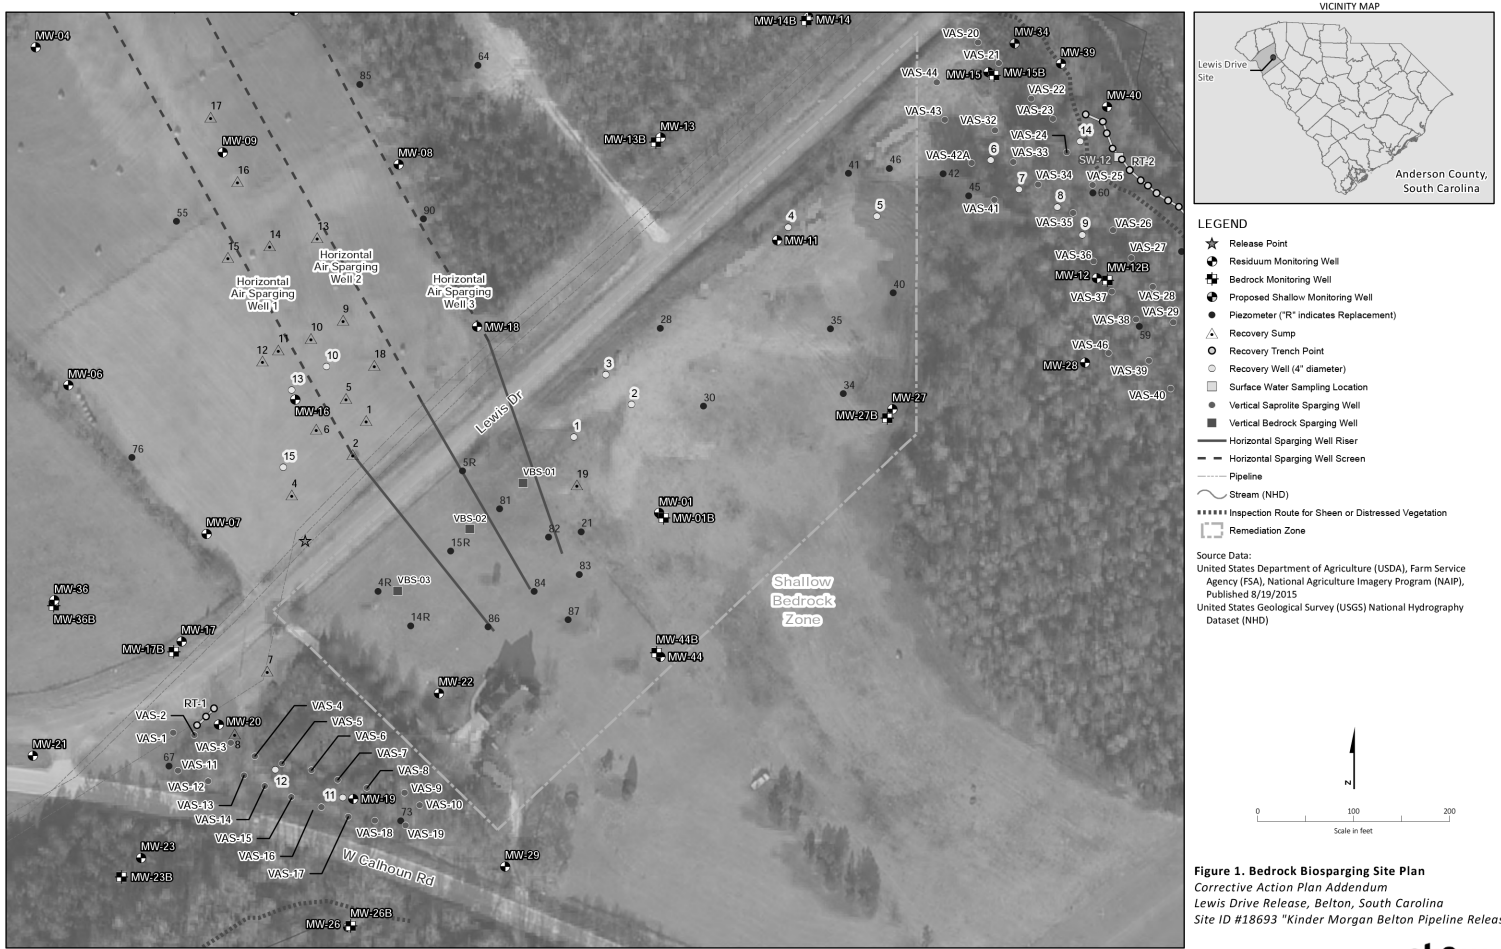
Figure

\\CANOPUS\GROUPS\GIS\00\_PROJ\KINDER\_MORGAN\654558LEWISDR\_ER\GIS\WAPS\2017\_04\_11\_FIGURE1\_BEDROCK\_BIOSPARGE\_SITE\_PLAN.MXD AUTHOR: AG 4/12/2017

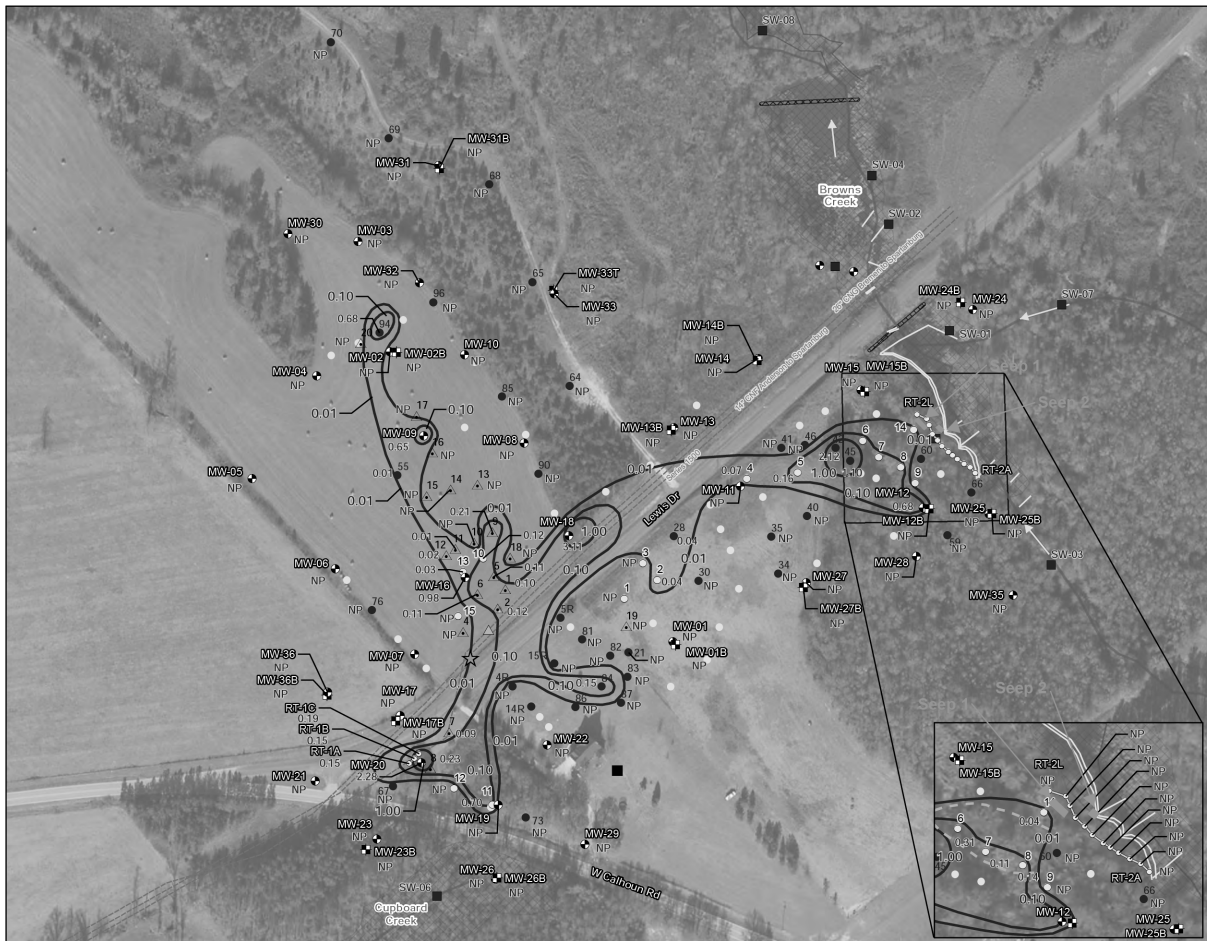
\\sanopus\Groups\GIS\00\_Proj\W\Kinder\_Morgan\654558\LewisDr\_ER\GIS\Maps\2016\_SiteAssessment\Figure2\_Site\_topography.mxd A601798 7/11/2016

- LEGEND**
- ★ Release Point
  - ⬮ Monitoring Well
  - ⬮ Bedrock Monitoring Well
  - △ Recovery Sump
  - ▲ Abandoned Recovery Sump
  - Piezometer ("R" indicates Replacement)
  - Abandoned Temporary Piezometer
  - Recovery Well (4" diameter)
  - Surface Water Sampling Location
  - Septic Tank
  - Recovery Trench Point
  - Recovery Trench
  - Recovery Water Flow Direction
  - Pipeline
  - Soft Boom
  - Hard Boom
  - ~ Interpreted Product Thickness base on 5/06/2016 and 5/10/2016 data
  - ~ Stream (NHD)
  - ▨ Delineated Wetland
  - ▨ Beaver Dam
  - Detail Area
  - 0.04 Product Thickness in feet as of 5/06/2016 and 5/10/16.
  - NP No Product detected

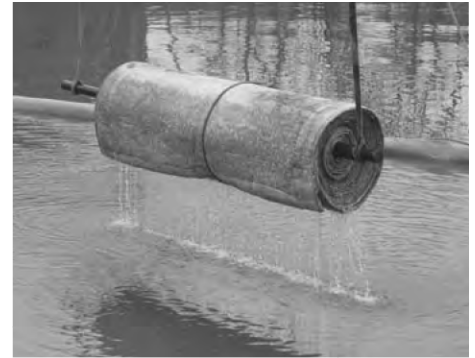
- REACTIVE CORE MAT™ GAC provides a reactive material that treats contaminants which are carried by advective or diffusive flow.
- Reactive cap allows for thinner cap thickness than a traditional sand cap.
- Geotextiles provide stability and physical isolation of contaminants.

REACTIVE CORE MAT™ GAC is designed to provide a simple method of placing active materials into subaqueous sediment caps.
