SITE ASSESSMENT,
REMEDICATION &
REVITALIZATION

**Subject: Injection Completion Update
Auriga, Spartanburg Facility
BoW Site ID# 00225, VCC 13-5841-RP
AECOM Project No. 60280417**

Table 1
Injection Summary
June 2014
Auriga Spartanburg Facility
AECOM Project No. 60280417

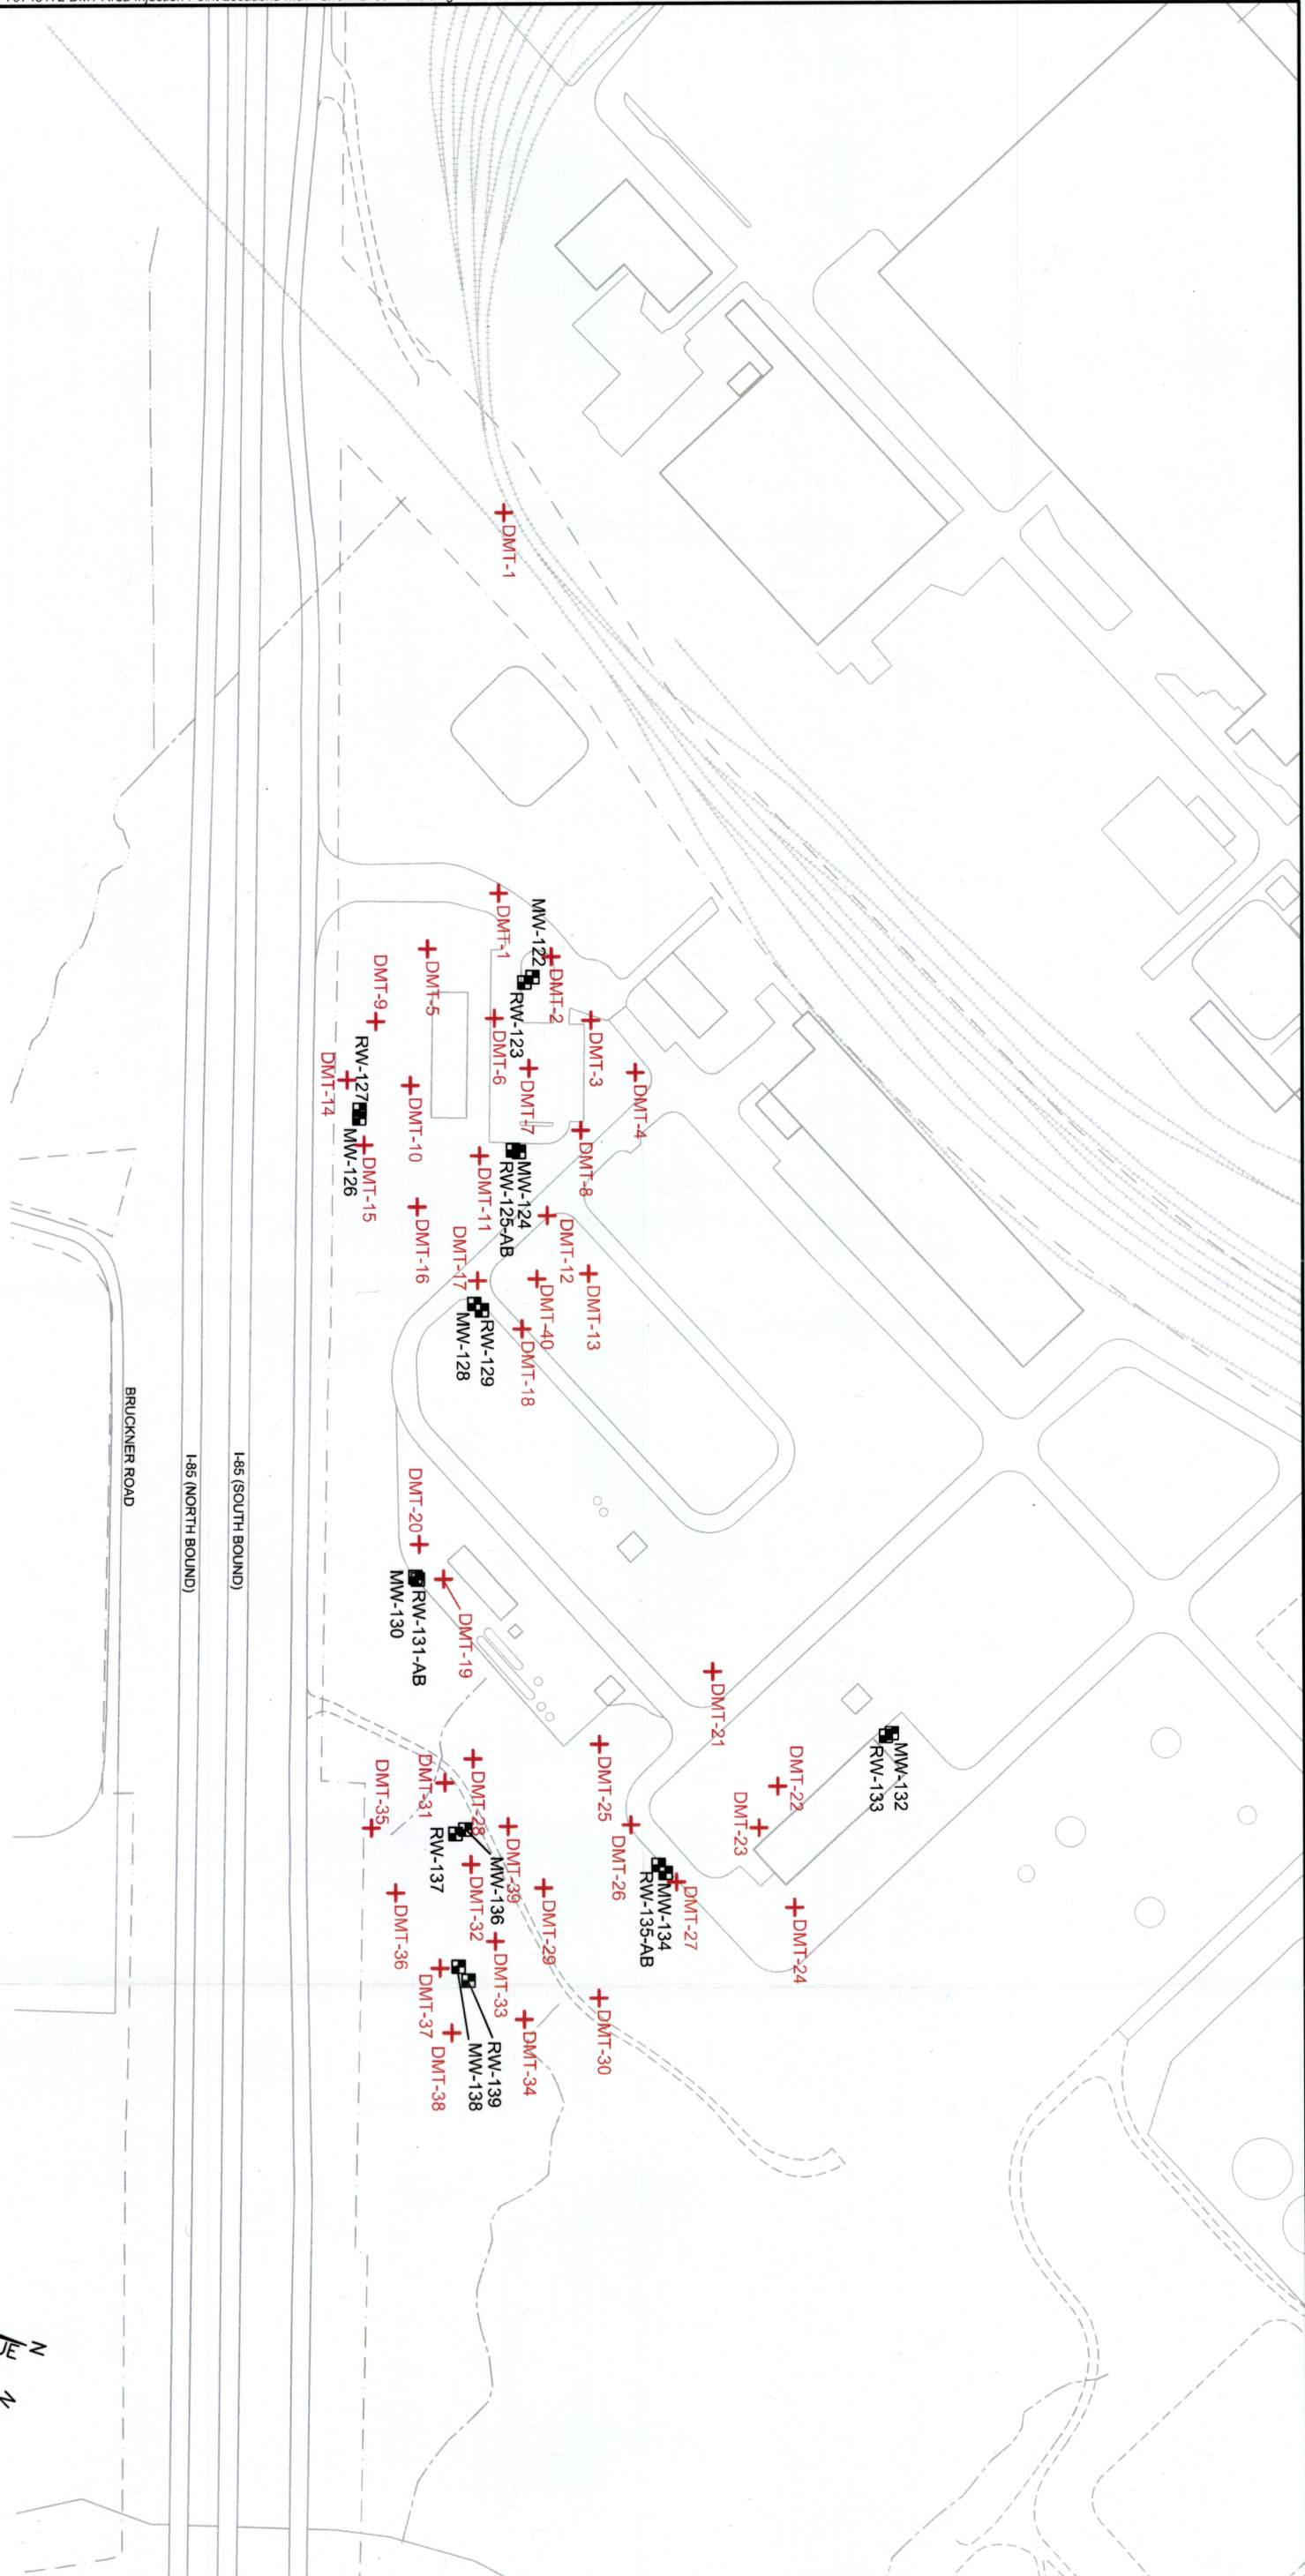
FIGURE 1
DMT INJECTION POINT LOCATIONS

Injection activities were completed in the DMT vicinity between April 21 and May 9th. A total of 40 injection locations were completed. As described in the March 2013 recommendation, the 38 proposed injection locations were supplemented with two additional locations within the target treatment area.

Injection details are summarized on Table 1 and the surveyed injection locations are presented on Figures 1. Injection activities were completed as described in the March 25, 2013, recommendation and subsequent modifications. One drum of sodium lactate was diluted in water to approximately 500 gallons in a portable container. The mixture was then injected under pressure into a temporary injection well. Injection was initiated at approximately refusal depth. Injection was continued at intervals between the refusal depth and potentiometric surface. In some cases, injection fluid was observed returning to the surface either through the well or through the ground nearby. In each case, the daylighting was controlled by reducing injection pressure and limiting the elevation of injection. Complete injection of the 500 gallons was achieved at each location under conditions which did not produce daylighting. The injections depths, pressures and total time of injection activity are included on Table 1.

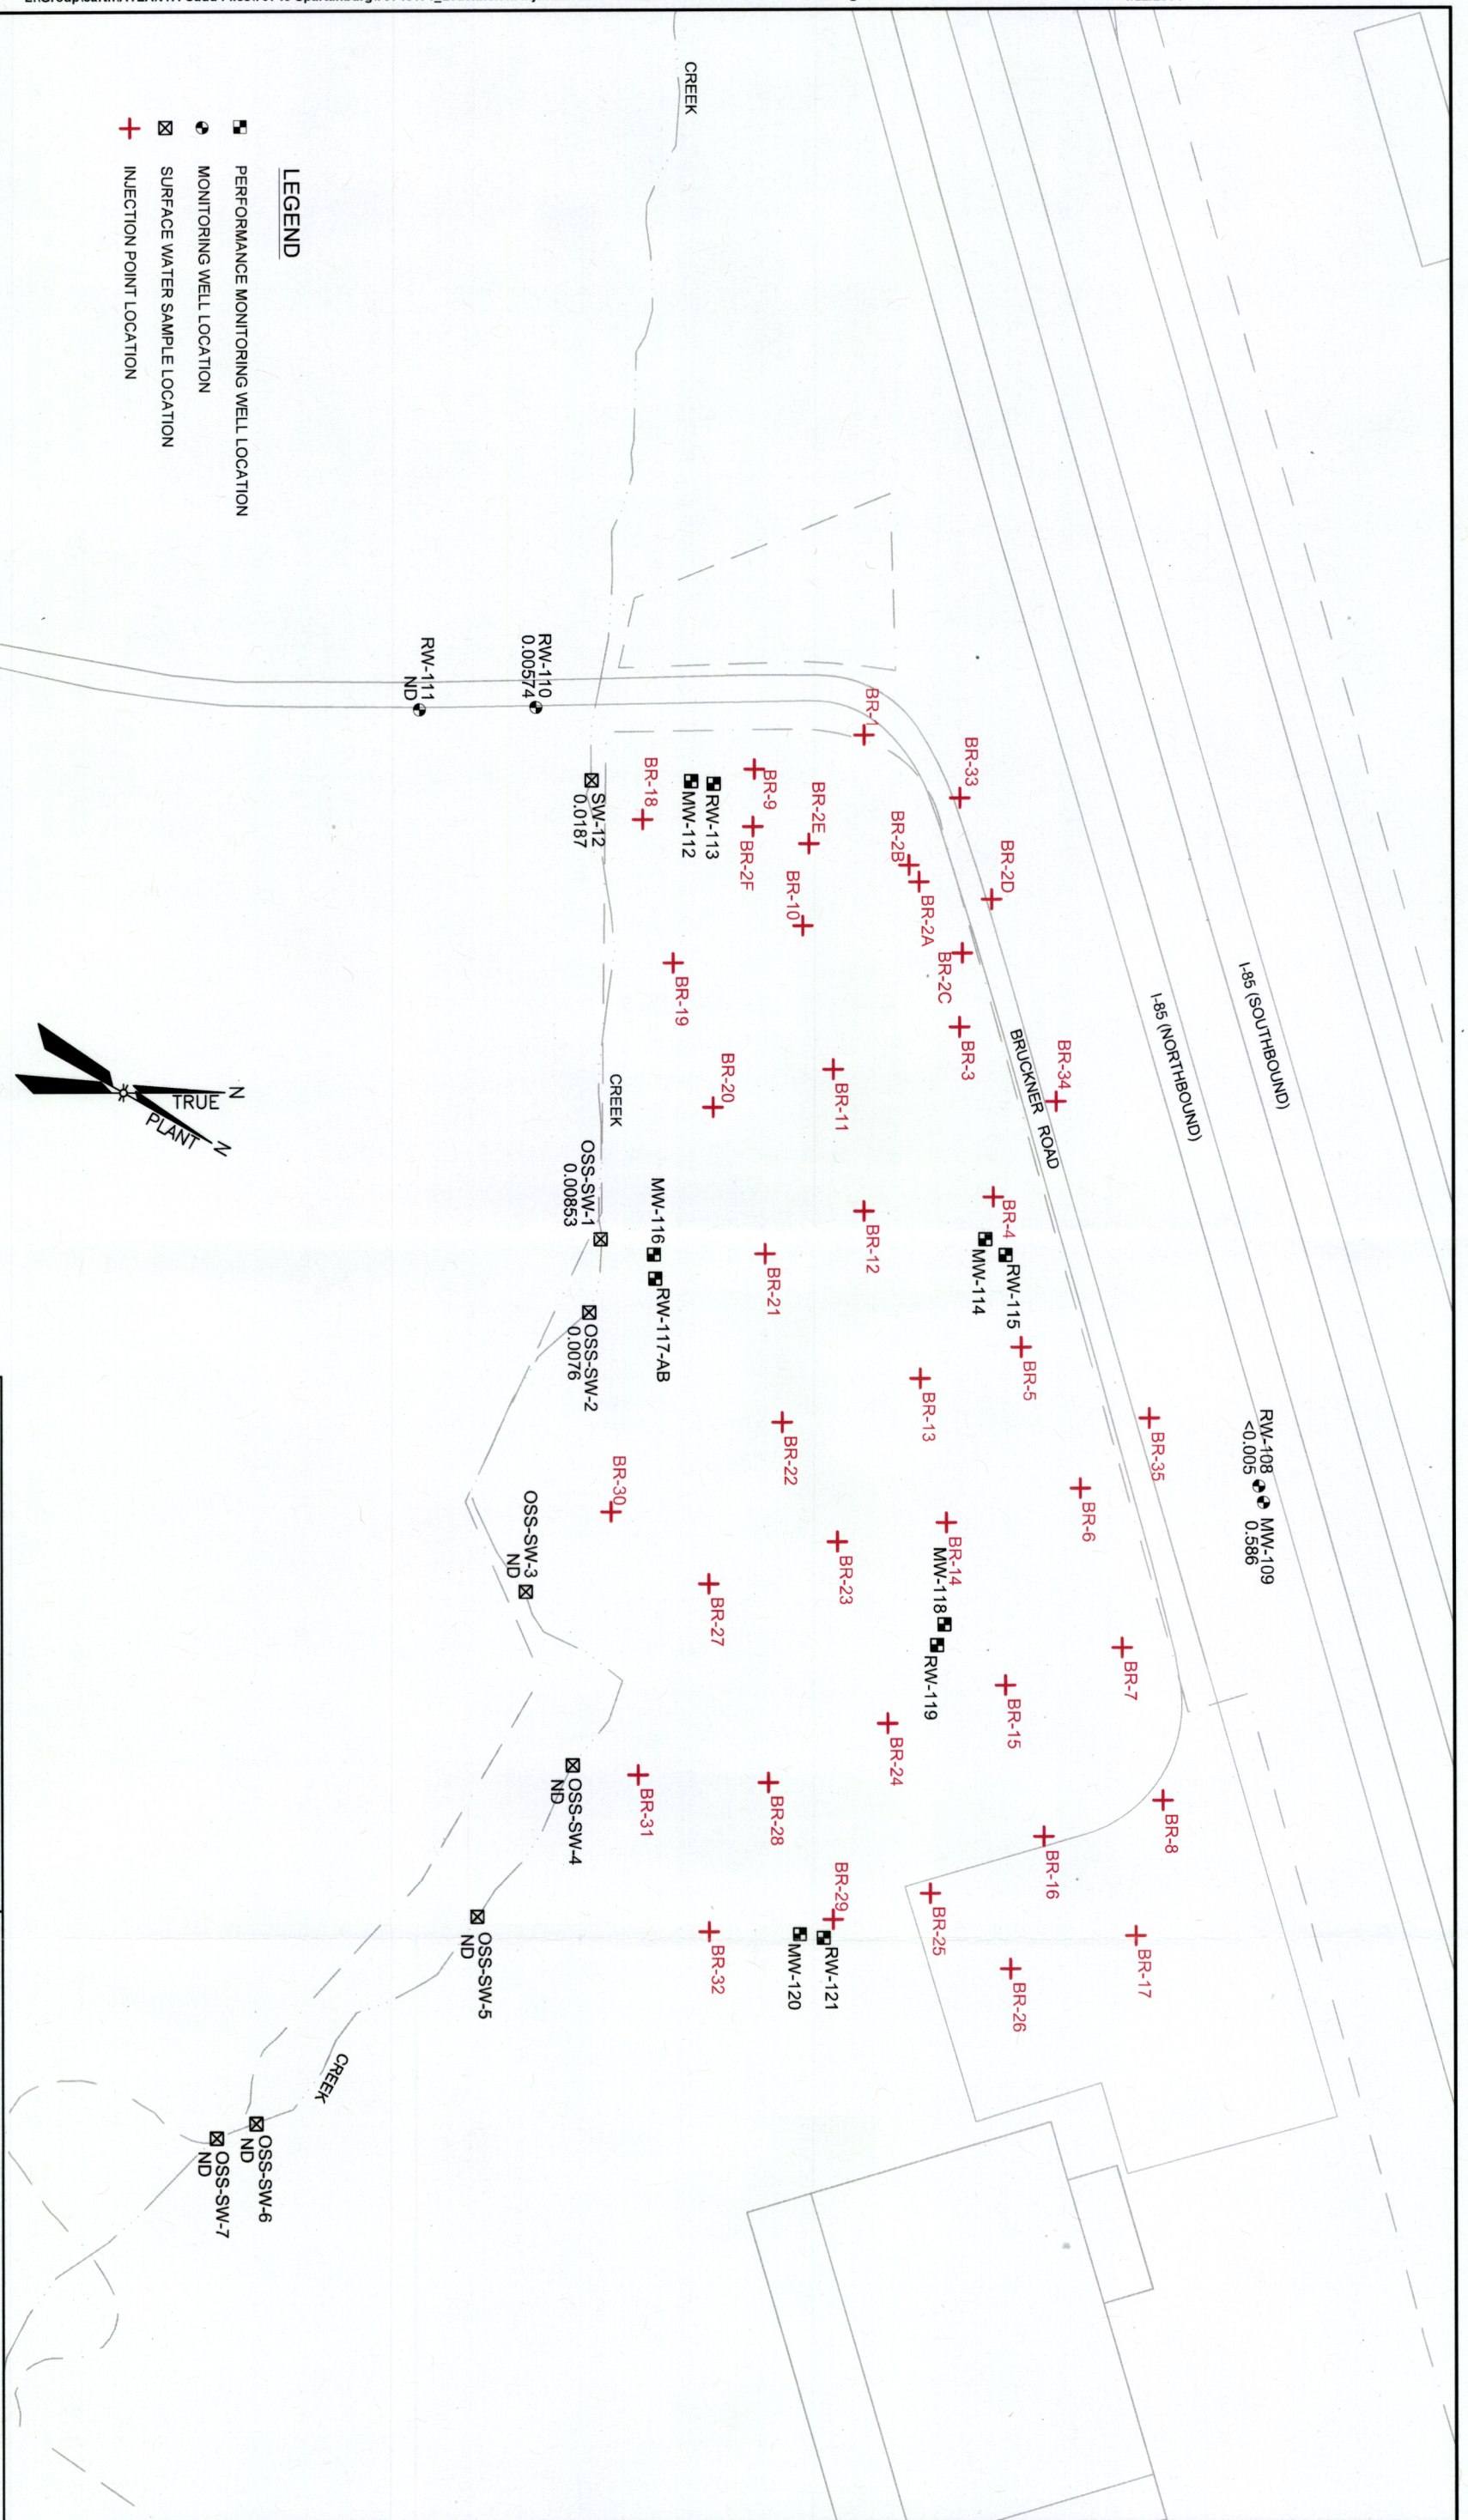
FIGURE 2
BRUCKNER ROAD INJECTION POINT LOCATIONS

Injections were completed at 36 locations within the property at 600 Bruckner Road between May 13 and May 30th. As described in the August 2013 plan, the 32 proposed injection locations were supplemented with three additional locations within the target treatment area.

Injection details are included on Table 1 and the injection locations are presented on Figure 2. Several attempts were required to complete injection at location BR-INJ2. At several points, refusal was encountered prior to groundwater. At one location (BR-INJ2E), groundwater was encountered, but the matrix limited the rate and acceptance of injected material. The balance of material was injected at adjacent alternate location BR-INJ2F. Both BR-INJ2E and BRINJ2-F are included on Table 1. Each of the attempted BR-INJ2 locations, including dry refusals, is presented on Figure 2. Injection locations BR-INJ2E and BR-INJ2F are two separate injection points for the total count of 36 permitted injection wells. However, because the total injection was 500 gallons and these locations are immediately adjacent, they are considered to be a single injection location for remediation purposes.

Injection at location BR-INJ33 resulted in significant daylighting and slow progress. The injection at this location was halted after 250 gallons. The additional 250 gallons was injected at location BR-INJ1 for a total of 750 gallons at this location. The target volume of 500 gallons was injected at all other locations.
